Inspection Photos

Operator: BP America
API: 067-07175
Date: 10/20/2020

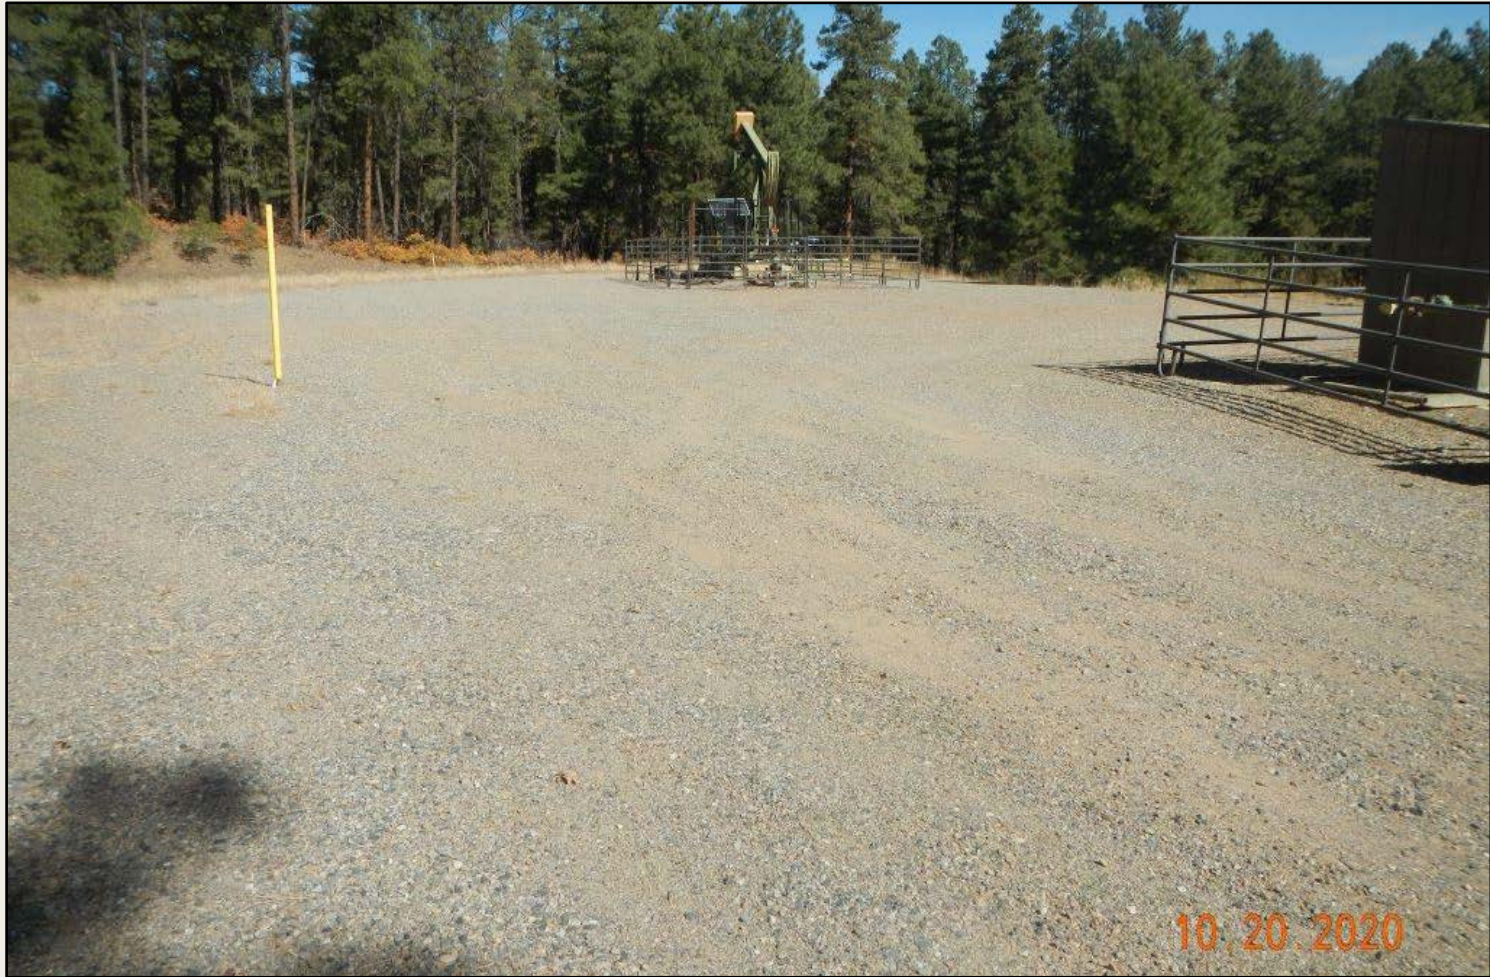
Photo 1. View of the project area from the well pad entrance facing center.

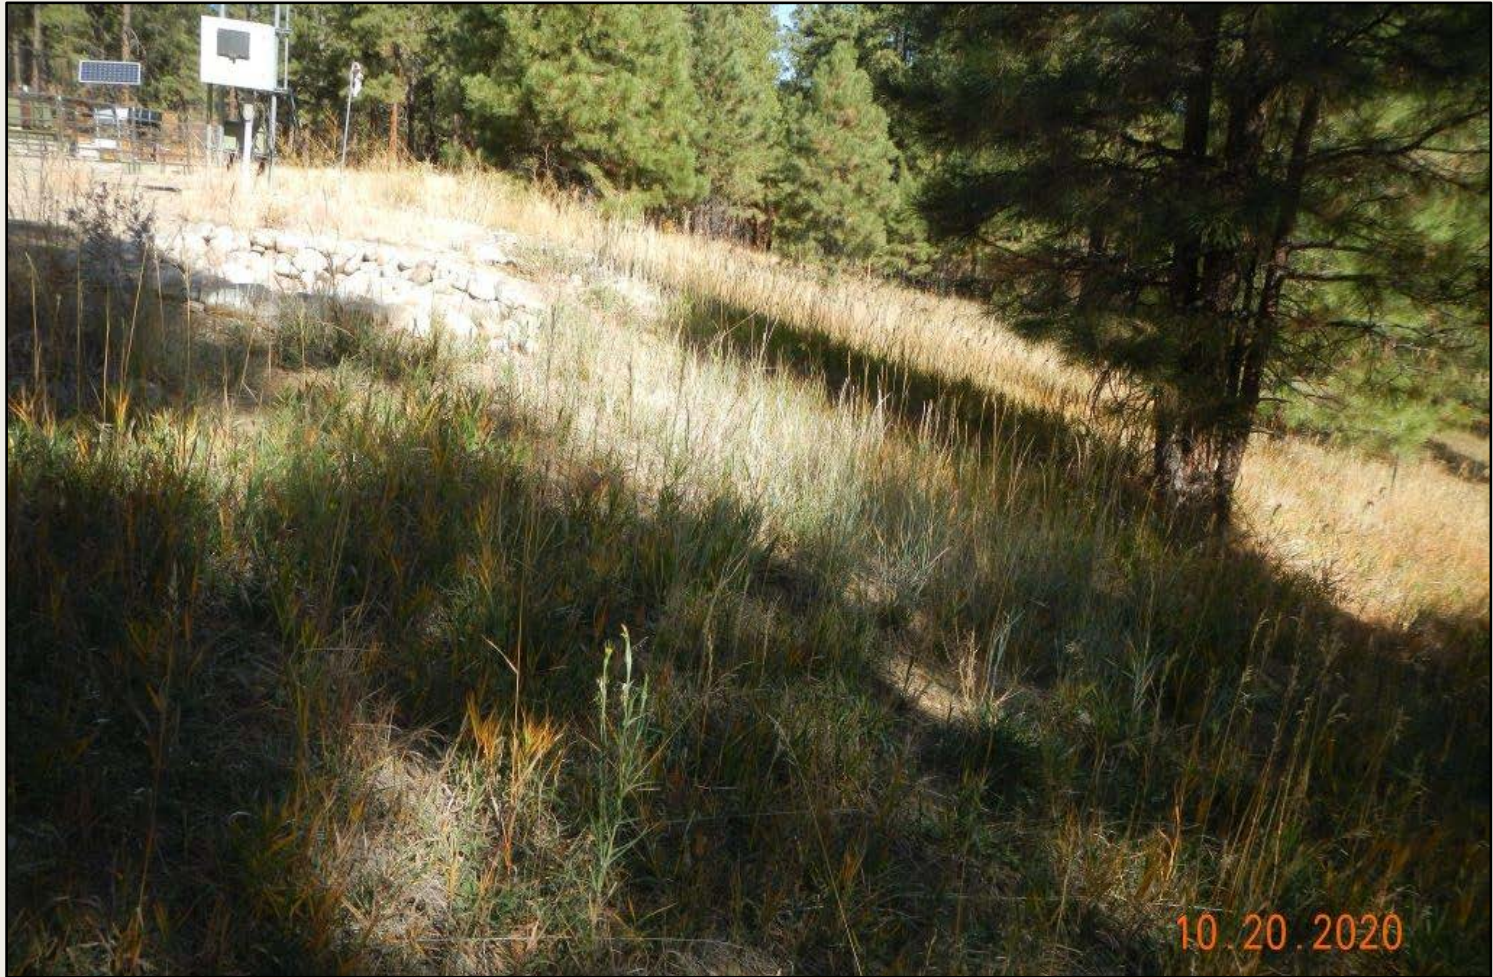
Photo 2. View of the eastern fill slope from the southeastern corner facing northward. Revegetation is progressing with western wheatgrass, sand dropseed, and smooth brome. Stormwater controls appear to be functioning at this time.

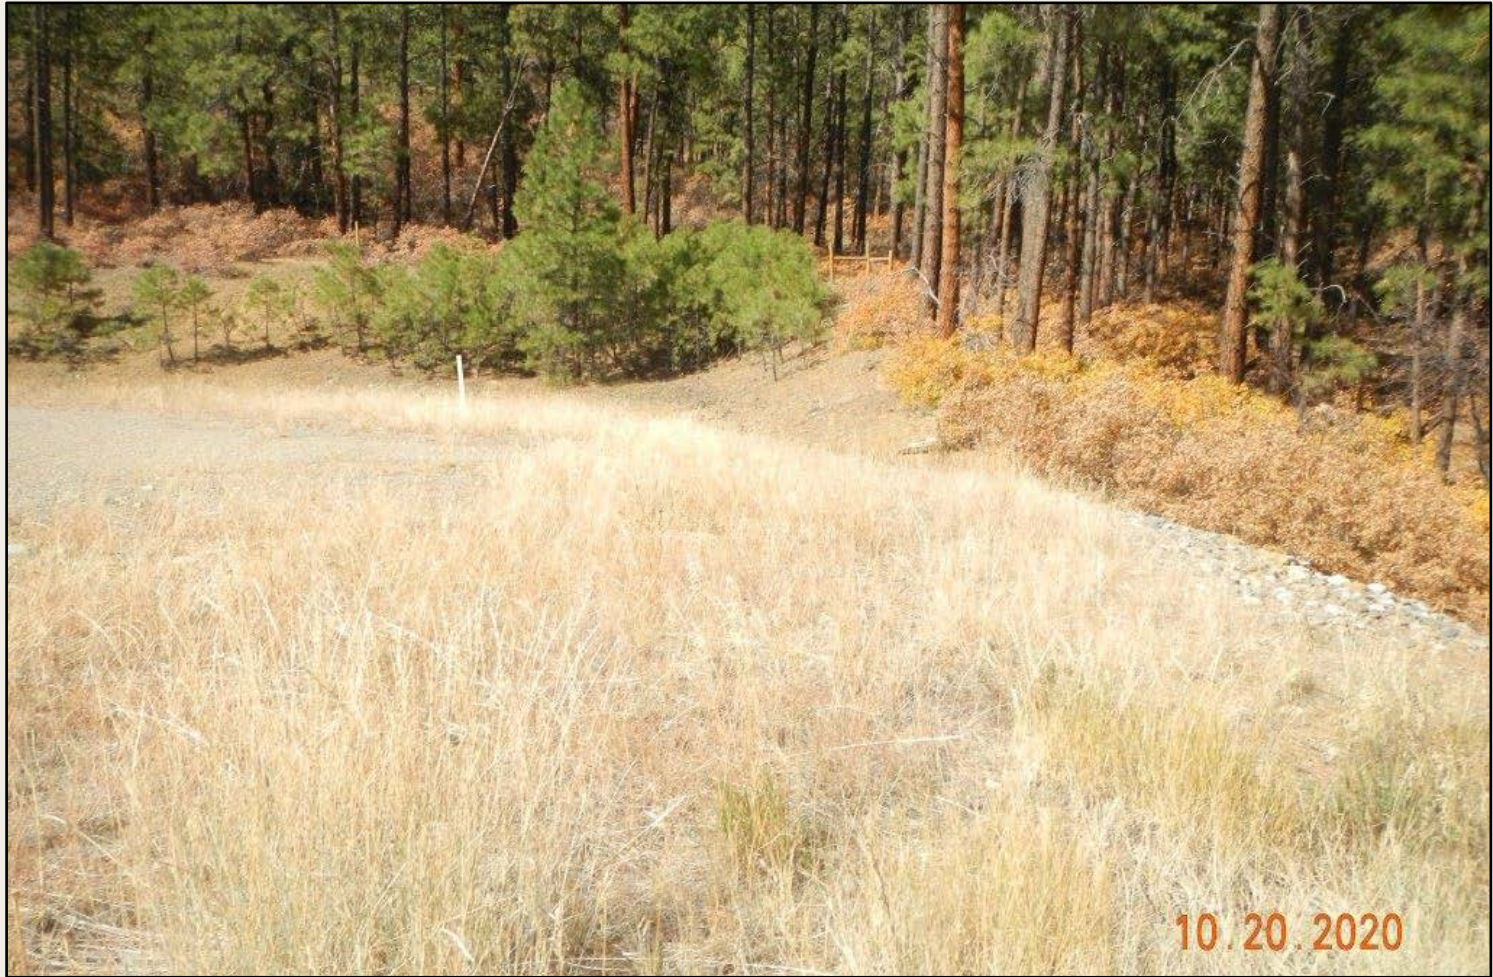
Photo 3. View of the northern project area from the northeastern corner facing westward.

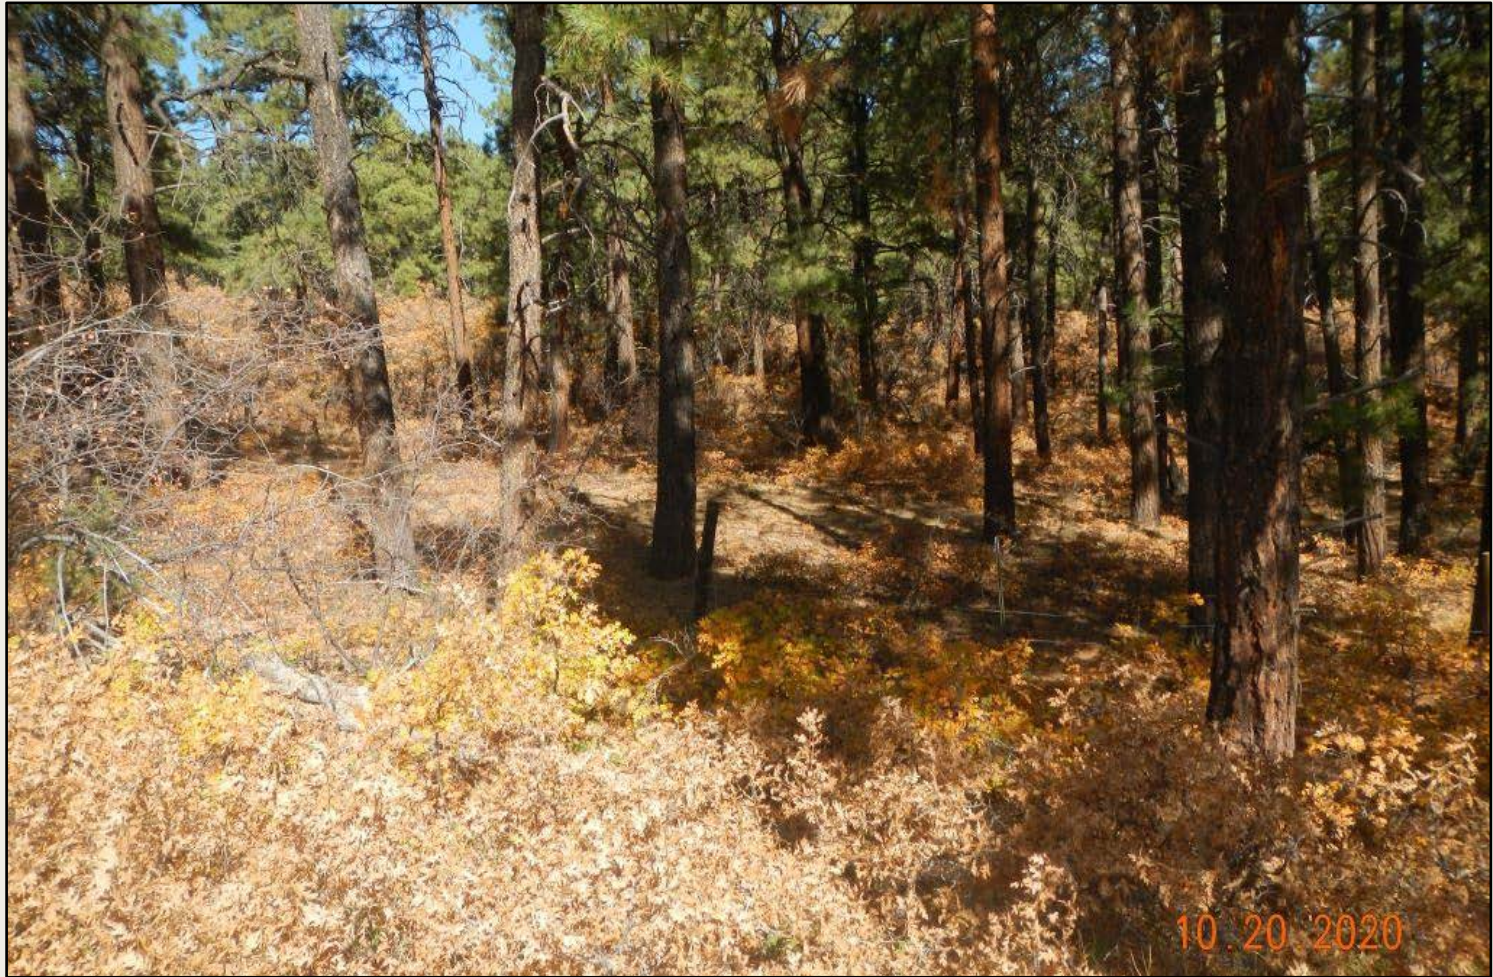
Photo 4. View of reference area vegetation comprised of ponderosa pine woodland with gambel oak, western wheatgrass, prairie junegrass, and Oregon grape in the understory.
