Inspection Photos

Operator: Crescent Point Energy
API: 113-06220
Date: 10/20/2020

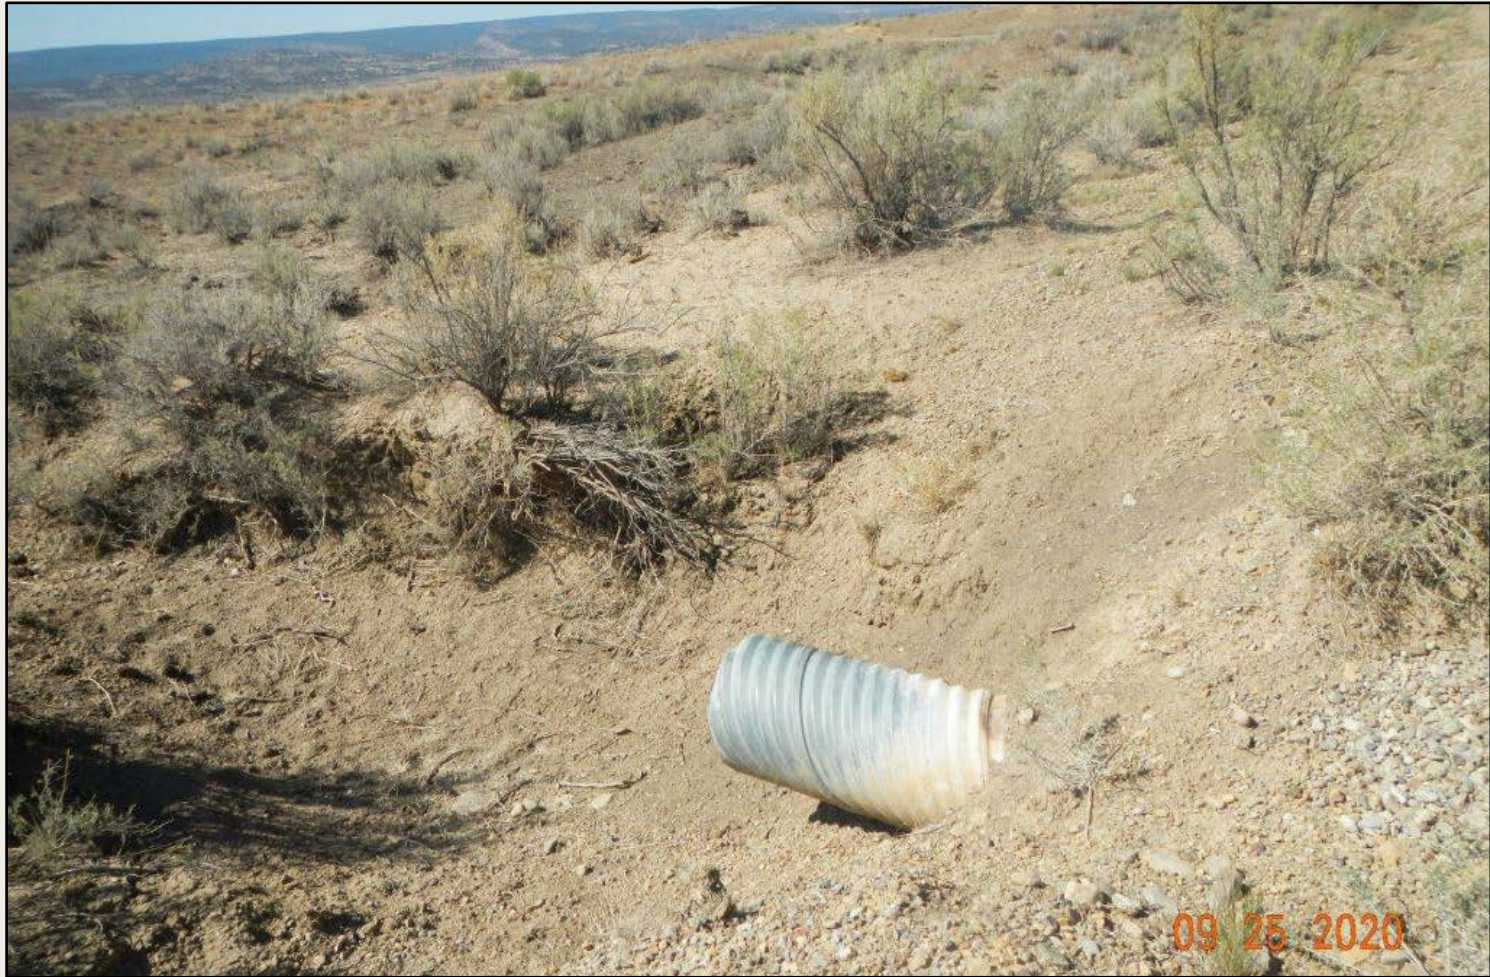
Photo 2. View of culvert outlet along the access road that is not stabilized and above grade.

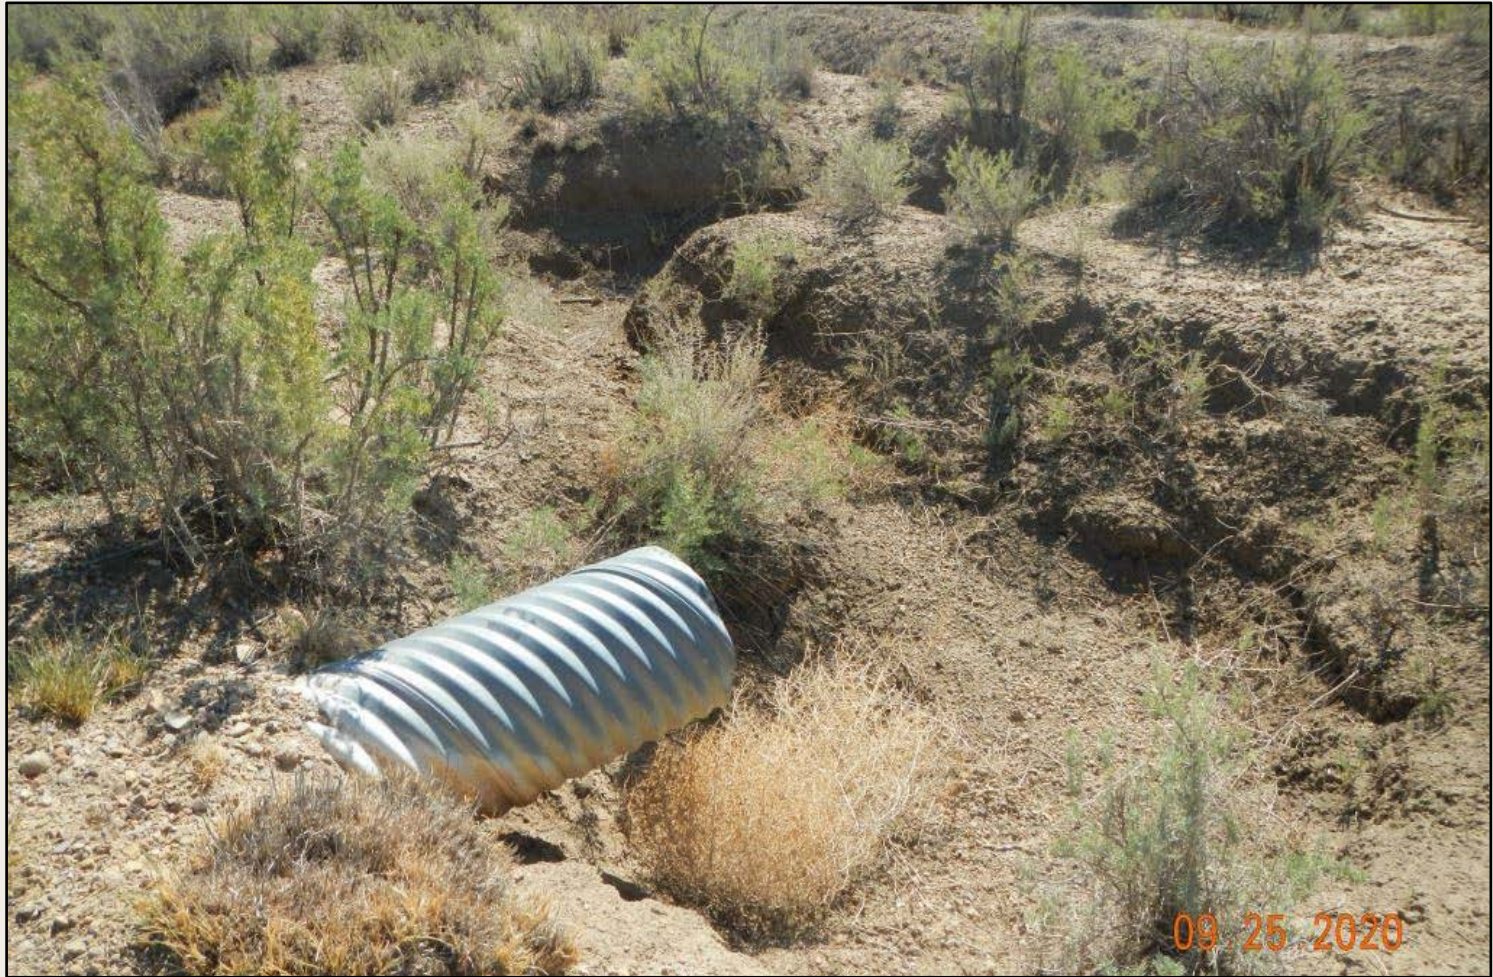
Photo 3. View of another culvert outlet needing stabilization.

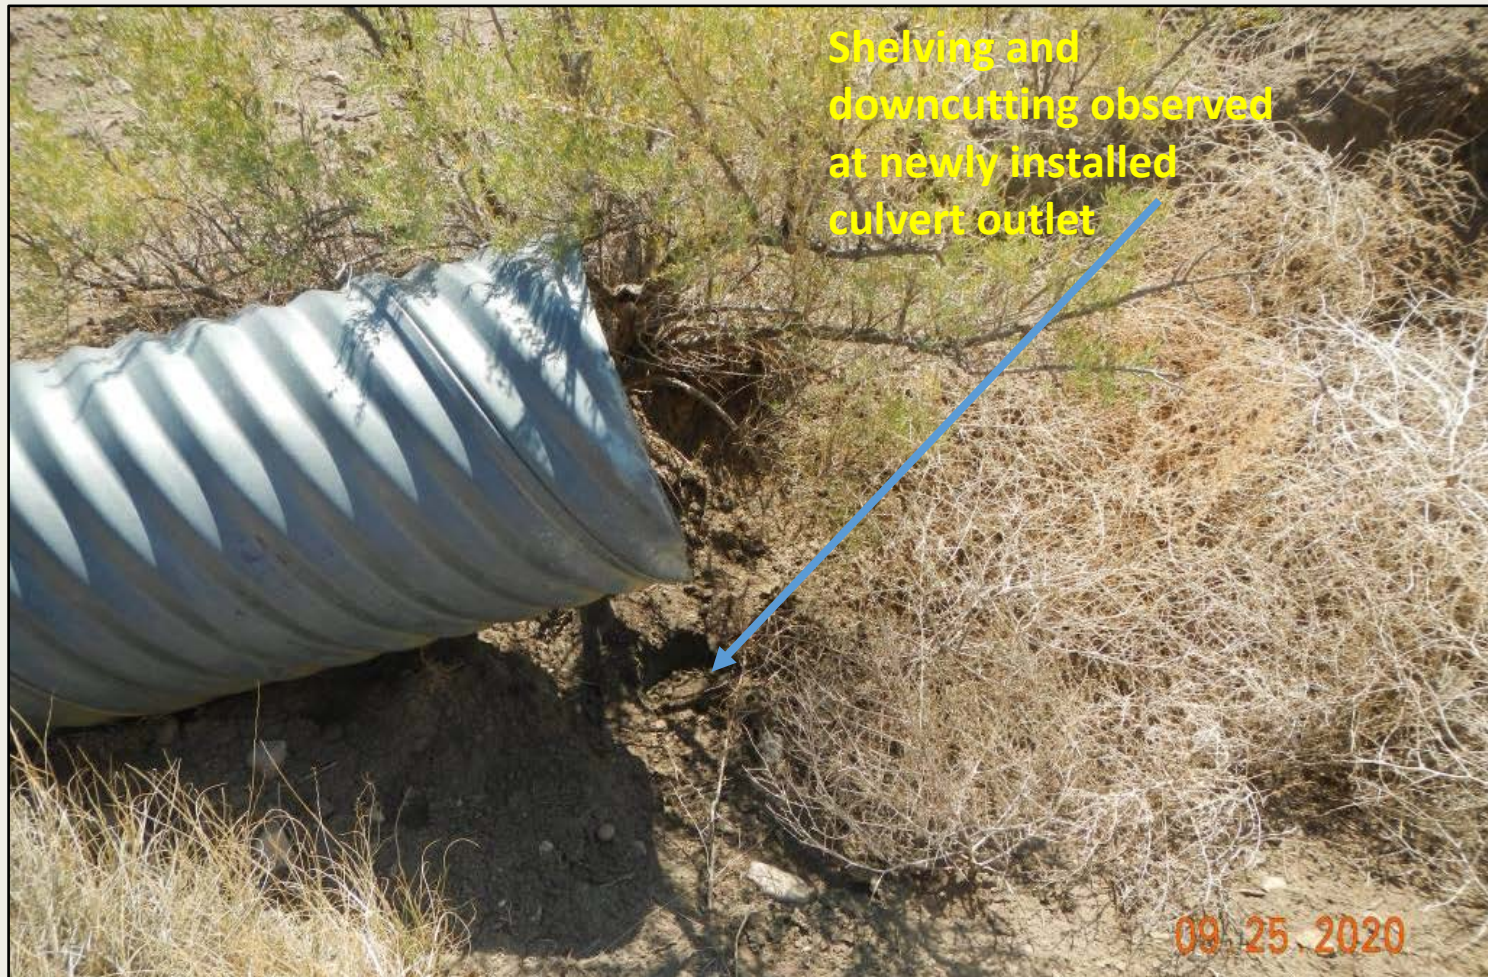
Photo 4. Closeup view of culvert outlet needing stabilization, where you can see erosional down-cutting starting to occur.
