Stormwater Inspection Report

| Operator: | Laramie Energy, LLC |
| Project: | Homer Deep |
| Location: | HDU 15-23 |

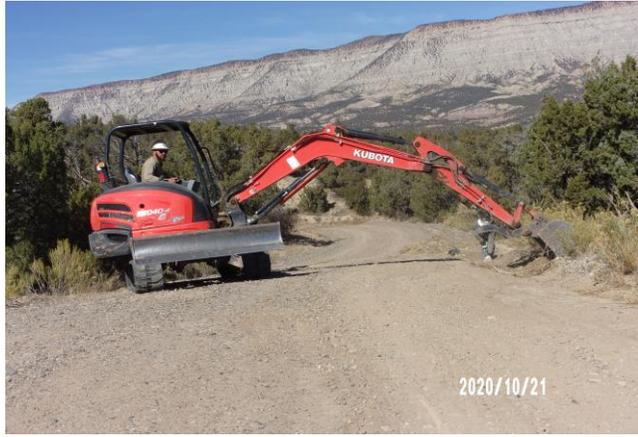
Photo 1

BMP Operations on the HDU 15-23 Access Rd

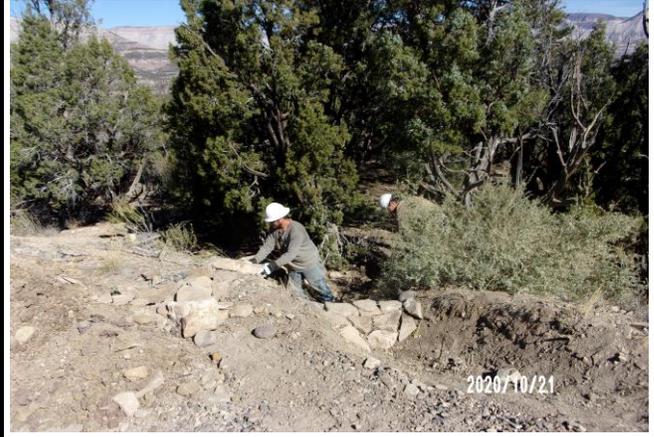
Photo 2

BMP Operations on the HDU 15-23 Access Rd

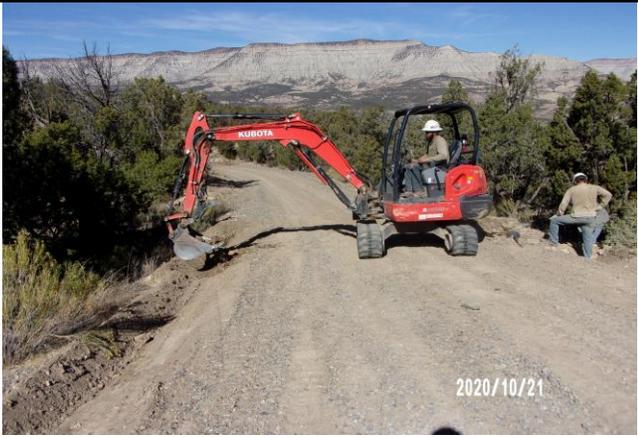
Photo 3

BMP Operations on the HDU 15-23 Access Rd
