Inspection Photos

API: 043-40014

Operator: JAVERNICK OIL

Inspection Date: 10/19/2020

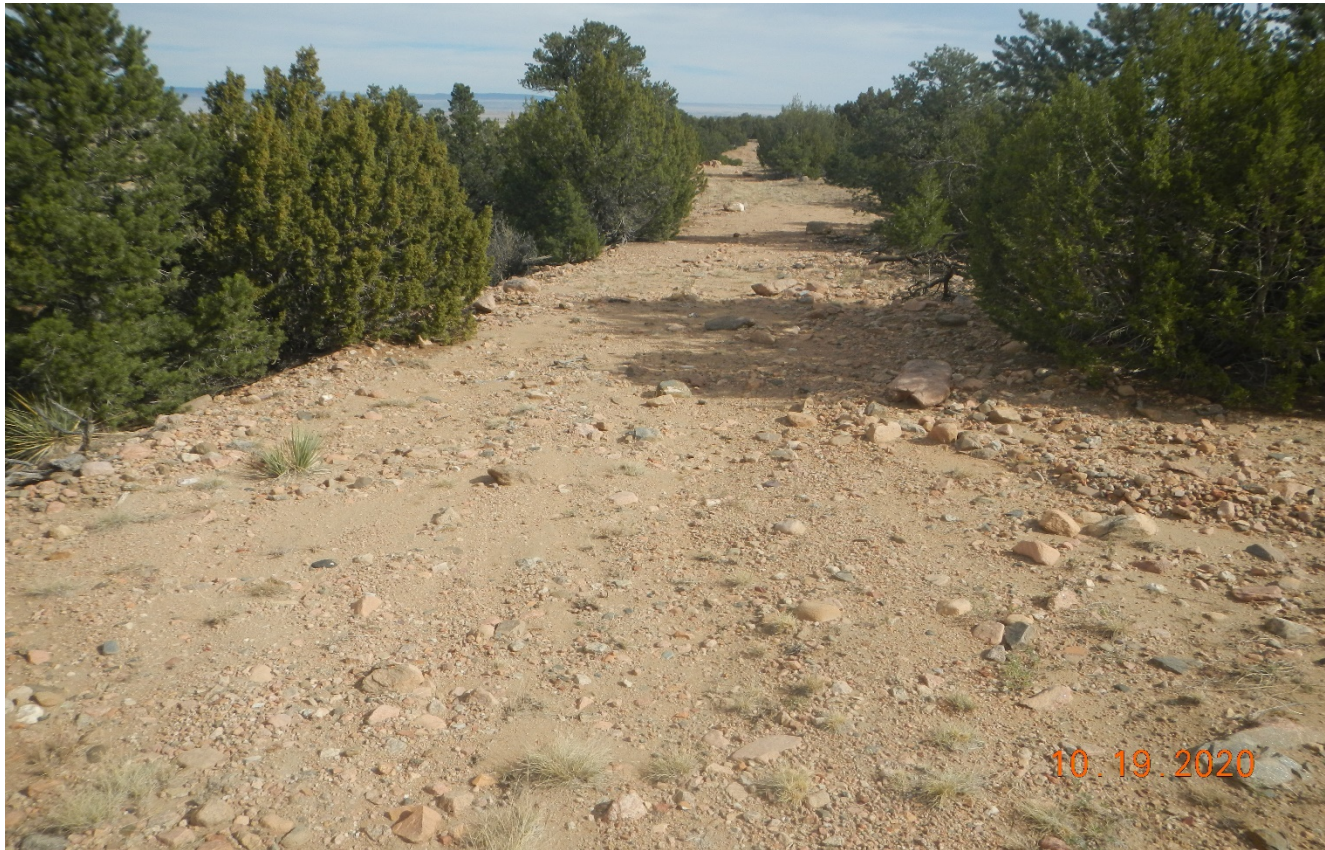
Photo 1. Facing northeast along the access road. The road has not been recontoured and reclaimed. Previous corrective action was not performed.

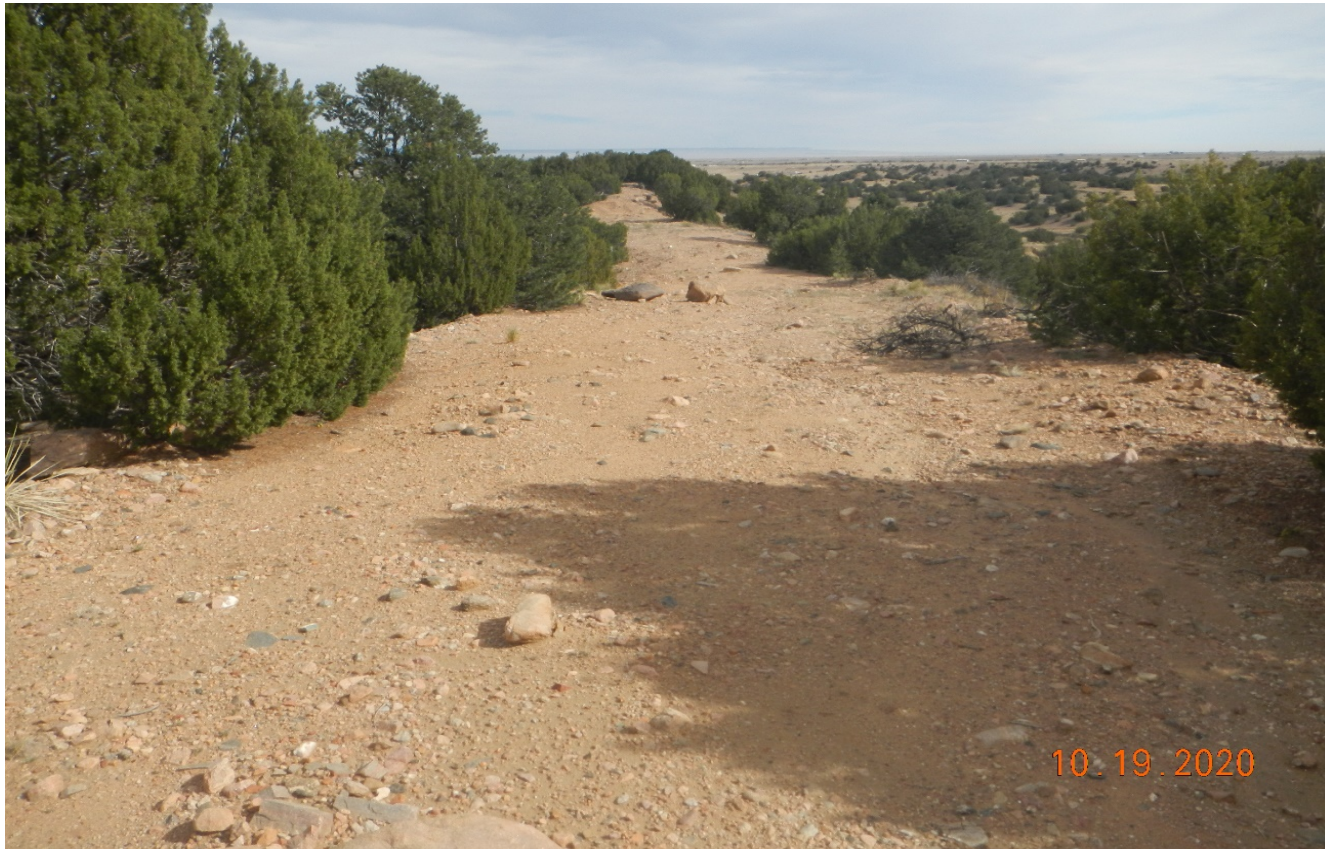
Photo 2. Facing northeast along the access road. The road has not been recontoured and reclaimed. The soils are bare of vegetation and susceptible to erosion.

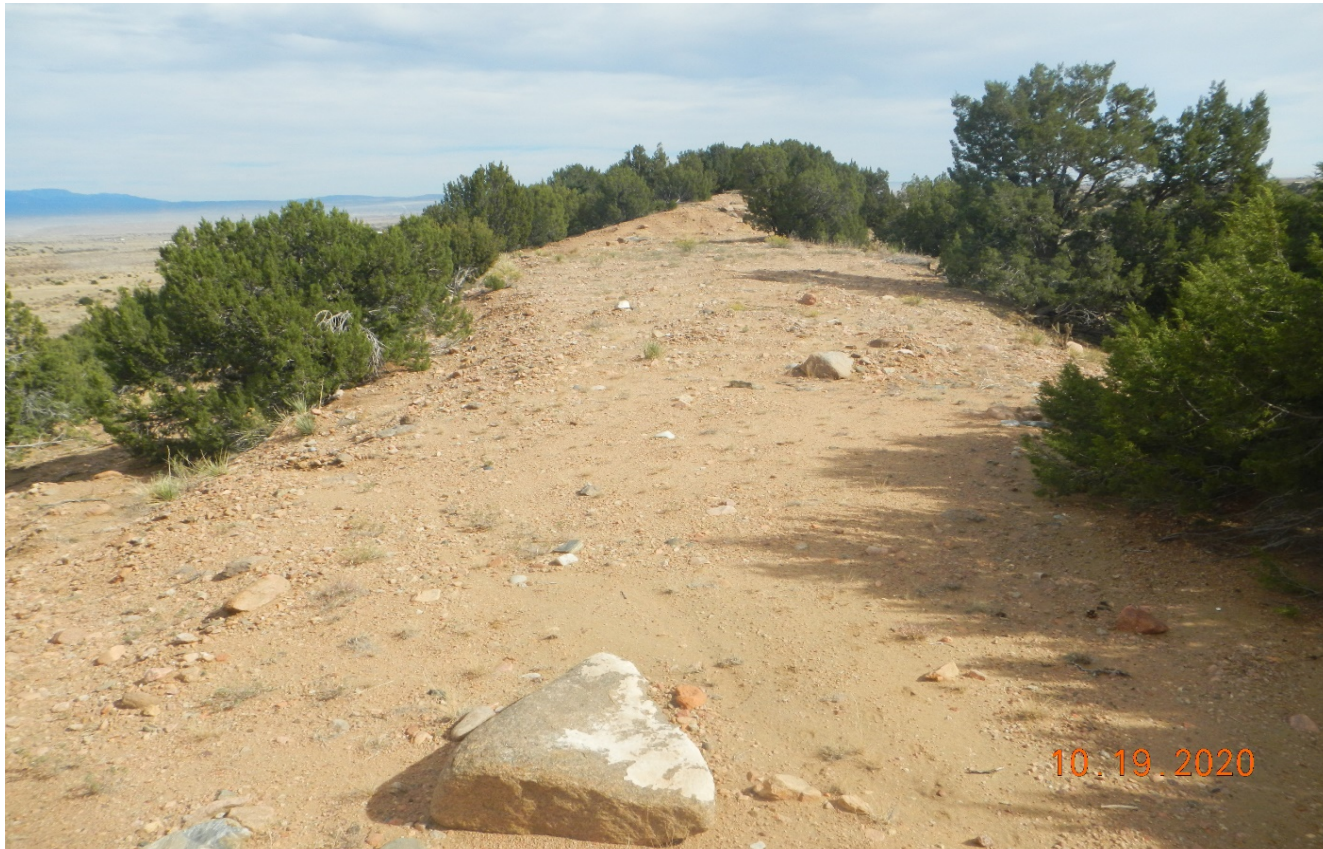
Photo 3. Facing northeast at the location which has not been recontoured and reclaimed.

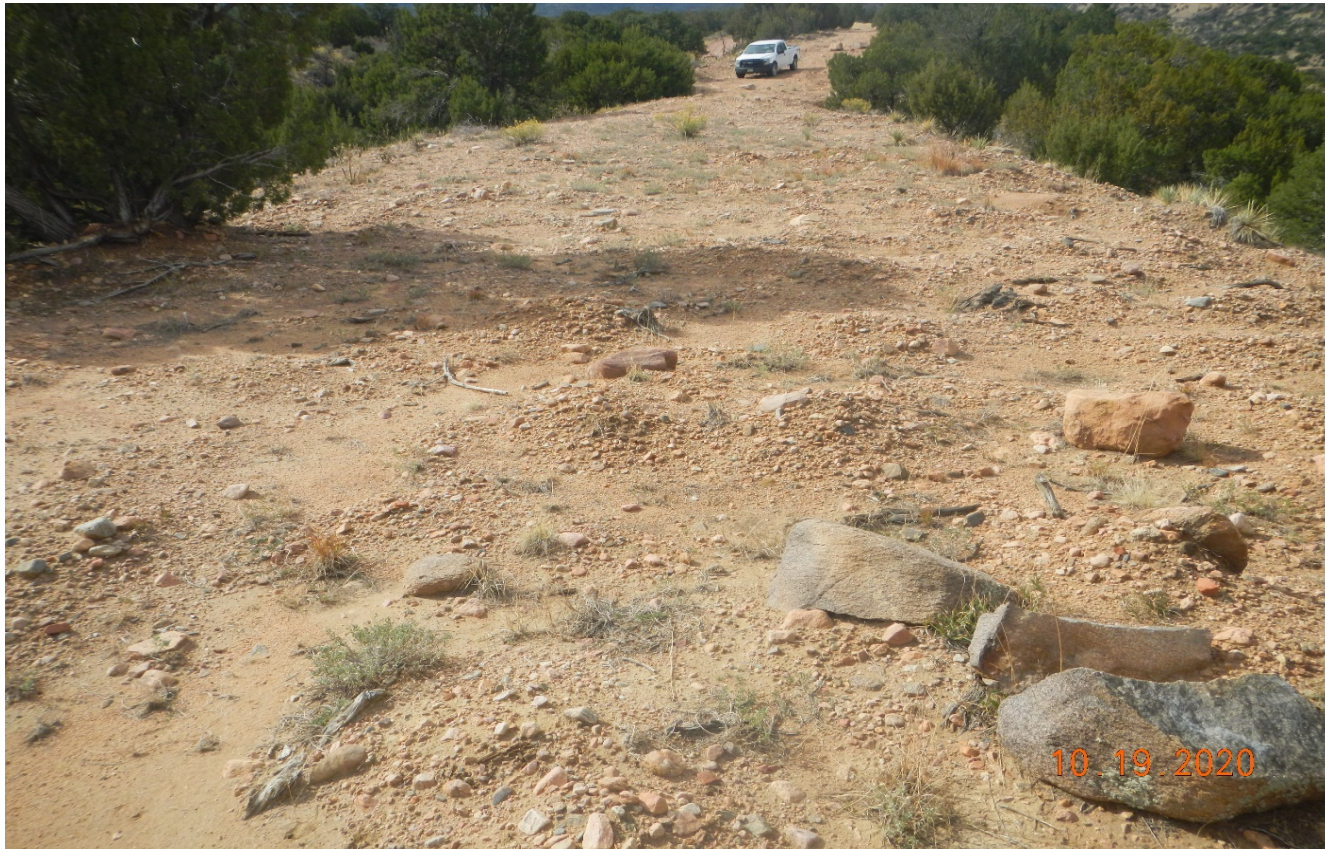
Photo 4. Facing back toward the southwest at the location.

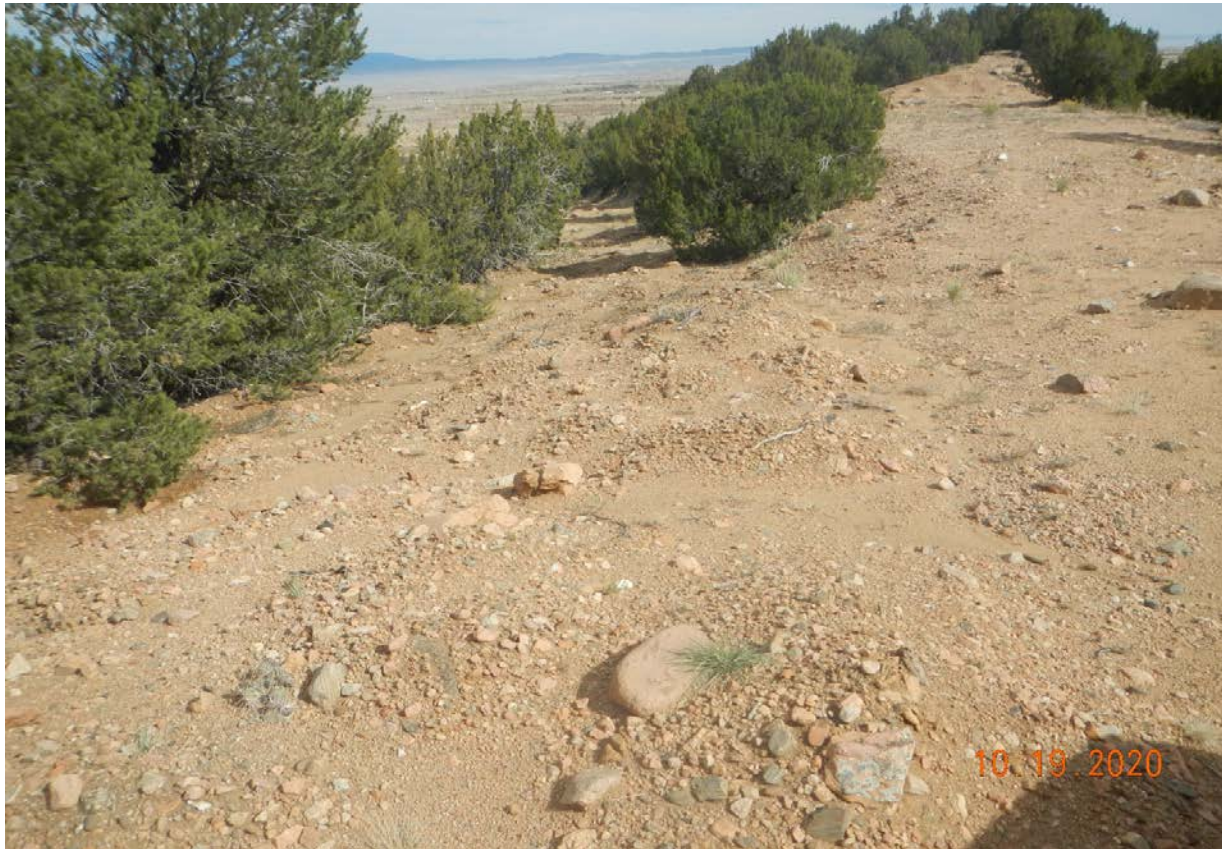
Photo 5. There is an access road that leads northeast to the Drapper4 well site which has not been recontoured and reclaimed.

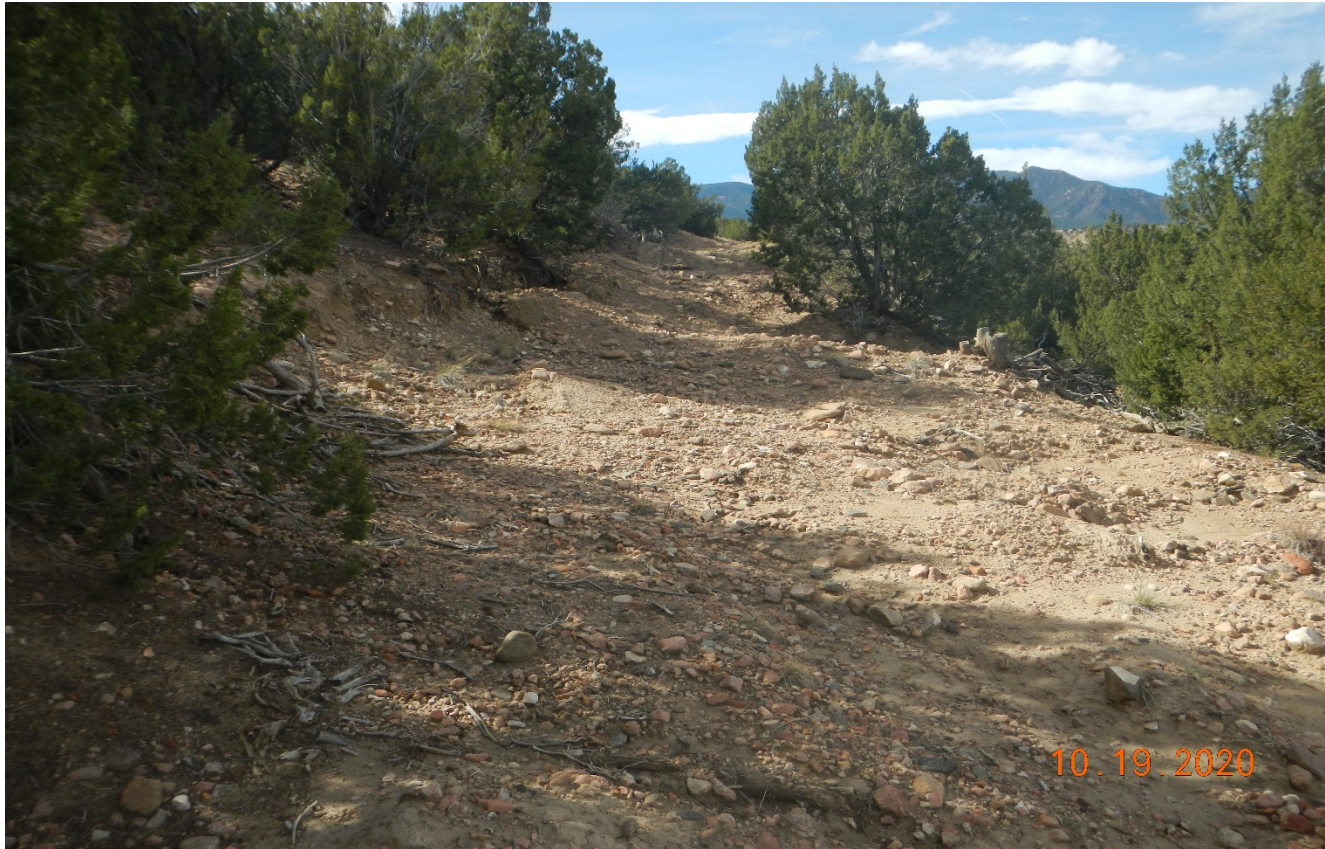
Photo 6. Facing southwest along the access road between the Hassler 24 and Drapper4 well site. This area has not been recontoured and reclaimed and is susceptible to further erosion.
