Inspection Photos

API: 043-40006

Operator: JAVERNICK OIL

Inspection Date: 10/19/2020

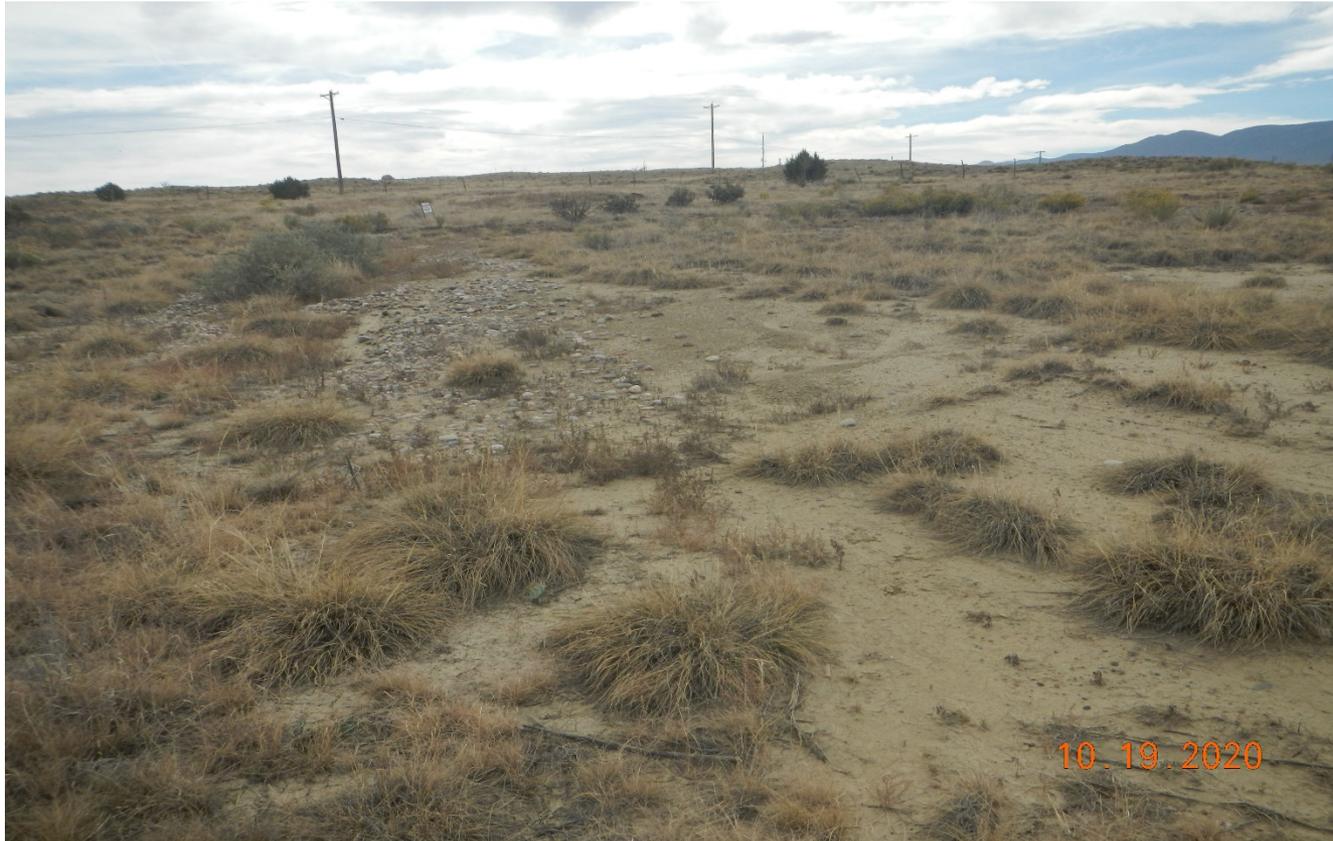
Photo 1. Facing south toward the location. There is large cobble size gravel that remains on the former access road shown in photo. Areas of the location are bare of vegetation and have not been reclaimed. Previous corrective action is not completed.

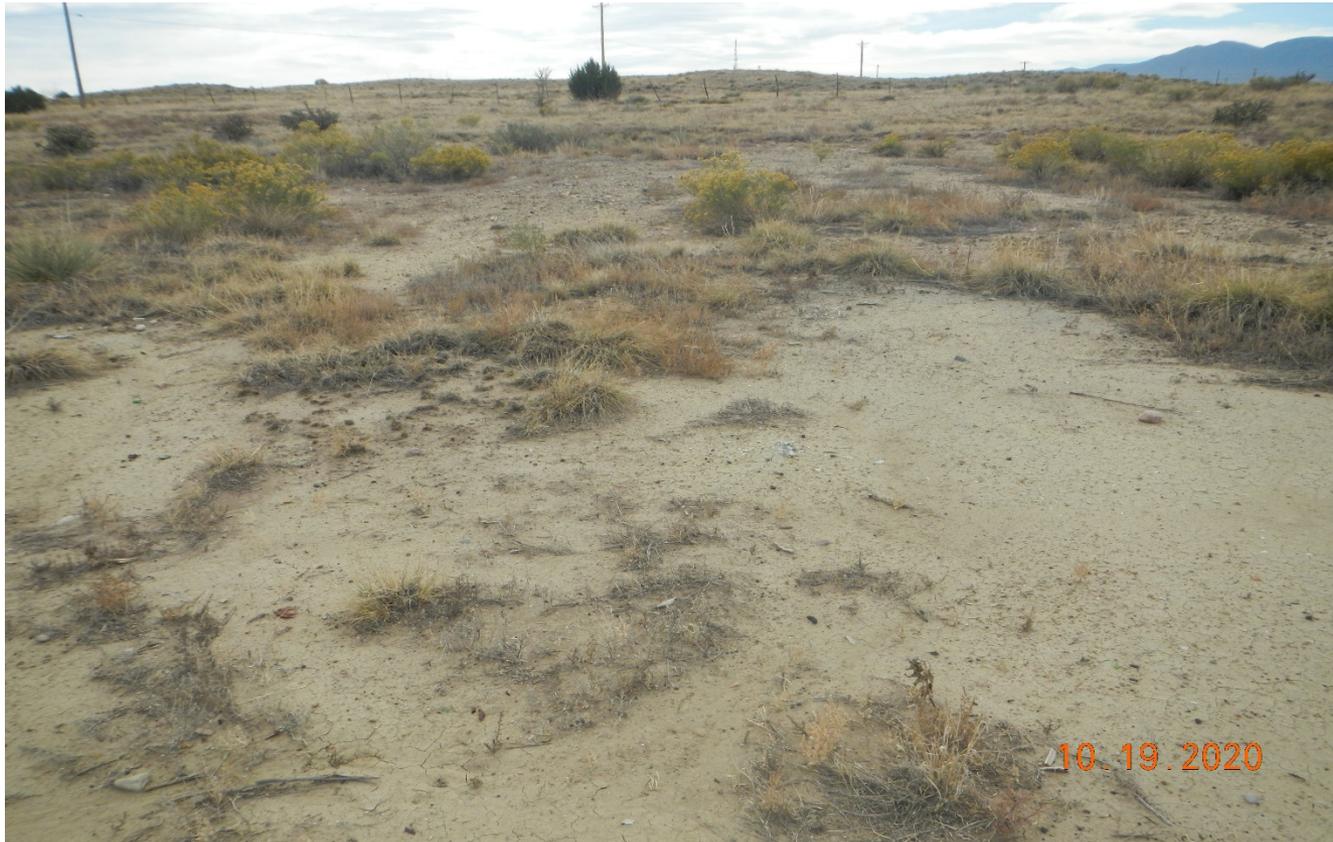
Photo 2. Facing south toward the location. Areas of the location are bare of vegetation and have not been reclaimed.

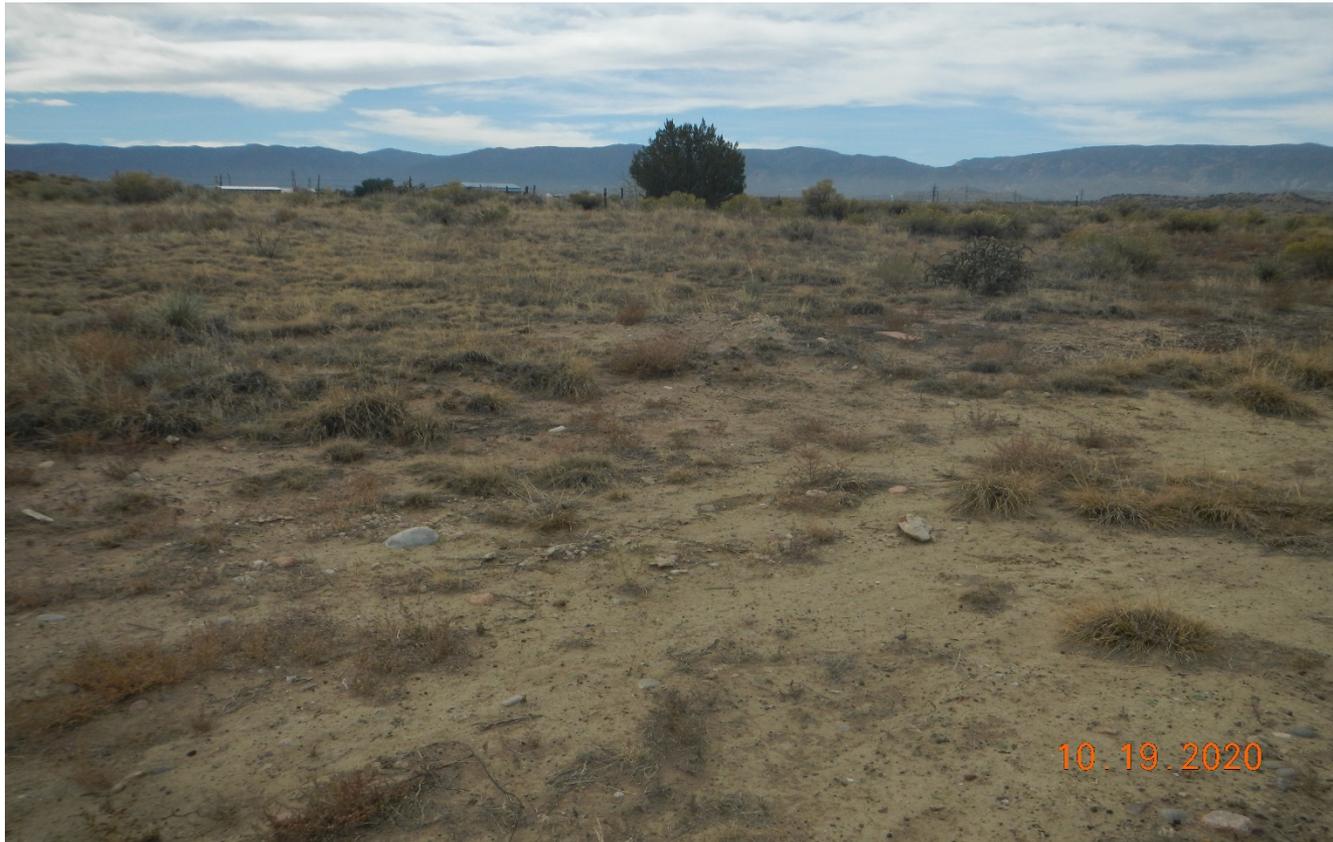
Photo 3. The cement blocks and anchors have been removed since previous inspection from rea shown in photo.

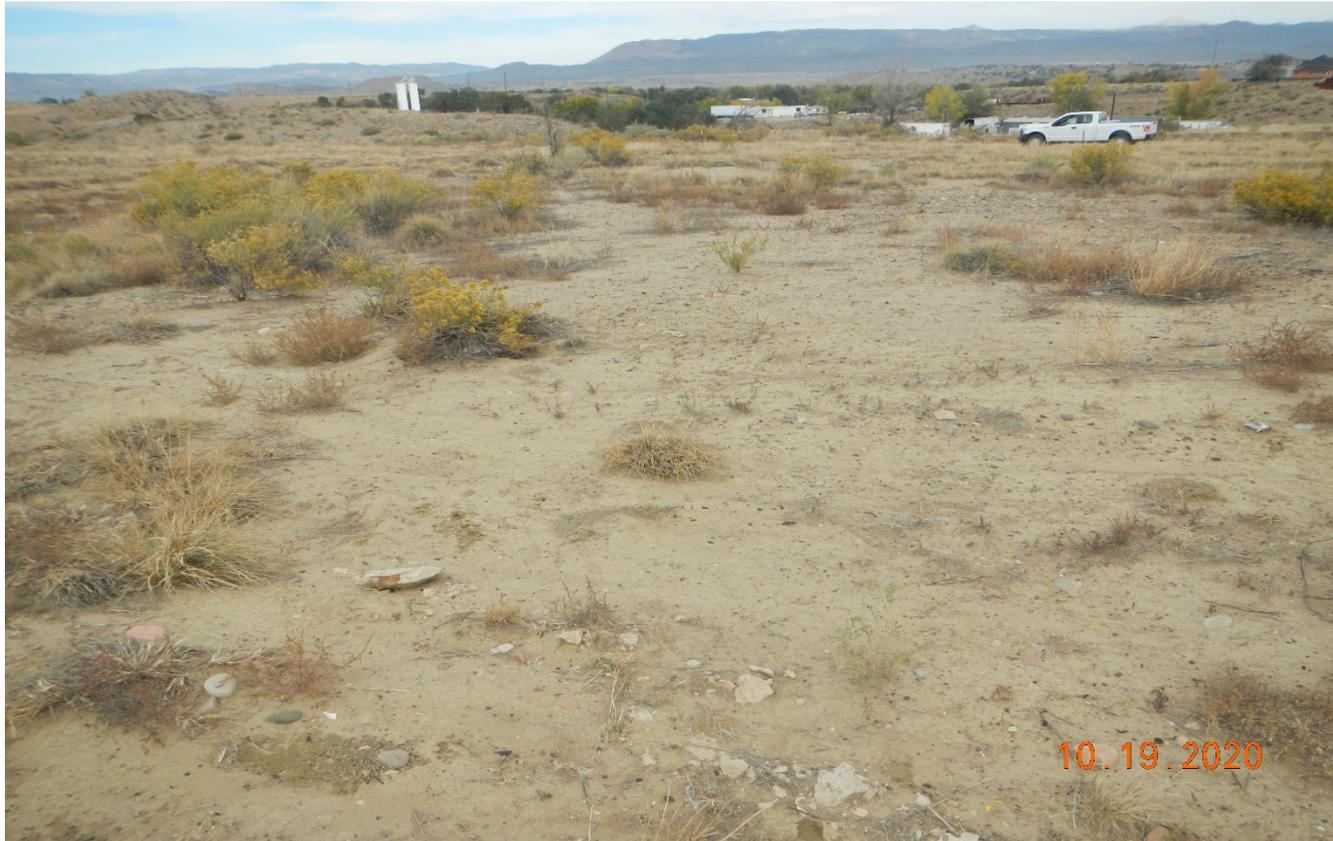
Photo 4. Facing north at the location. Areas of the location are bare of vegetation and have not been reclaimed. Previous corrective action is not completed.
