TEP
RWF 311-15
Location # 335571

COLORADO
Oil & Gas Conservation
Commission
Department of Natural Resources

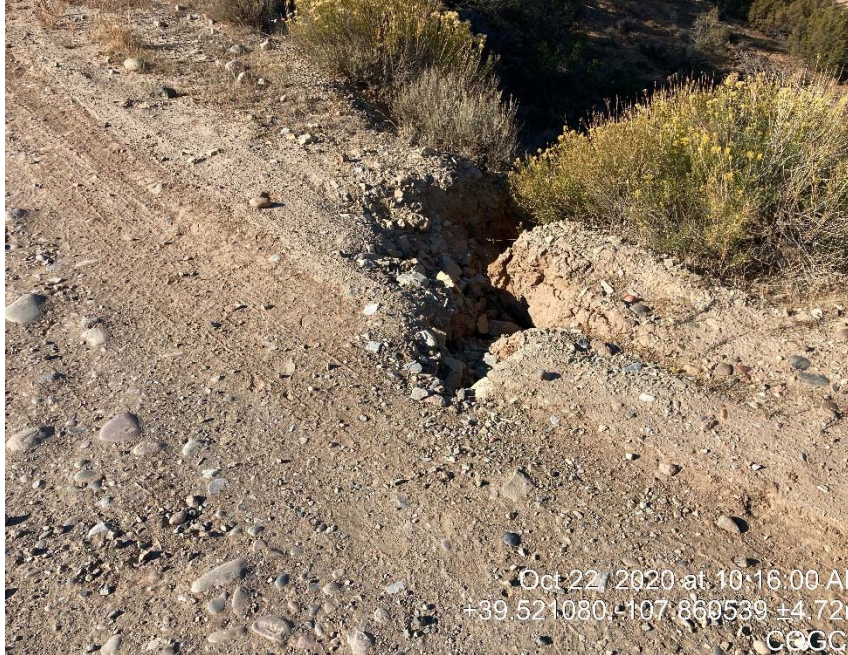
Main road to access pad erosion. At top of hill just before compressor station.

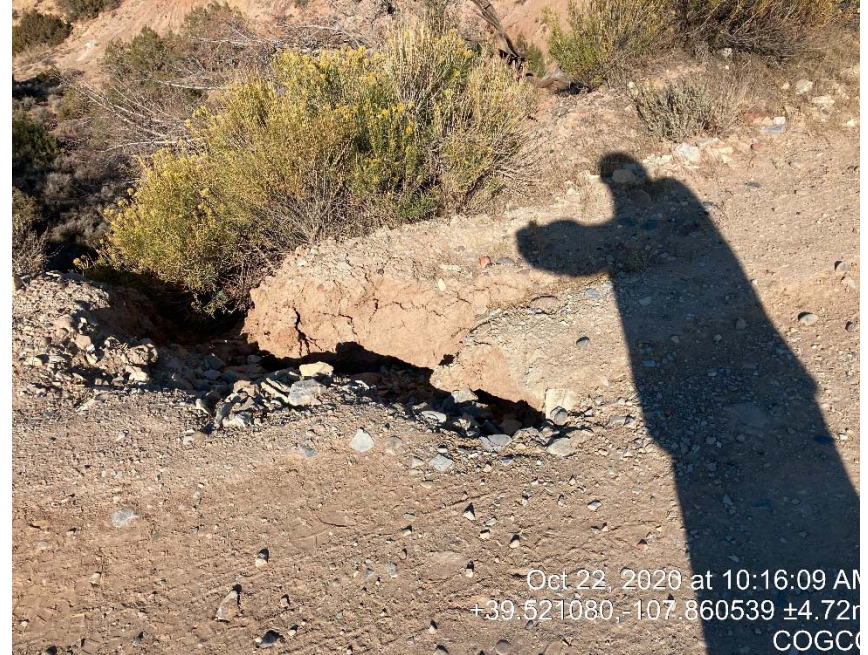
Main road to access pad erosion. At top of hill just before compressor station.

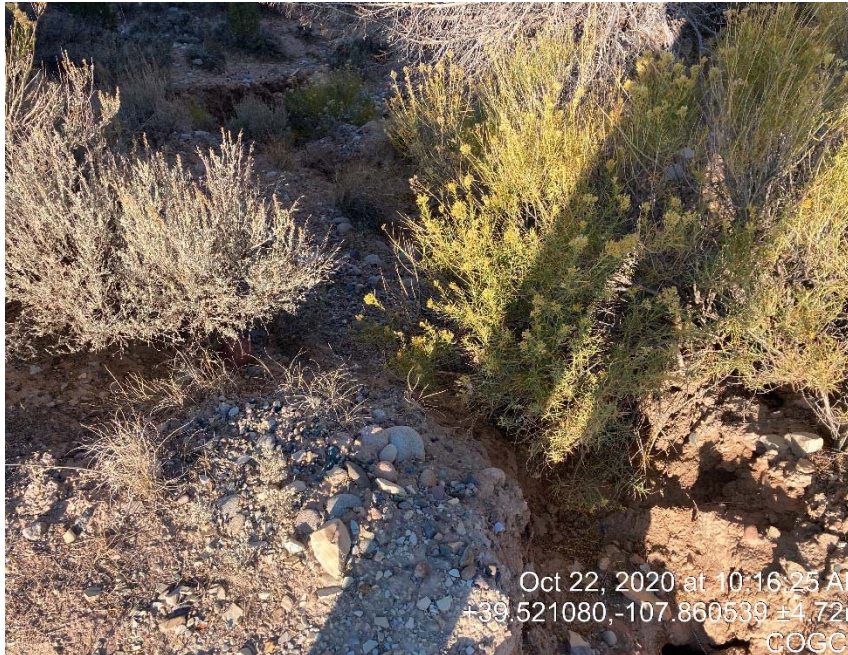
Main road to access pad erosion. At top of hill just before compressor station.

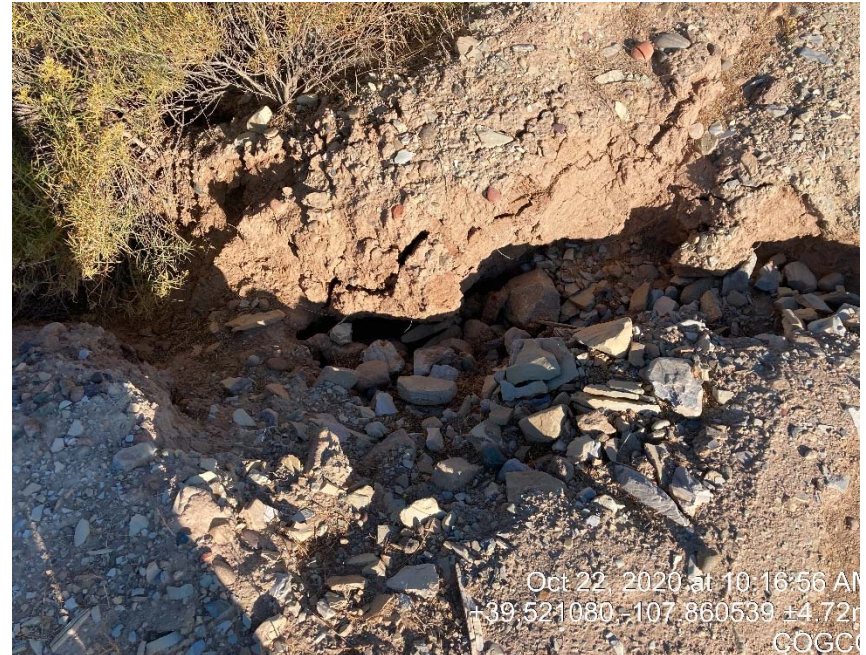
Main road to access pad erosion. At top of hill just before compressor station.

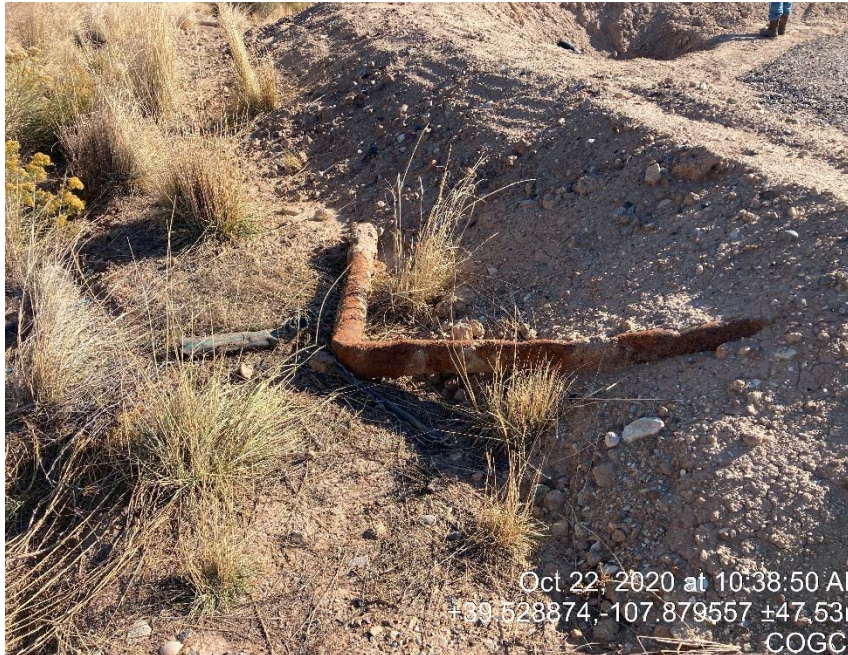
Debris in and next to new berm.

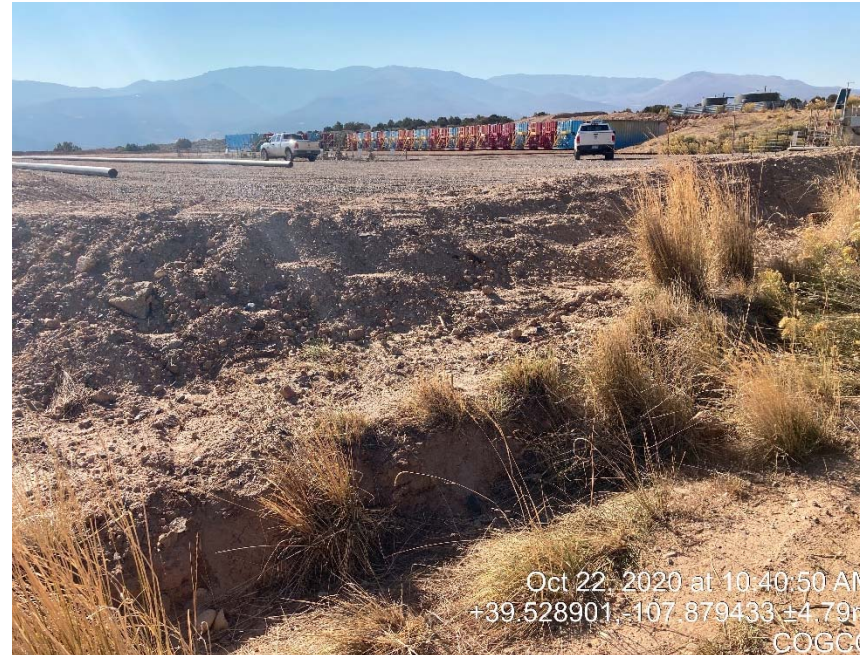
Berm sediment migration to ditch on main road.

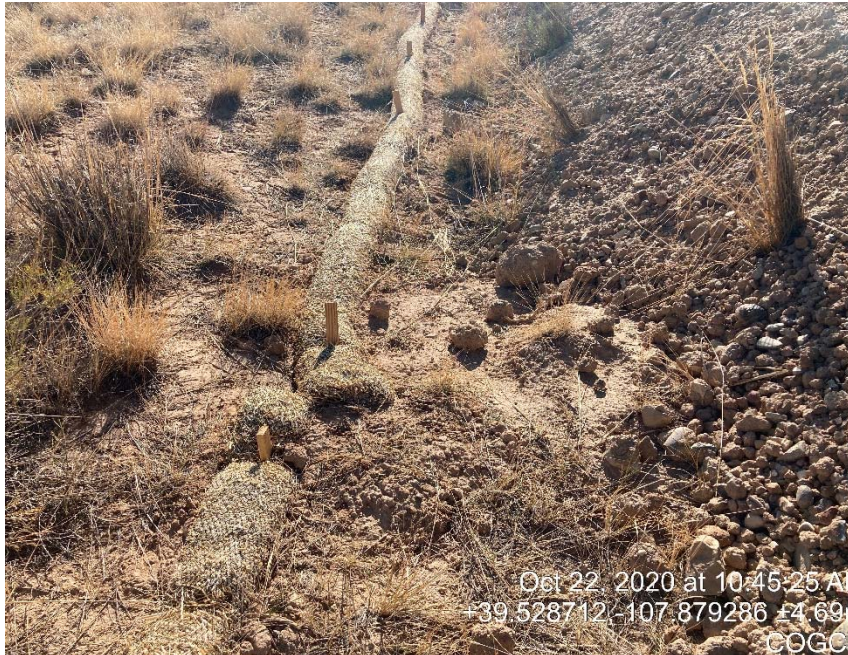
Waddles that around location are already collecting sediment and quite possibly will fail with the next rain storm.

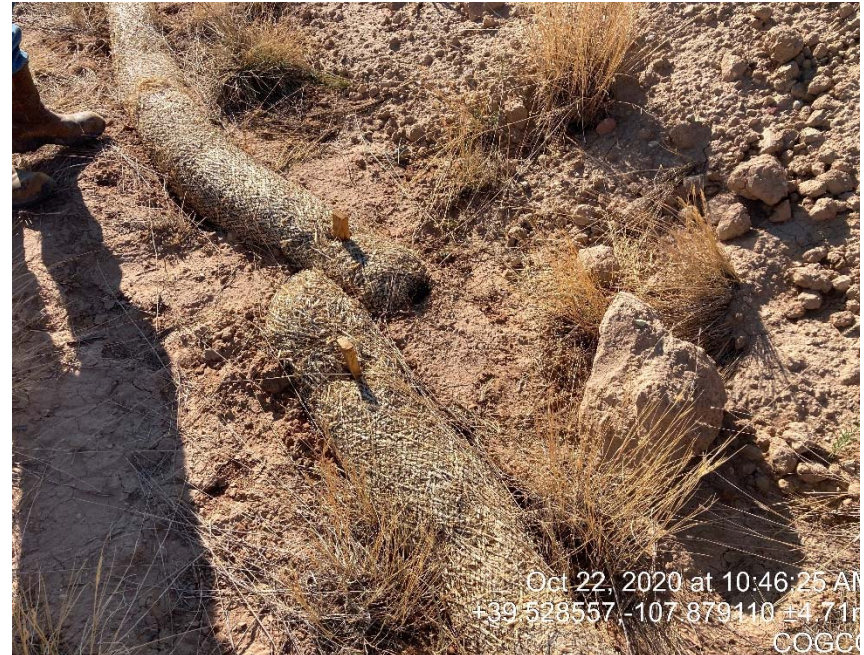
Waddles that around location are already collecting sediment and quite possibly will fail with the next rain storm.

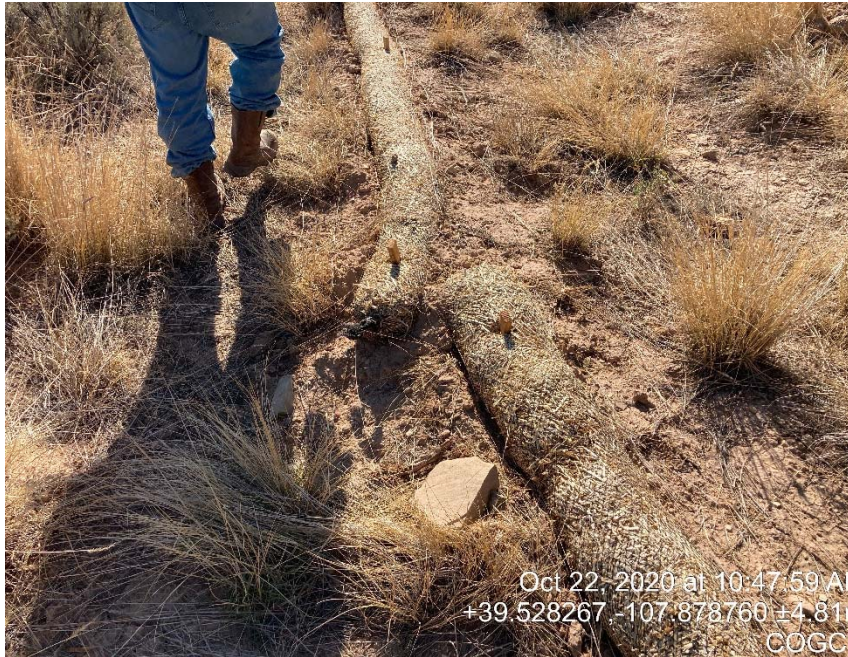
Waddles that around location are already collecting sediment and quite possibly will fail with the next rain storm.

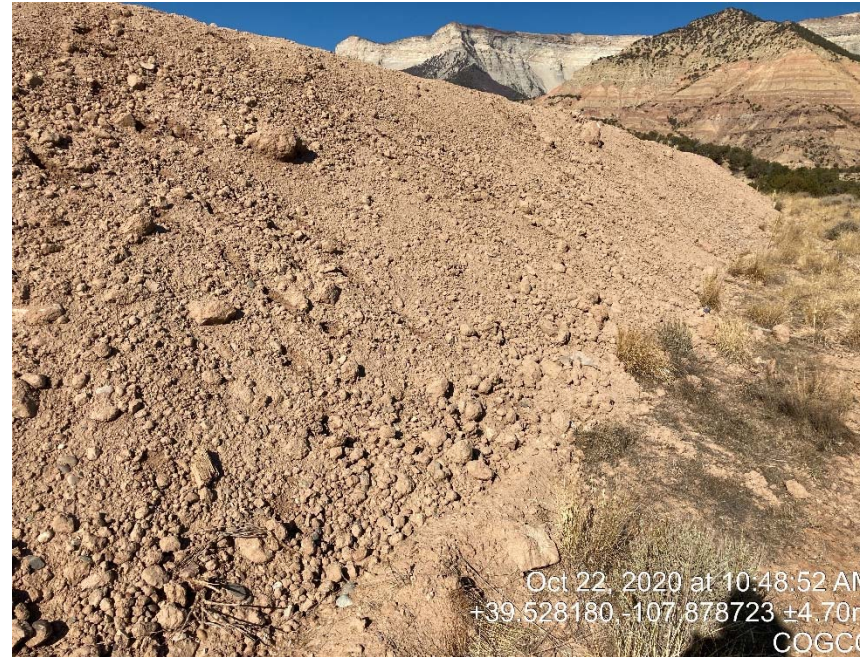
Outside of berms need stabilization.

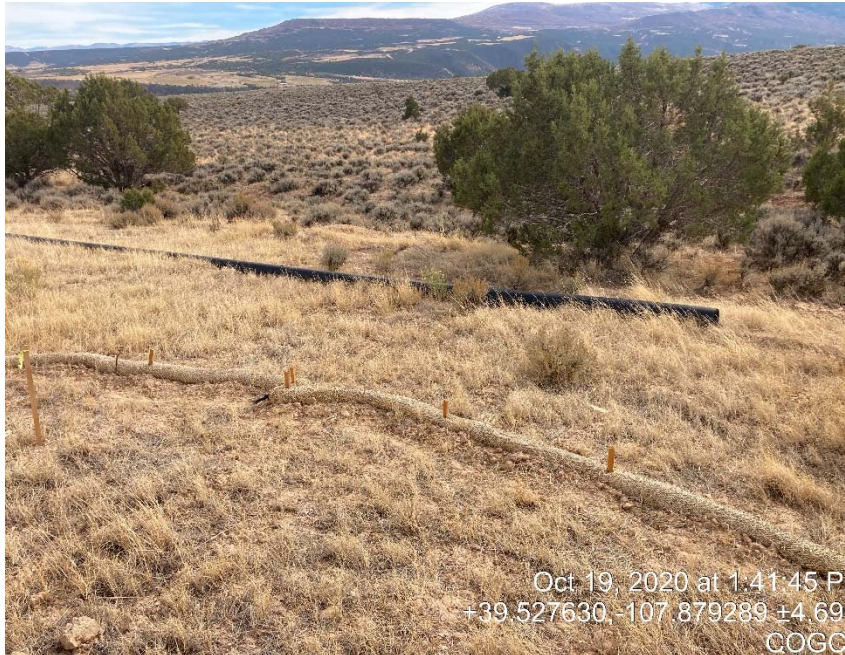
Poly pipe location before it was moved onto pad.

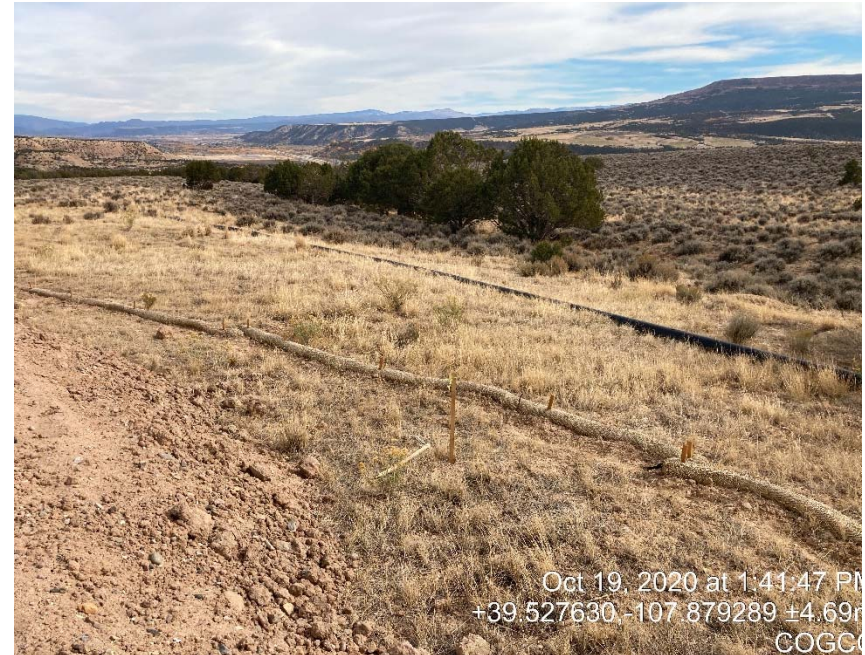
Poly pipe location before it was moved onto pad.

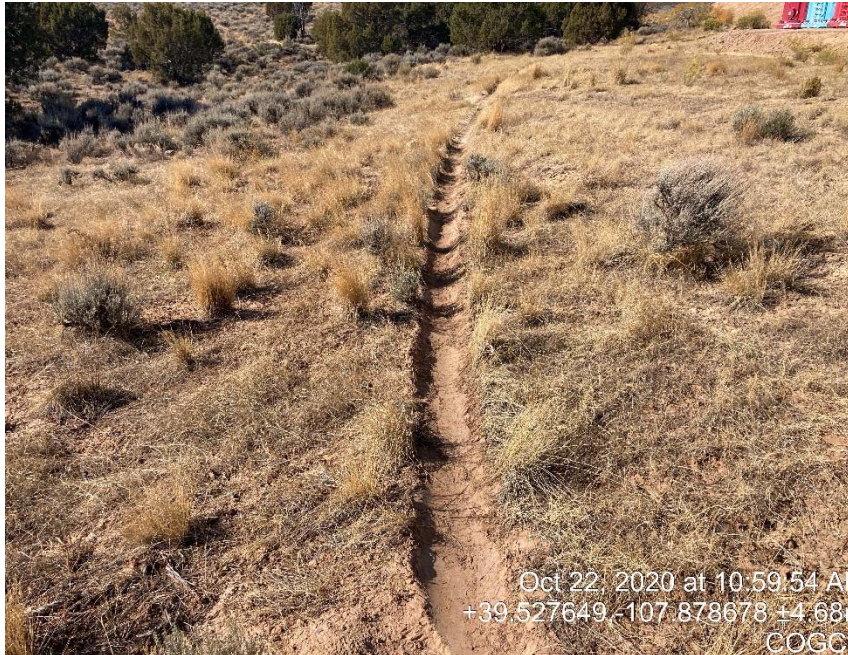
Surface disturbance from poly pipe.

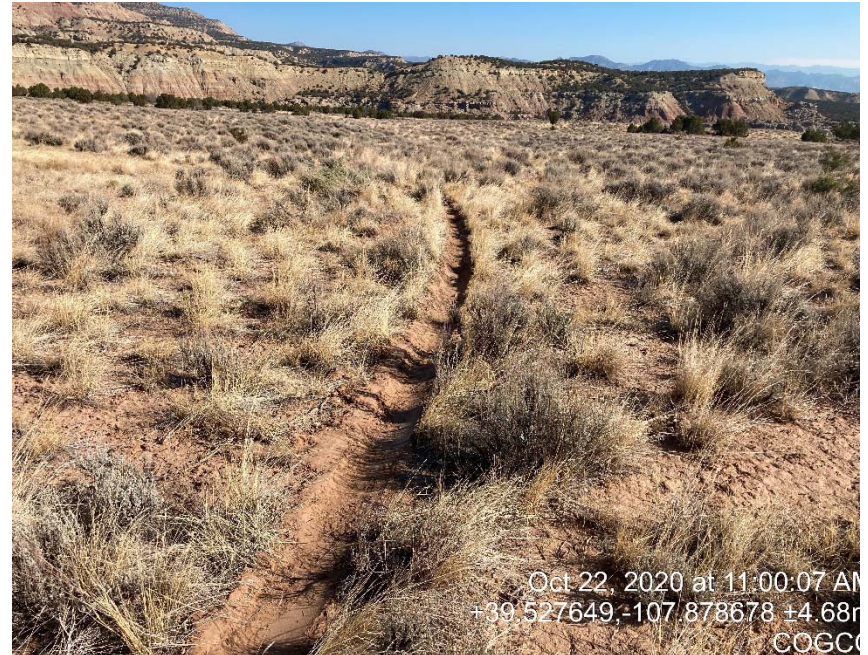
Surface disturbance from poly pipe.

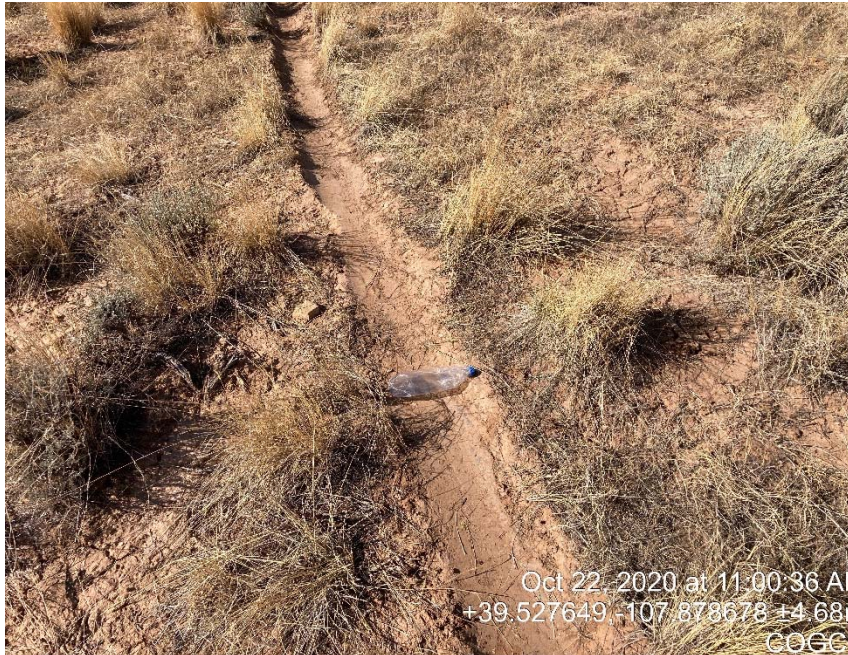
Surface disturbance from poly pipe.

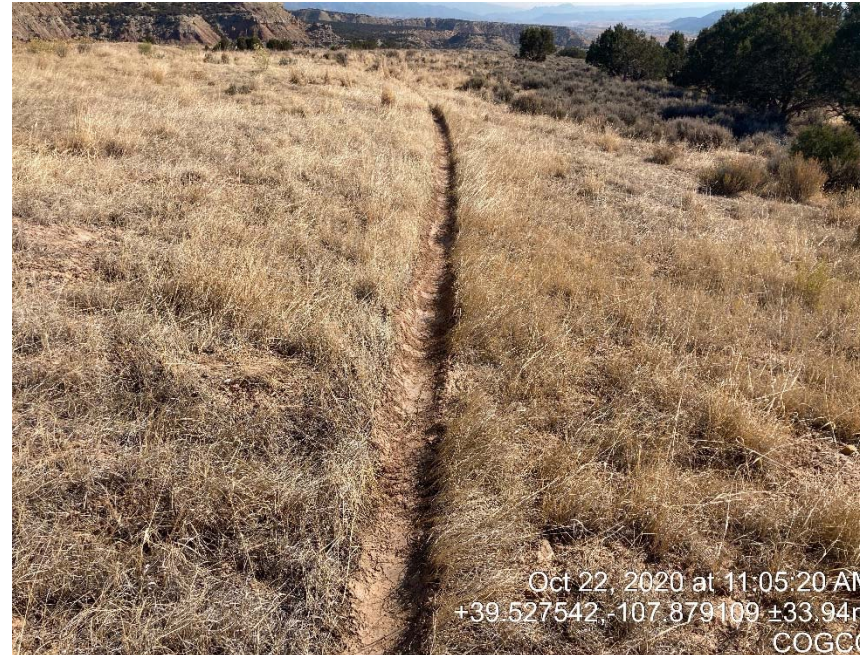
Surface disturbance from poly pipe.

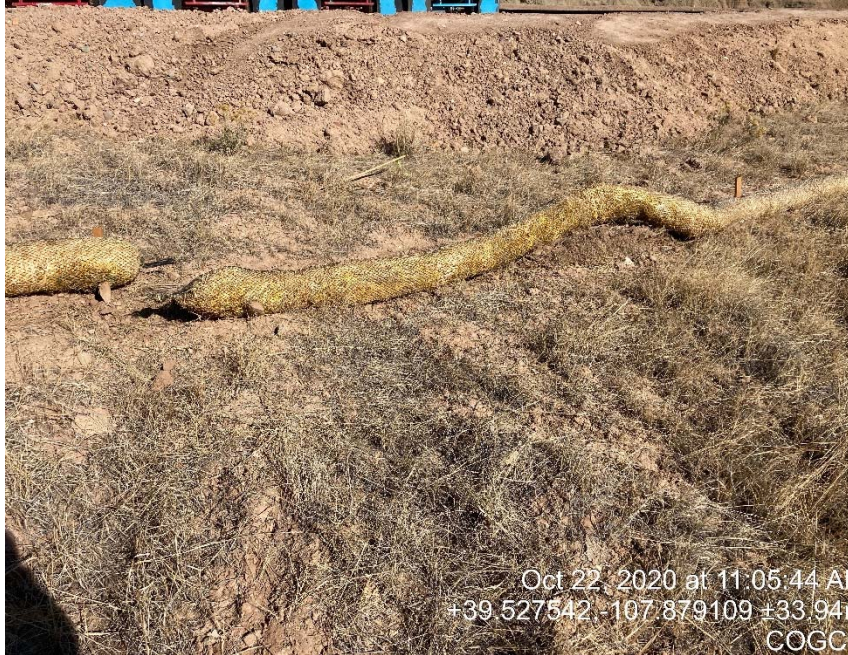
Surface disturbance from poly pipe being dragged on to pad.

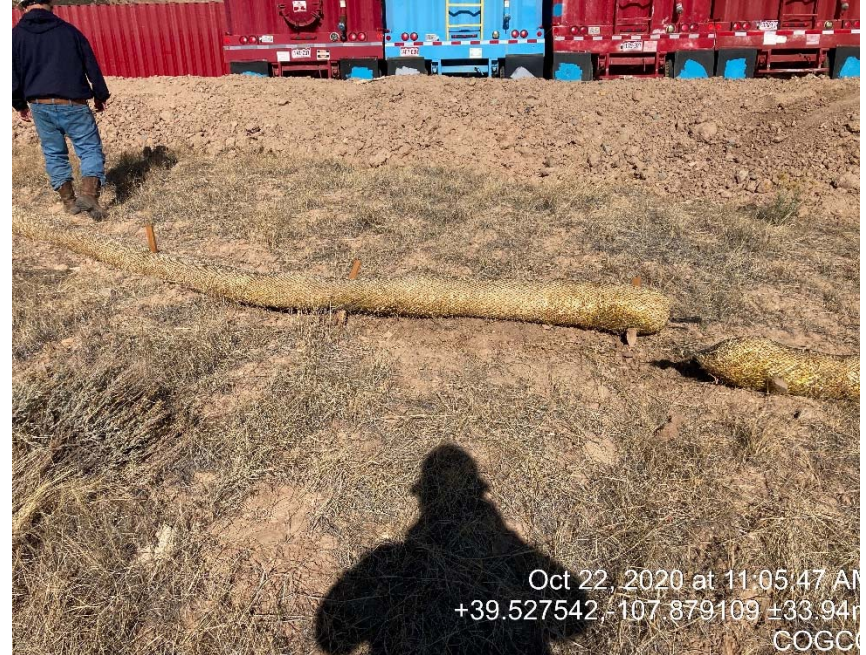
Surface disturbance from poly pipe being dragged on to pad.

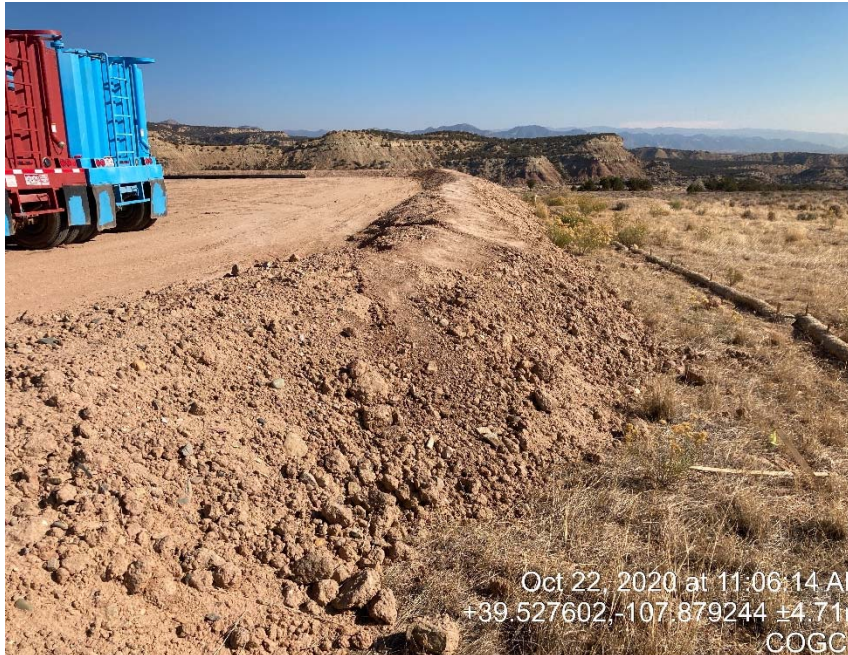
Surface disturbance from poly pipe being dragged on to pad.

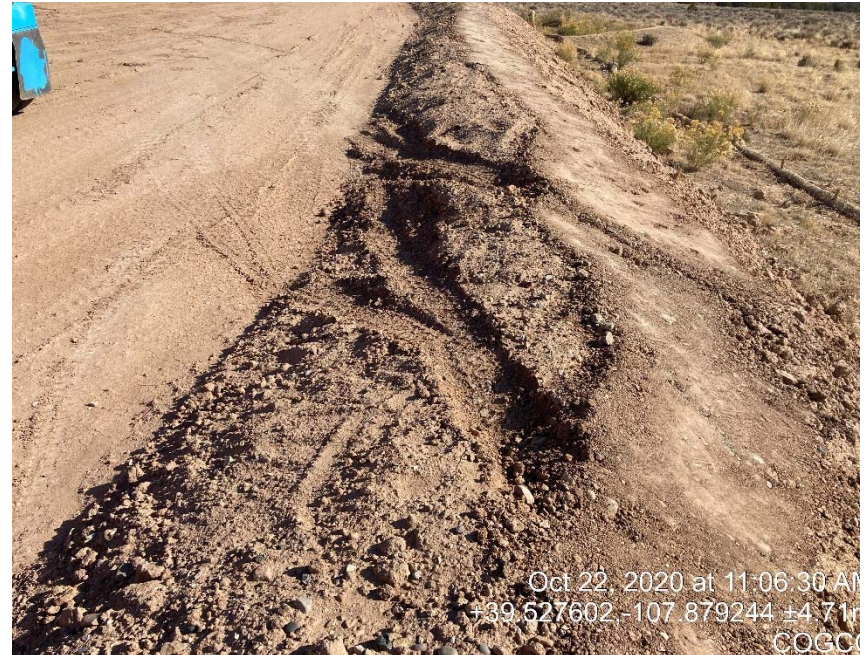
Surface disturbance from poly pipe being dragged on to pad. Truck has degraded integrity of berm.

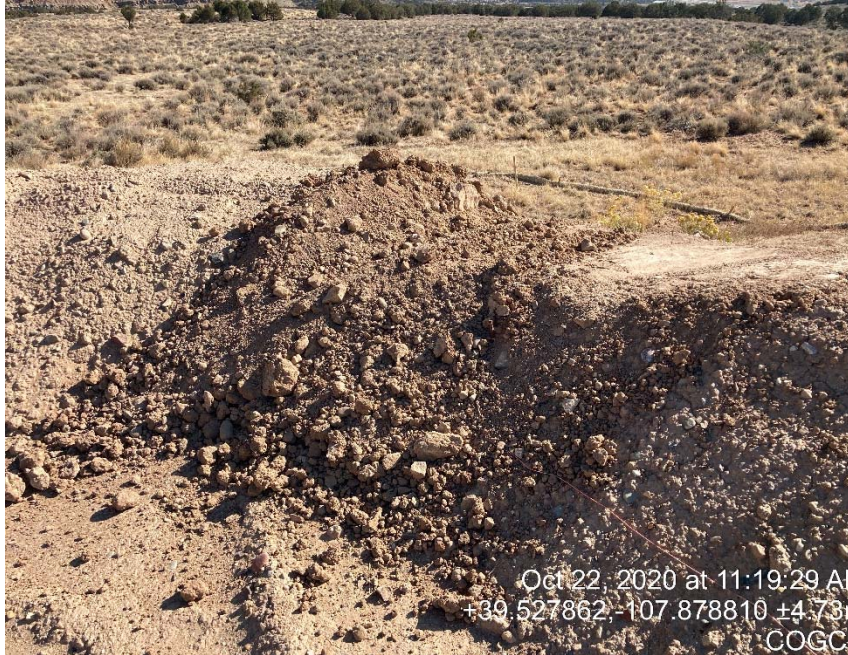
Surface disturbance from poly pipe being dragged on to pad.

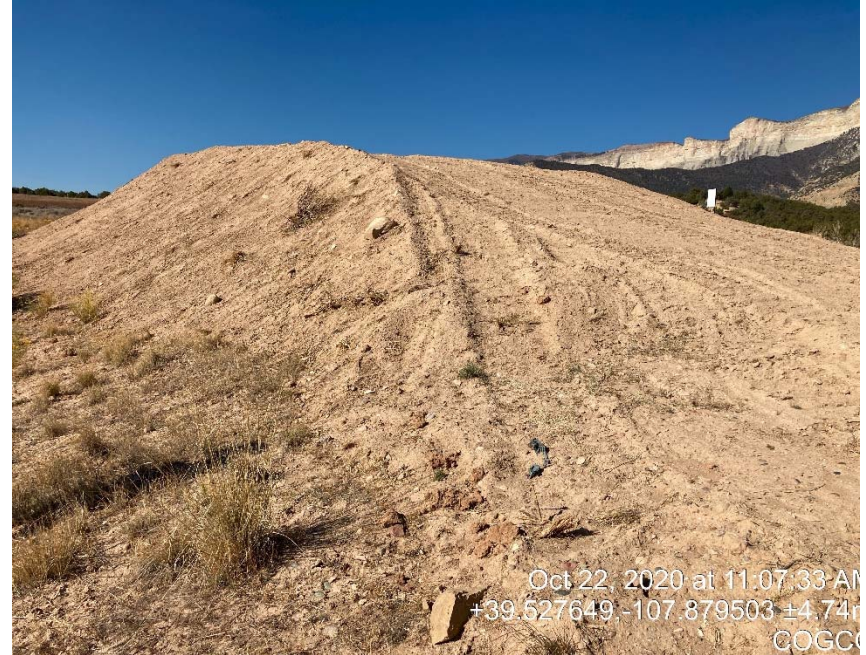
Top soil stock pile need stabilization.

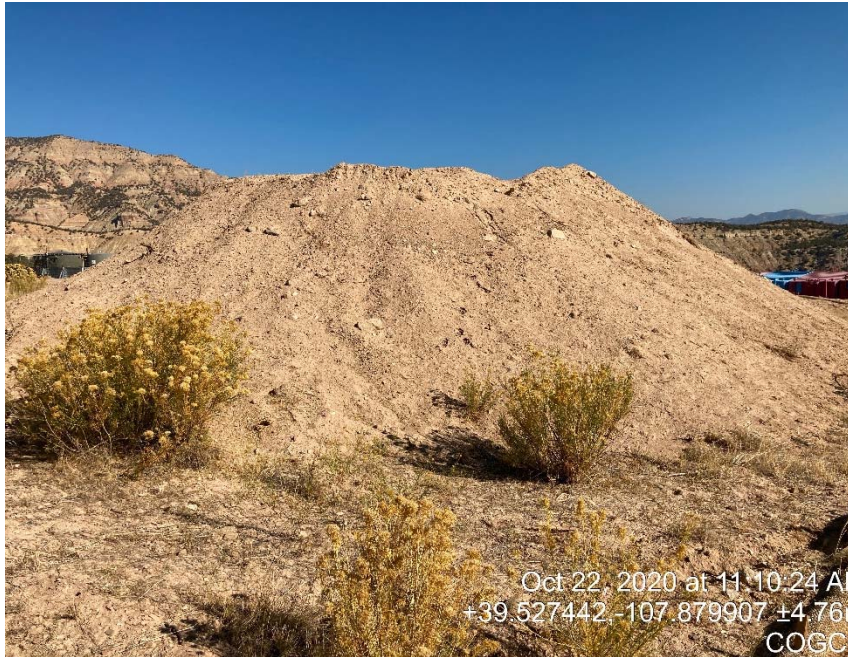
Top soil stock pile need stabilization.

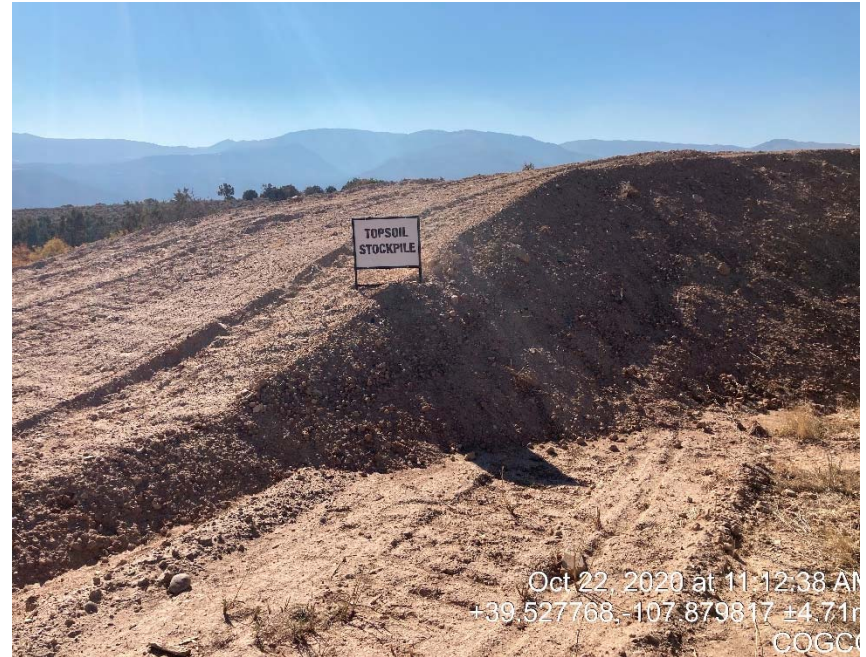
Top soil stock pile need stabilization.

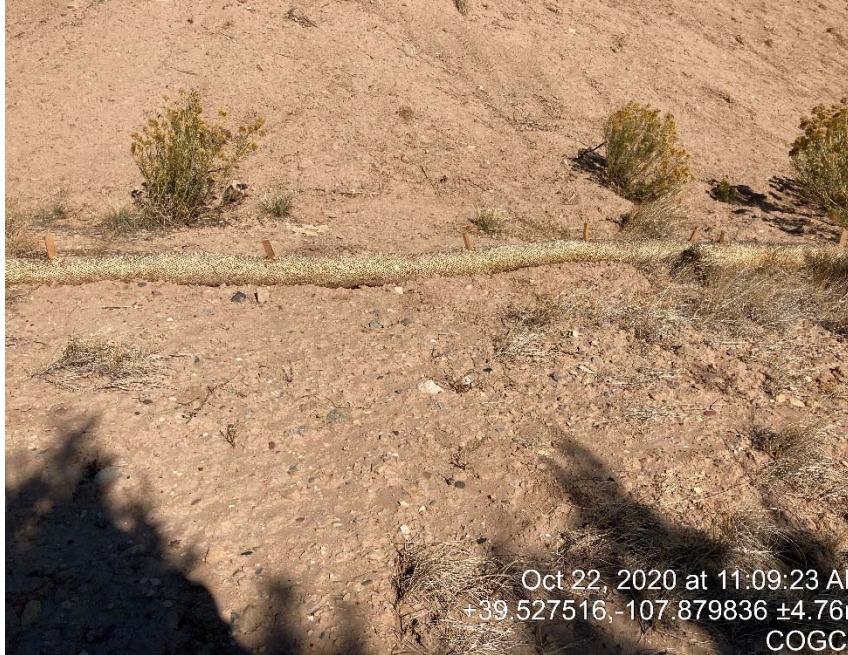
Top soil stock pile has migrated past waddles

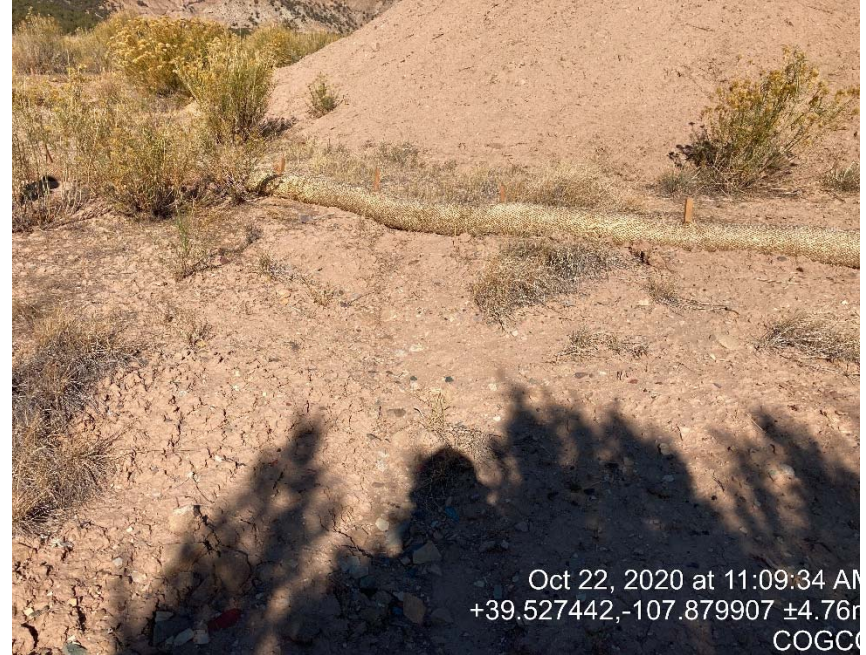
Top soil stock pile has migrated past waddles

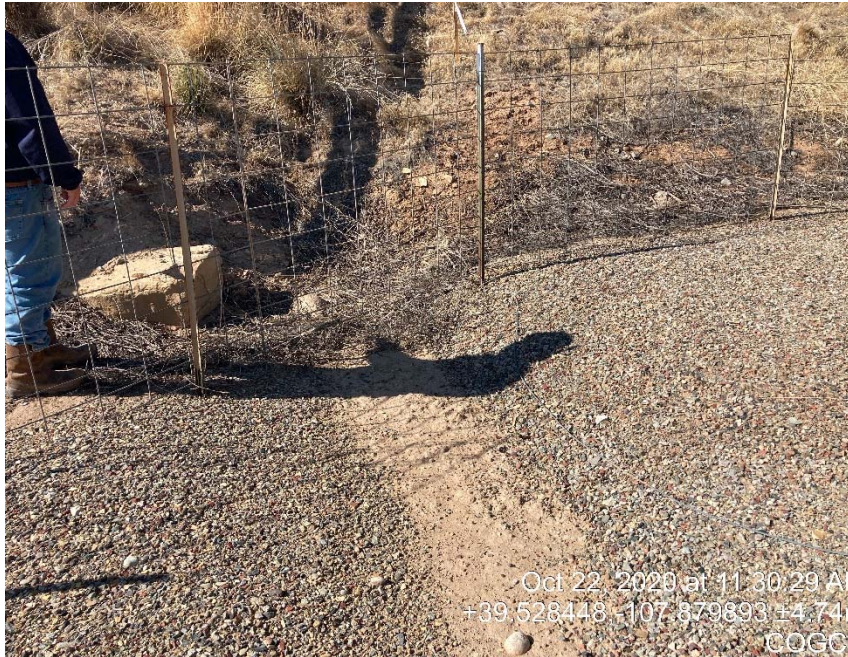
Sediment migration

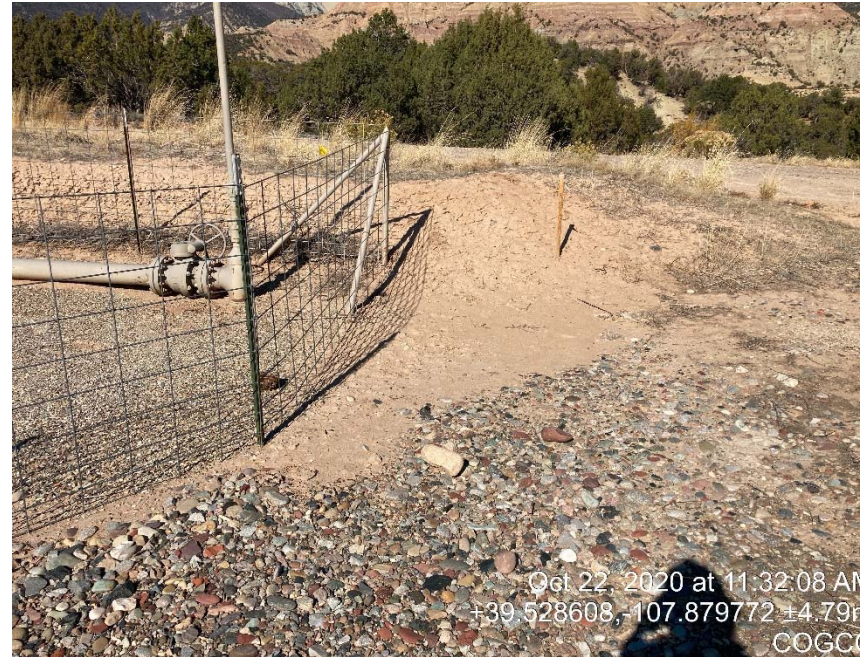
Sediment migration

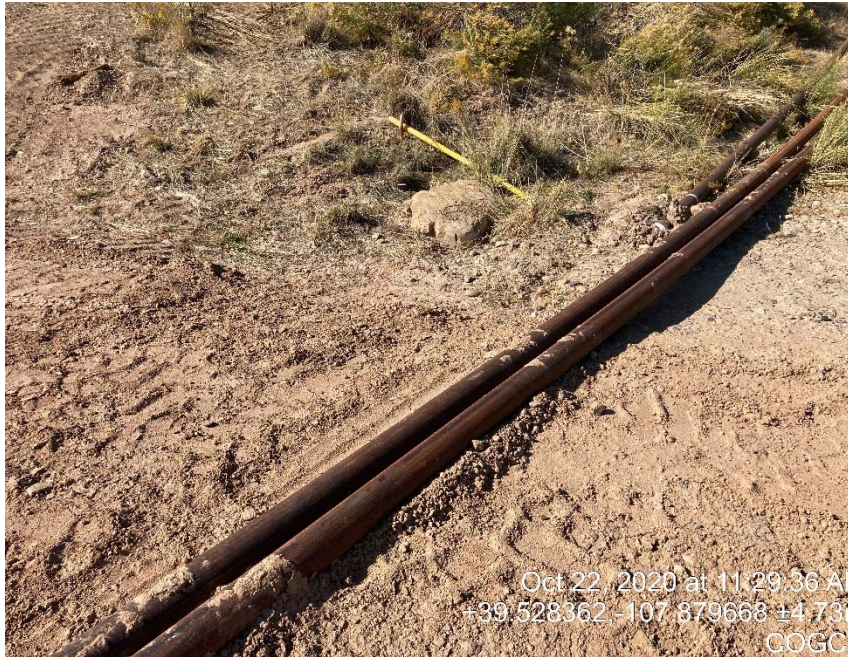
Dead man needs re marked

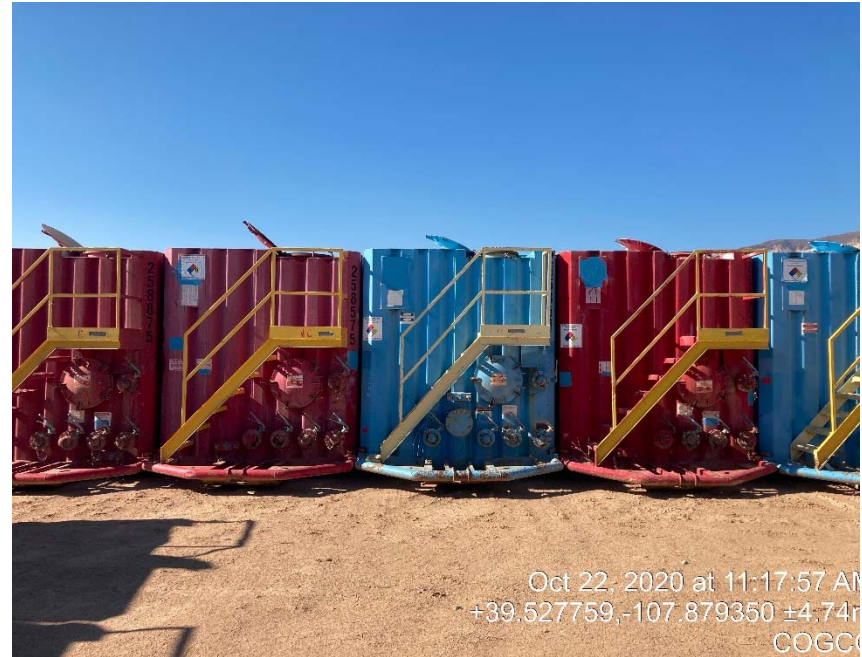
Tanks are open and can allow wildlife egress.

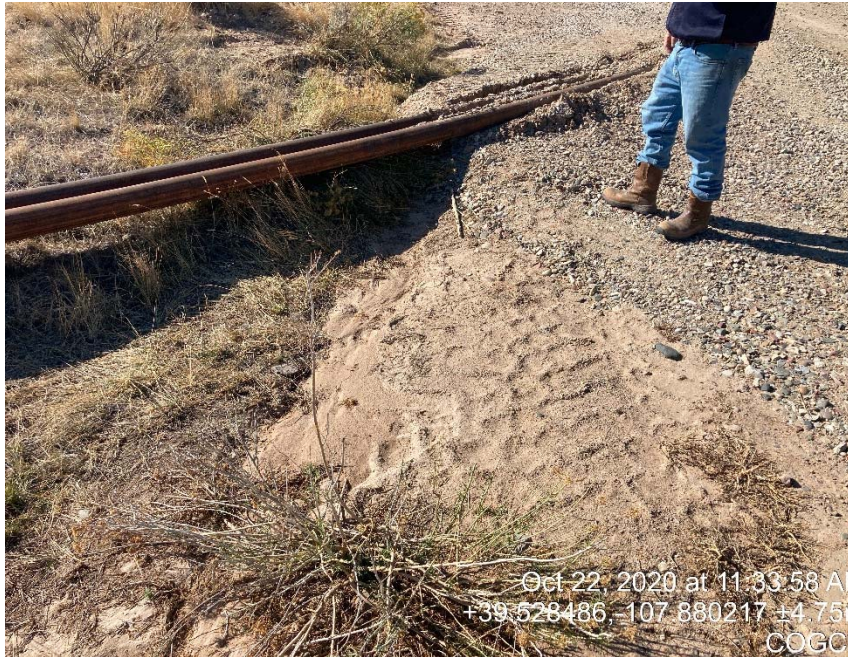
Sediment migration BMP's need to be addressed.

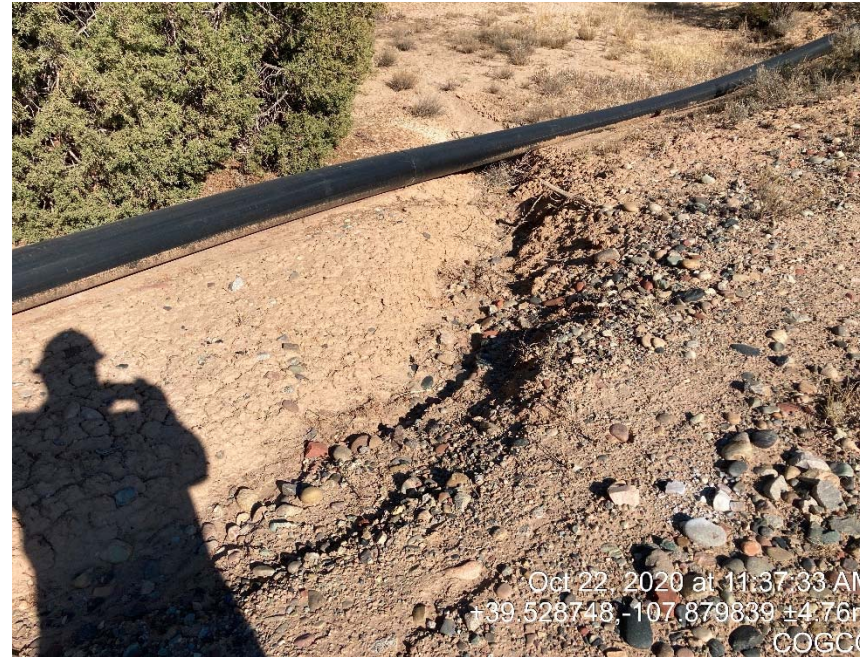
BMP's need to be addressed.
