## Inspection Photos

Location Name: CAERUS PICEANCE LLC ORCHARD UNIT-68S96W /15SWNE

Location ID: 334105

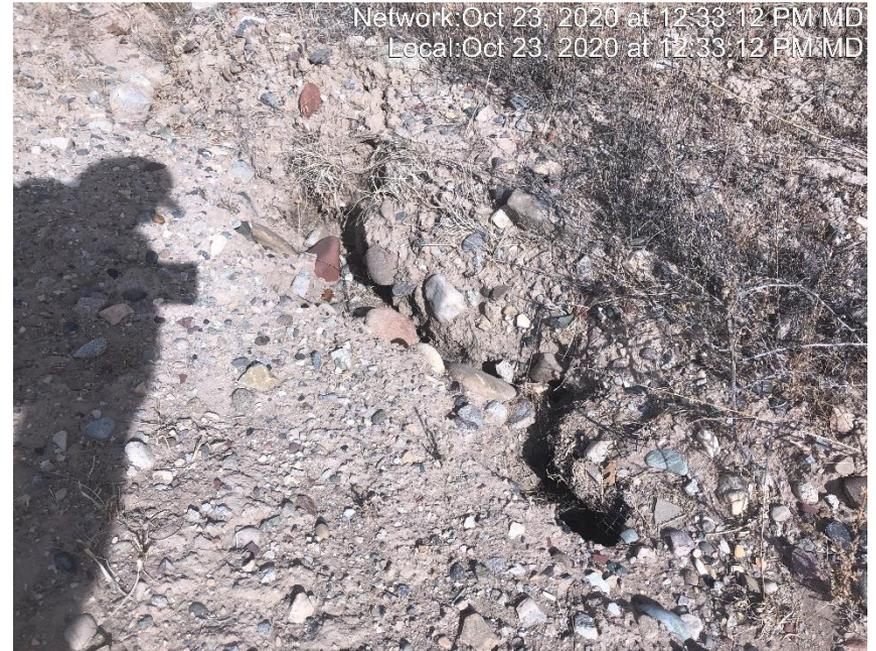
Photo #2101 Multiple places with rill erosion.

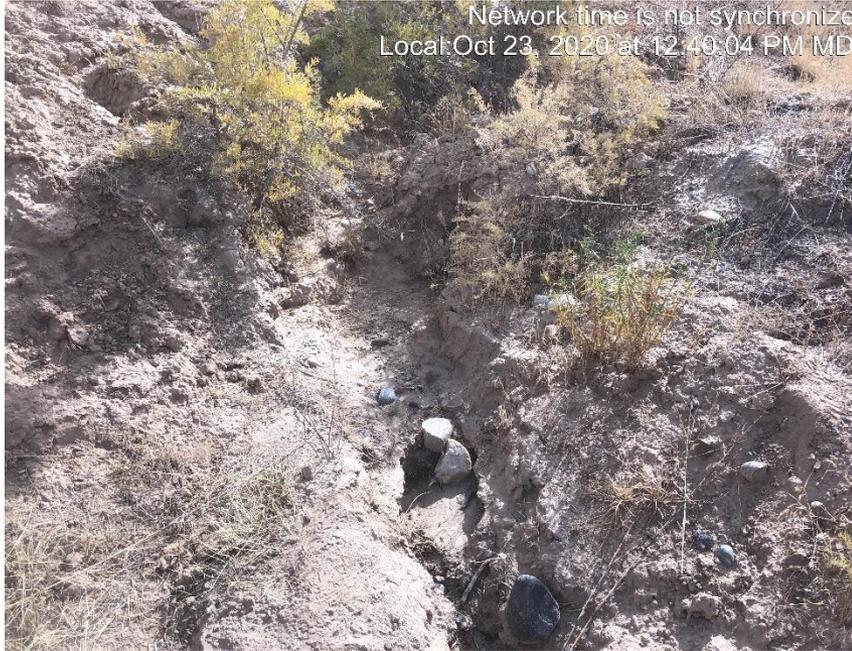
**Photo #2104 Multiple places with rill erosion.**

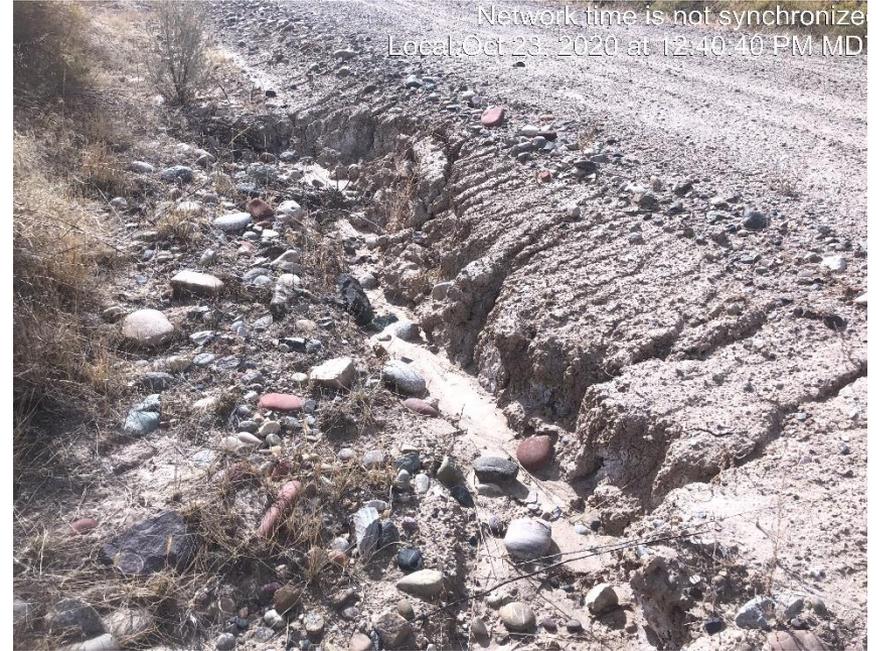
**Photo #2105 Multiple places with rill erosion.**

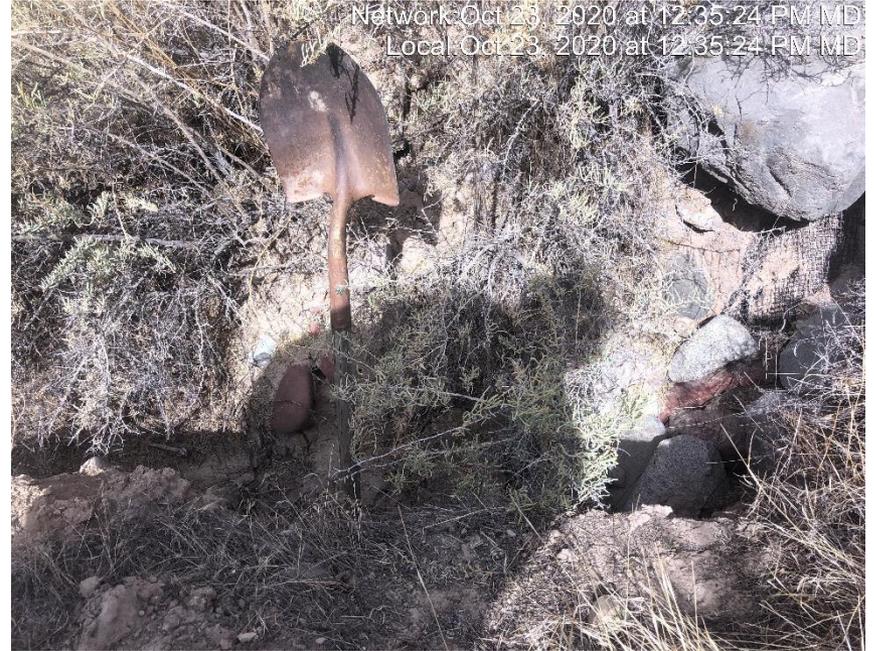
Photo #2103 2 to 3 feet deep gully erosion.
