Inspection Photos

API: 055-06309

Operator: ALTA MESA SERVICES LP

Inspection Date: 10/23/2020

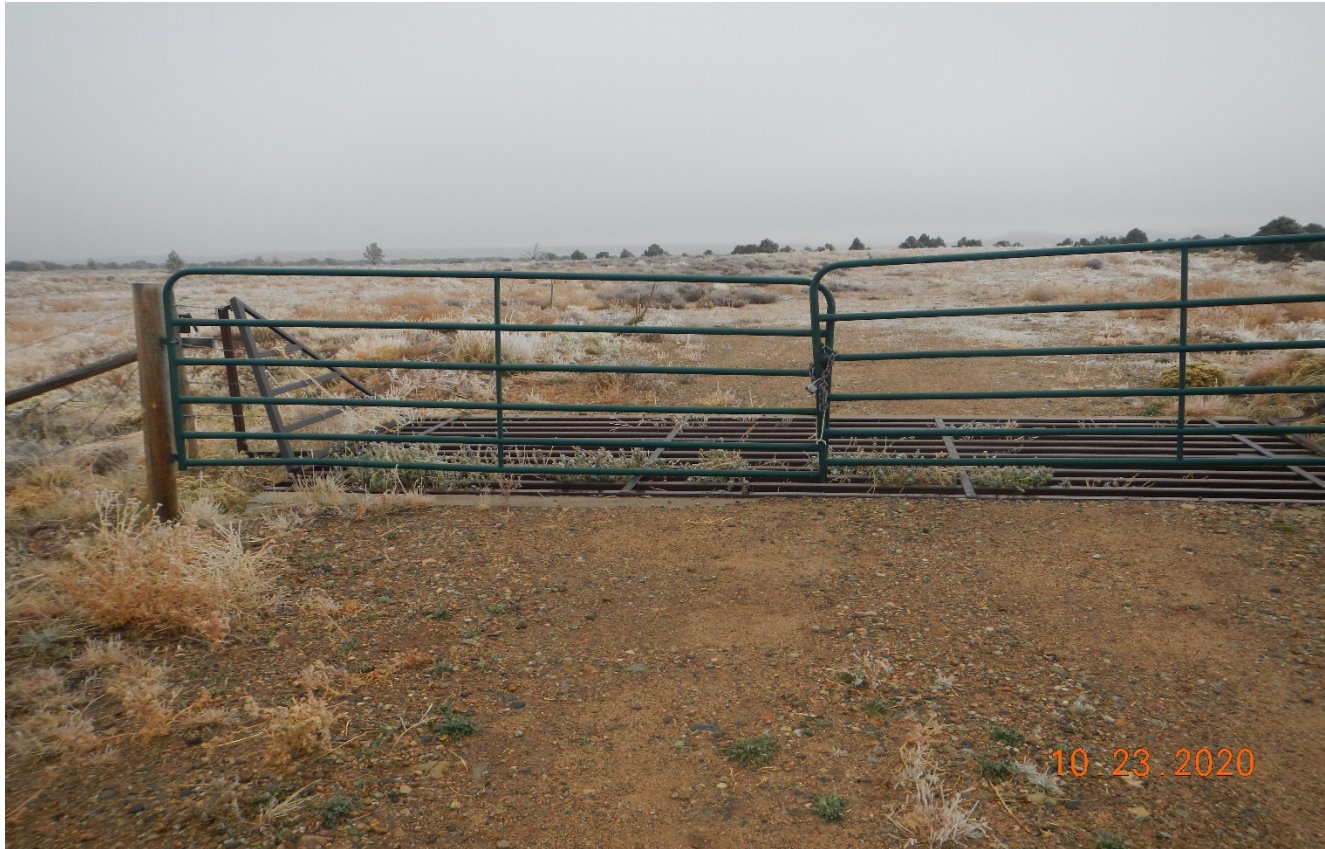
Photo 1. Facing north toward the location. The access road has not been reclaimed. The cattle guard and gates remain and the perimeter of the location is fenced.

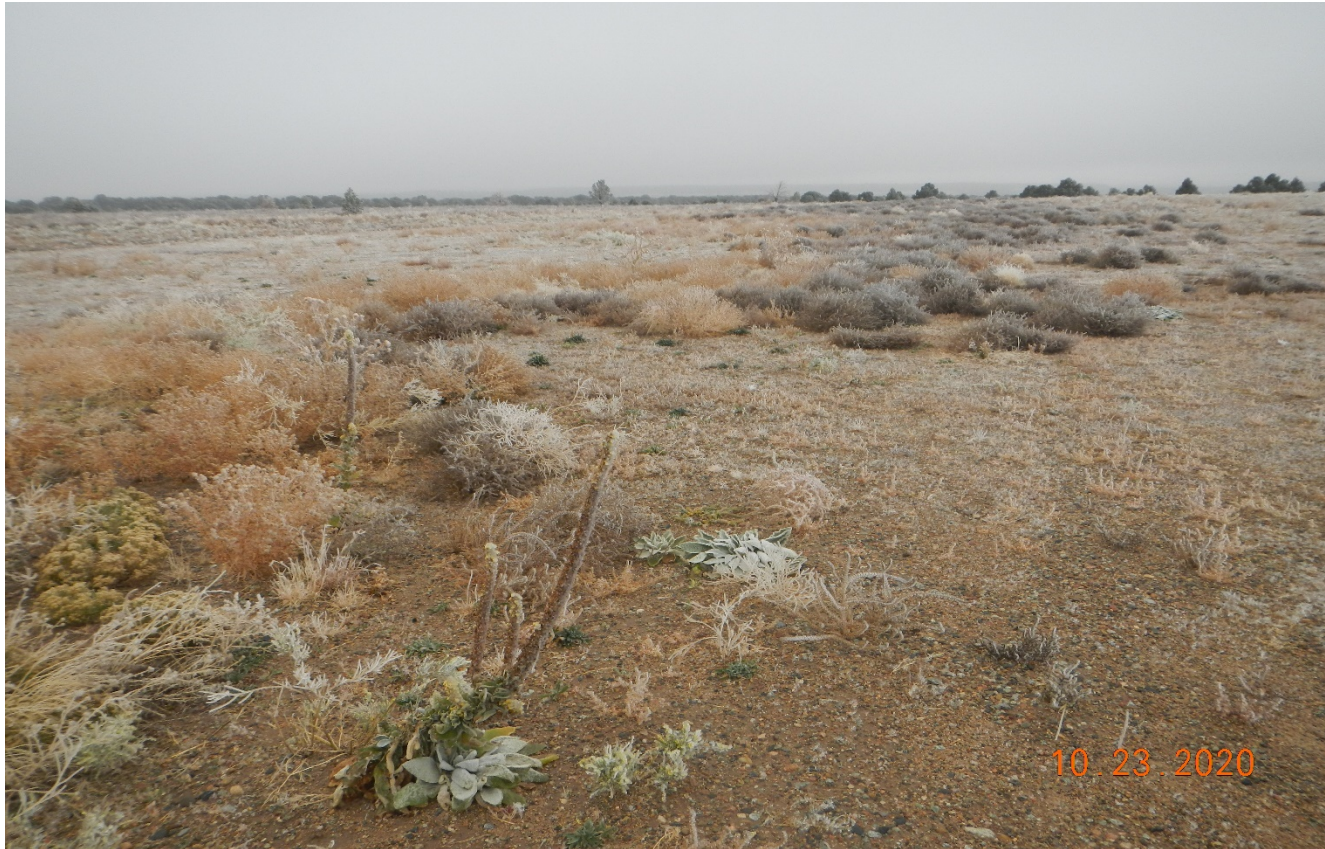
Photo 2. Facing northwest toward the location. This portion of the location has not been recontoured and reclaimed. There are undesirable and noxious weeds growing throughout the location which have not been controlled.

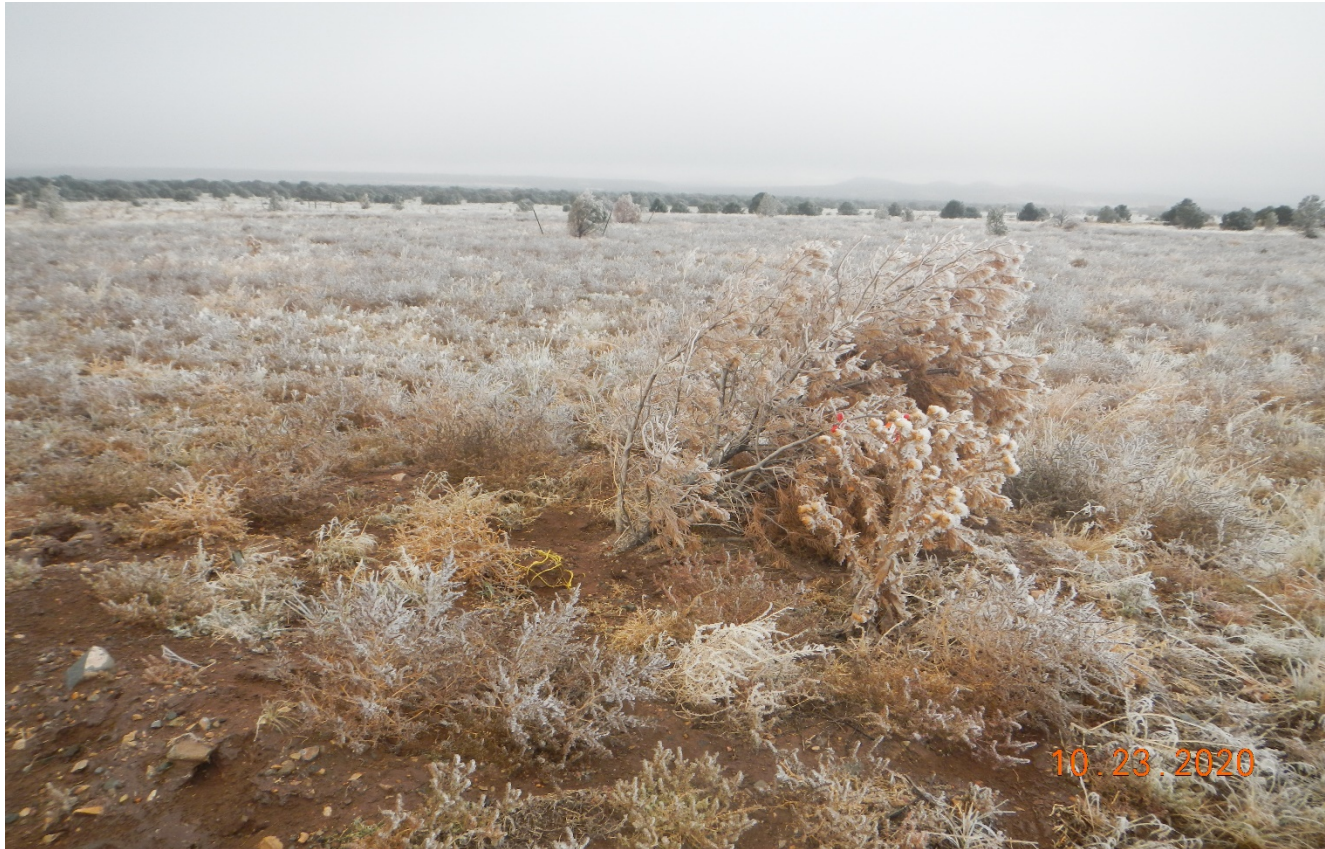
Photo 4. Facing northwest at the location. There are dead tree debris that remain at the location which have not been removed.

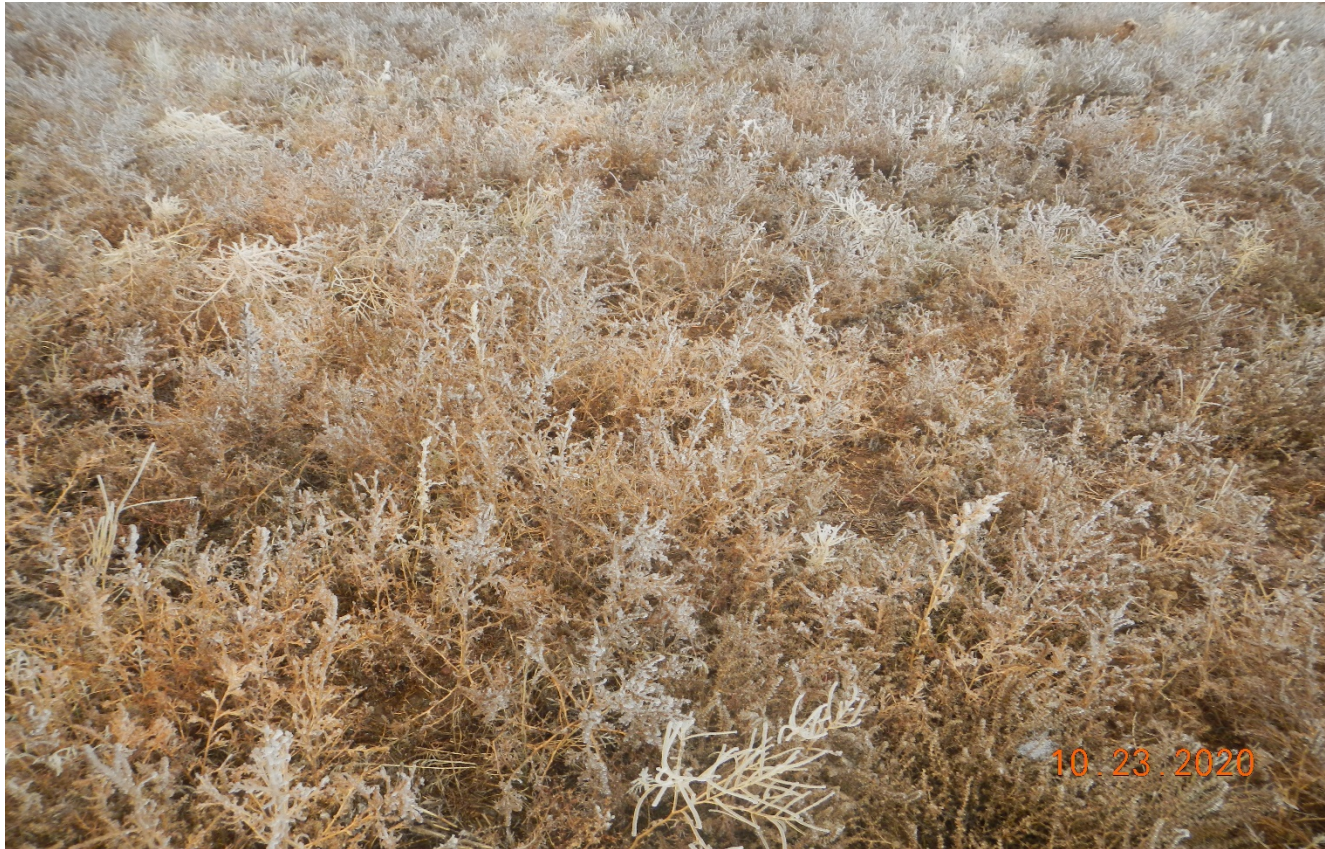
Photo 5. There is undesirable weeds throughout the location which have not been controlled. The desirable vegetation is not establishing and reseeding needs to be performed. The weed debris needs to be cut and removed.

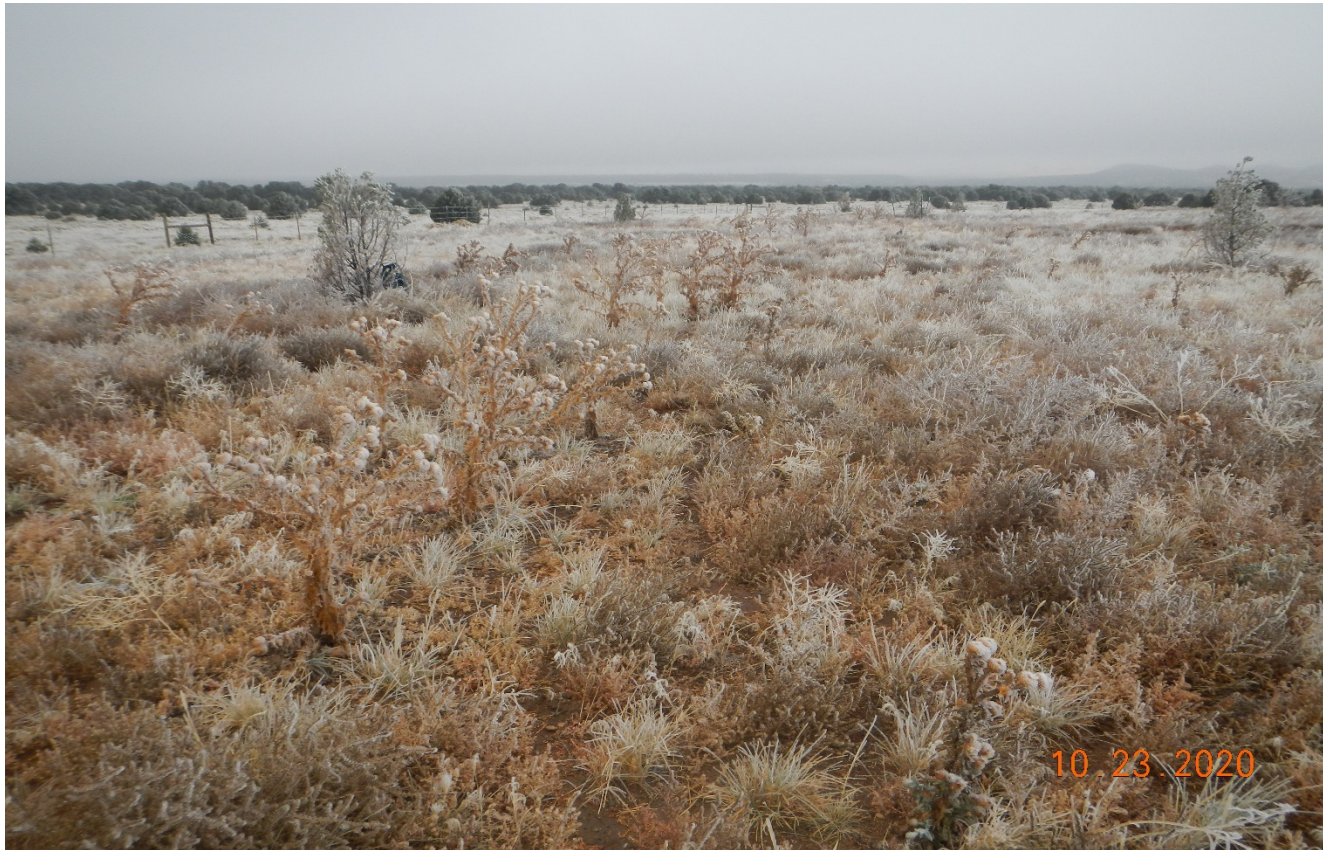
Photo 6. Facing northwest at the west side of the location. There are numerous noxious weeds growing throughout the location shown by red arrow which points to Scotch thistle List B noxious weed. Other weeds observed were Cheat grass, Russian thistle, Common mullein, Kochia, Mustard.

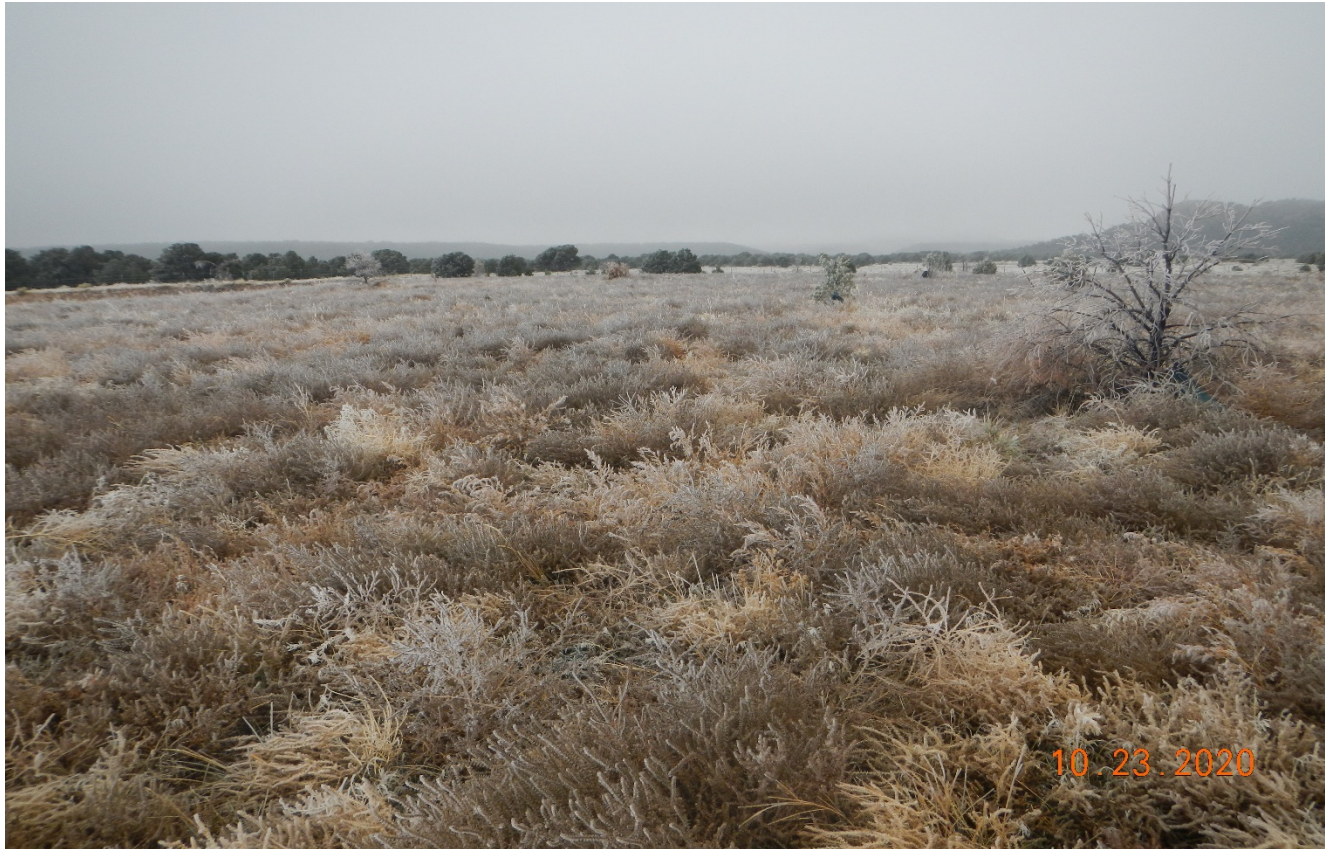
Photo 7. Facing east at the north side of the location. The dark brown vegetation is undesirable weeds, Russian thistle. The weed debris needs to be cut and removed.

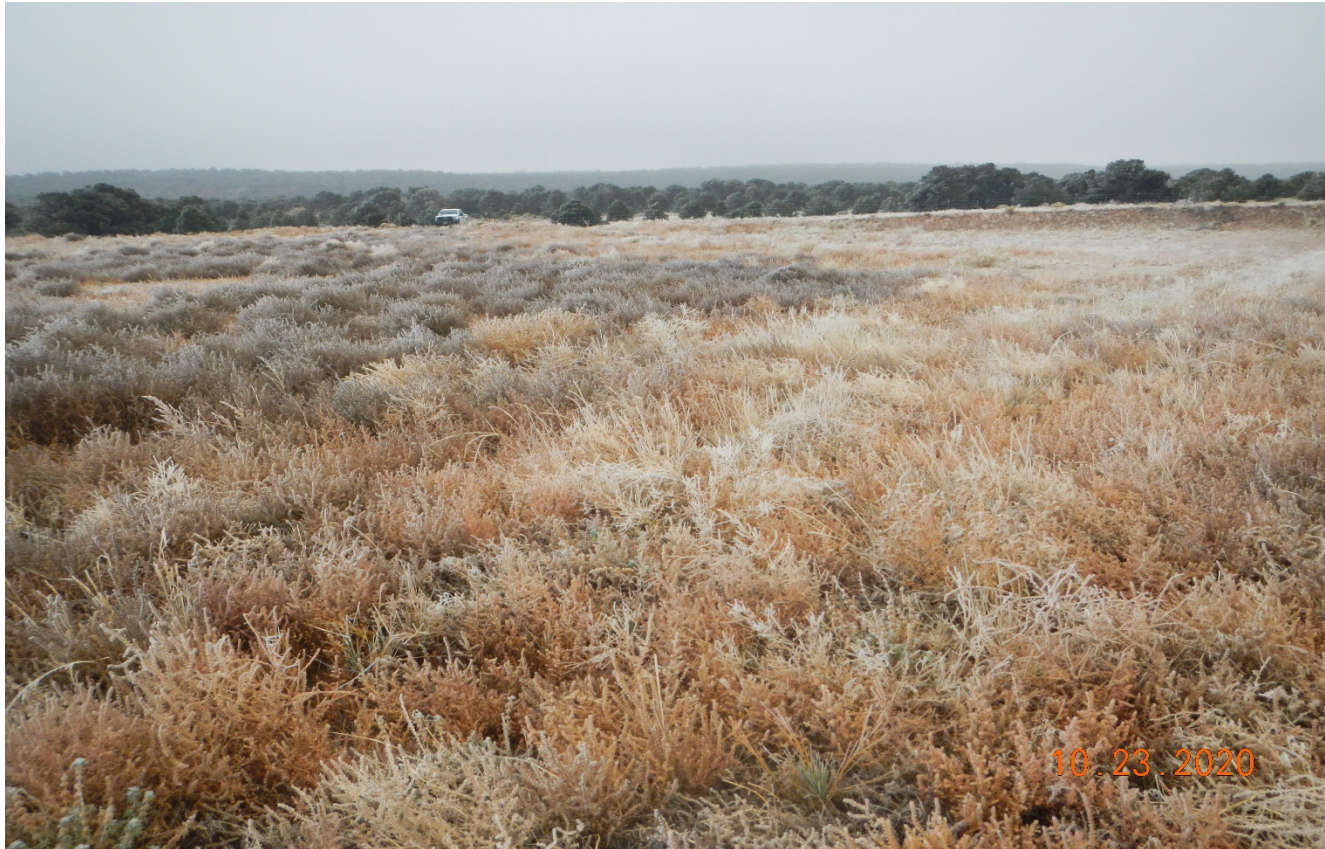
Photo 8. Facing north at the location. This portion of the location was not reclaimed and gravel remained on this flat portion. There are undesirable weeds throughout this area.

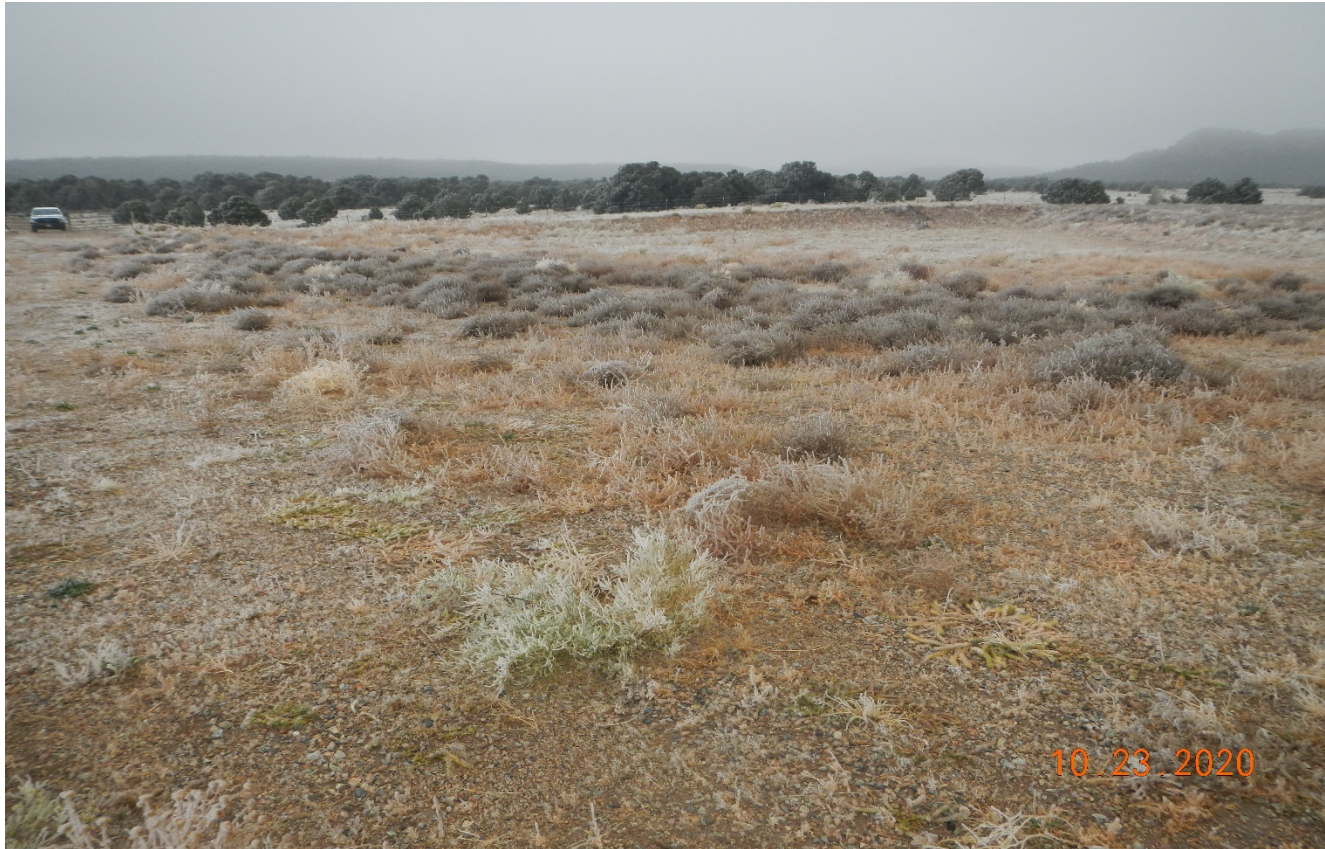
Photo 9. Facing southwest at the east side of the location. This area of the location has not been recontoured and reclaimed and gravel remains within this area.
