Inspection Photos

Operator: BP America
API: 067-08655
Date: 10/22/2020

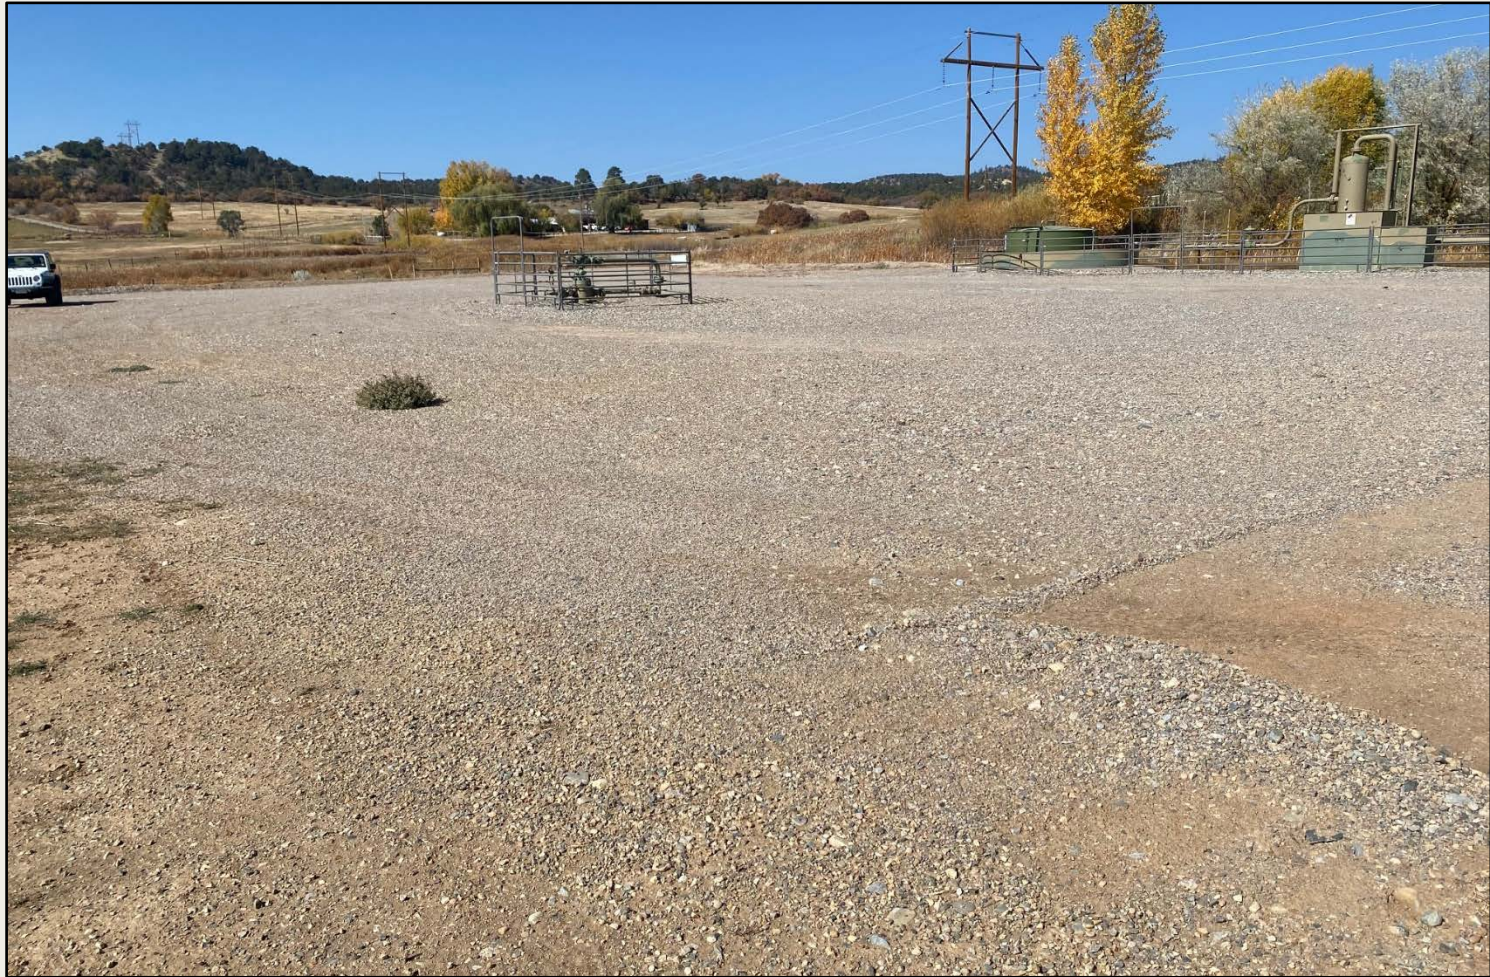
Photo 1. View of the project area from the southeastern corner facing center.

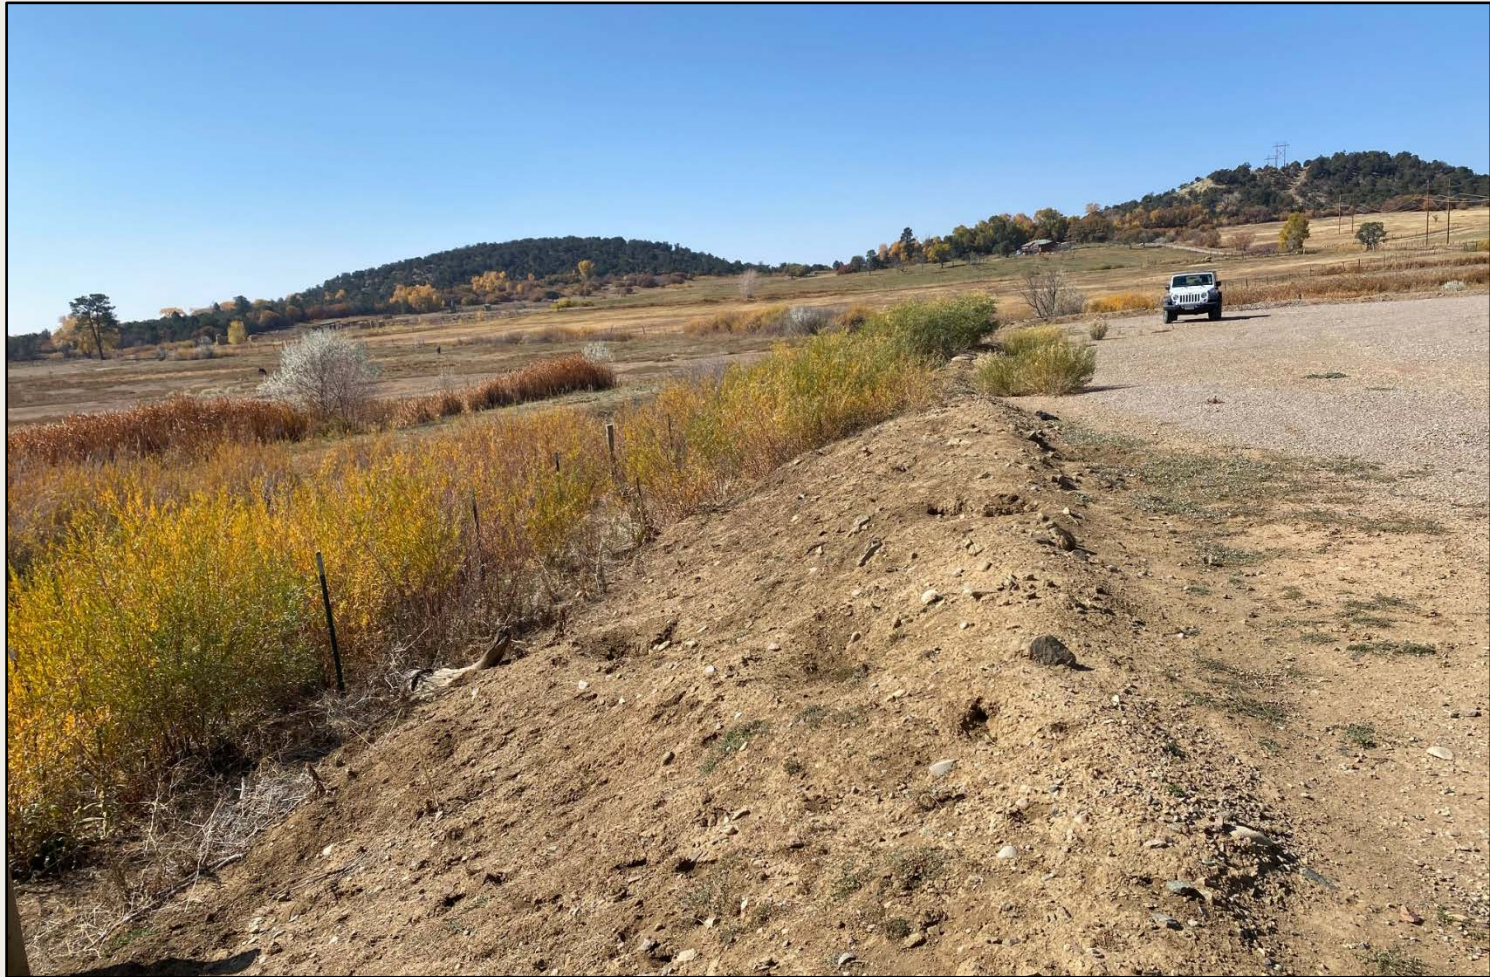
Photo 2. View of the southern project area from the southeastern corner facing westward. Berm is installed, bare/weedy soils on fill slopes remain.

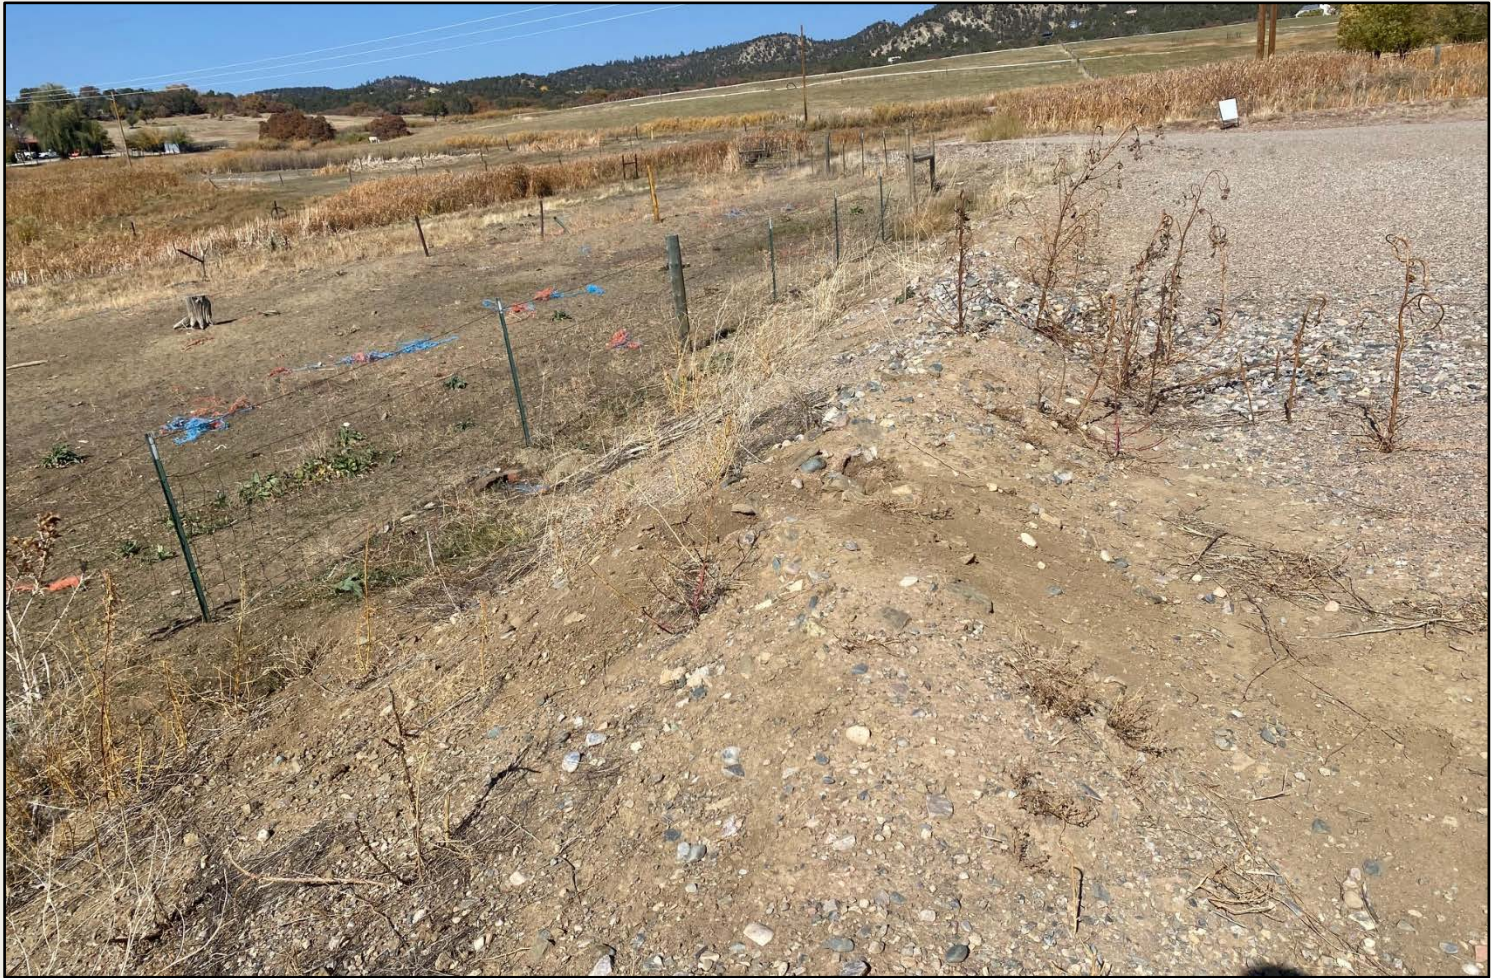
Photo 3. View of the western project area from the southwestern corner facing northward. Berm is installed, bare soils on fill slopes remain.

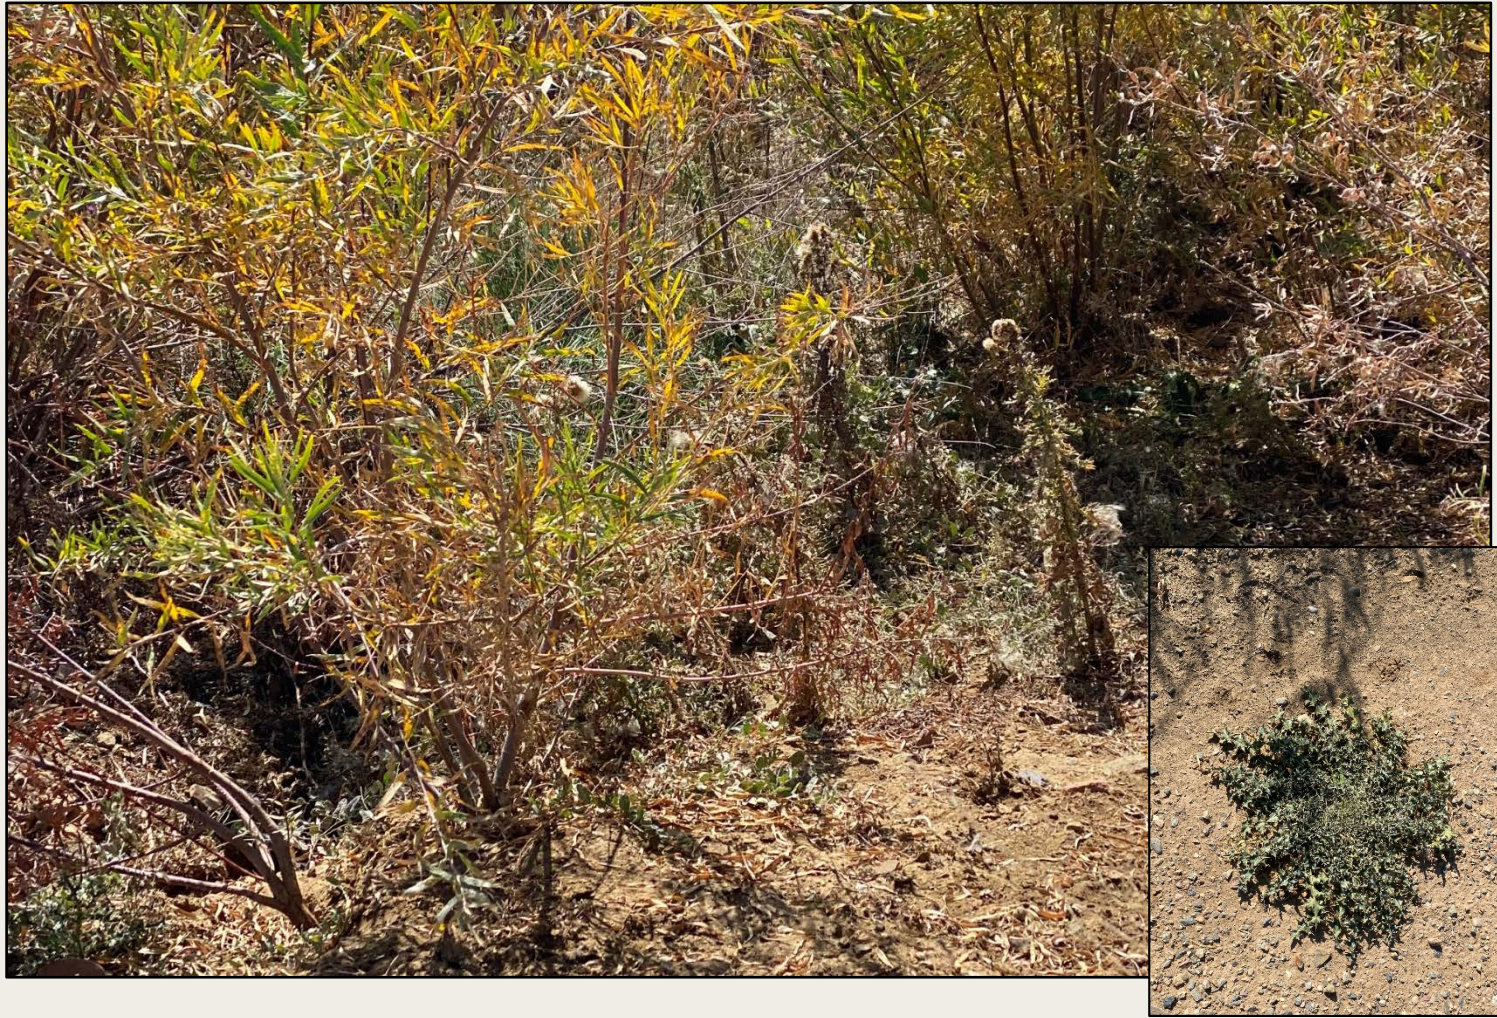
Photo 4. View of Canada thistles and musk thistle that remains within the project area. Canada thistles are partially treated but persist. Scattered musk thistle rosettes observed (inset).

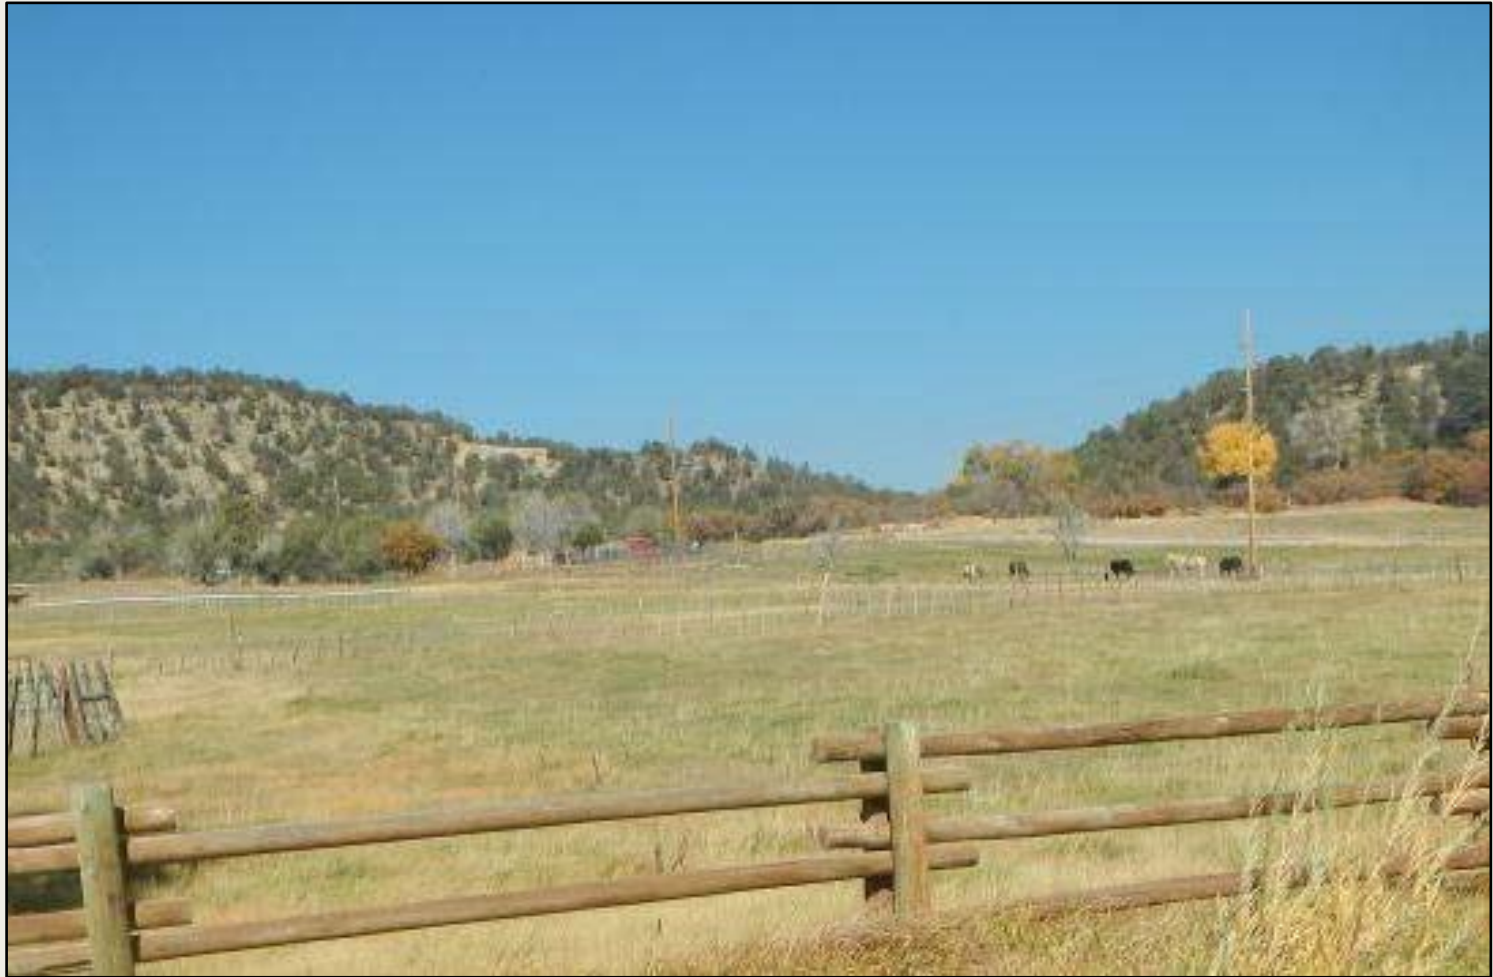
Photo 5. View of reference area comprised of irrigated grass field.

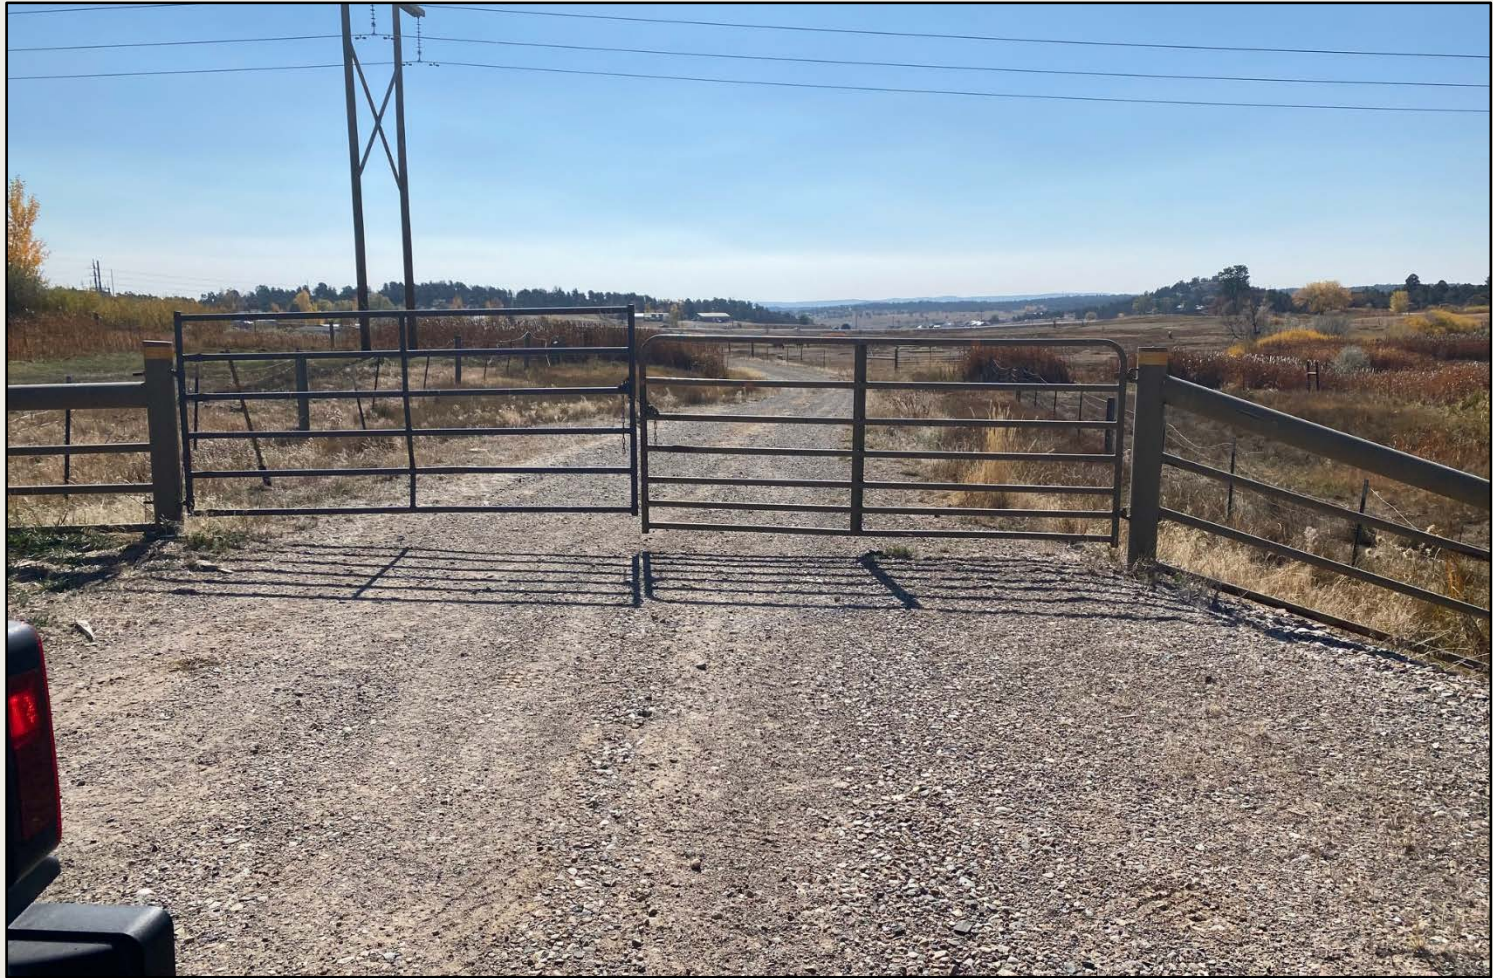
Photo 6. View of closed gate after leaving location.
