Site Assessment

Matt #1 Well Pad and
Tank Battery

Weld County, Colorado

Date:
October 2020

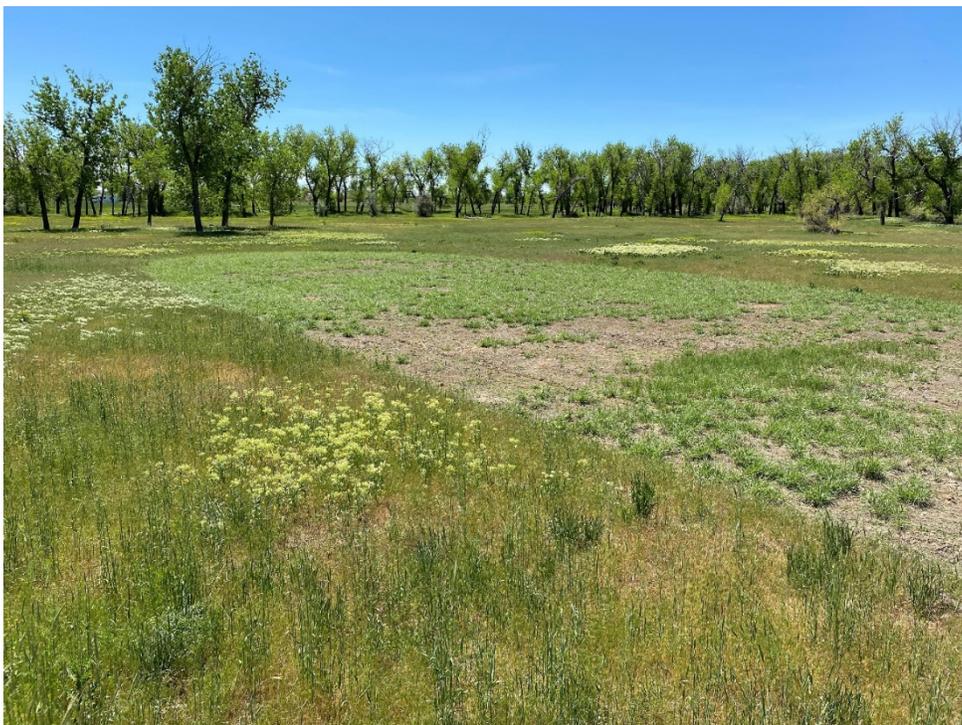
Figure 1. Vegetative conditions after weed control of the reclaimed Matt #1 well pad location viewing southeast.

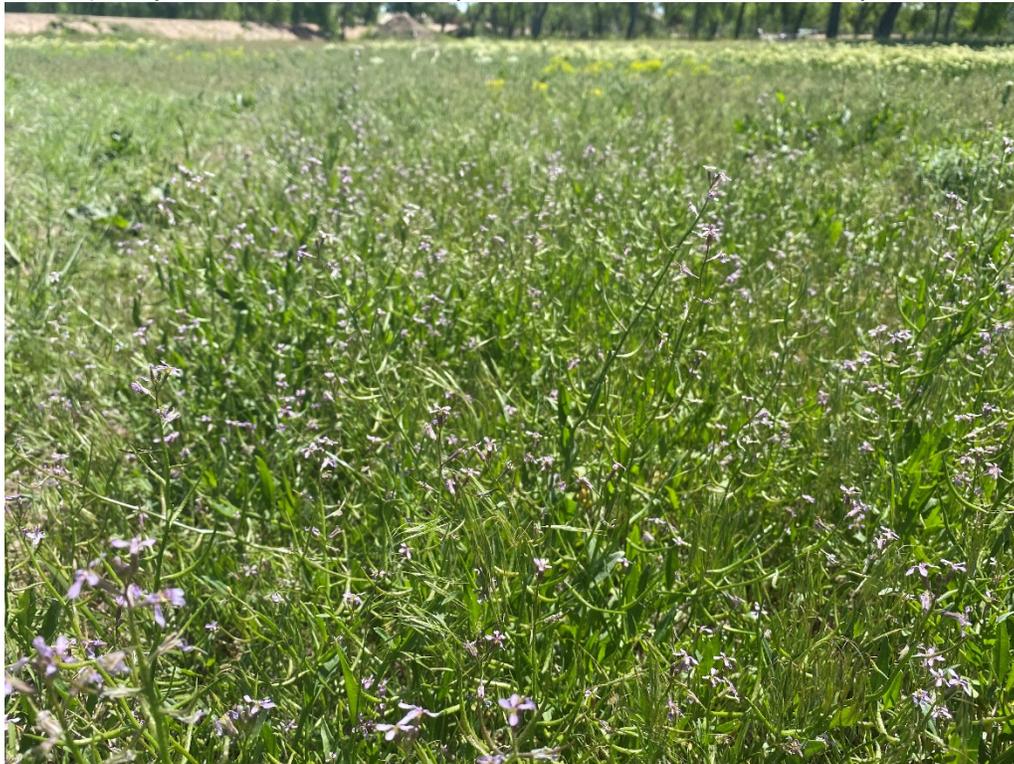
Figure 2. Blue mustard (*Chorispora tenella*) observed on the perimeter of the reclaimed Matt #1 well pad and tank battery locations.

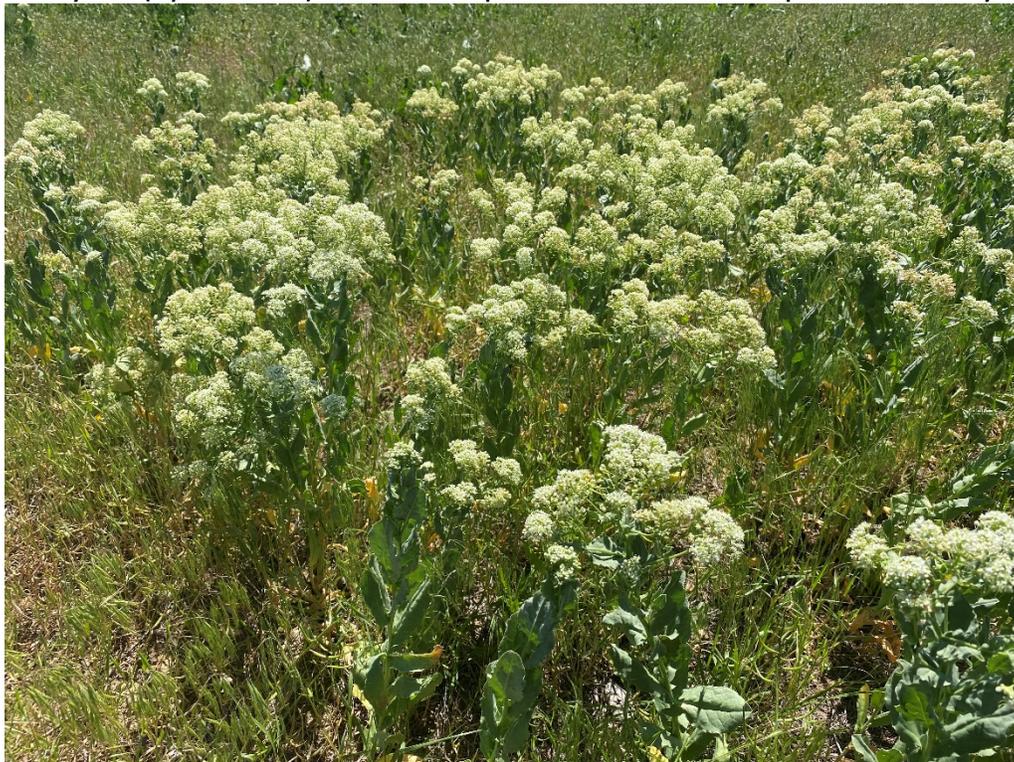
Figure 3. Hoary cress (*Lepidium draba*) observed on the perimeter of the Matt #1 well pad and tank battery locations.

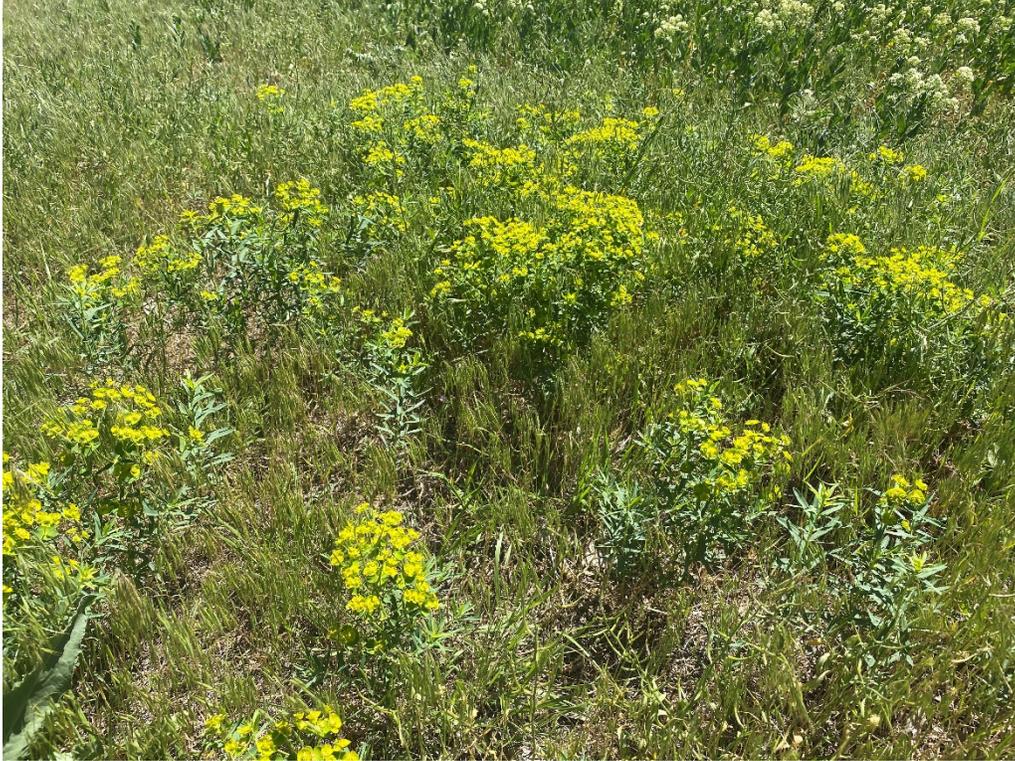
Figure 4. Leafy spurge (*Euphorbia esula* L.) observed on the perimeter of the reclaimed Matt #1 well pad and tank battery locations.

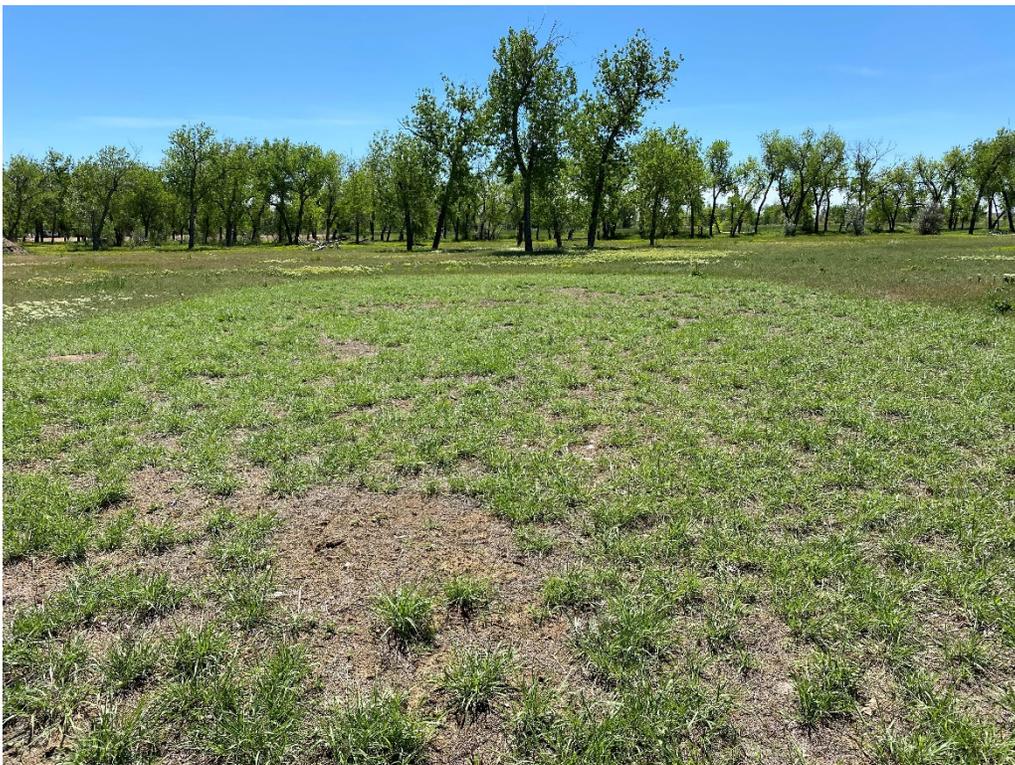
The Matt #1 well pad and tank battery locations were observed as having little to no invasive weeds on the reclaimed areas. This was in contrast to the surrounding vegetation that consisted mostly of cheatgrass, leafy spurge, blue mustard, and hoary cress (Figures 1-4). The well pad and tank battery locations were sprayed by a certified herbicide treatment professional on April 8, 2020. Native grass was observed on the reclaimed location but appeared sparse in some areas (Figures 5-7).

Figure 5. Native grass growing after weed control on the Matt #1 well pad at the time of the assessment viewing southeast.

The area requires additional time for germination success to reach a higher revegetation percentage. Both locations were interseeded on May 12, 2020. Warmer soil temperatures, additional precipitation, and time will lead to more surface coverage of the native grasses. At that time, it was advised PDC conduct a quantitative vegetation assessment (QA) in the Fall after germination of the May 2020 reseeded efforts have proven to be successful. Additional prescriptive measures, such as weed maintenance and/or inter-seeding, can also be performed based on the results from the Fall QA. PDC will perform mechanical weed control during the summer growing months and if needed, to treat onsite weedy species with selective herbicides. Duraroot will monitor both locations throughout the summer growing season and advise PDC on prescriptive measures.

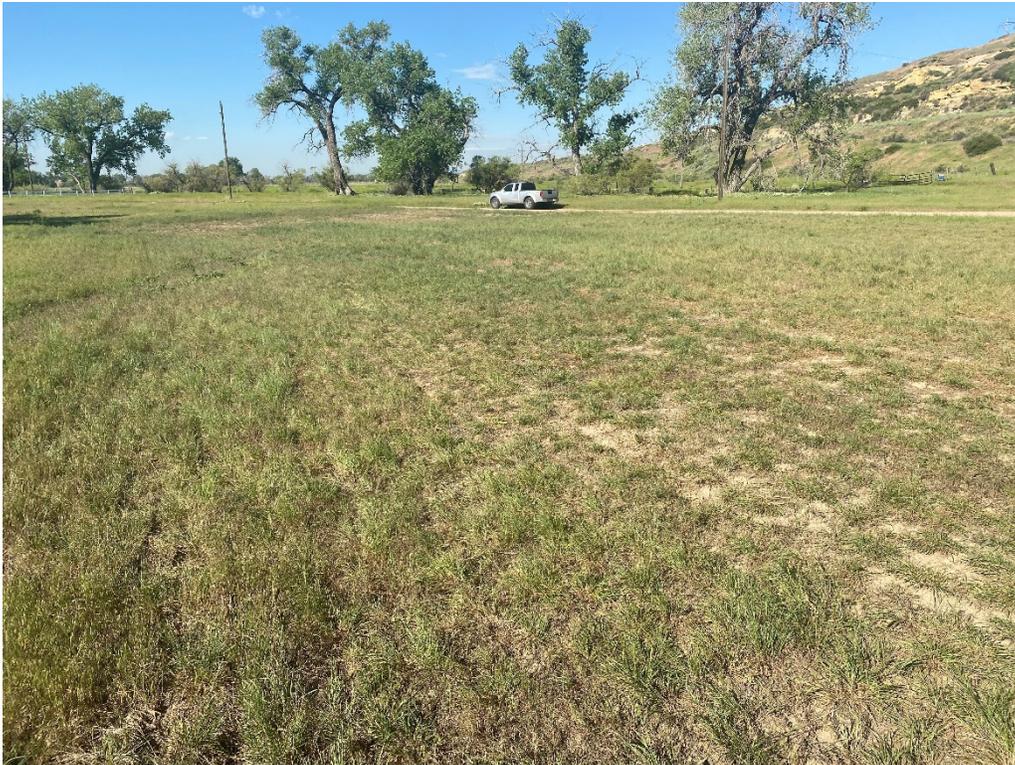
Figure 6. Native grass growing after weed control on the Matt #1 tank battery at the time of the assessment viewing southwest

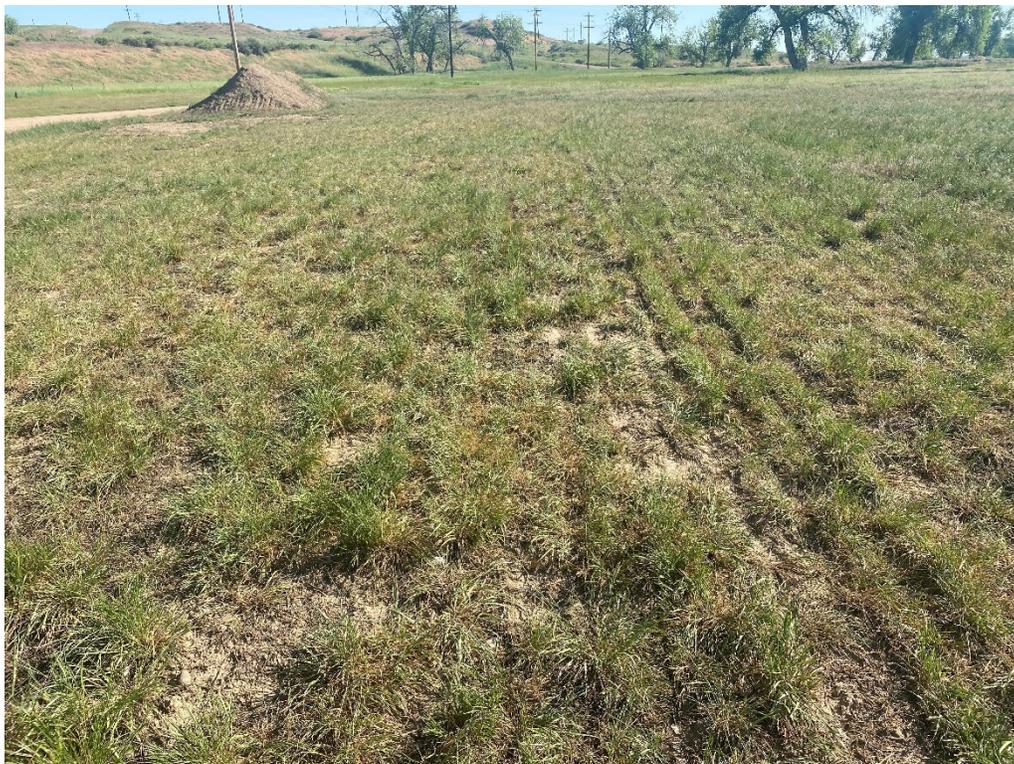
Figure 7. Native grass is quickly reaching the desired surface coverage percentage on the tank battery location viewing north.

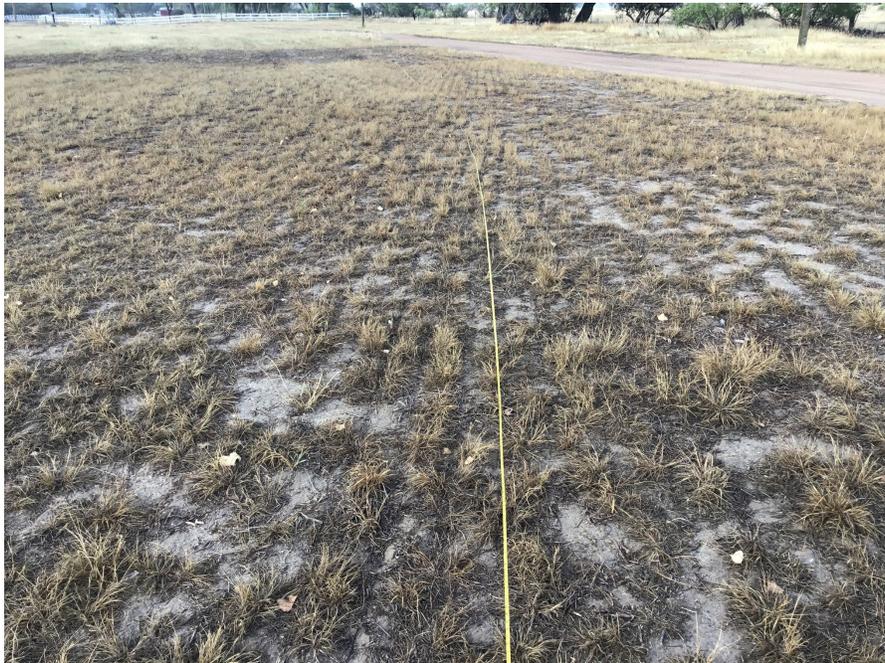
Figure 1. Vegetative conditions of the reclaimed Matt #1 tank battery location viewing south.

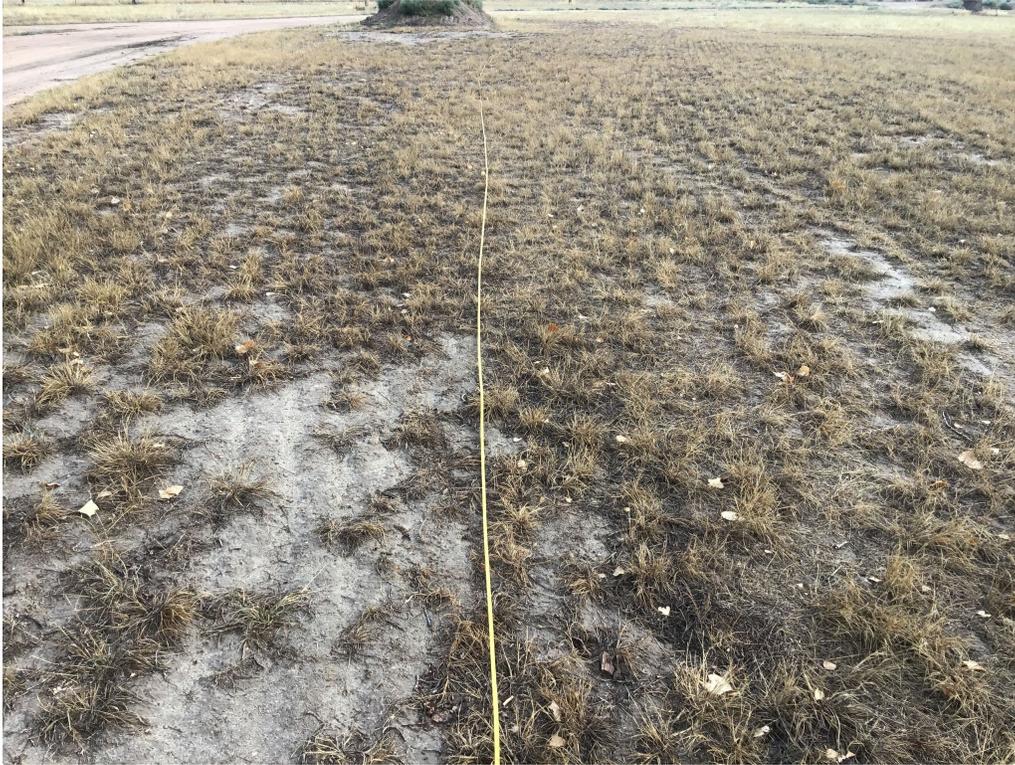
Figure 2. Vegetative conditions of the reclaimed Matt #1 tank battery location viewing north.

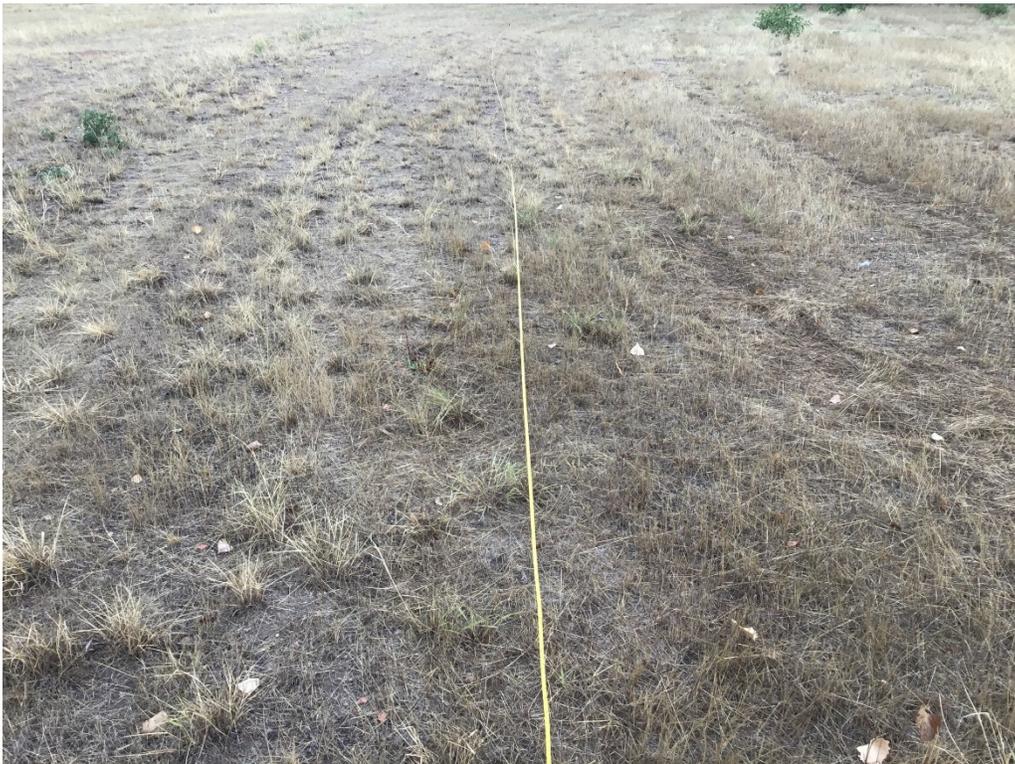
Figure 3. Vegetative conditions of the off-site adjacent area to the Matt #1 tank battery location viewing east.

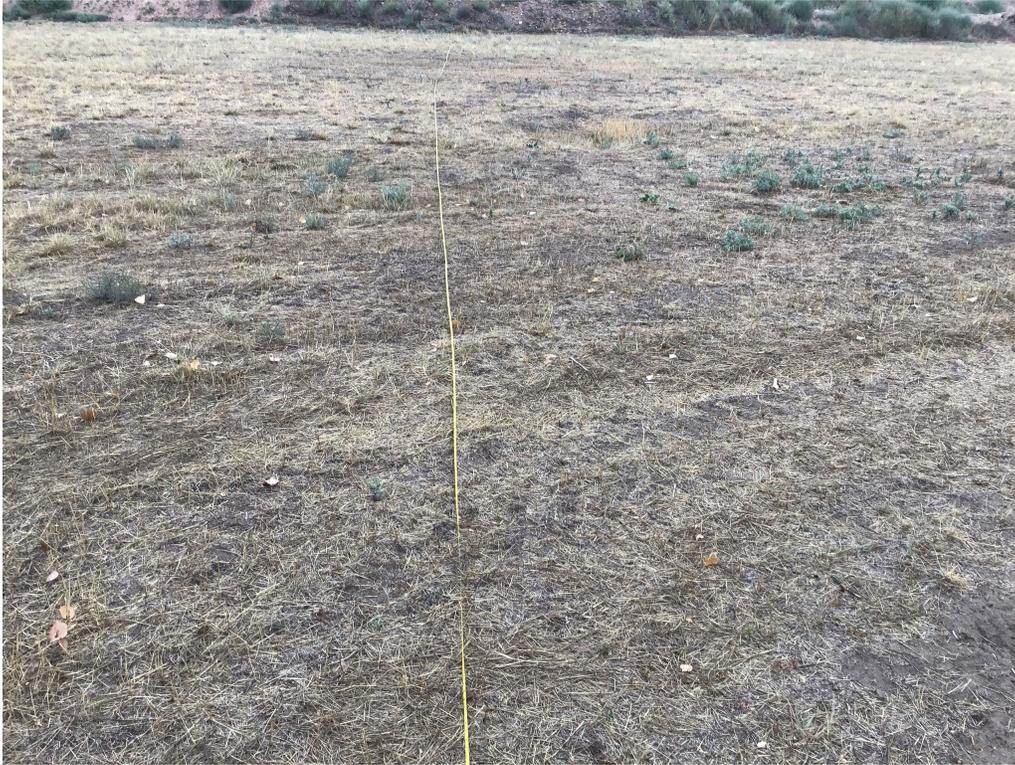
Figure 4. Vegetative conditions of the reclaimed Matt #1 well pad location viewing north

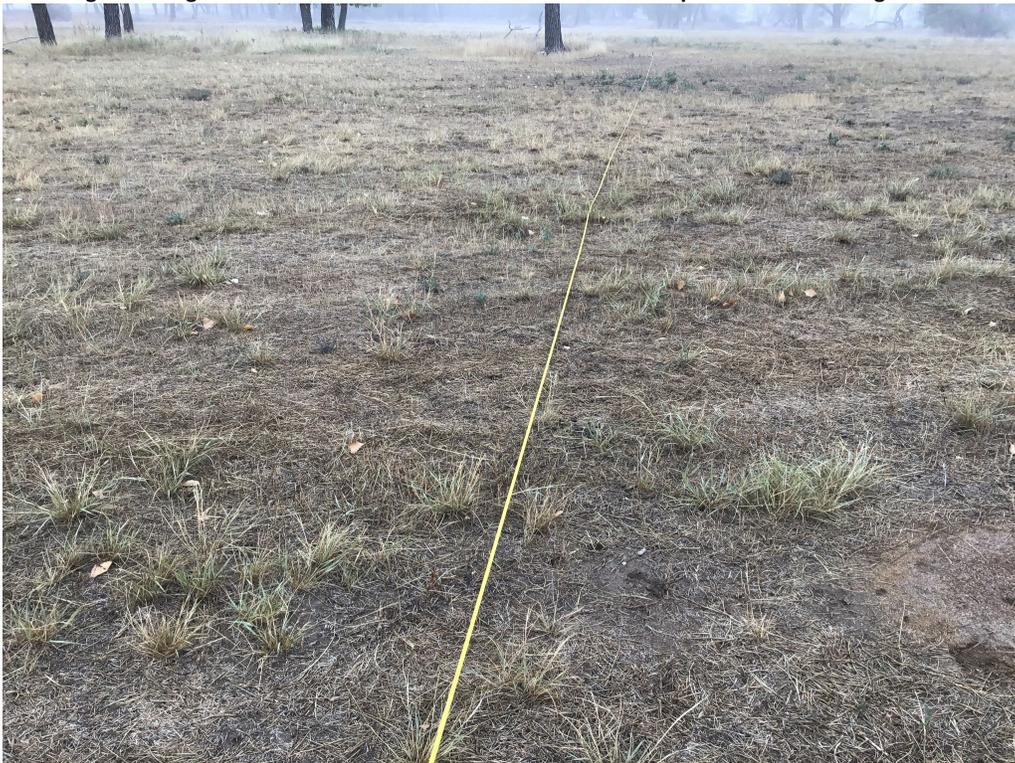
Figure 5. Vegetative conditions of the reclaimed Matt #1 well pad location viewing south.
