**COLORADO**  
Oil & Gas Conservation  
Commission  
Department of Natural Resources

**CRU 4401D-A23-1N100      API: 05-103-10561**  
**Inspection: 700403928**

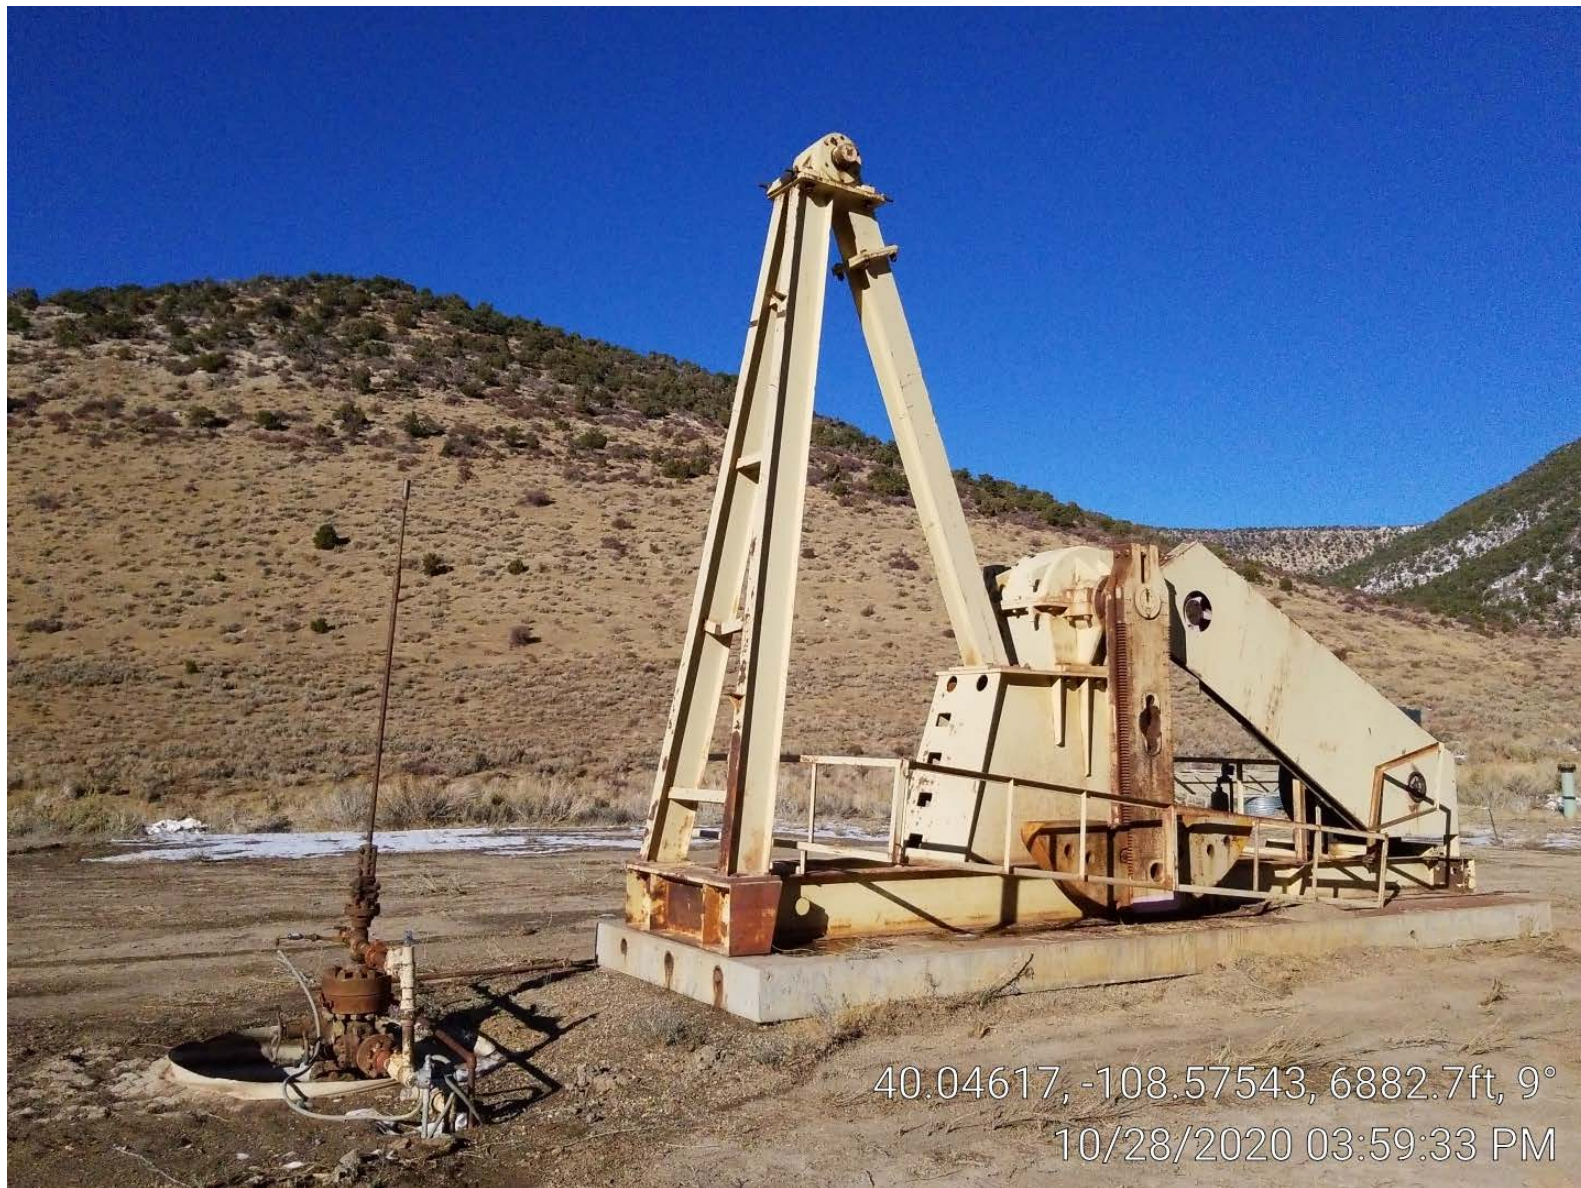
**Photo 2. Pump jack.**

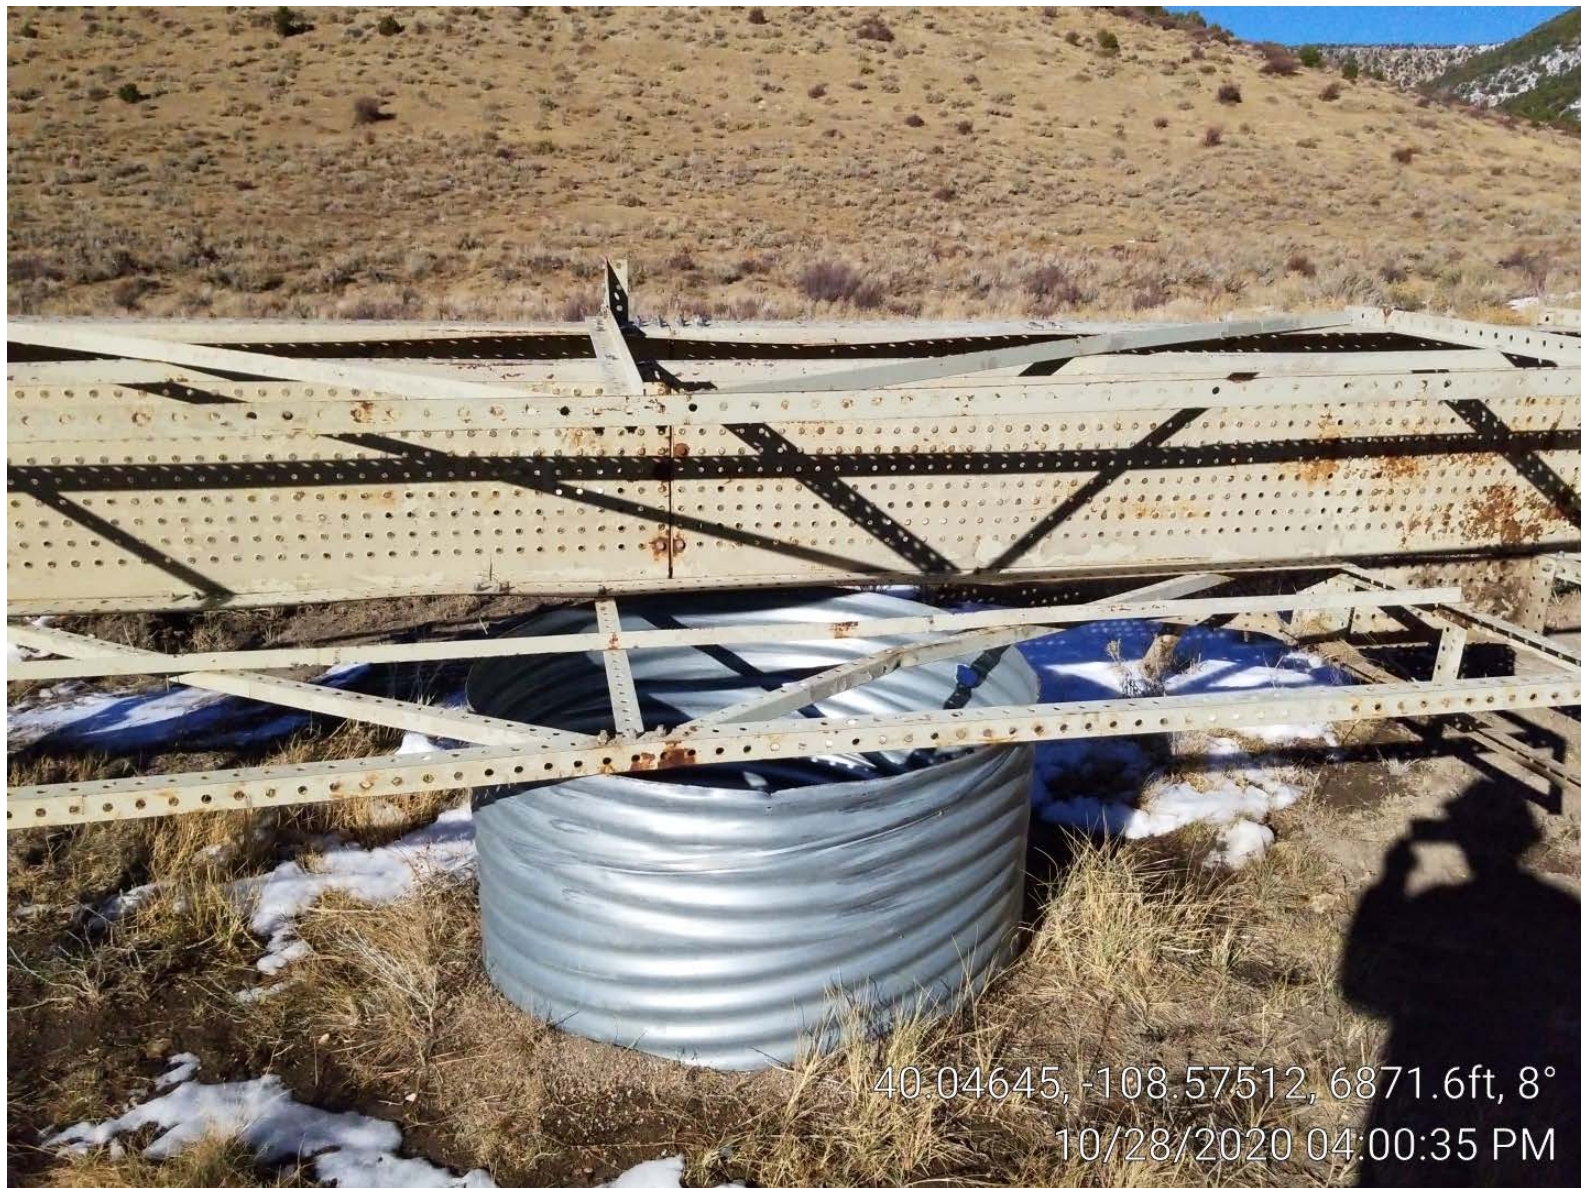
**Photo 3. Valve can.**

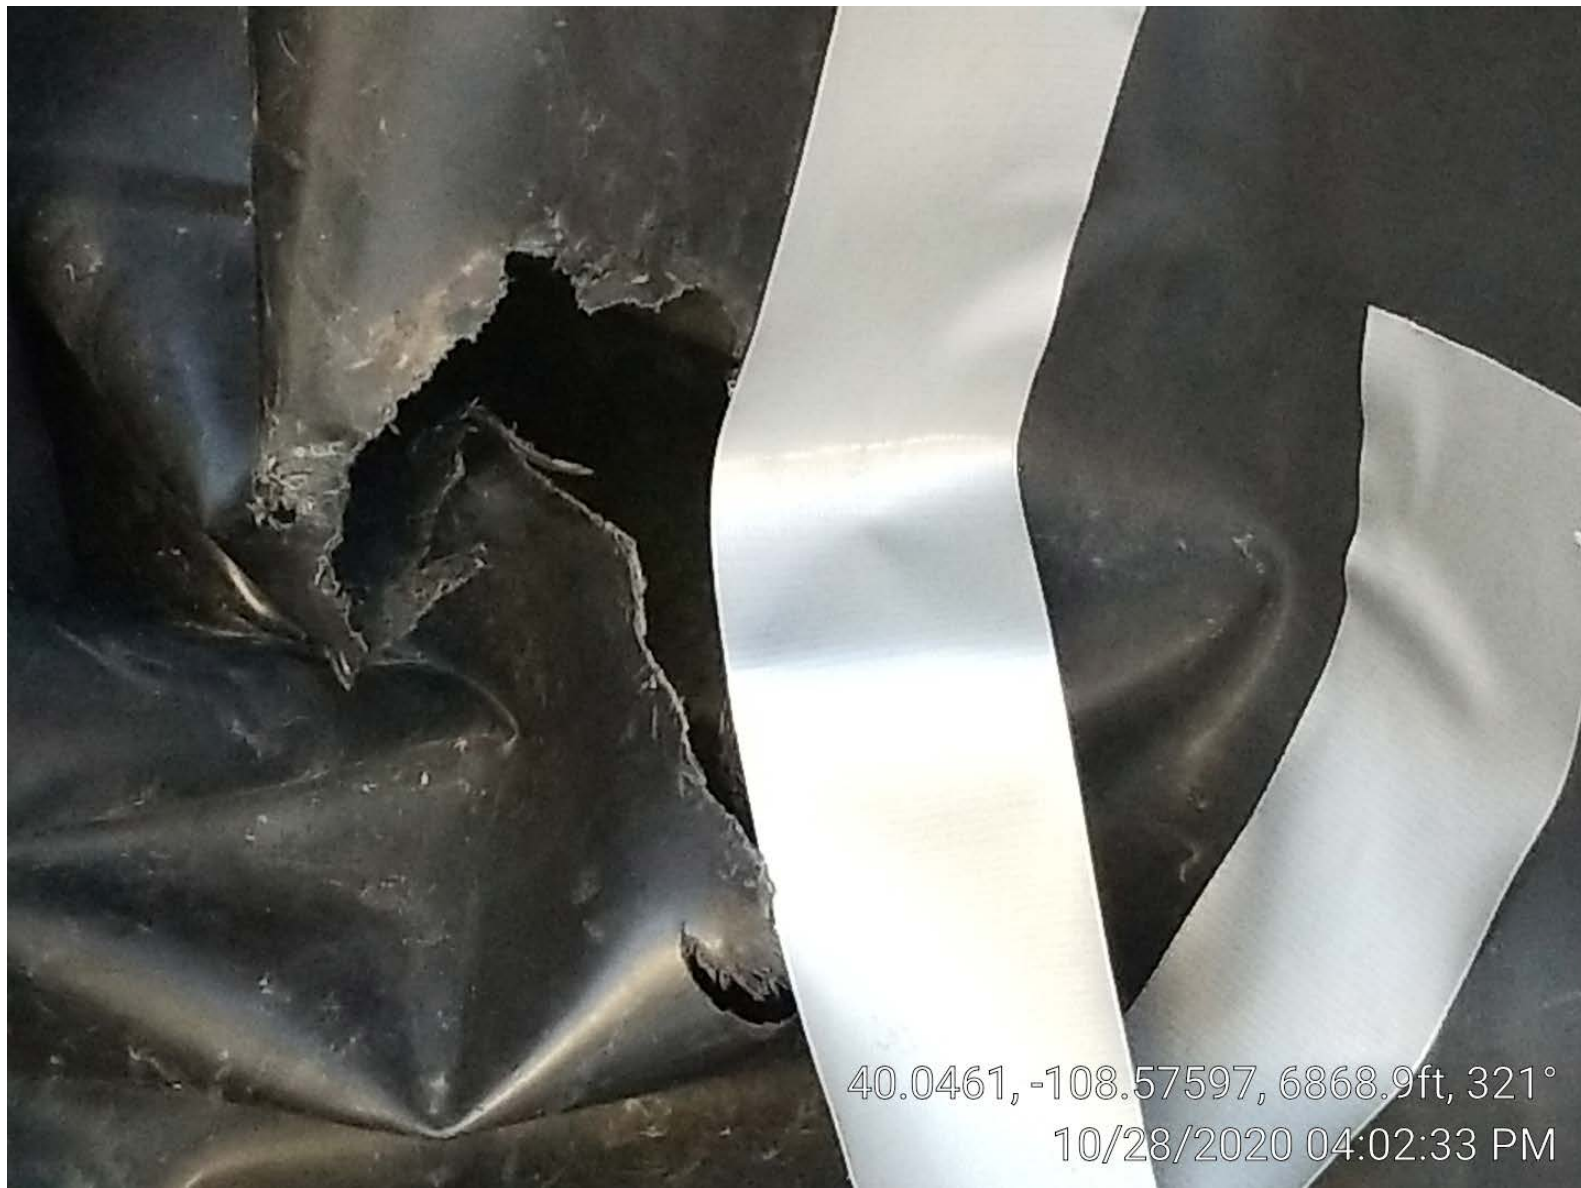
**Photo 5. Secondary containment liner hole.**
