Inspection Photos
Operator: Kinder Morgan
API: 083-06573
Date: 10/27/2020

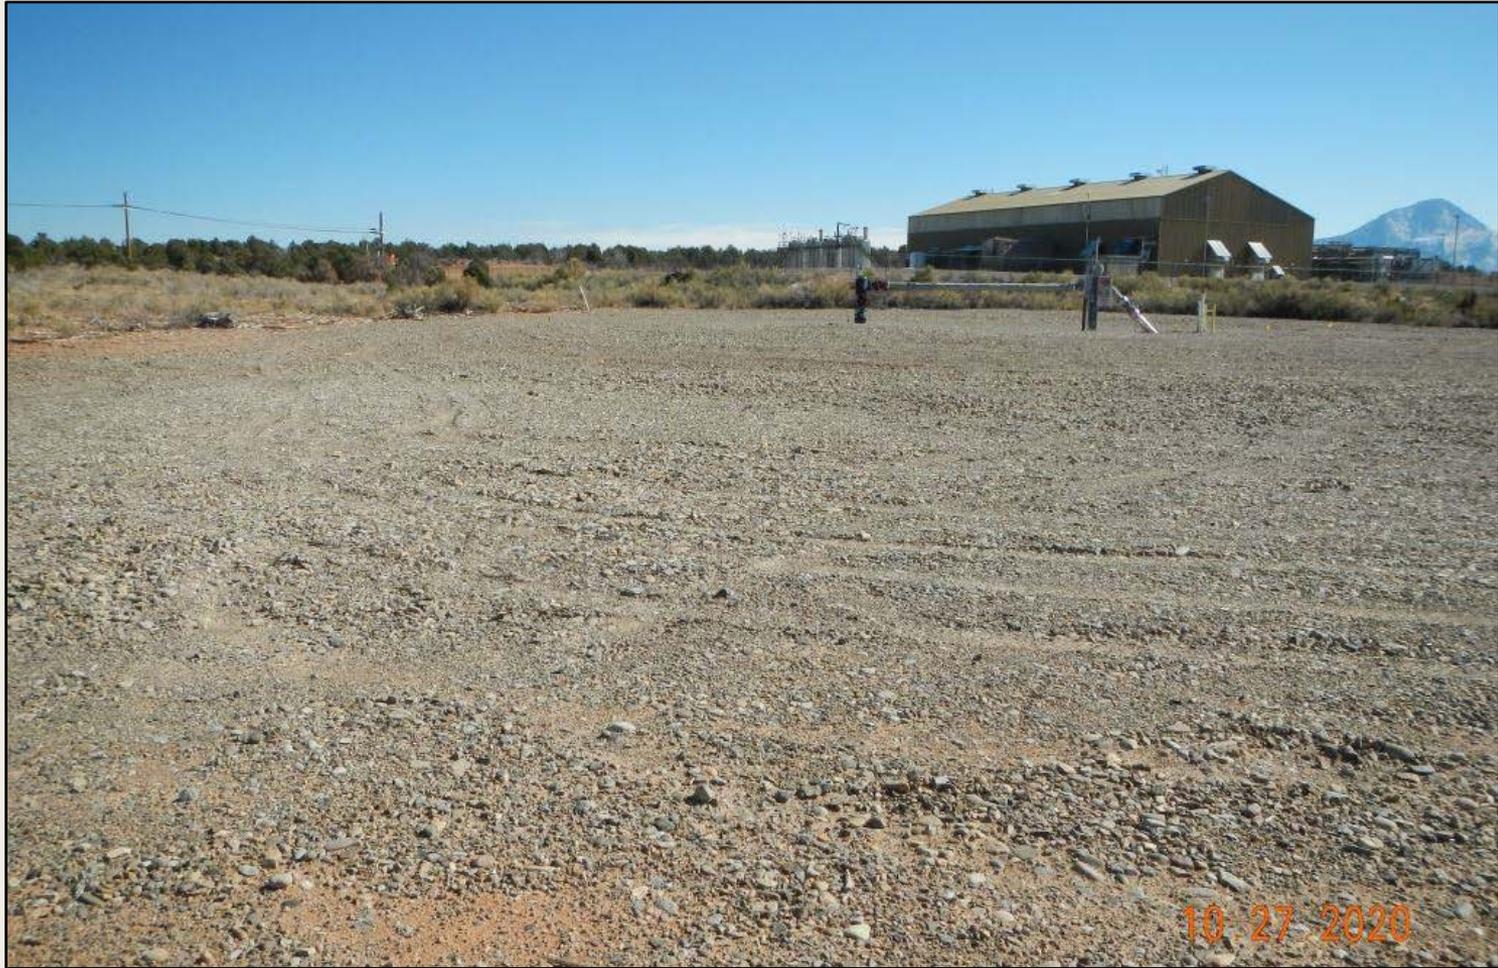
Photo 1. View of the project area from the well pad entrance facing center.

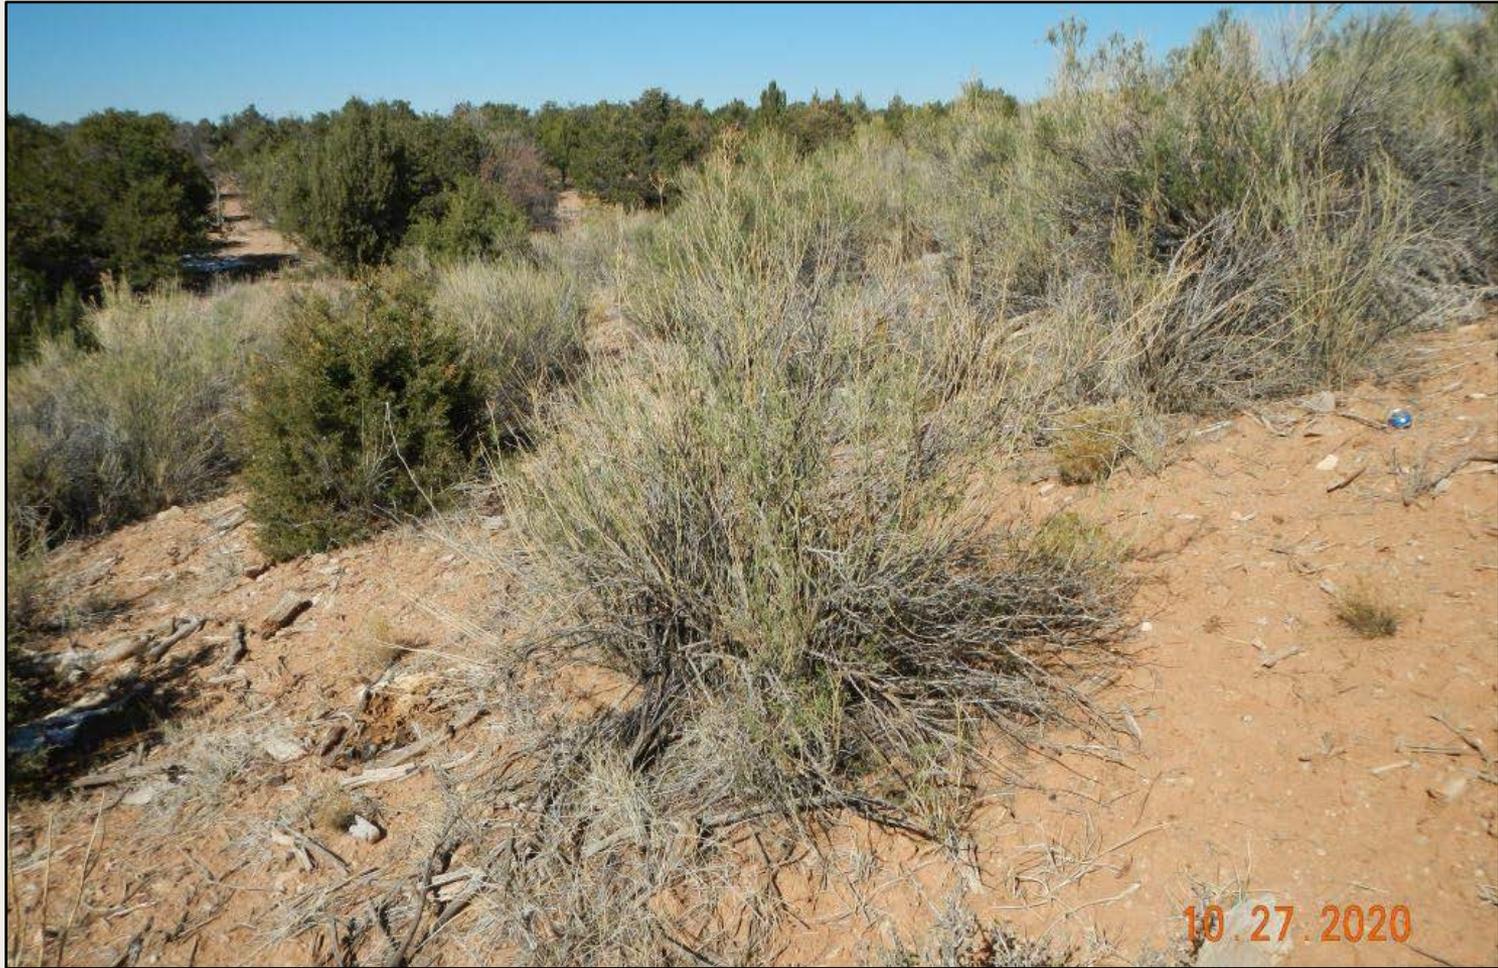
Photo 2. View of the western portion of the interim reclamation area from the southwestern corner facing northward. Revegetation is progressing, largely with rubber rabbitbrush, Indian ricegrass, and young junipers.

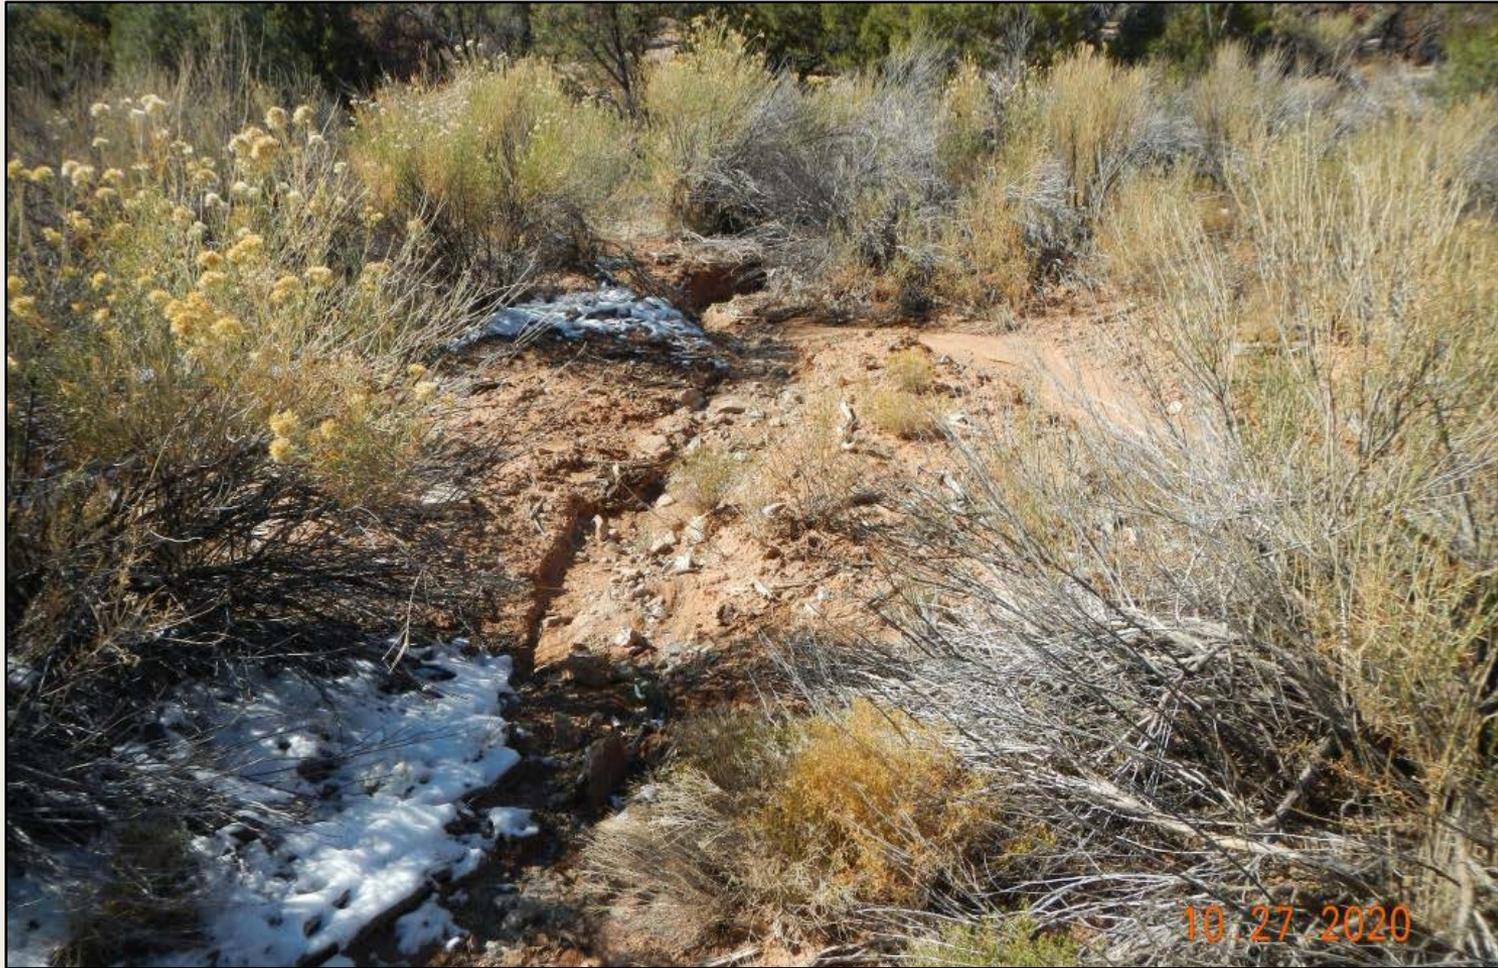
Photo 3. View of erosional channeling within the northwestern project area, approximately 2-3 feet wide and 6-8 inches deep.

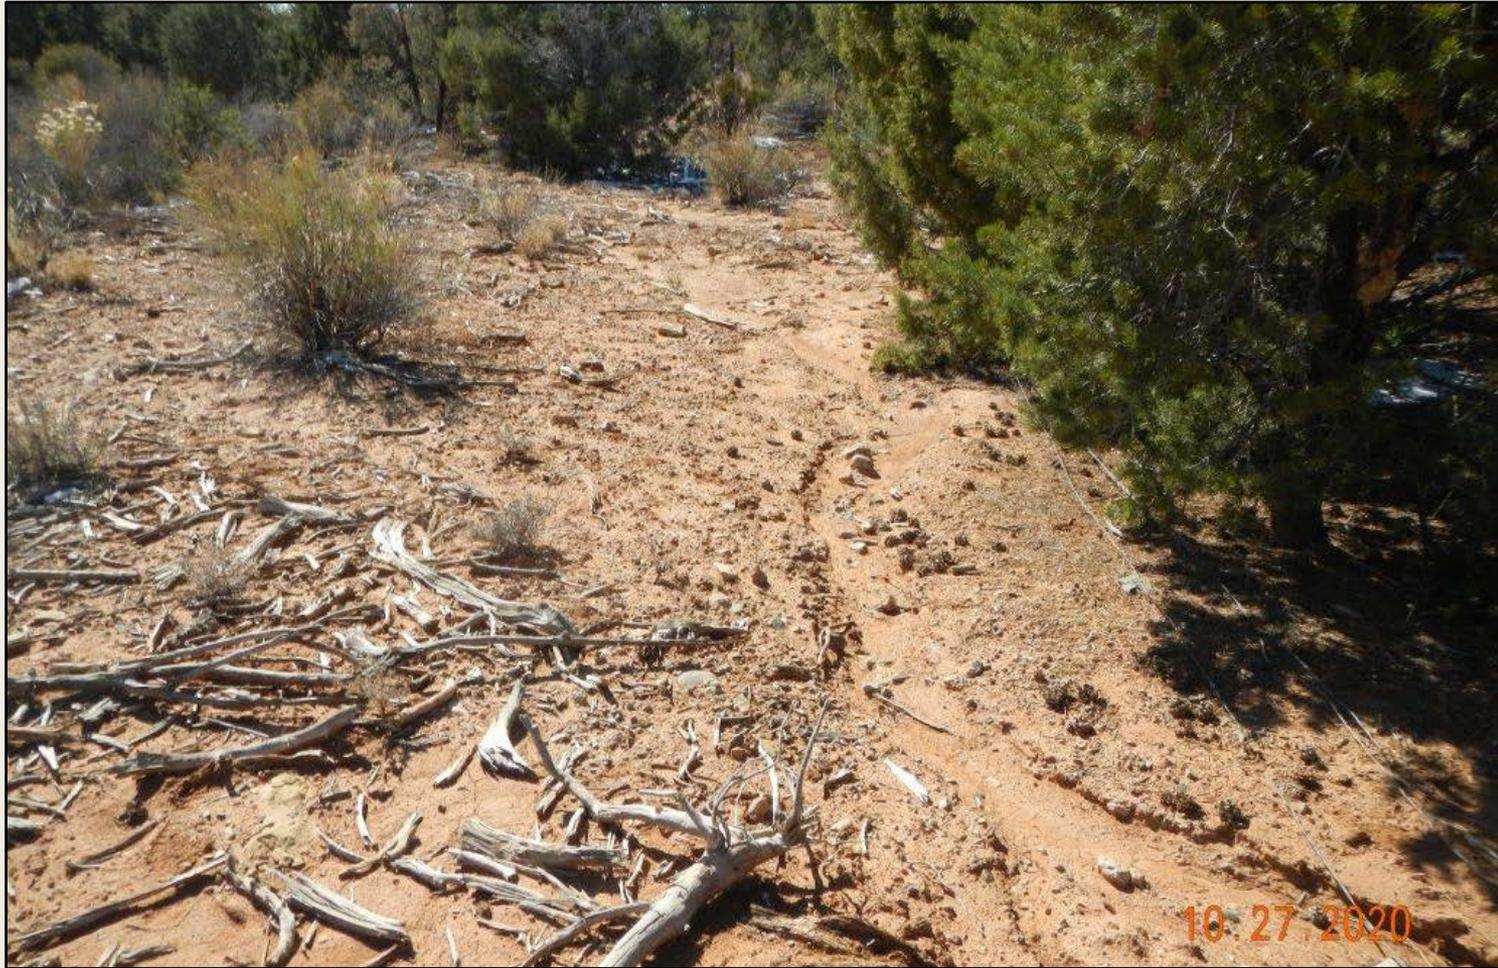
Photo 4. View of erosional stream along the northwestern boundary of the project area.

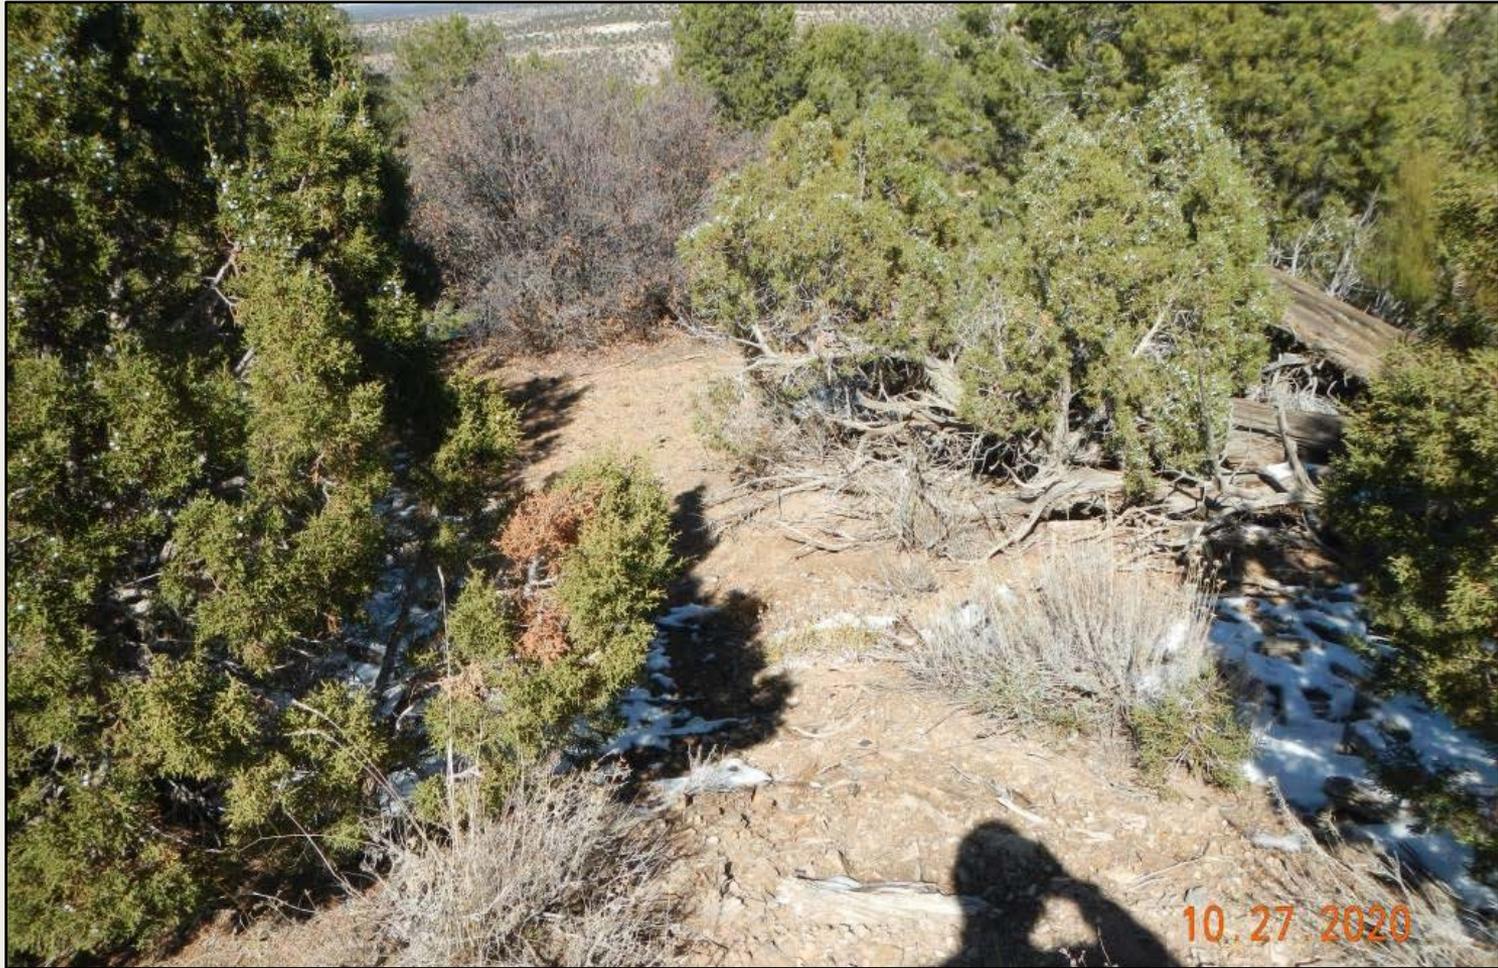
Photo 5. View of the reference area comprised of pinyon/juniper woodland with understory of shrubs, forbs, and grasses such as yucca, sagebrush, mountain mahogany, Indian ricegrass, purple threeawn, rock goldenrod, and ephedra.
