Inspection Photos
Operator: Kinder Morgan
API: 083-06527
Date: 10/27/2020

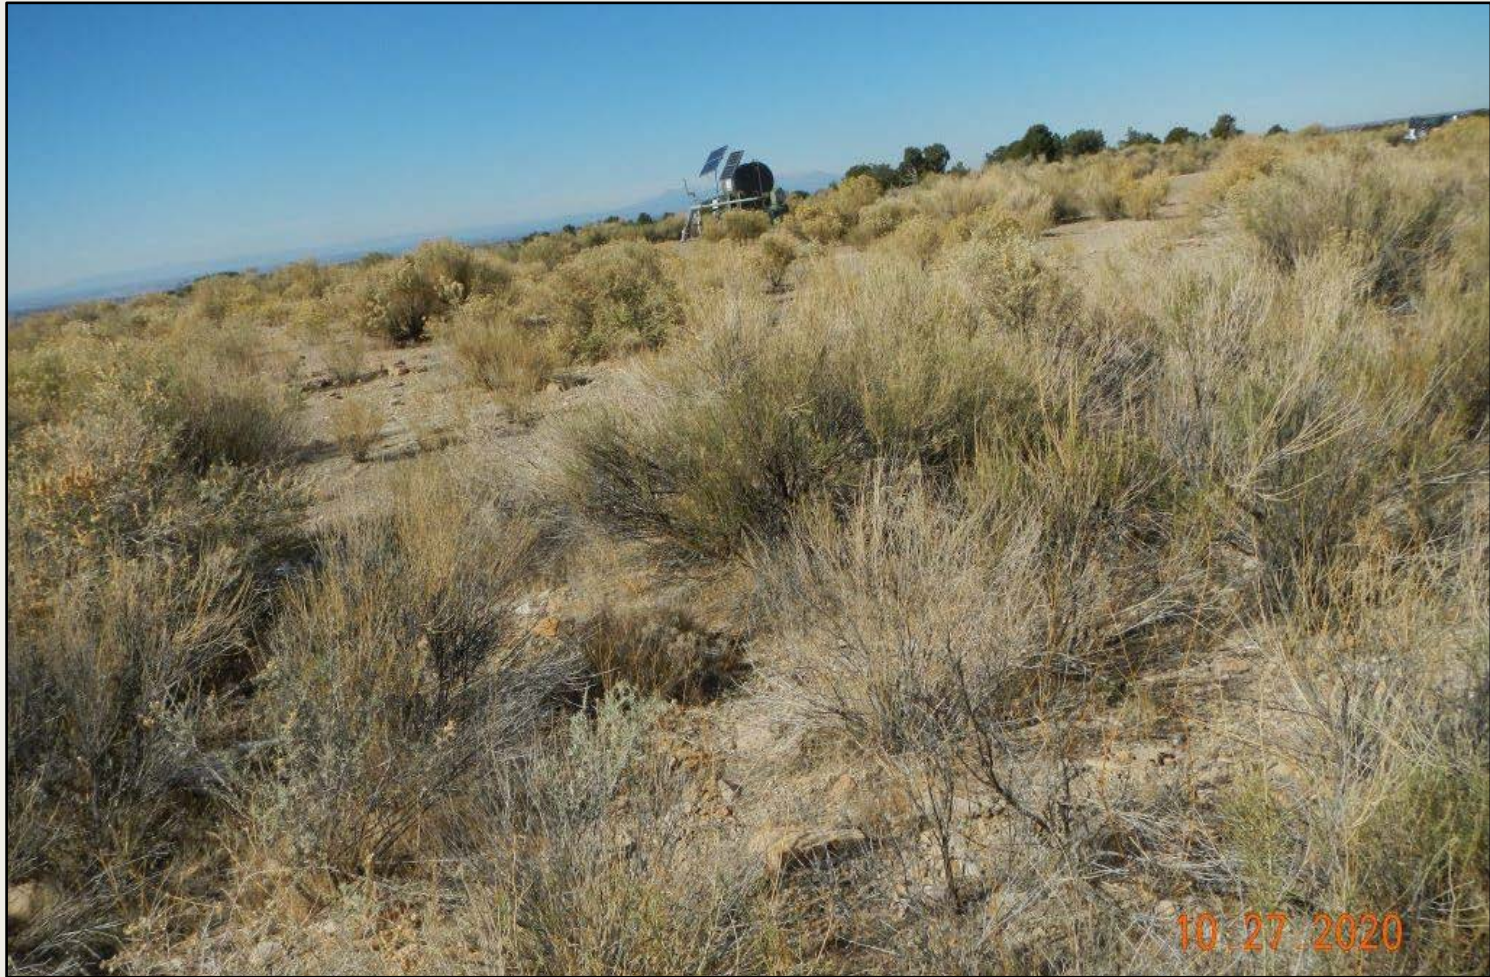
Photo 1. View of the project area from the southeastern corner facing center.

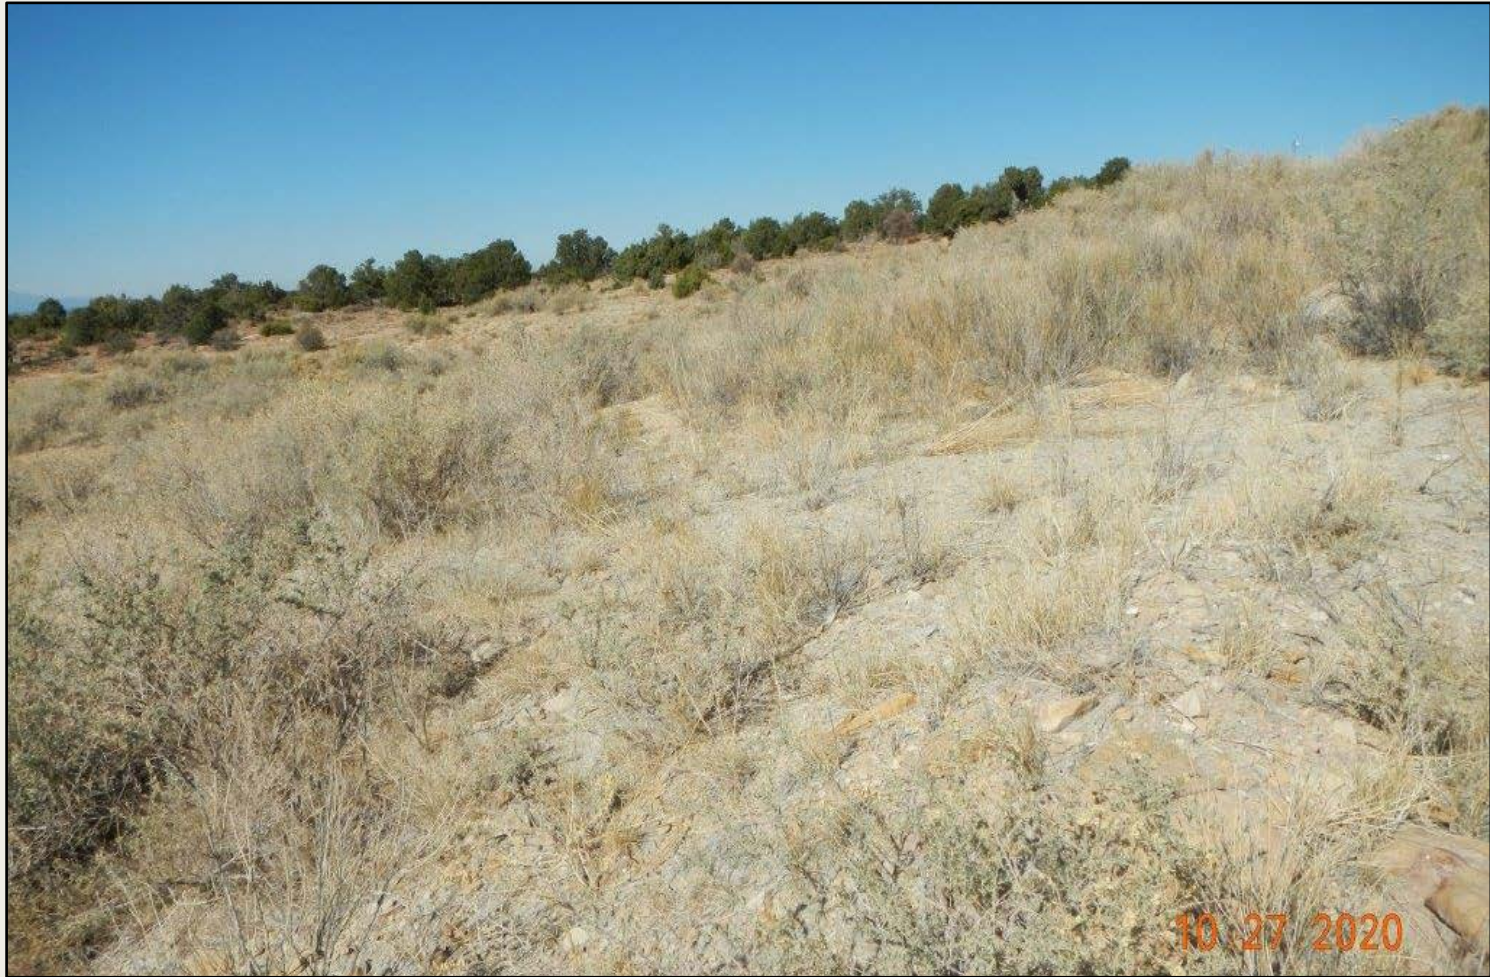
Photo 2. View of the western portion of the interim reclamation area from the southwestern corner facing northward. Revegetation is progressing, largely with rubber rabbitbrush, fourwing saltbush, Indian ricegrass, and western wheatgrass.

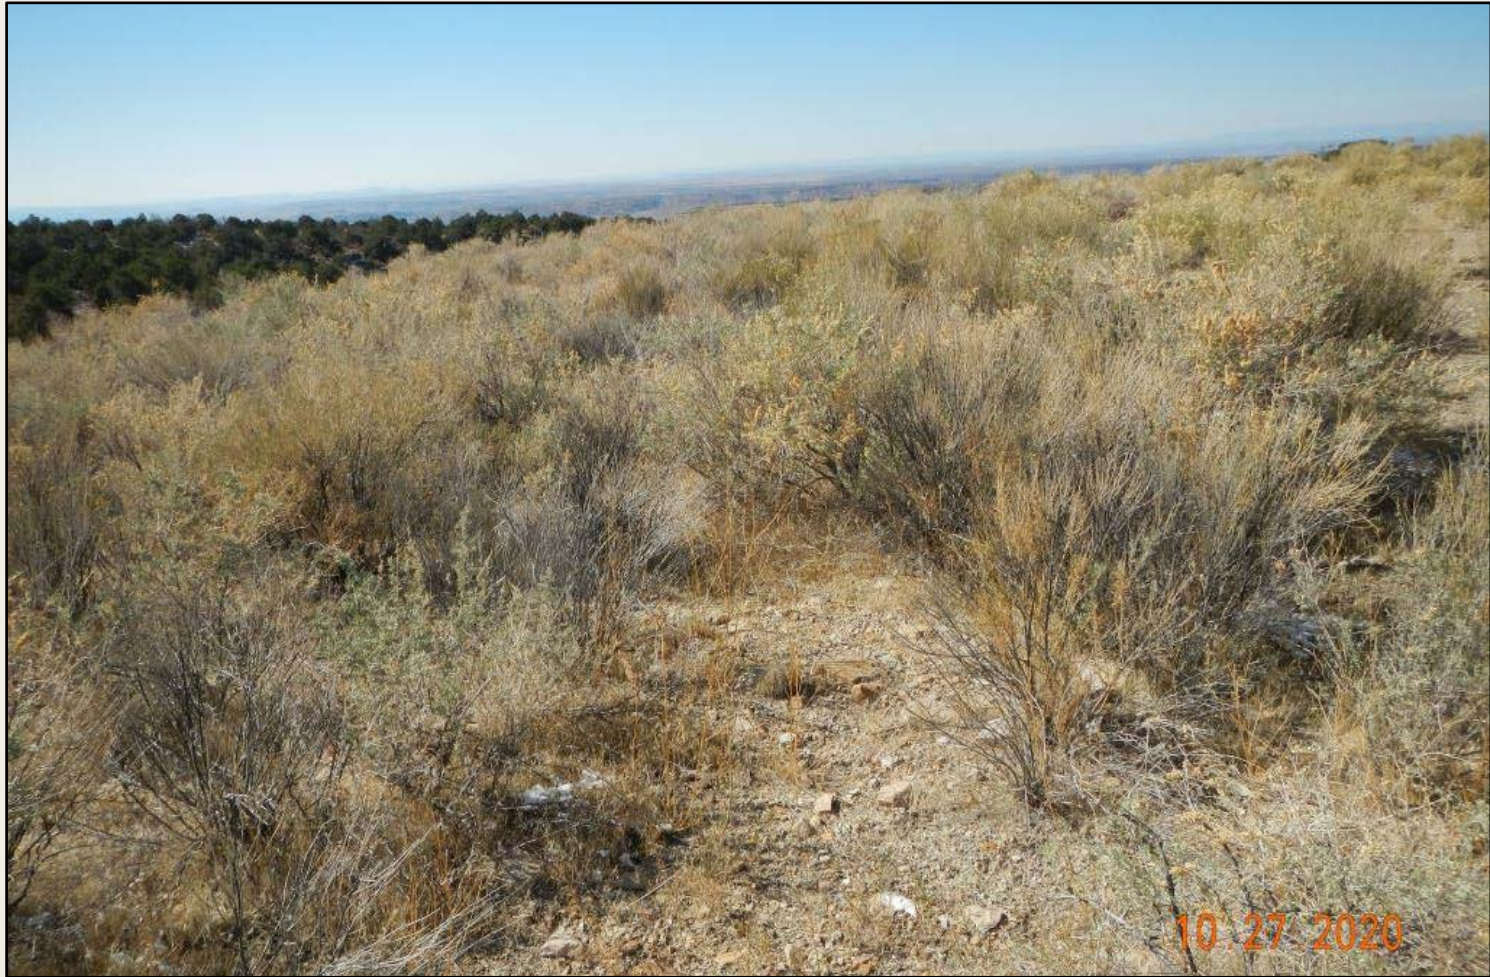
Photo 3. View of the southern project area from the southeastern corner facing westward.

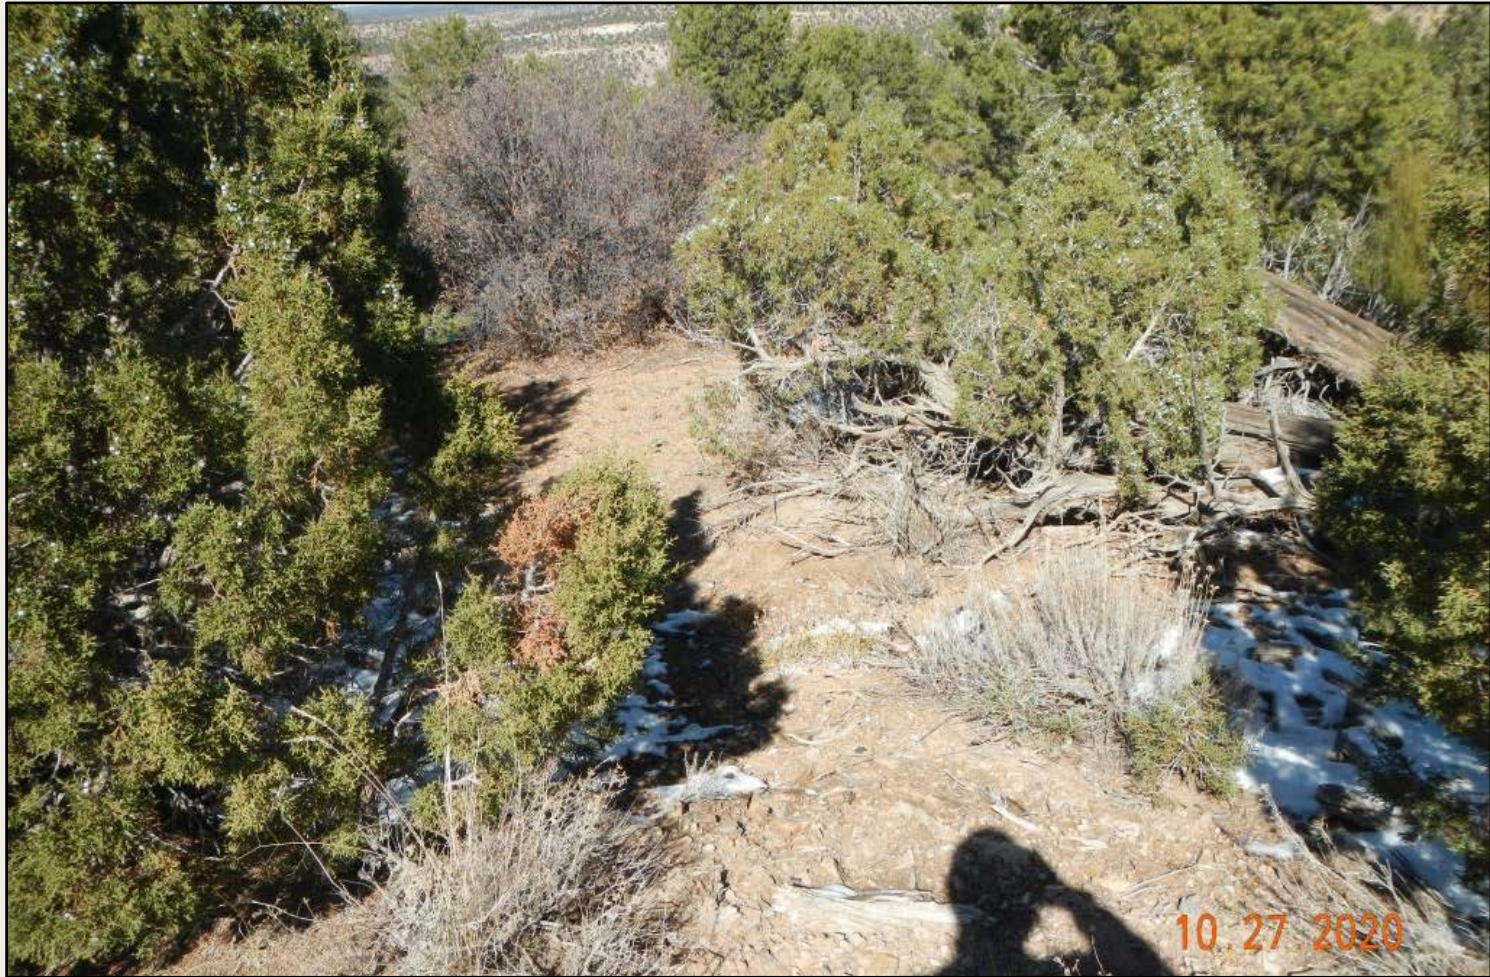
Photo 4. View of the reference area comprised of pinyon/juniper woodland with understory of shrubs, forbs, and grasses such as yucca, sagebrush, mountain mahogany, Indian ricegrass, purple threeawn, rock goldenrod, and ephedra.
