**TEP ROCKY MOUNTAIN LLC**  
**UIC Handling Location 33-6S-95W**  
**Location ID: 445074**

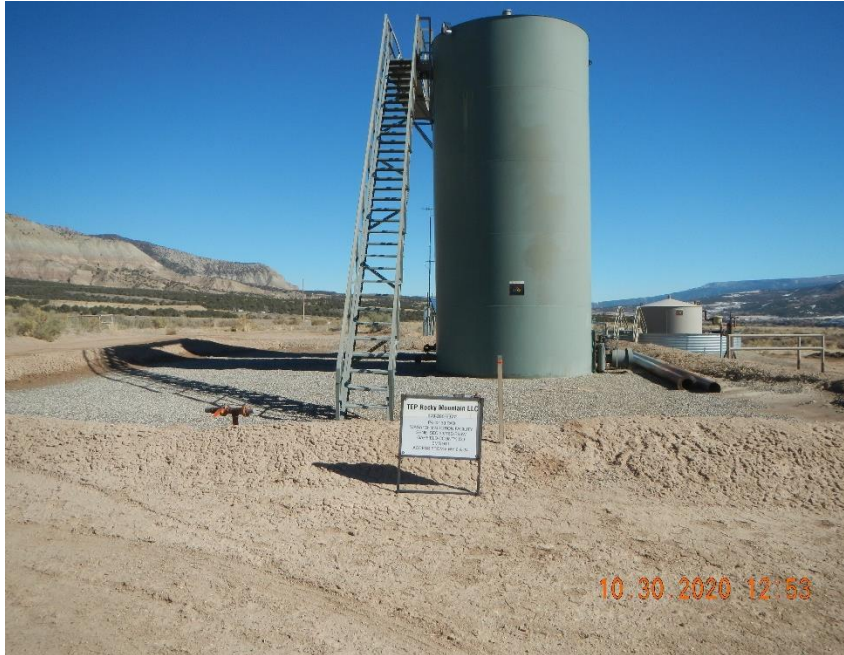
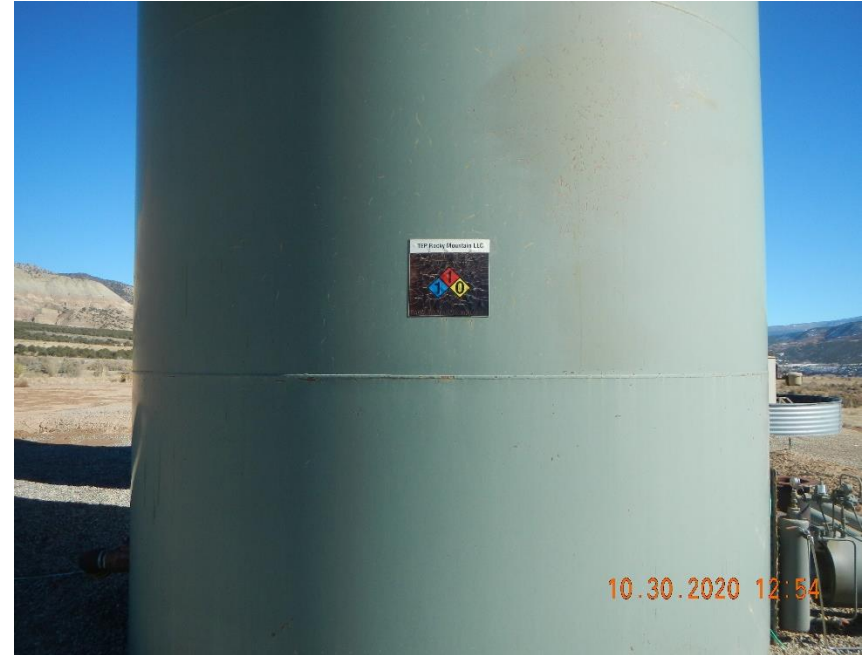
**Tank label on 500 bbl tank is blacked out.**

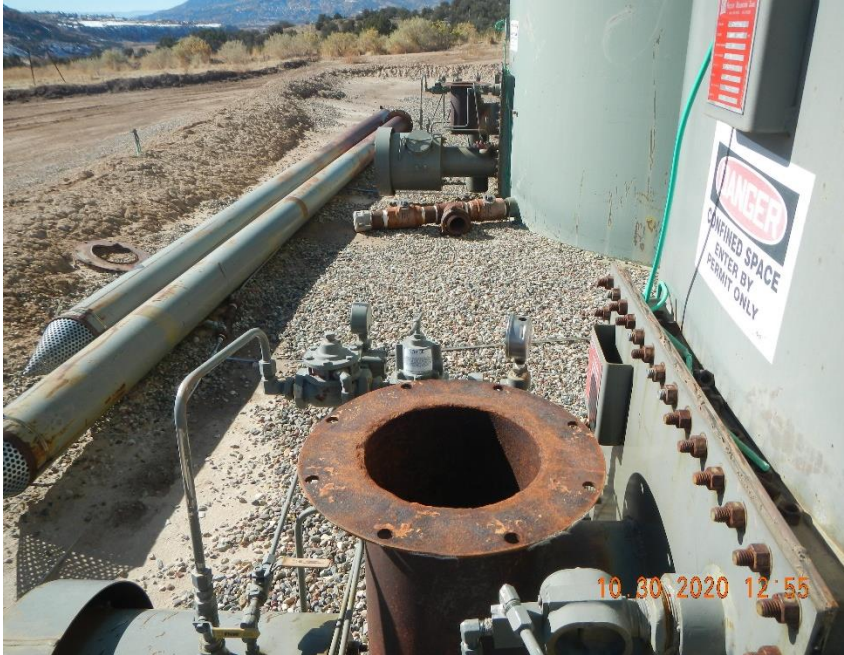
**2 out of service 500 bbl heated tanks with stacks off of the heat units.**

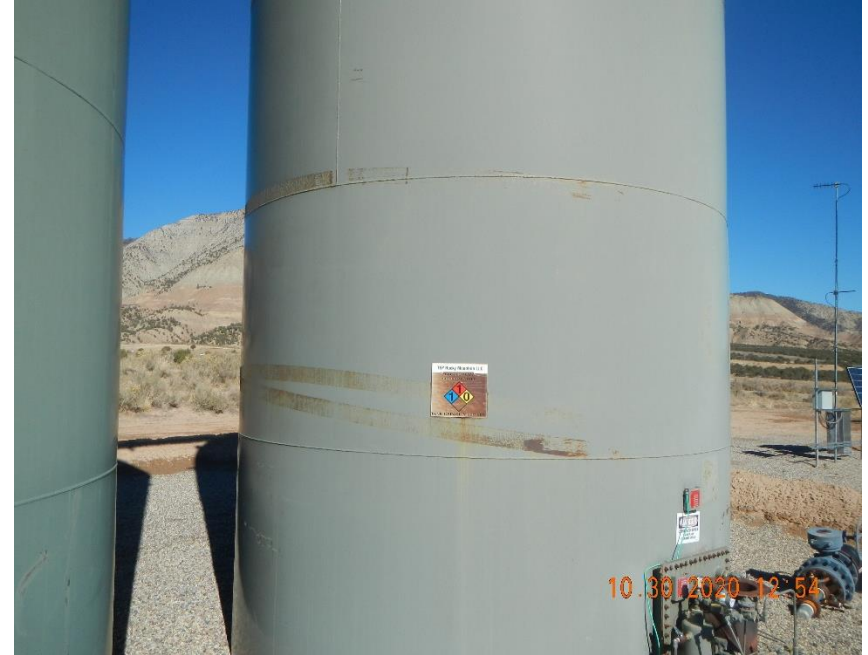
**Stacks have been removed from the tank heating units. There is no covers over the open flange for the exhaust stacks.**

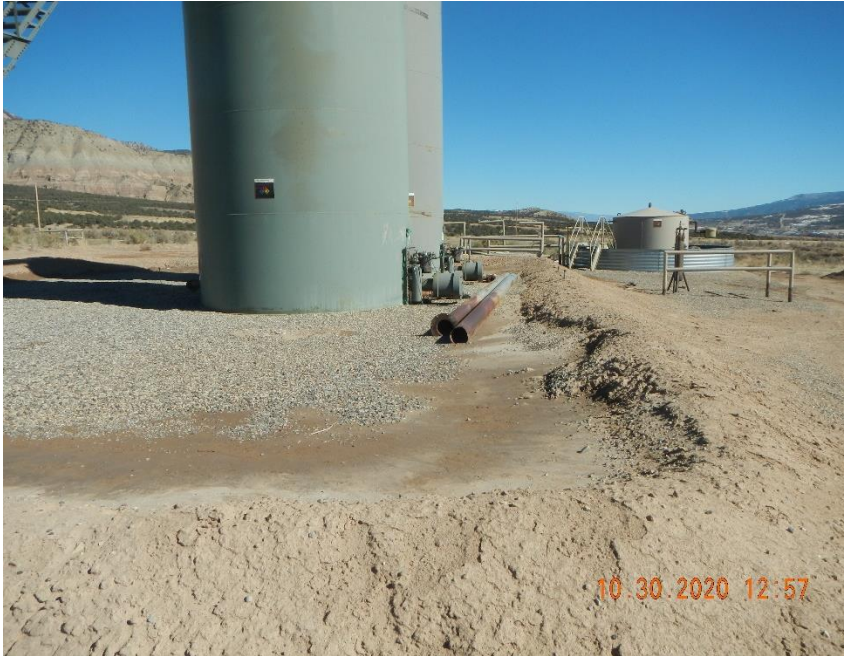
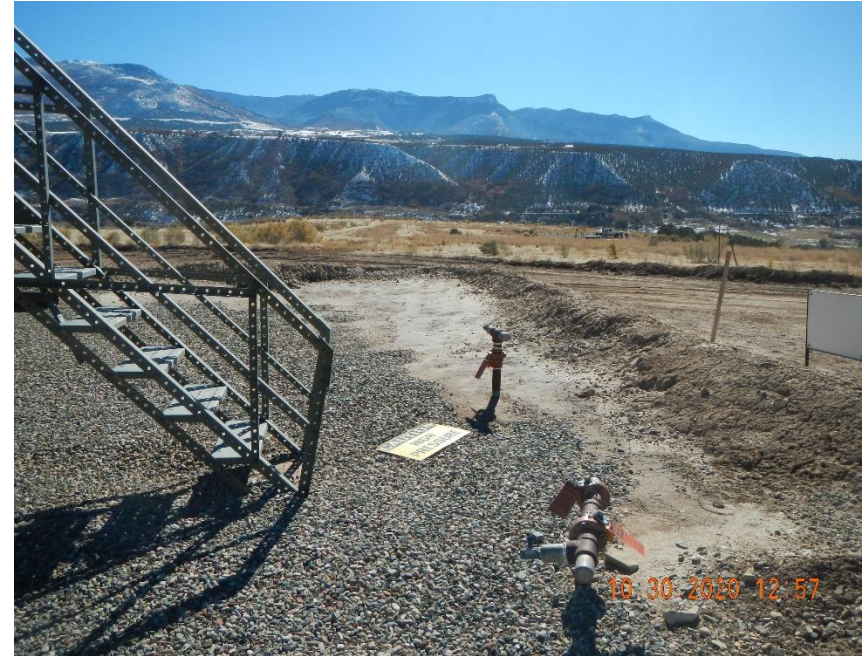
**Earthen berm has washed and sediment build up inside of berm.**

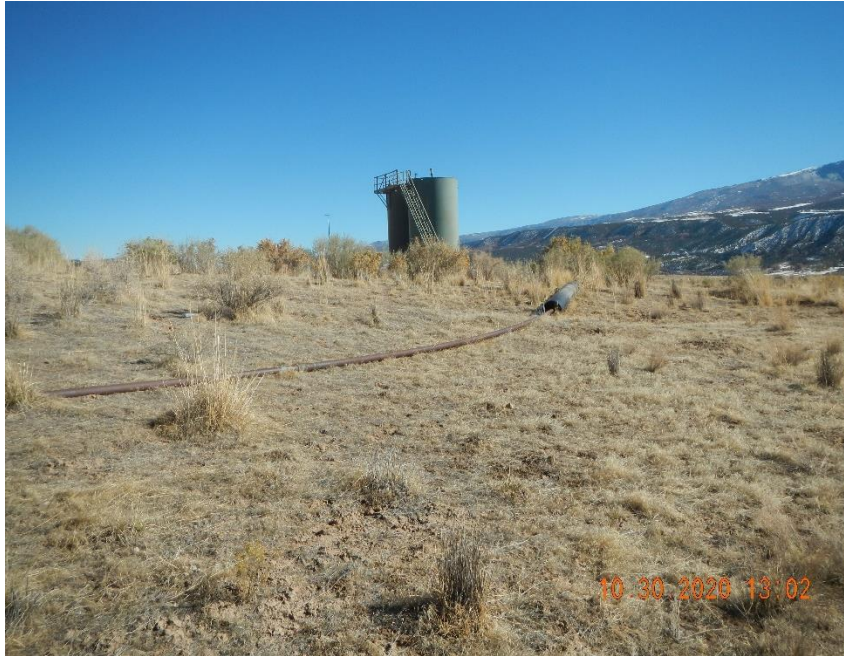
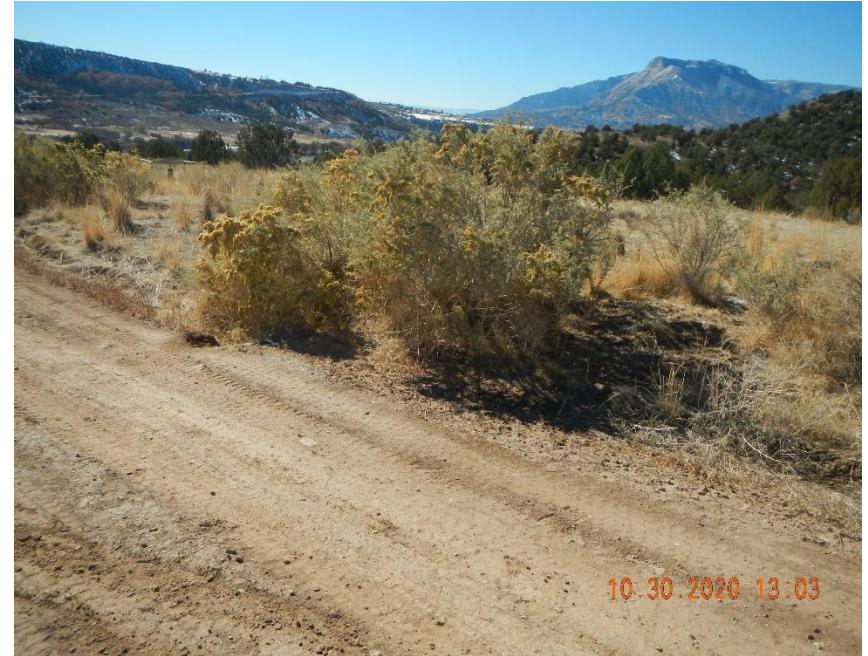
**Flow line ran under access road is causing road ditch to build up sediment and eroding around the poly pipe.**

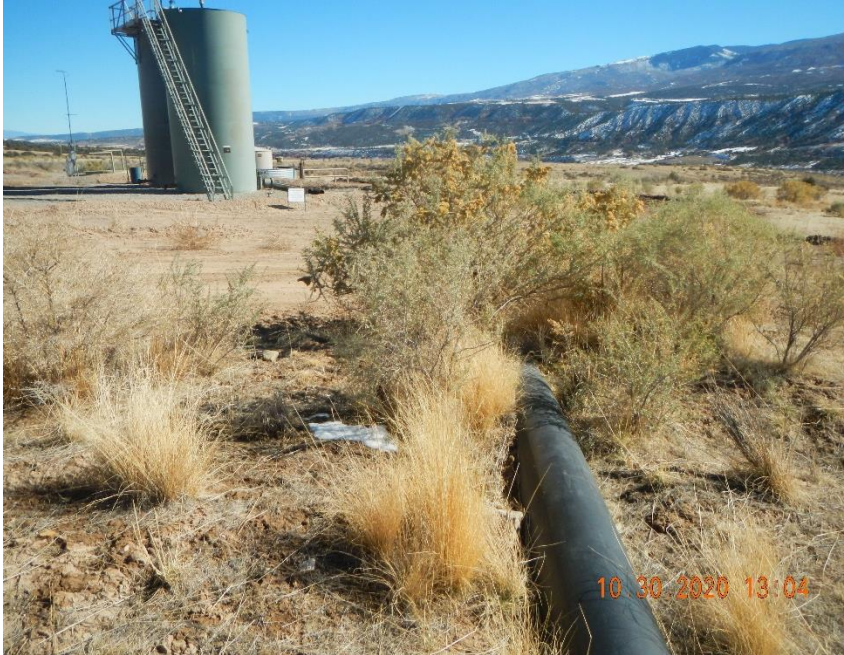
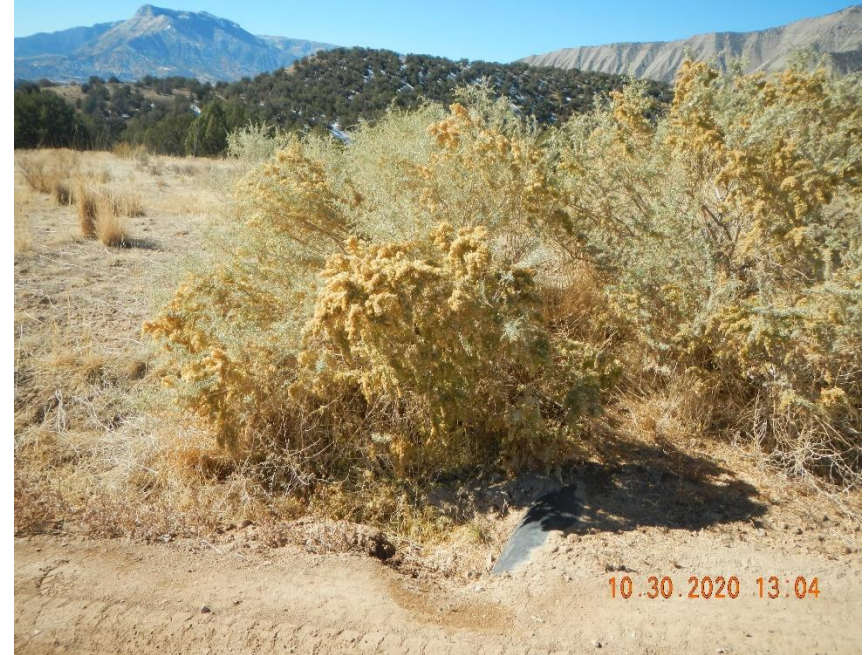
**Flow line ran under access road is causing road ditch to build up sediment and eroding around the poly pipe.**

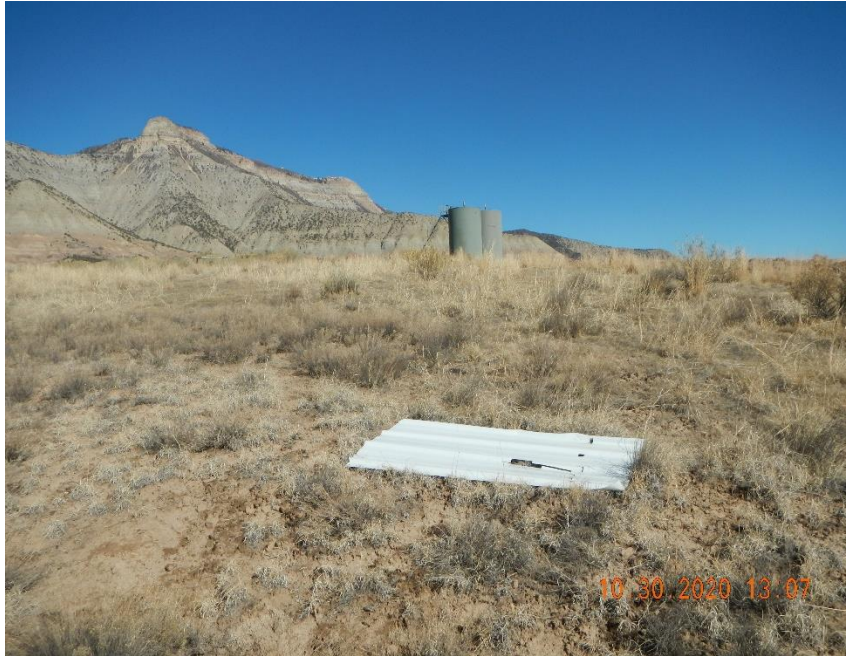
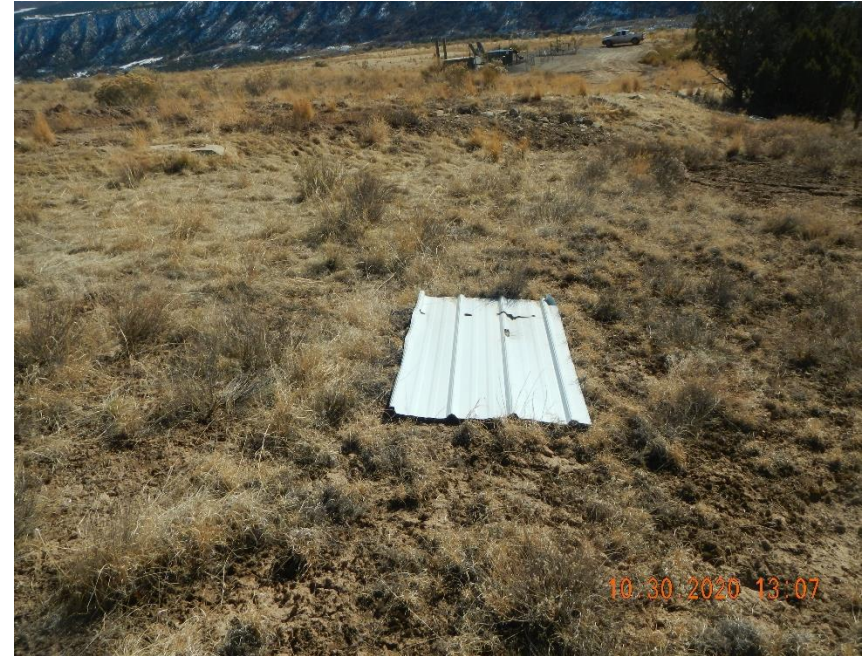
**Sheet of sheet metal from tin shed on location is laying out in field south west of location on wet side of the access road.**
