Inspection Photos  
Operator: Elm Ridge  
API: 067-06381  
Date: 10/15/2020

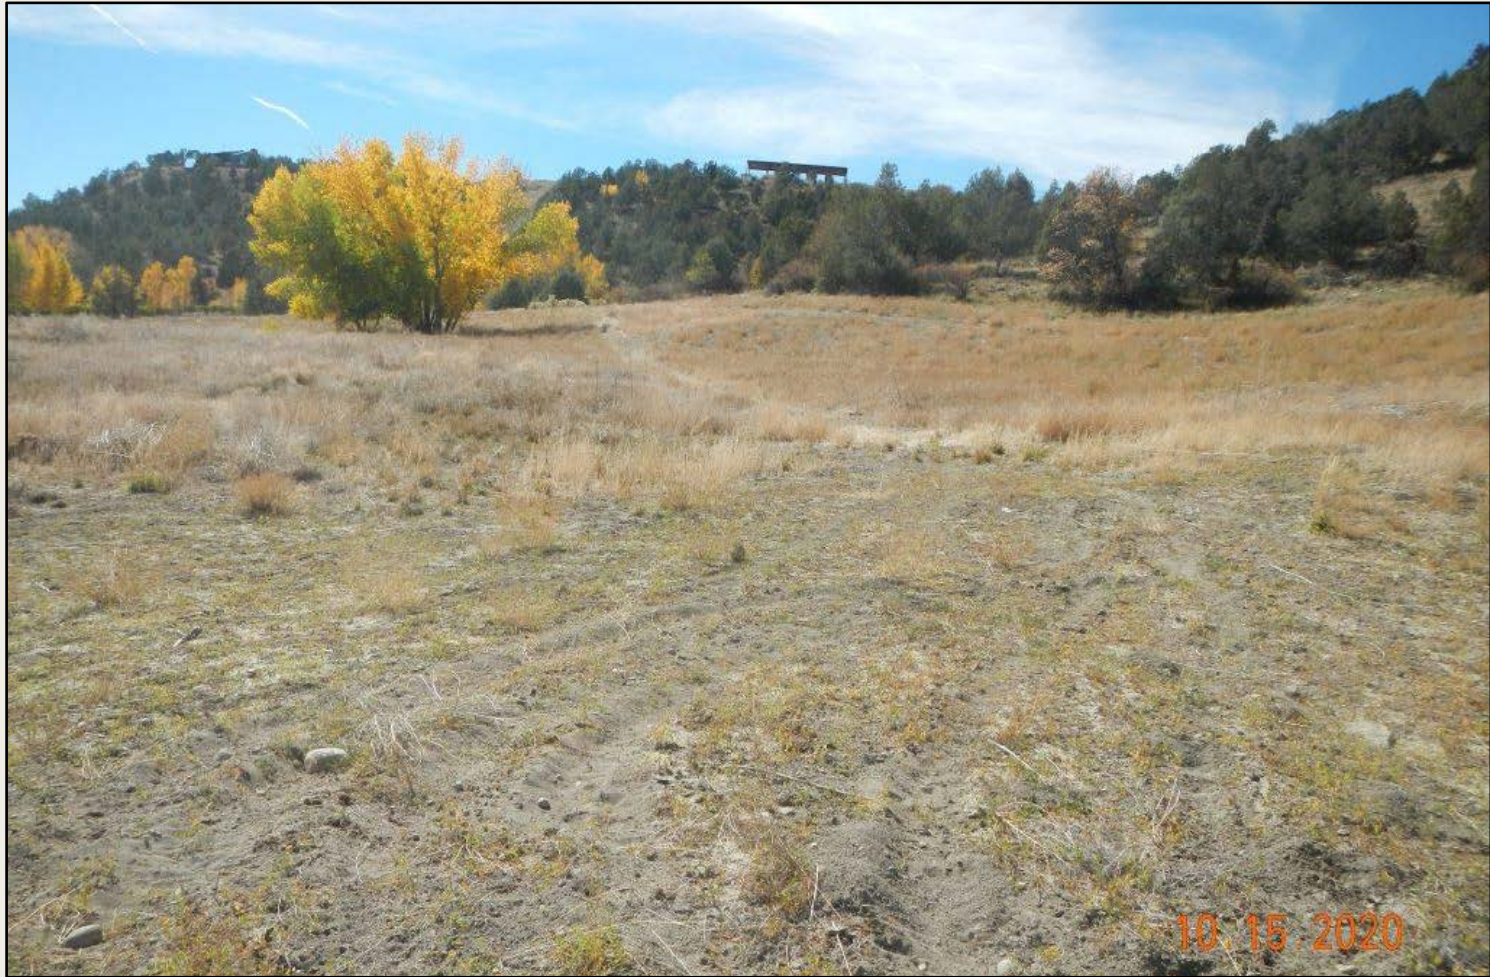
Photo 1. View of the project area from the northeastern corner facing center. Project area is recontoured. However, vehicles have been accessing the site and crushing vegetation. Access does not appear to have specific need as turnaround is on well pad.

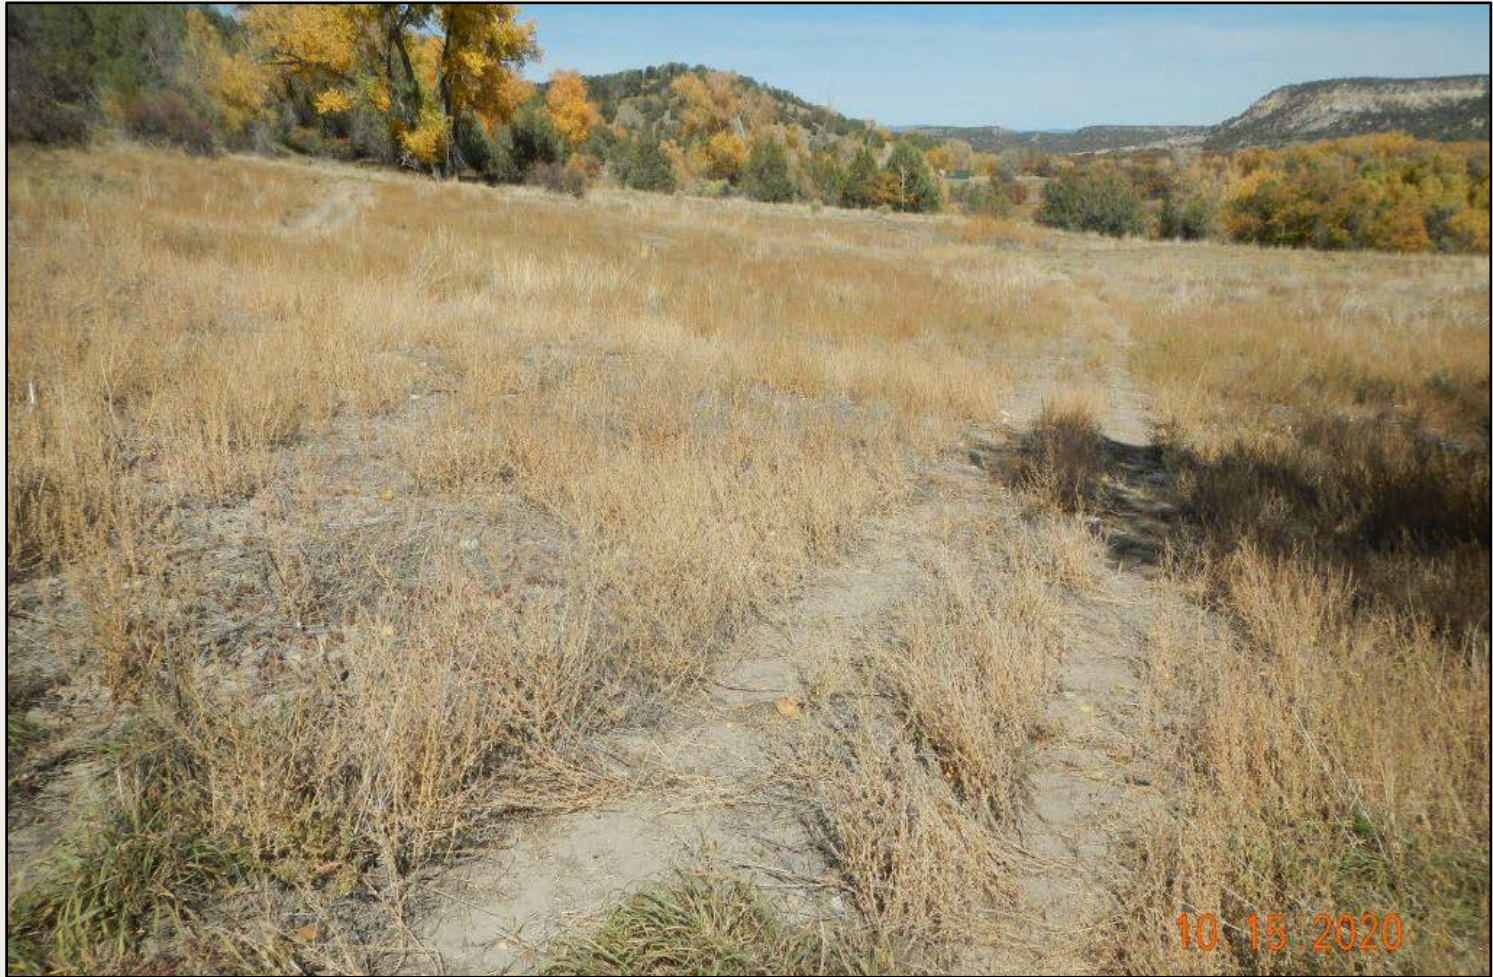
Photo 2. View of the western project area from the southwestern corner facing northward. Roads need to be closed and reclaimed.

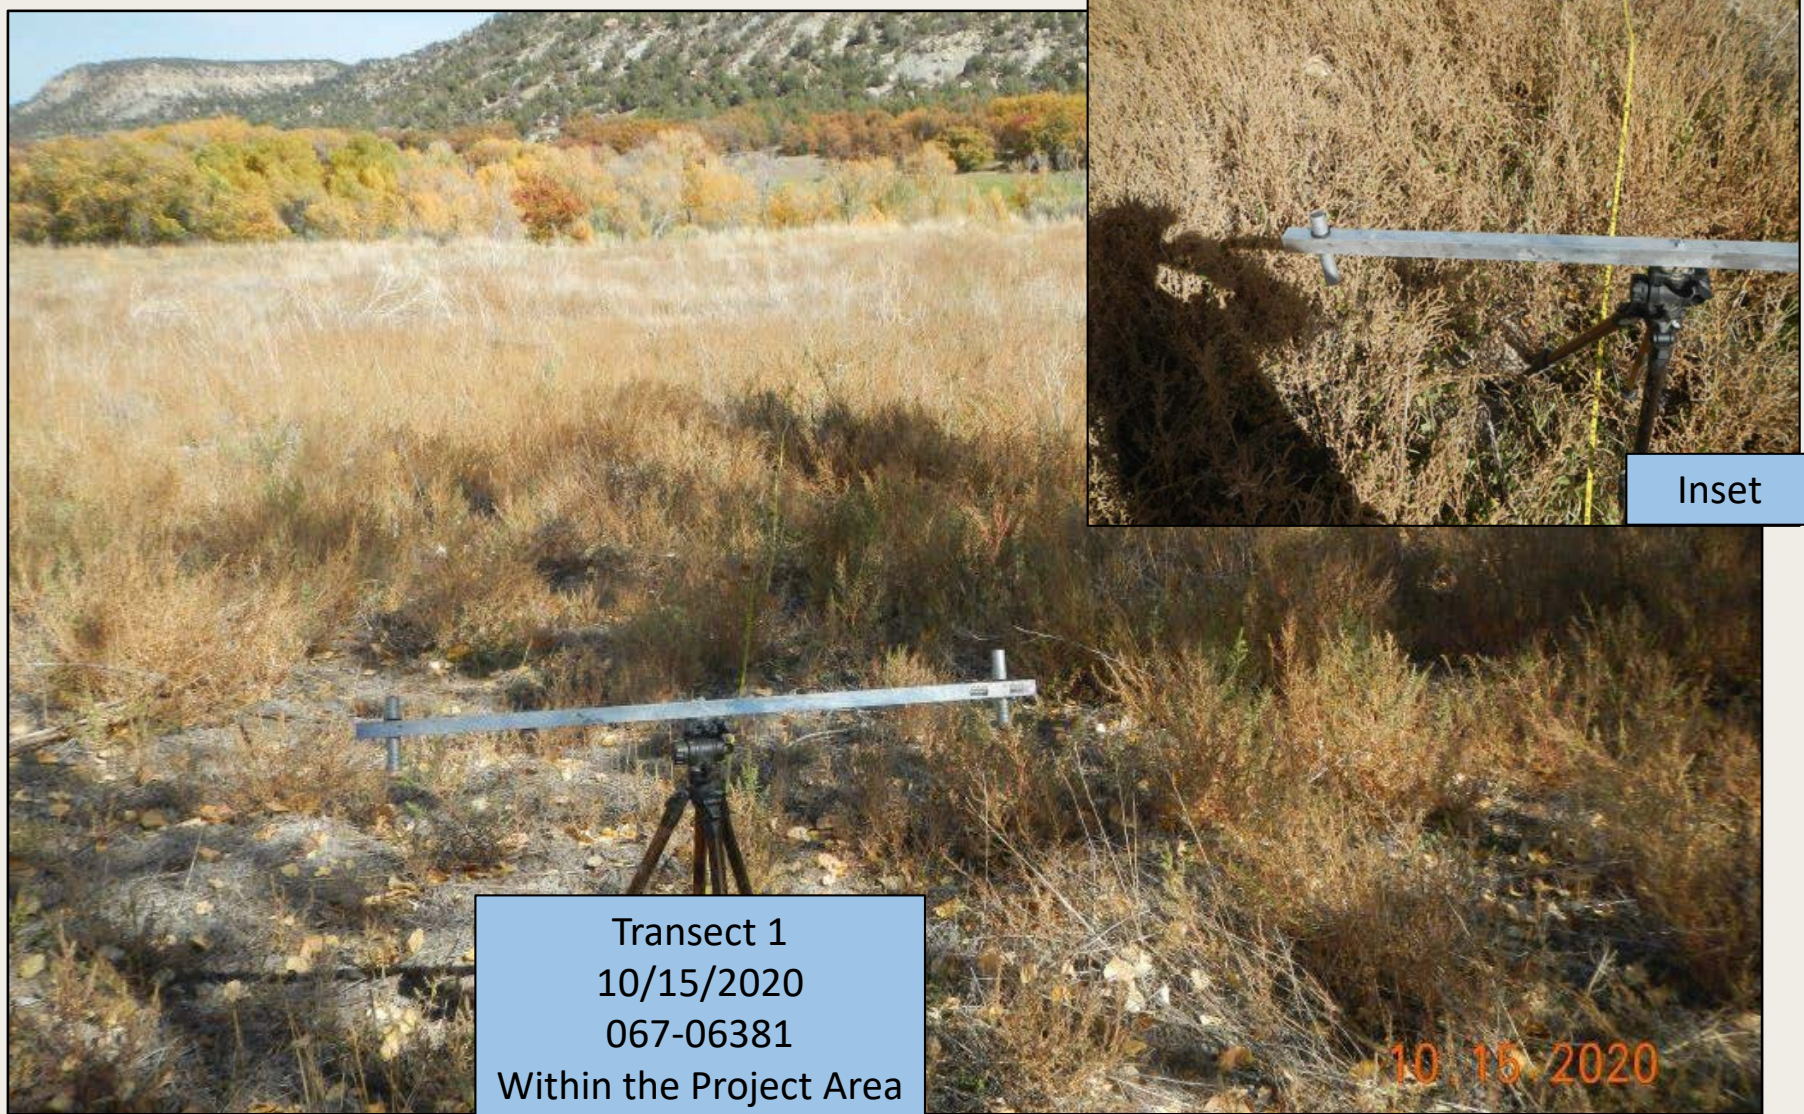
Photo 3. View of the beginning of Transect 1, within the project area facing northeastward. Inset shows a birds-eye view of vegetation at this midpoint of Transect 1, with dense kochia.

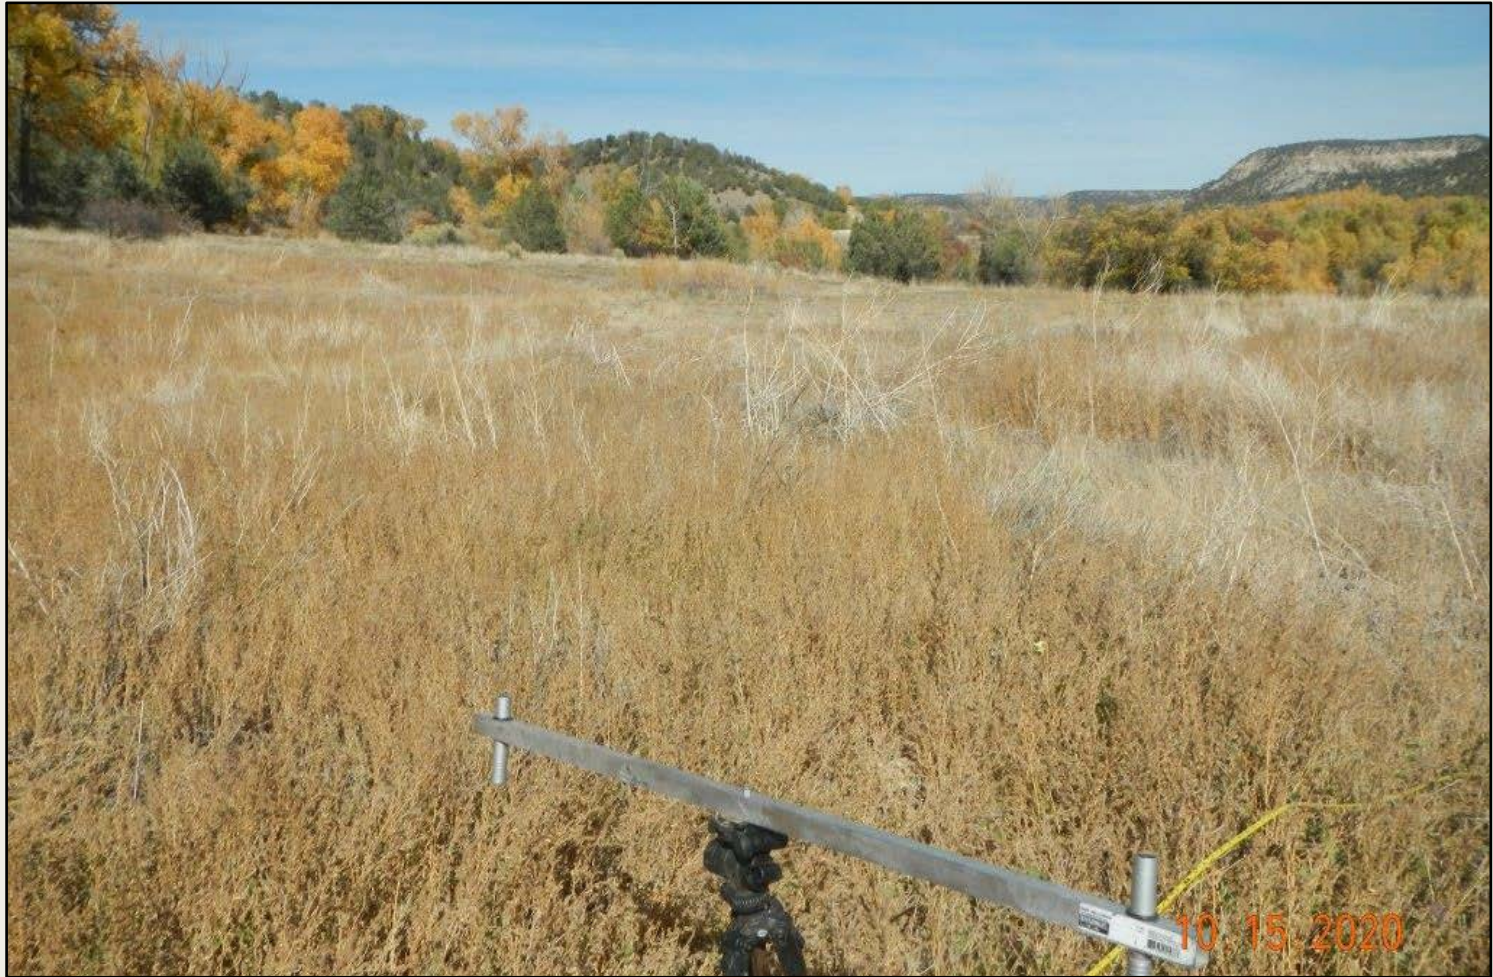
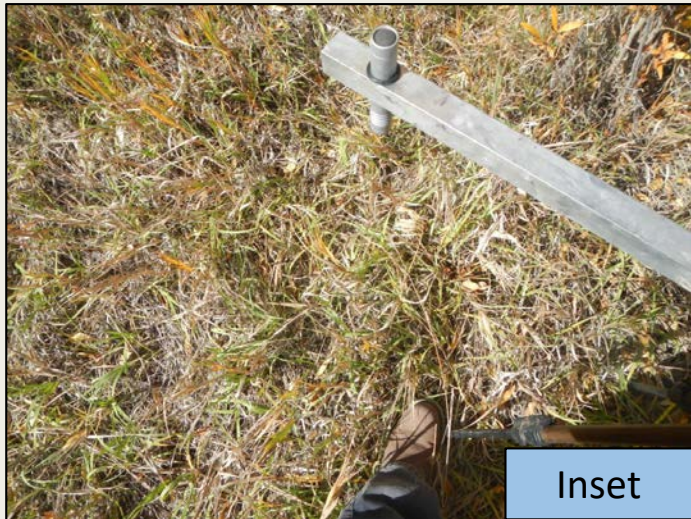
Photo 4. View of the project area from the mid-point along Transect 1, facing northward. Dense kochia observed.

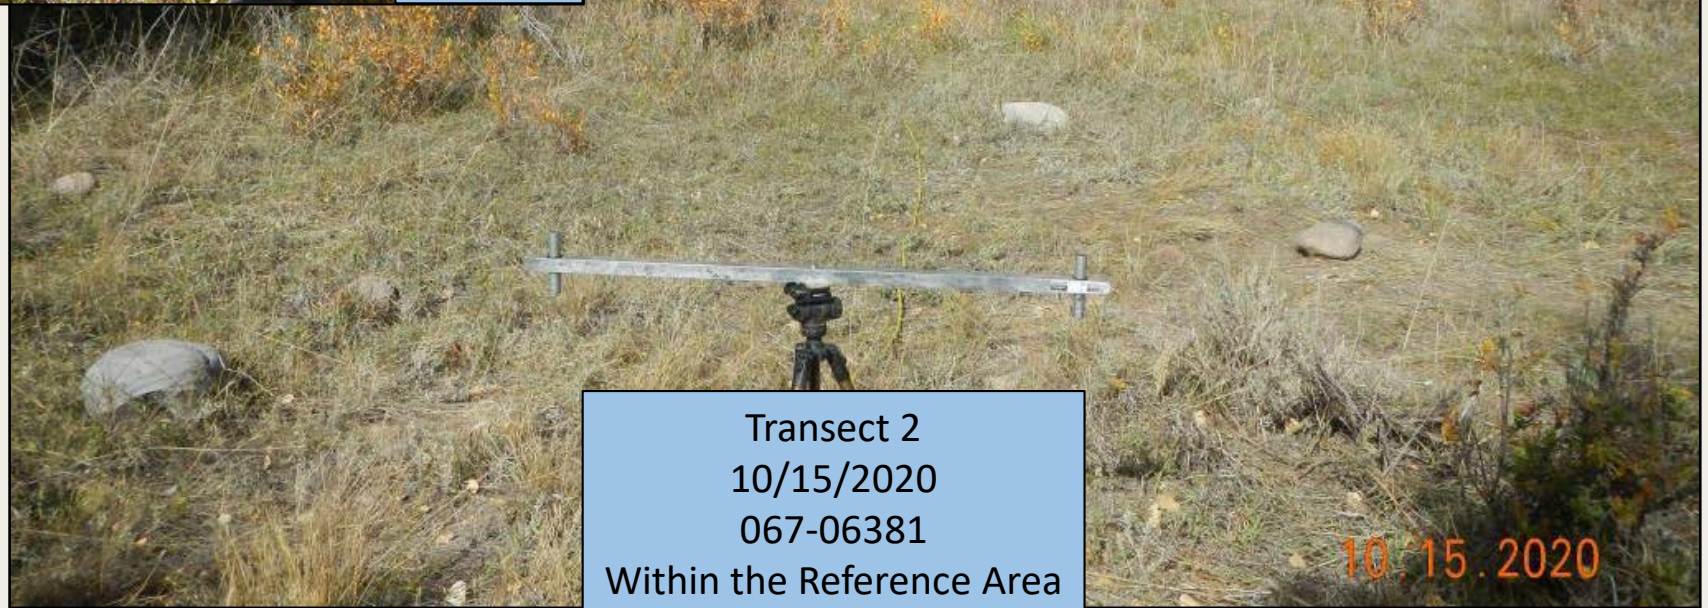
Transect 2  
10/15/2020  
067-06381  
Within the Reference Area

Photo 5. View of the beginning of Transect 2, within the reference area facing northward. Inset shows a birds-eye view of vegetation at the midpoint of Transect 2, with smooth brome.

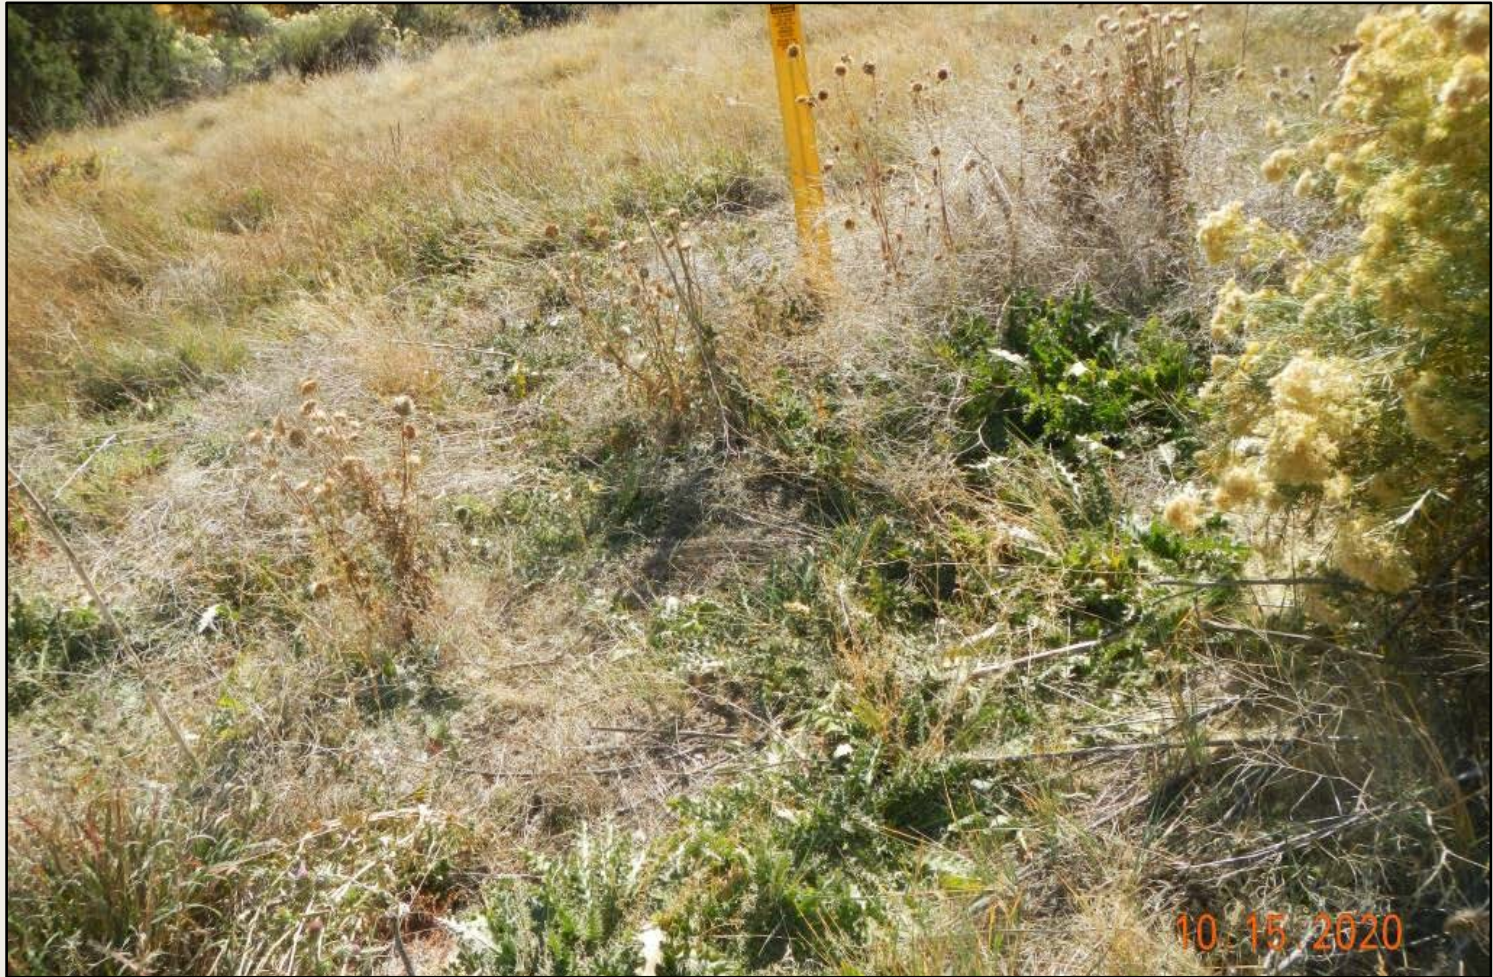
Photo 6. View of musk thistles within the southeastern project area. Approximately 200 individuals observed.

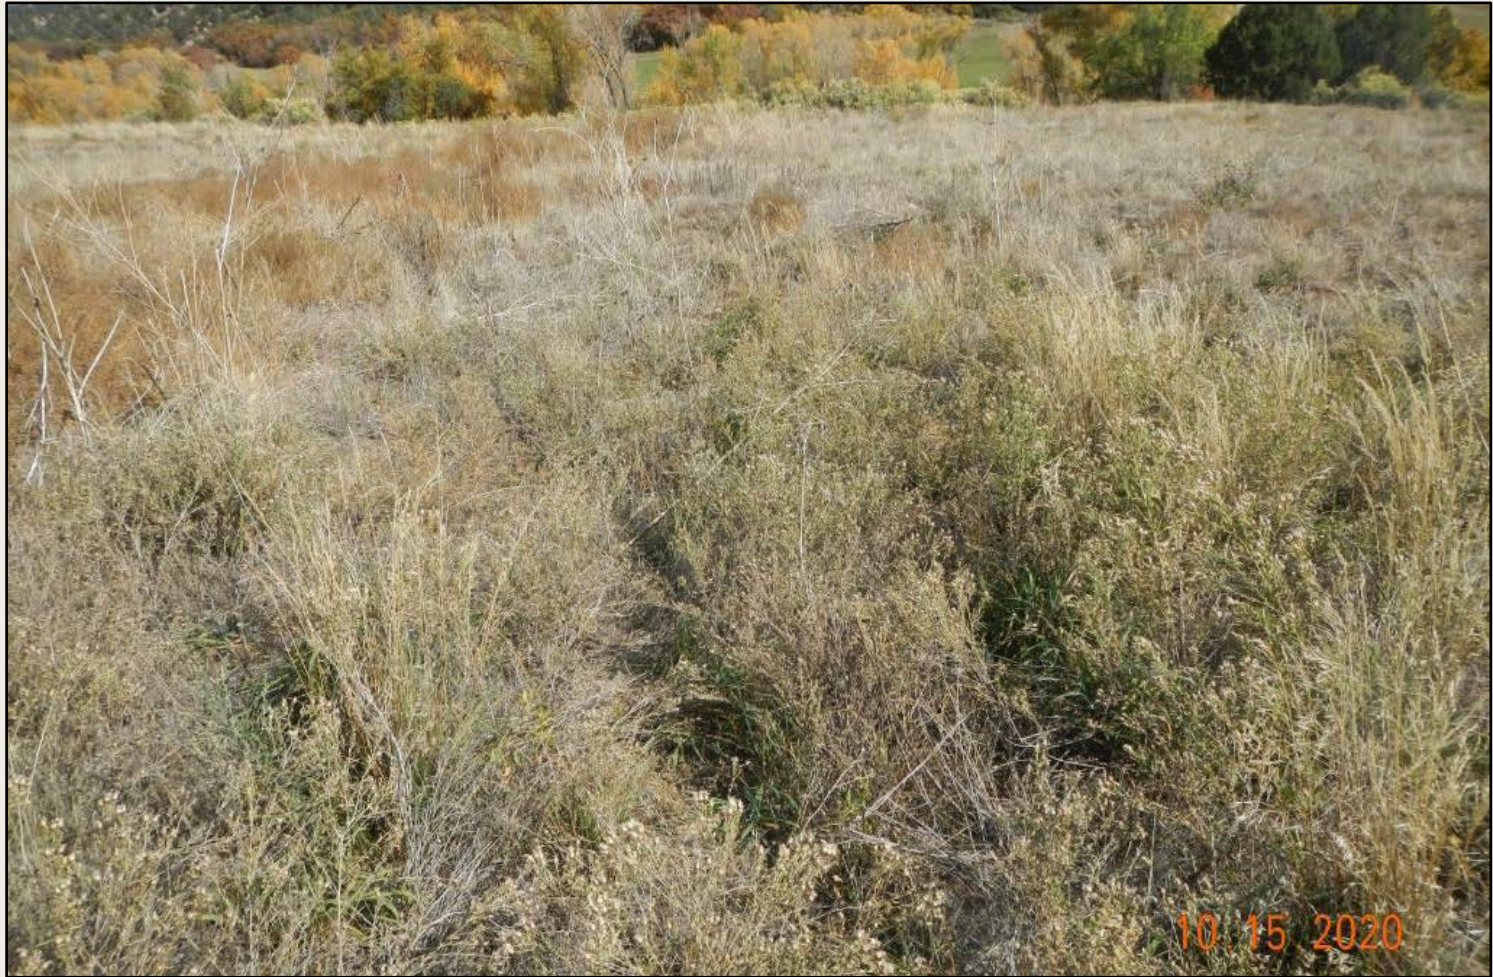
Photo 7. View of Russian knapweeds within the southern project area. Approximately 1000 individuals observed.

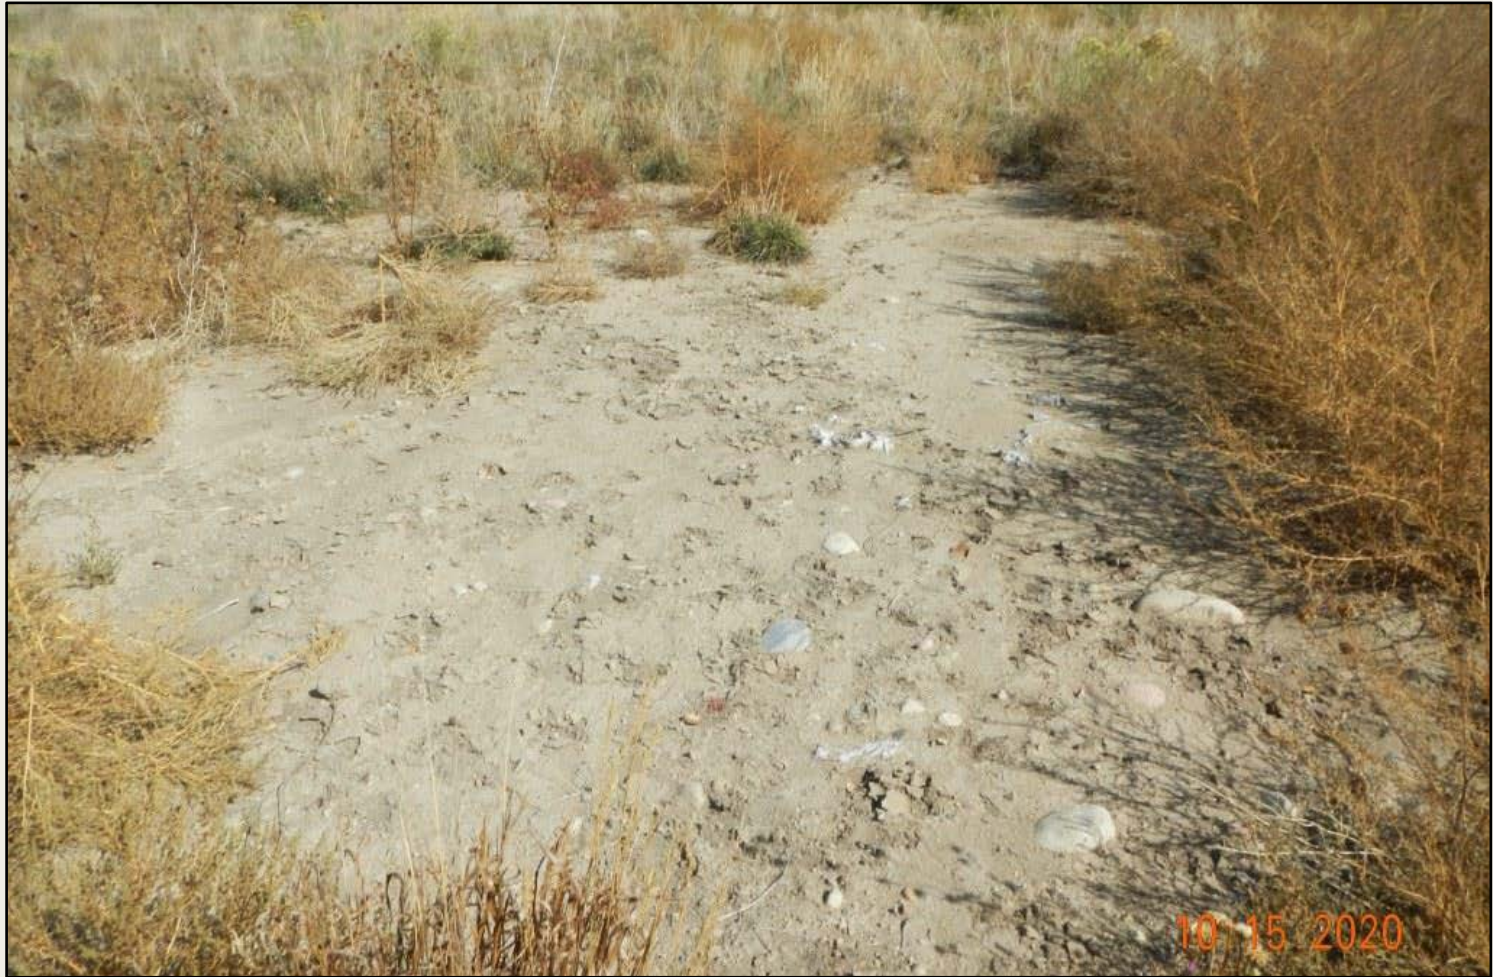
Photo 8. View of area within the northeastern project area with bare soils and little revegetation.

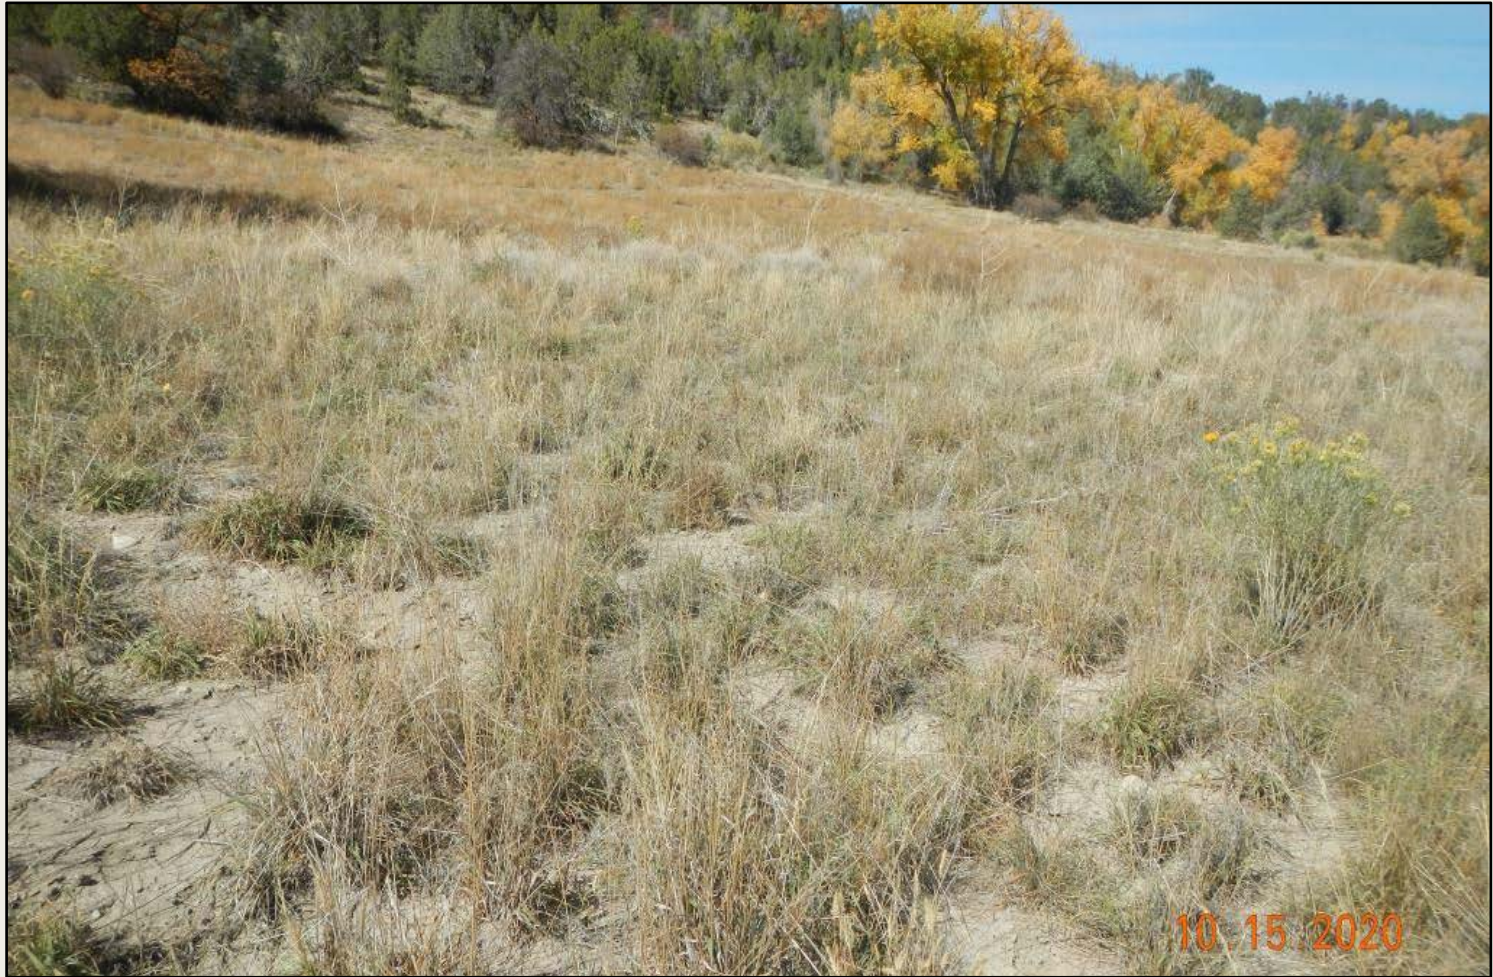
Photo 9. View of area within the southeastern project area where revegetation is progressing, largely with smooth brome.
