Inspection Photos

API: 071-09664

Operator: PIONEER NATURAL RESOURCES

Inspection Date: 11/3/2020

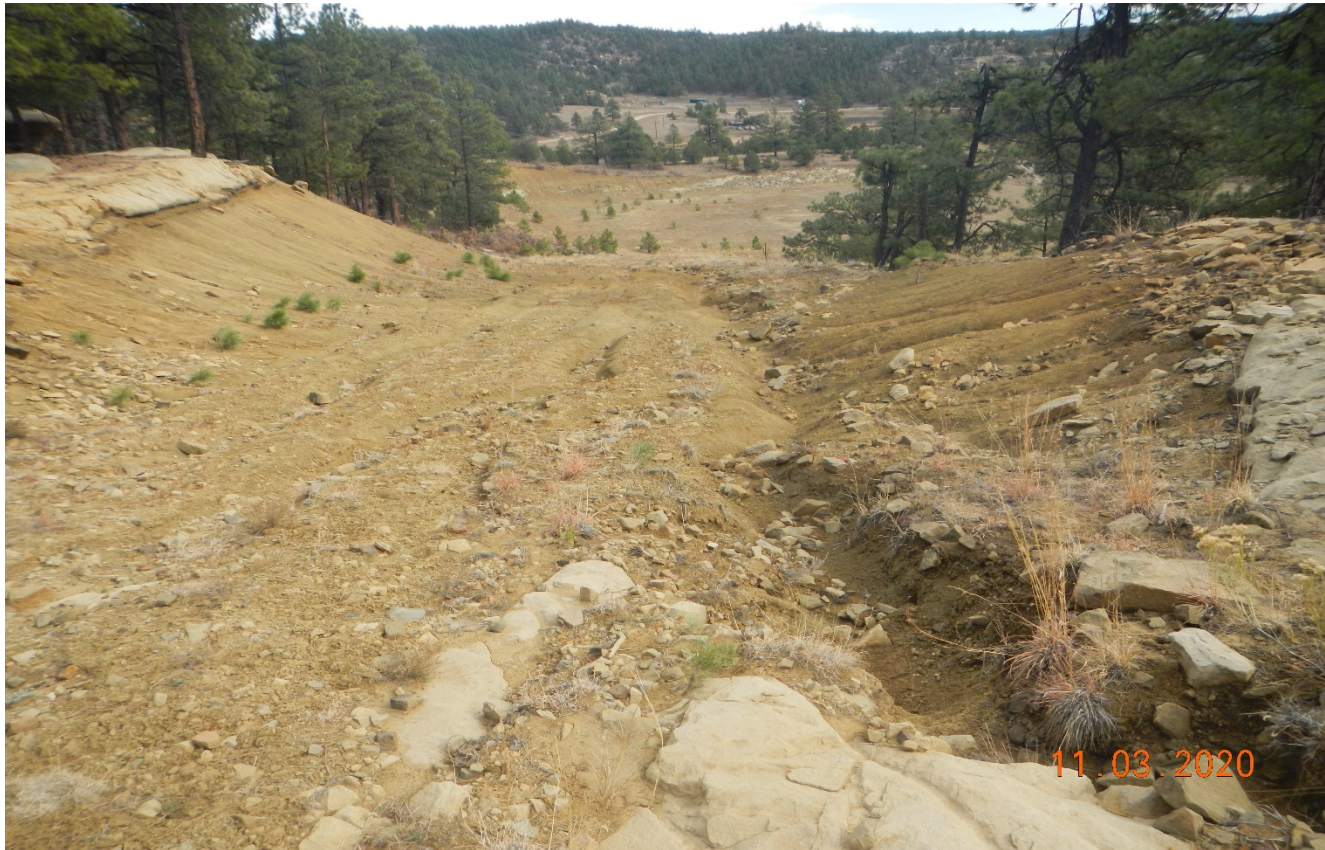
Photo 1. Facing east toward the access road which has not been recontoured and reclaimed.

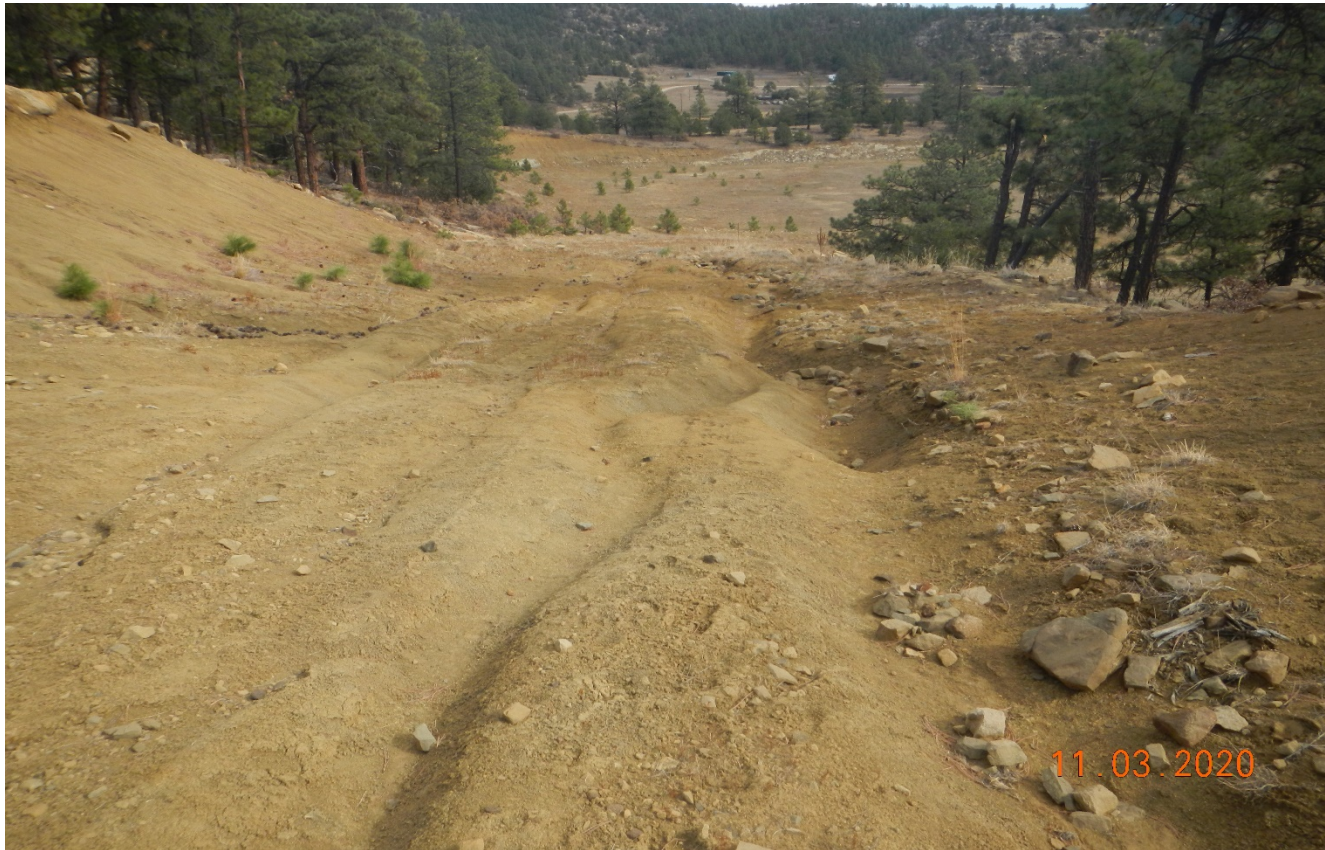
Photo 2. Facing east along the access road. There is erosion occurring down the road which is not stabilized.

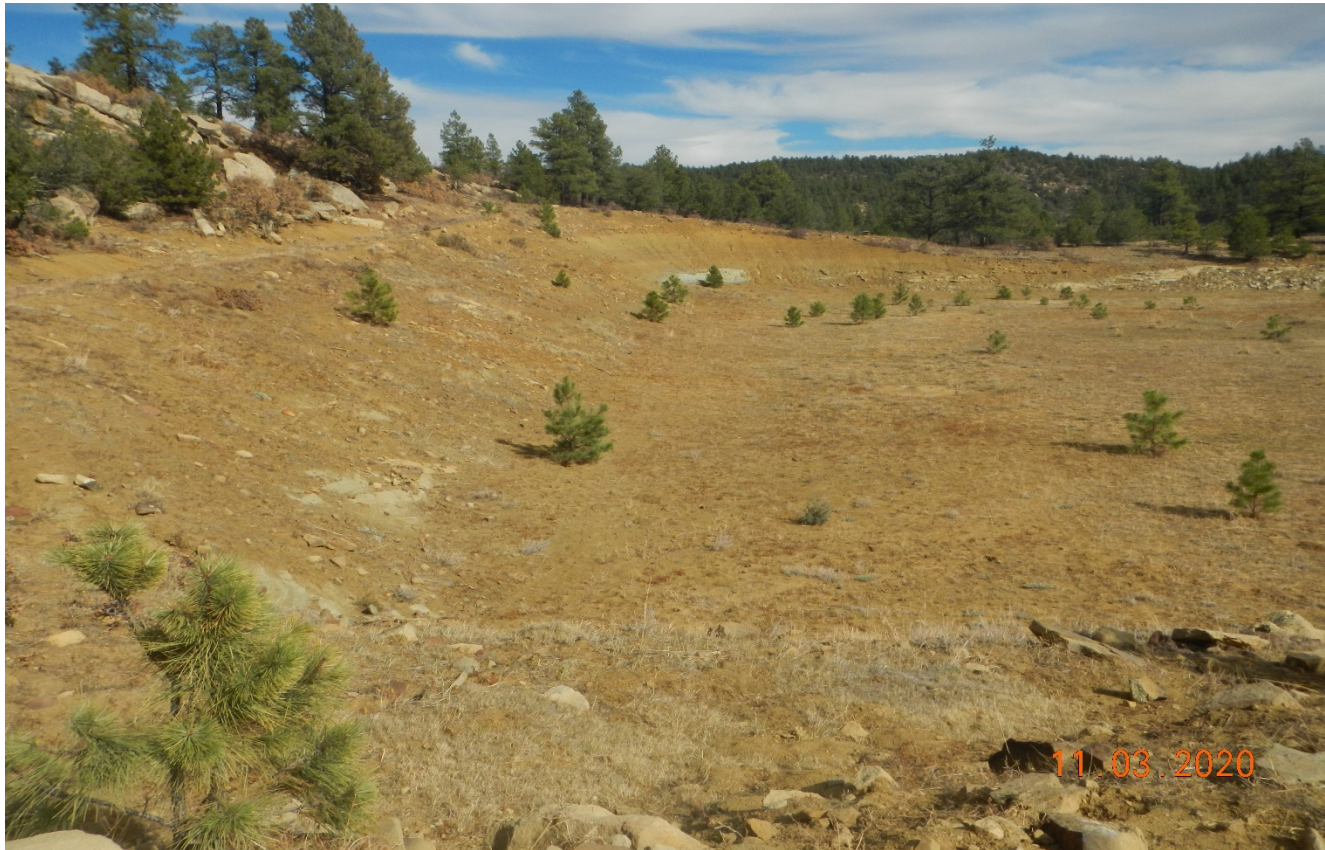
Photo 3. Facing northeast toward the location cut slope.

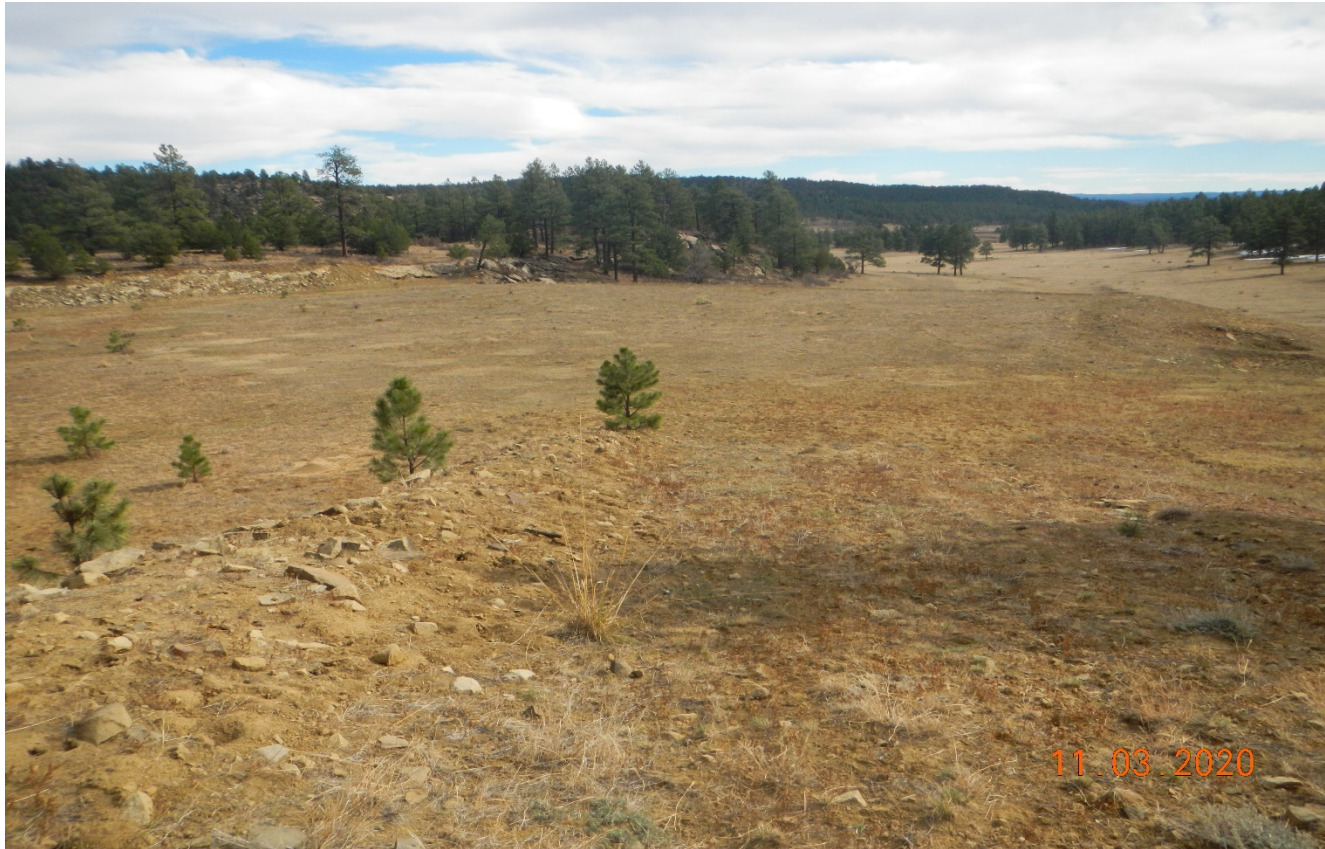
Photo 4. Facing southeast toward the location which has not been recontoured and reclaimed..

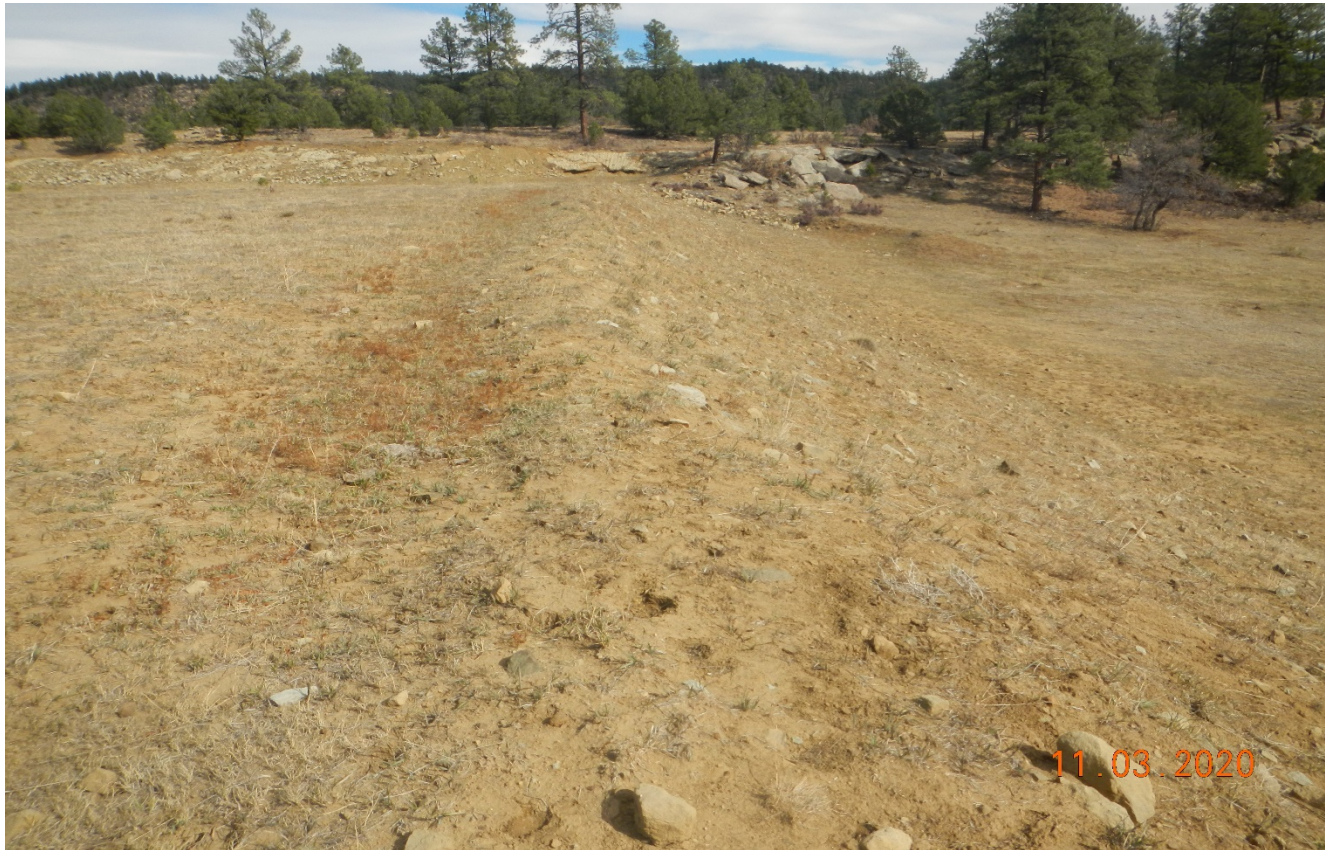
Photo 5. Facing northeast toward the fill slope.

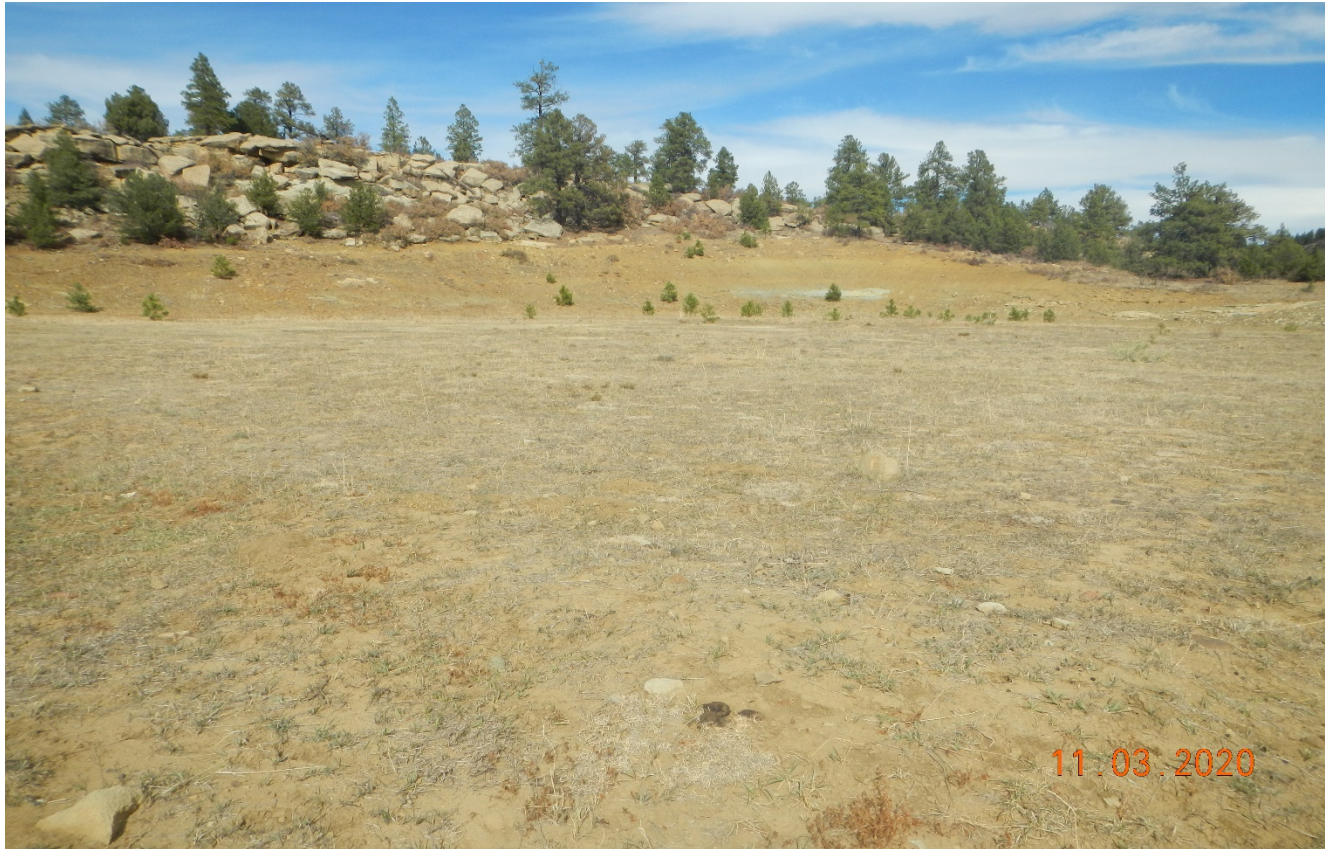
Photo 6. Facing north toward the location.
