**Inspection Photos**  
**Operator: BP America**  
**API: 067-06611**  
**Date: 11/2/2020**

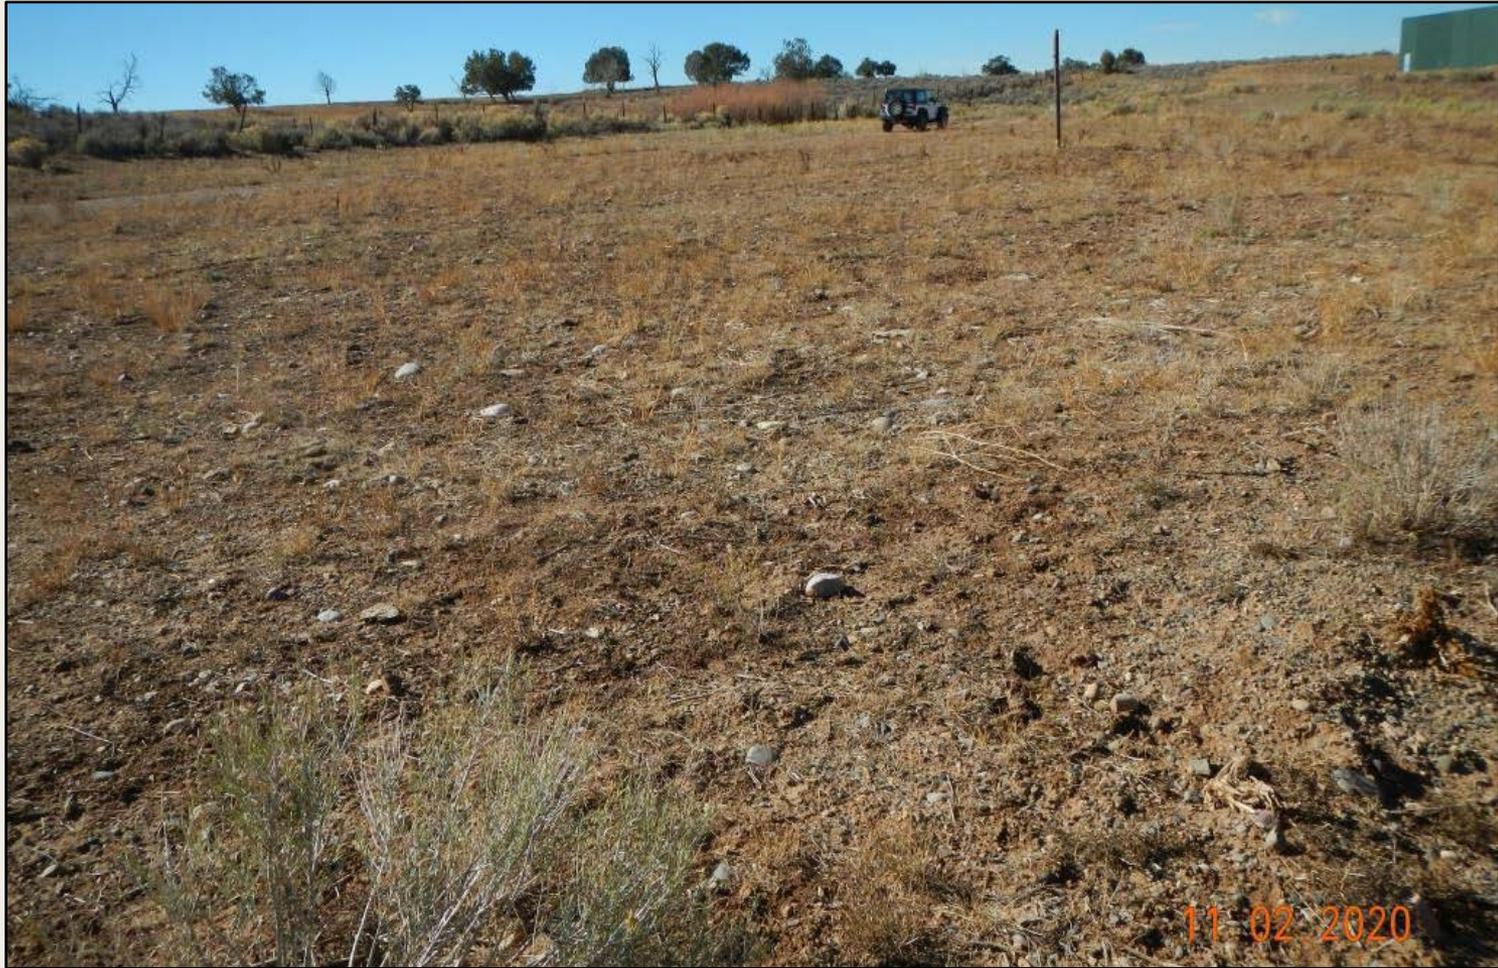
Photo 1. View of the project area from the northeastern corner facing center.

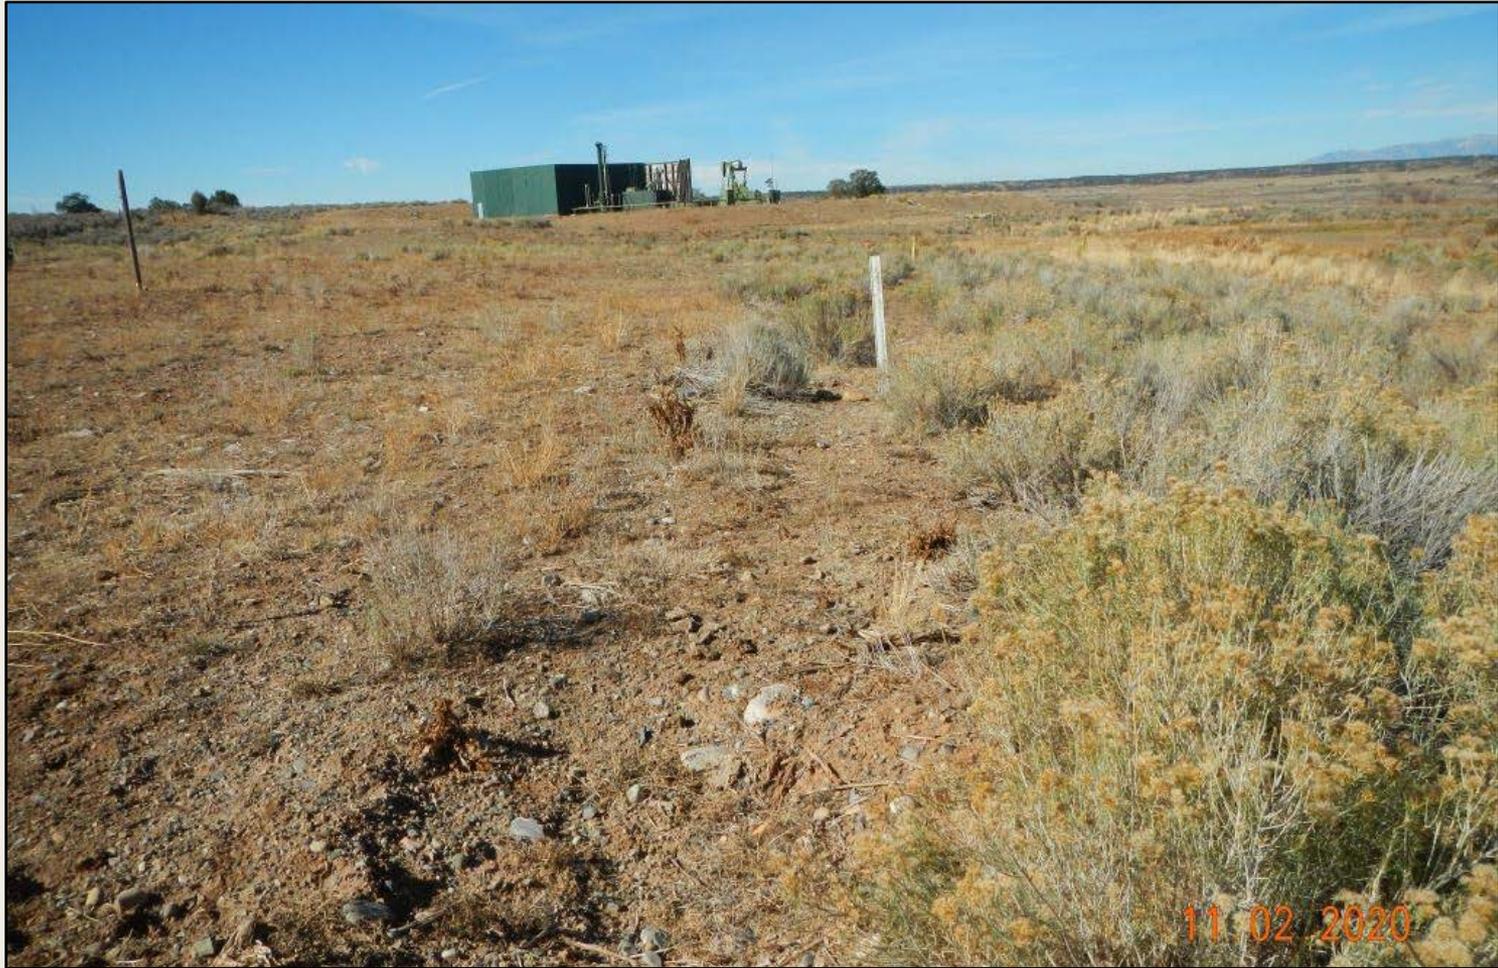
Photo 2. View of the northern project area from the northeastern corner facing westward. Revegetation is progressing with crested wheatgrass and smooth brome. Musk thistles appear to be herbicide-treated.

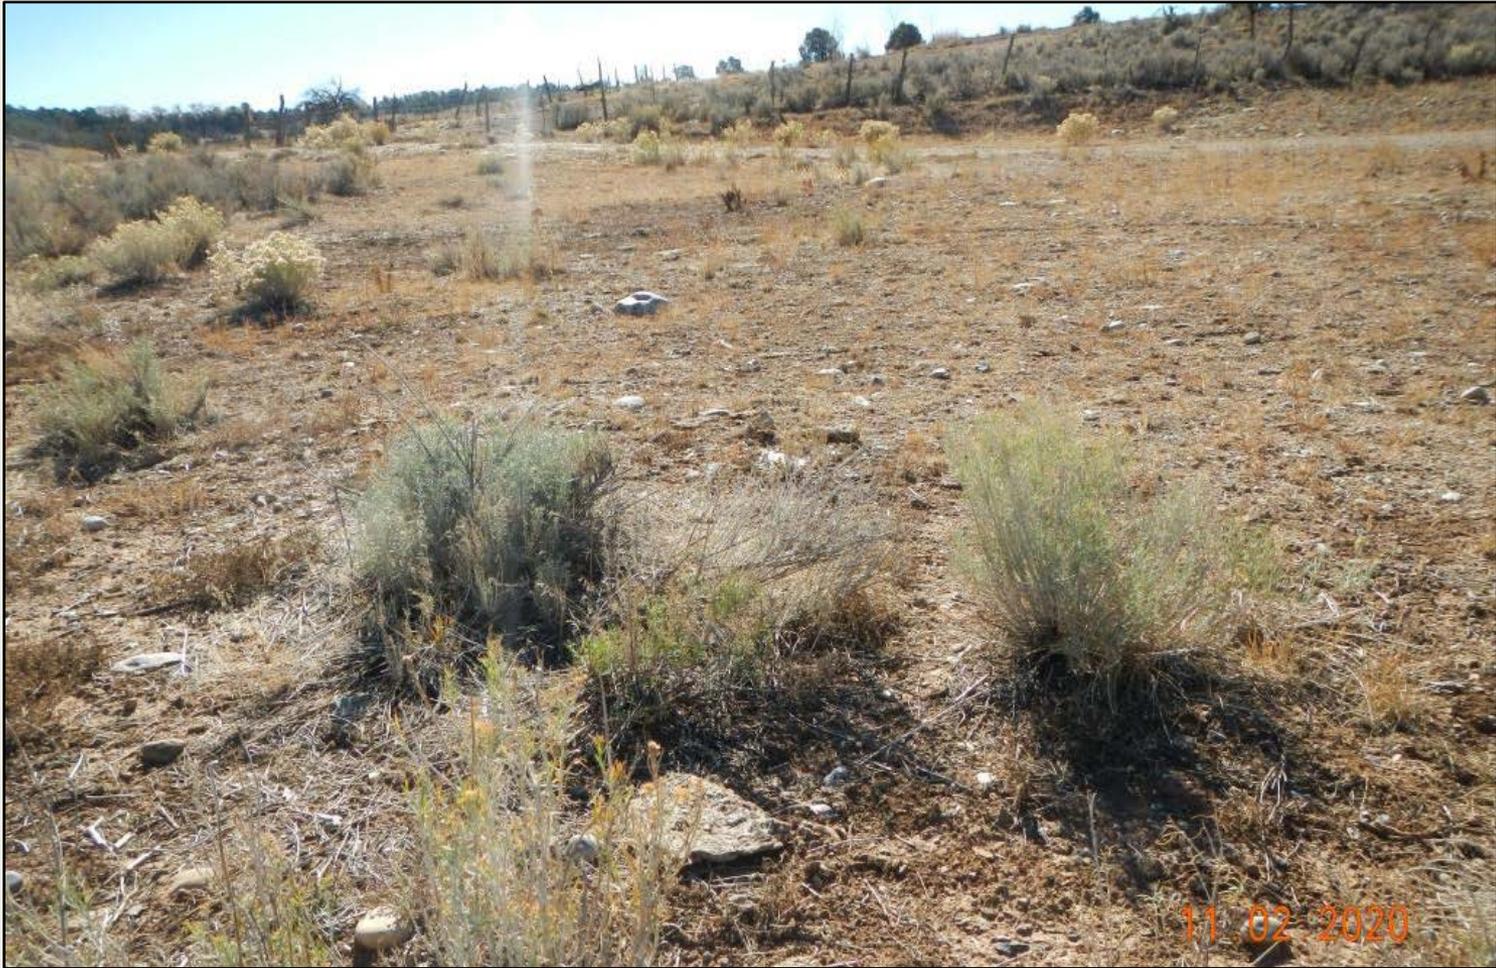
Photo 3. View of the eastern project area from the northeastern corner facing southward.

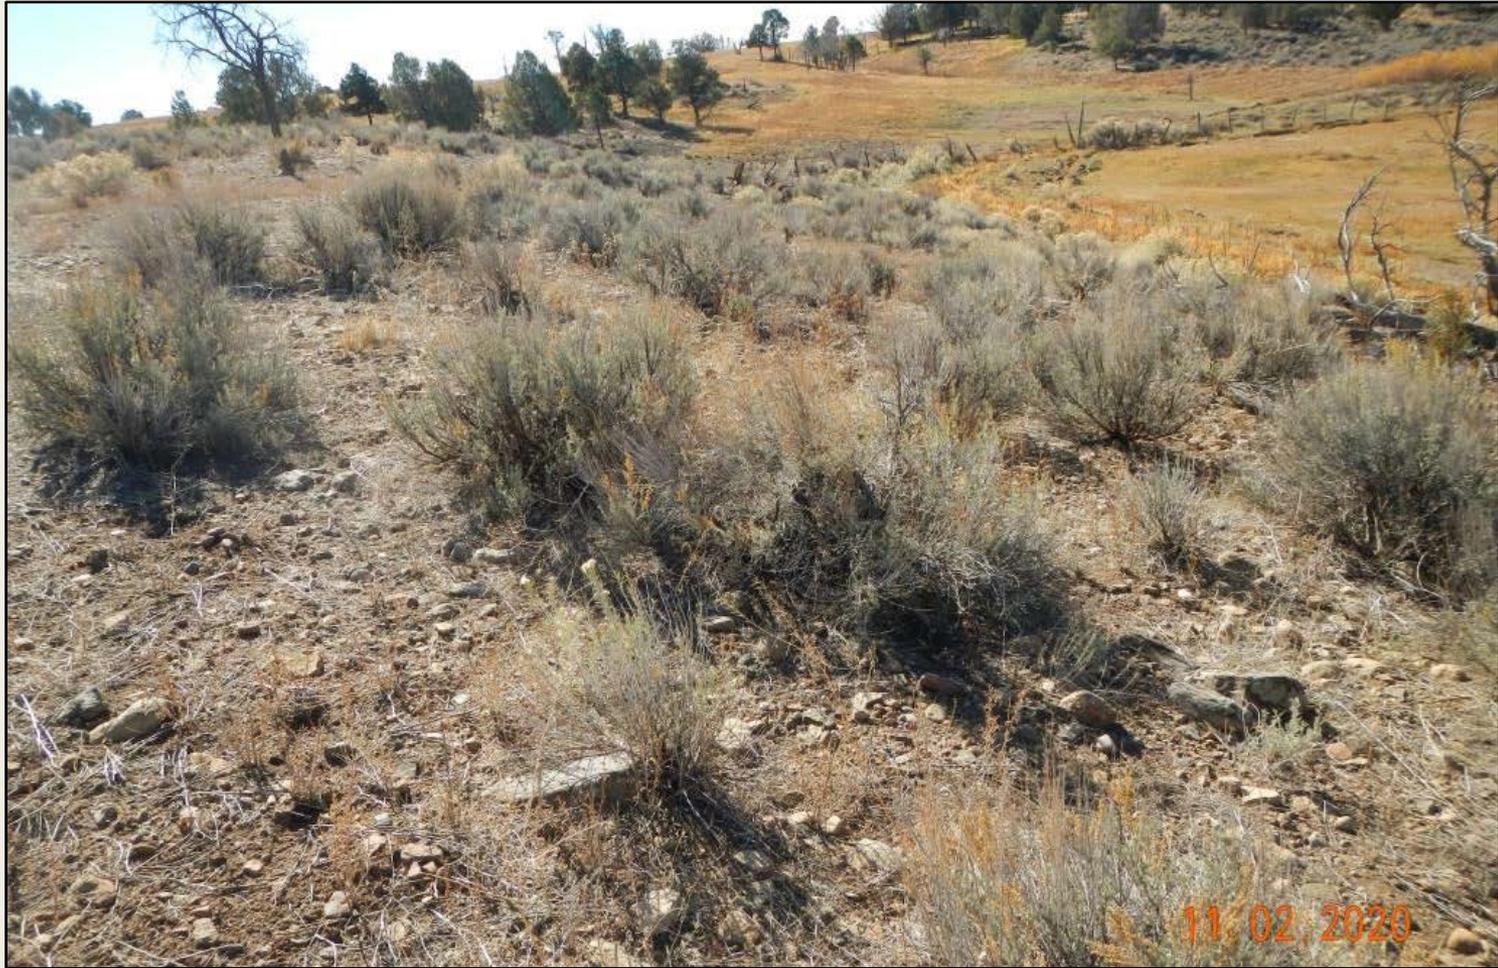
Photo 4. View of reference area comprised of mosaic of sagebrush shrubland with squirreltail and western wheatgrass, along with irrigated grass fields.

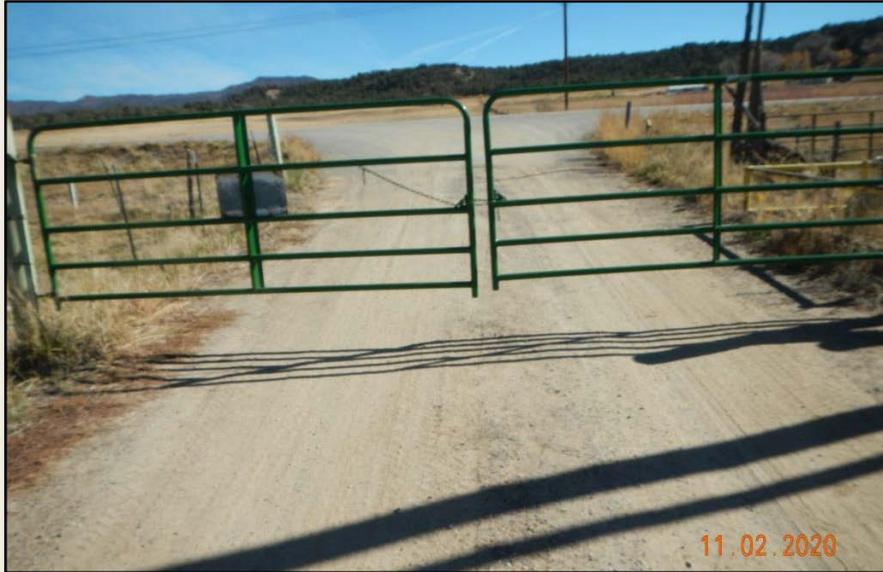
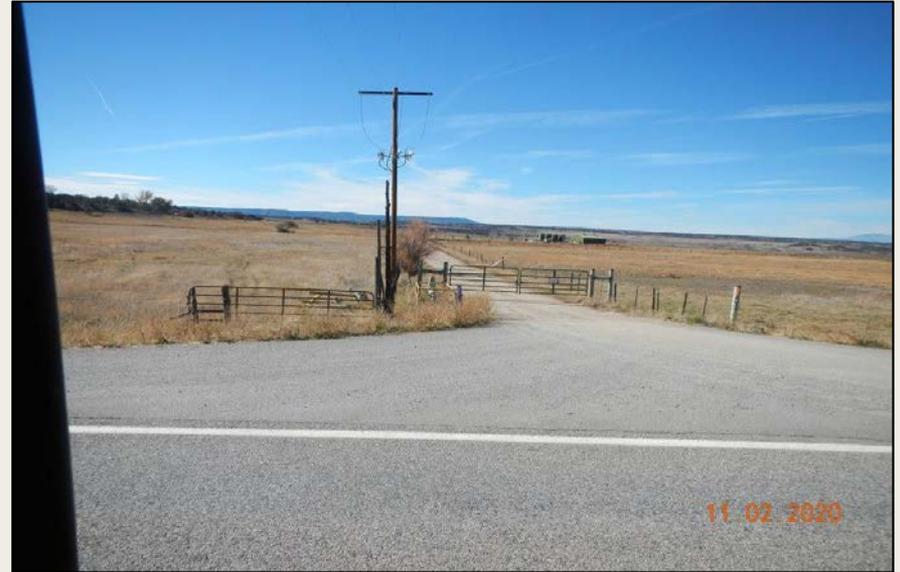
Photos 5/6. View of closed gates after entering (left) and leaving (right) project area.
