Inspection Photos
Operator: Hilcorp Energy
API: 067-06442
Date: 11/5/2020

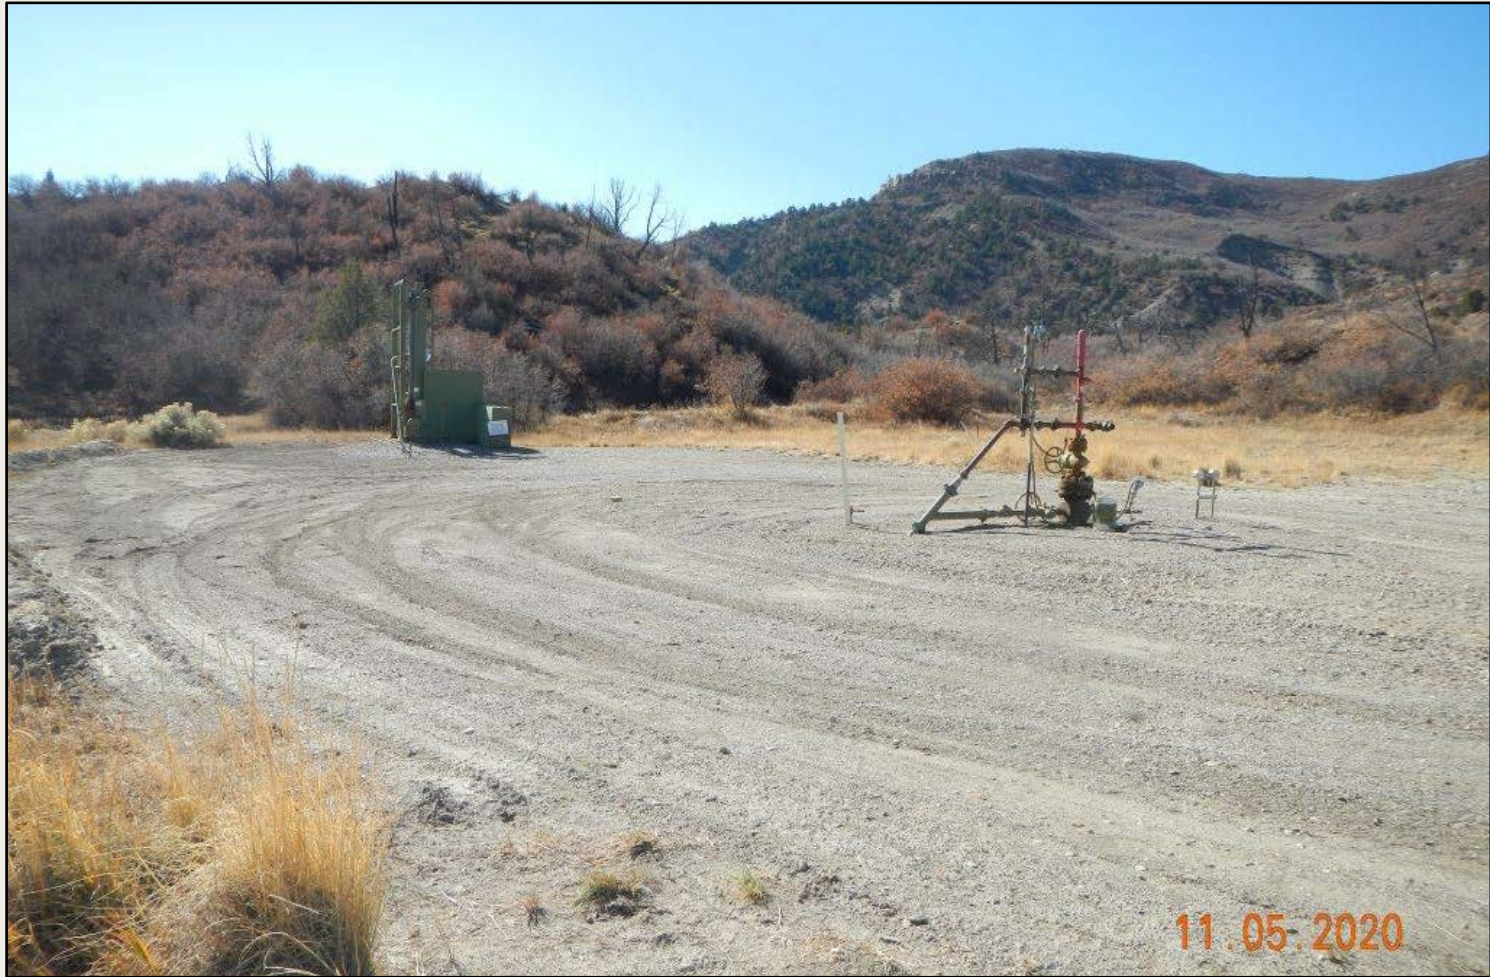
Photo 1. View of the project area from the northeastern corner facing center.

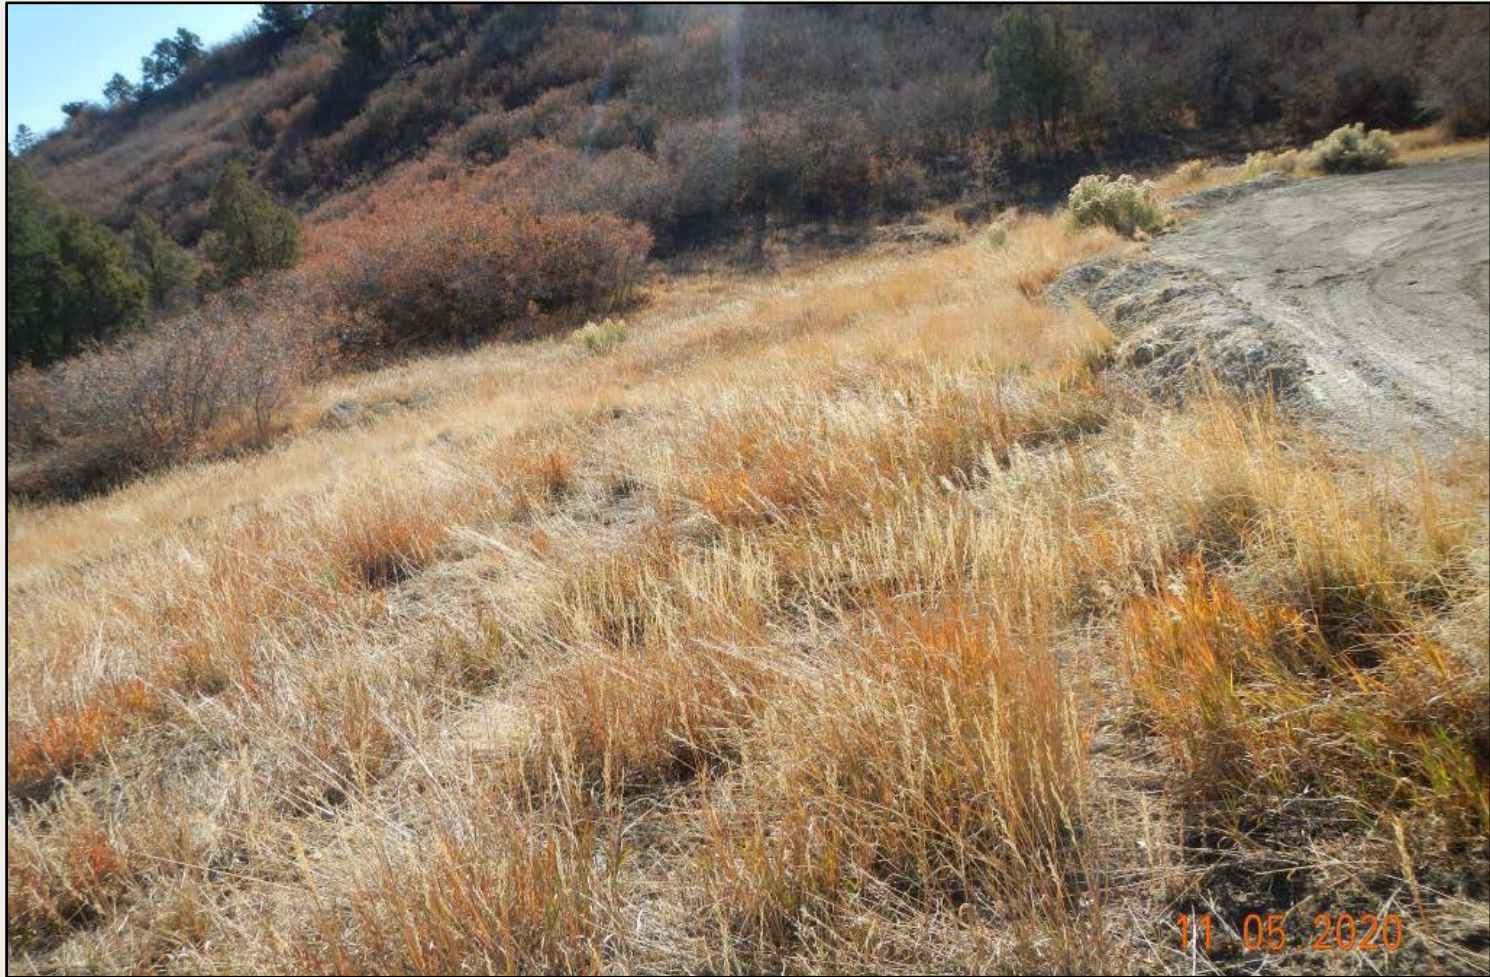
Photo 2. View of the eastern project area from the northeastern corner facing southward. Berms are installed at the edge of the well pad where erosion was identified during previous reclamation inspection. Weeds appear to be controlled at this time.

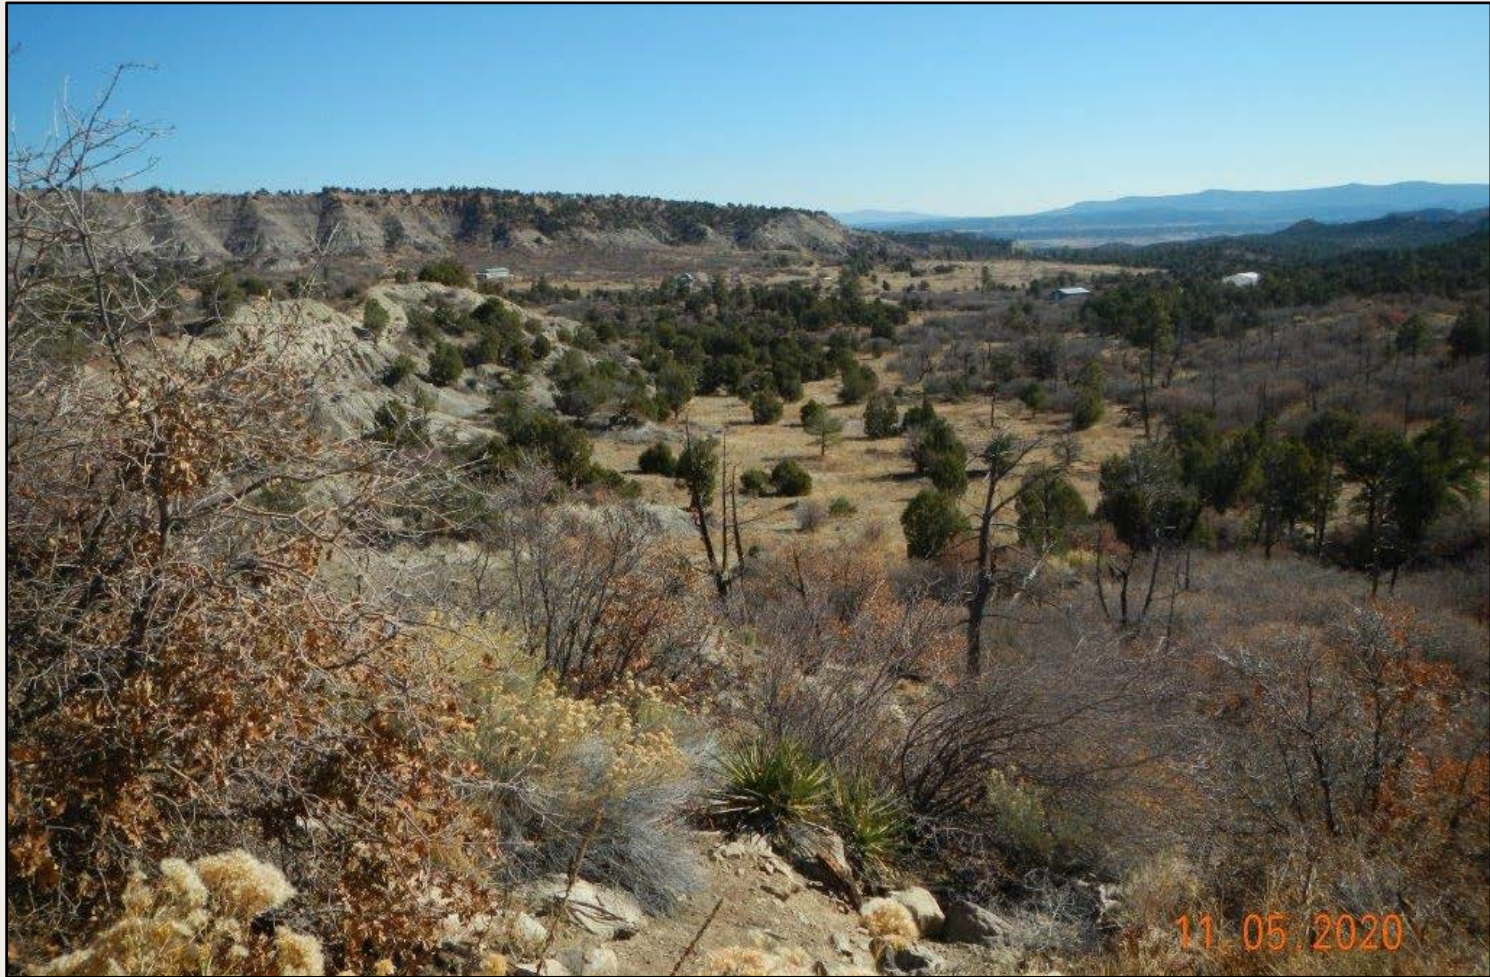
Photo 3. View of reference area facing southward. Vegetation is comprised of a mosaic of gambel oak shrubland, with ponderosa pine, pinyon and juniper trees, shrubs such as mountain mahogany, yucca, and grasses/forbs such as rocky mountain penstemon, squirreltail, western wheatgrass, smooth brome, and badlands.
