Inspection Photos

API: 073-06776

Operator: KODA EXPLORATION LLC

Inspection Date: 11/5/2020

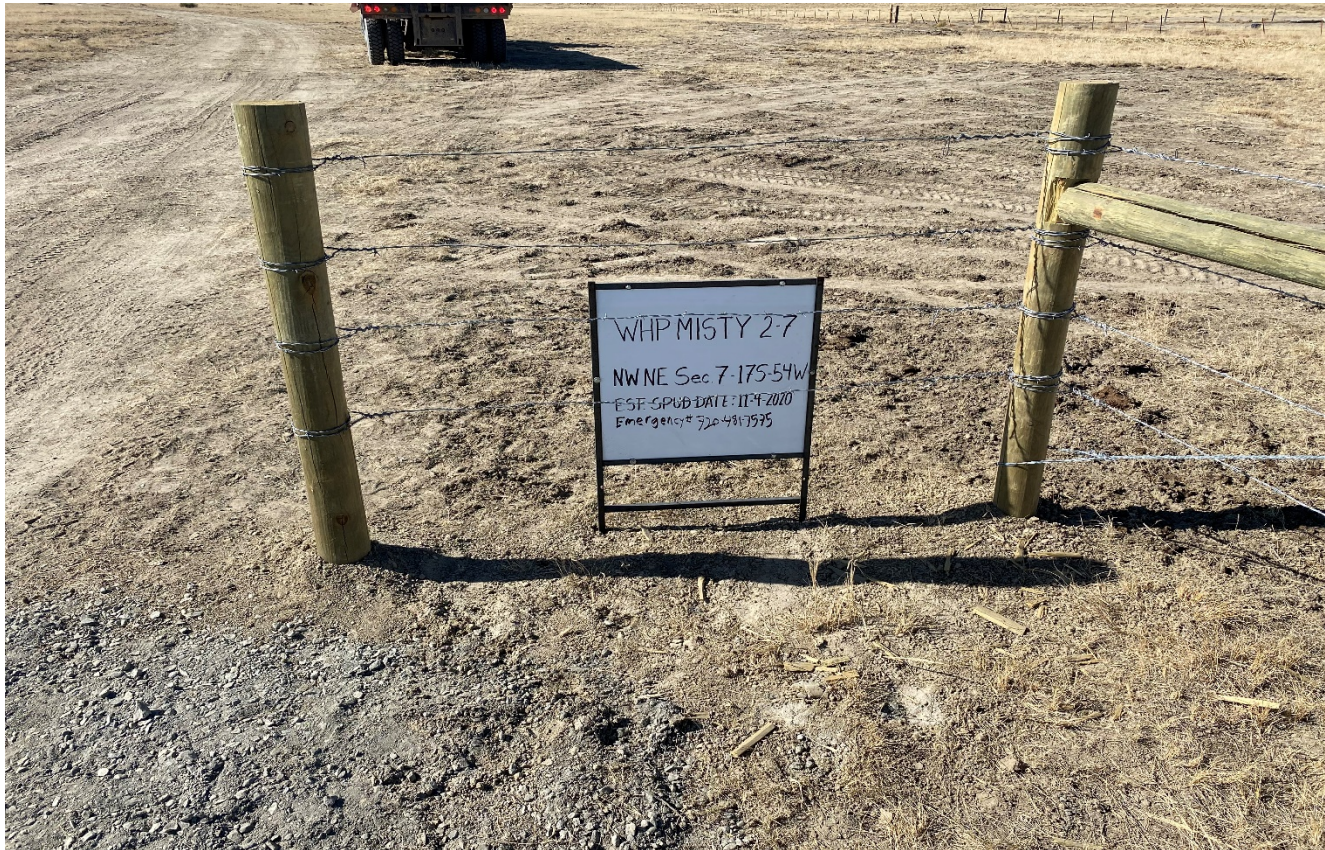
Photo 1. The drilling sign is posted at the beginning of the access road.

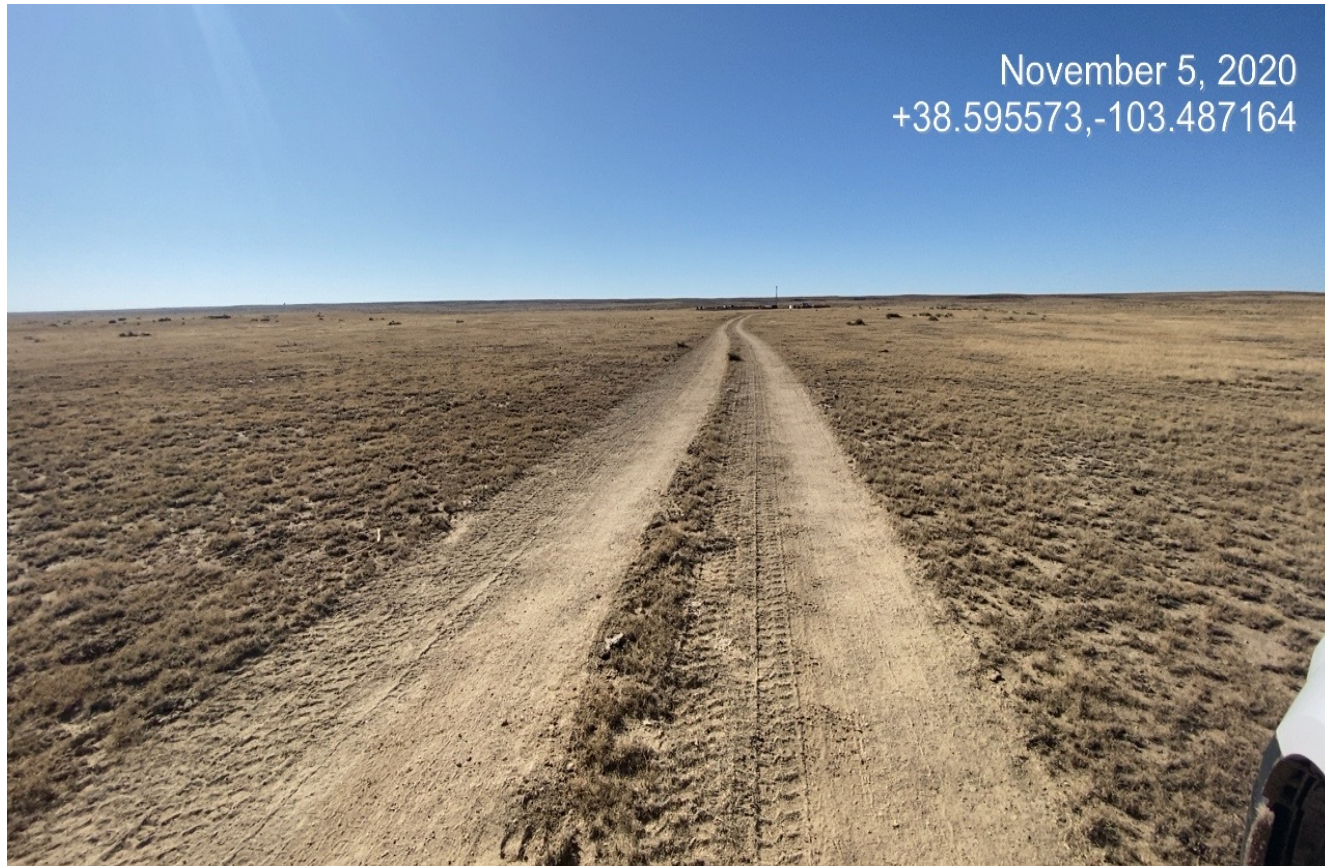
Photo 2. Facing southwest along the road used to access the site.

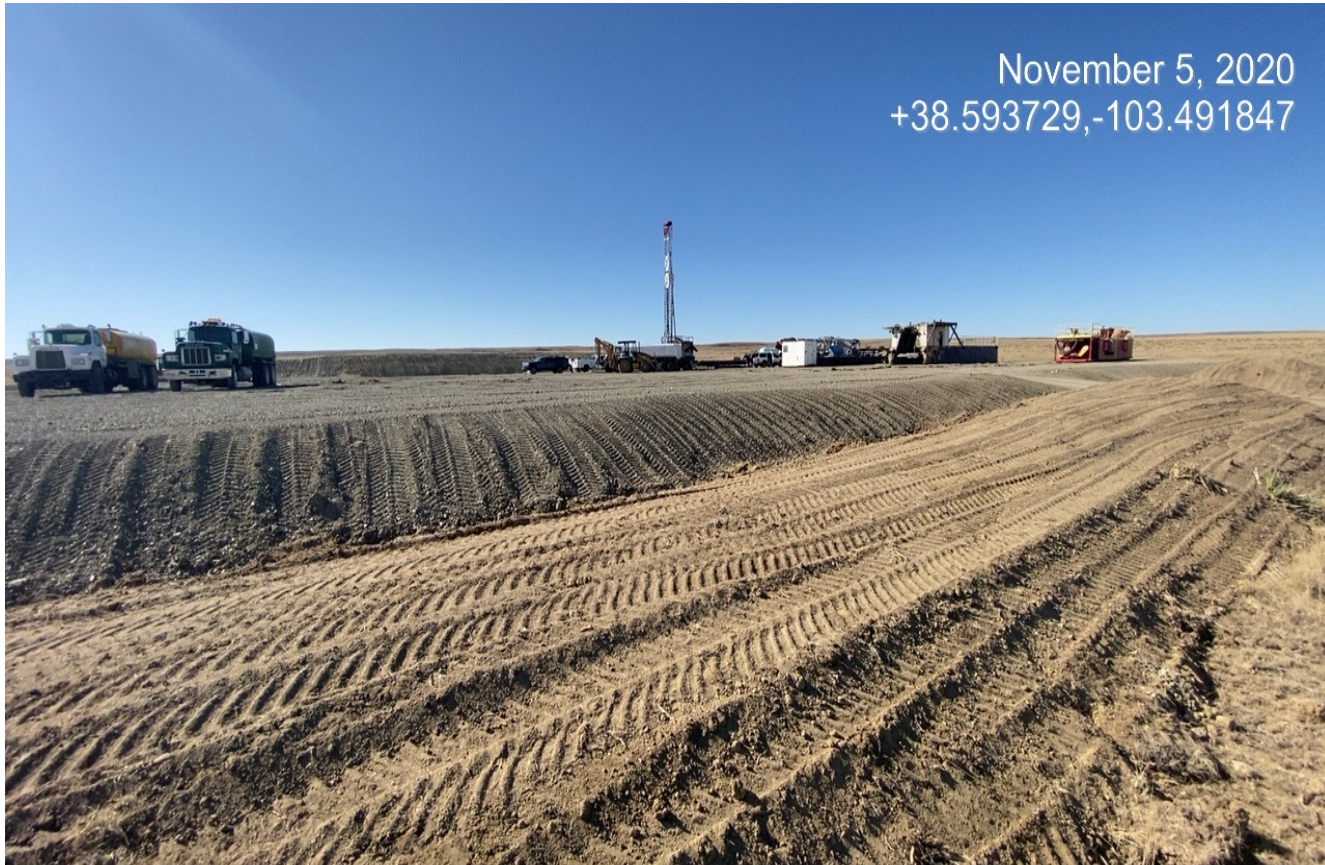
Photo 3. Facing west toward the location..

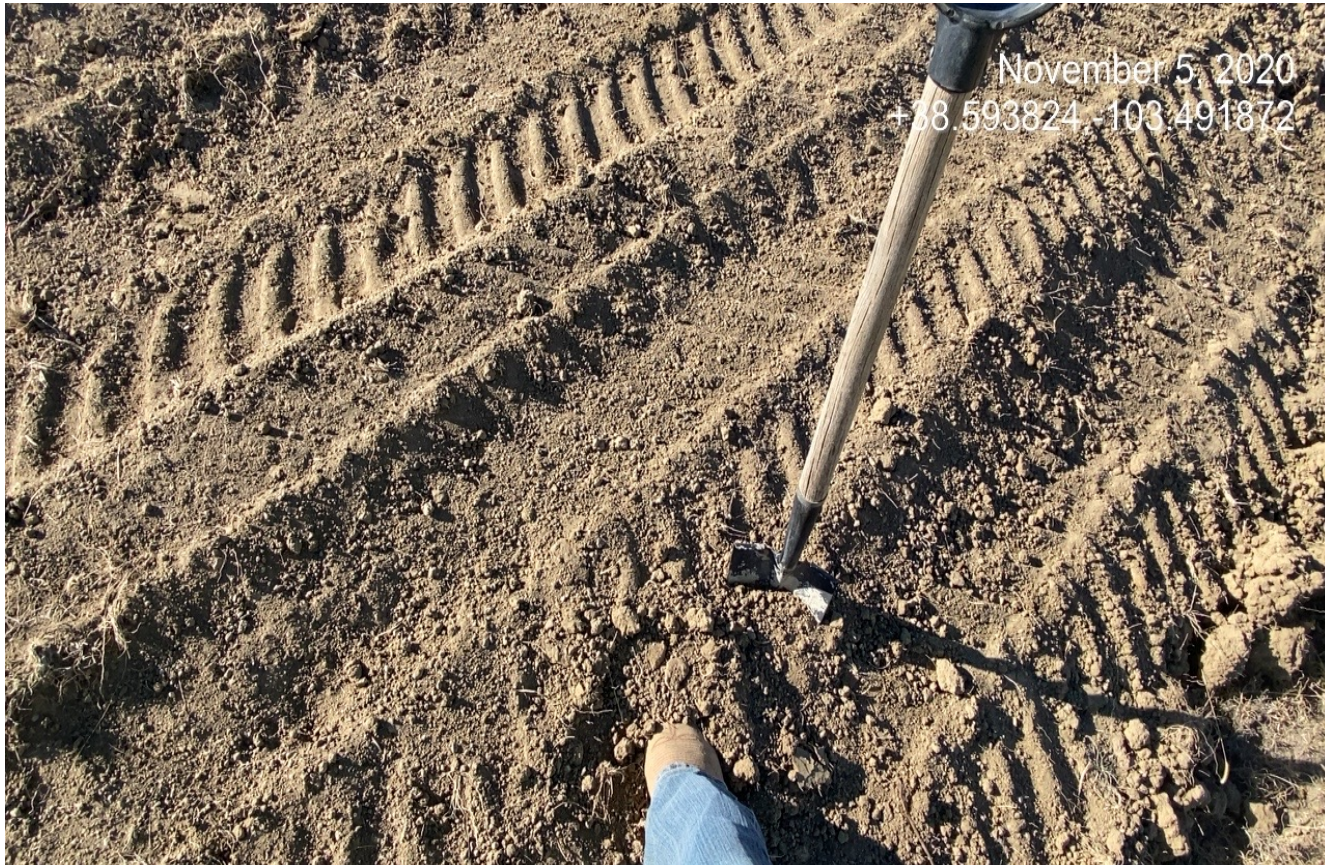
Photo 4. The topsoil pile has been tracked but is not sufficient to stabilize and maintain the topsoil pile. The topsoil is susceptible to erosion.

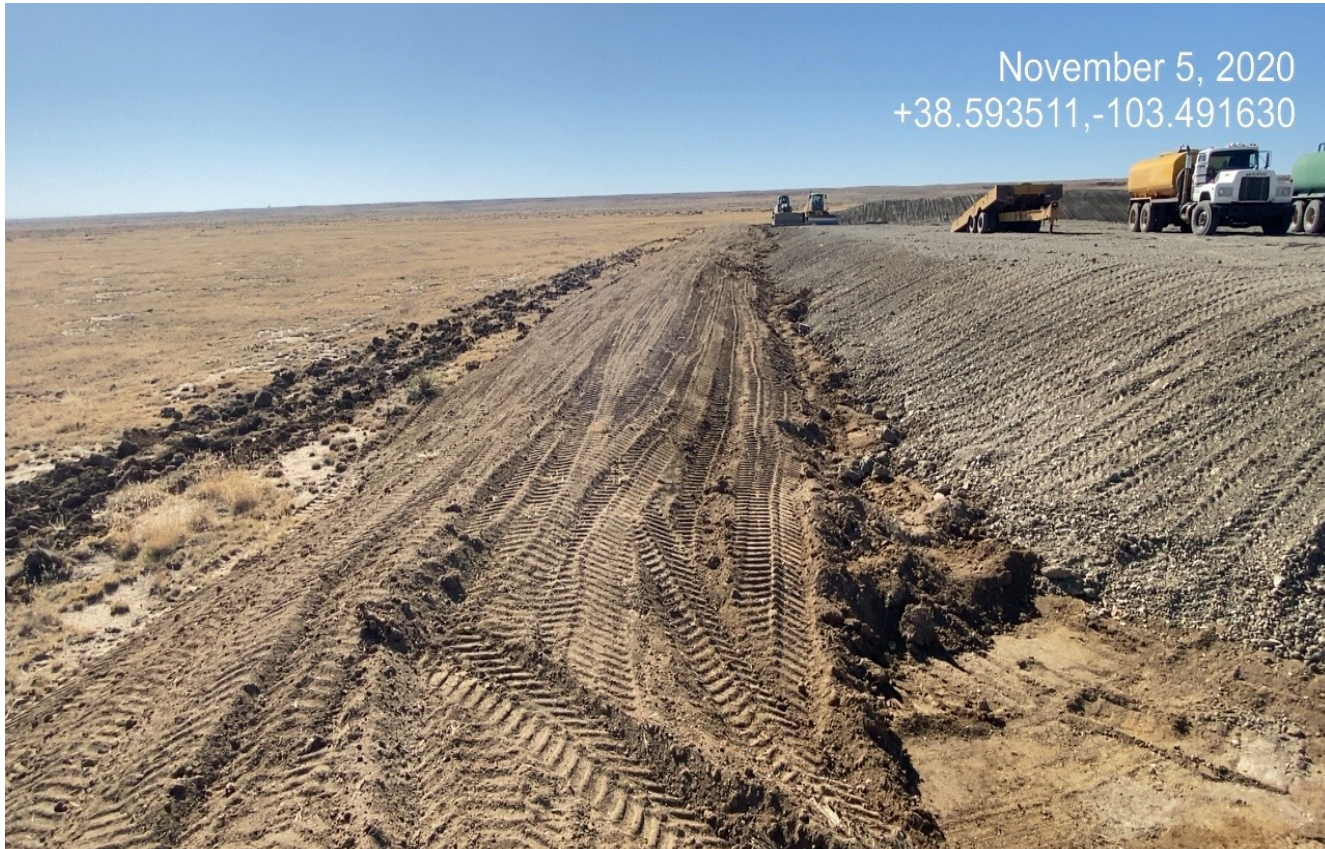
Photo 5. Facing southwest on top of the topsoil berm.

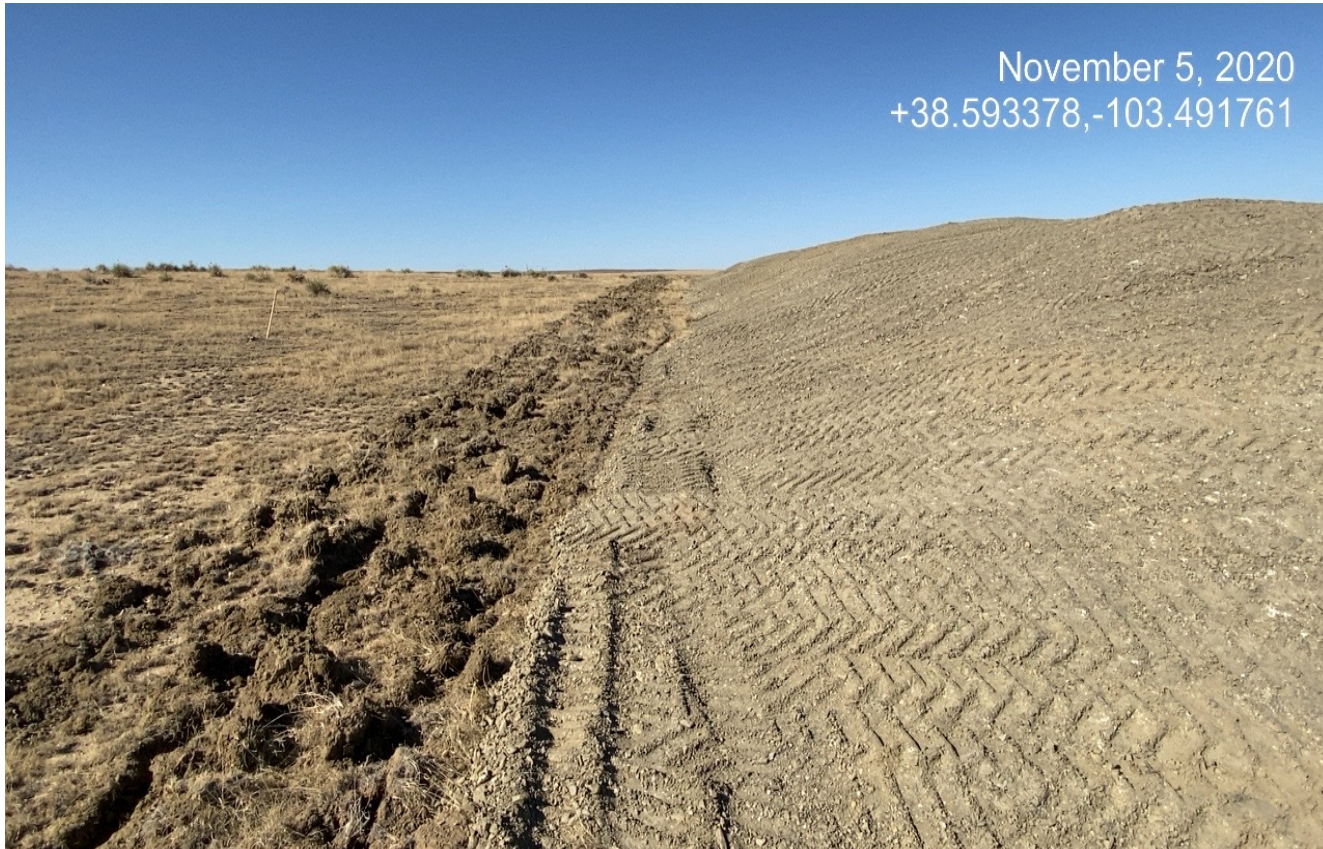
Photo 6. Soil roughening has occurred around the location.

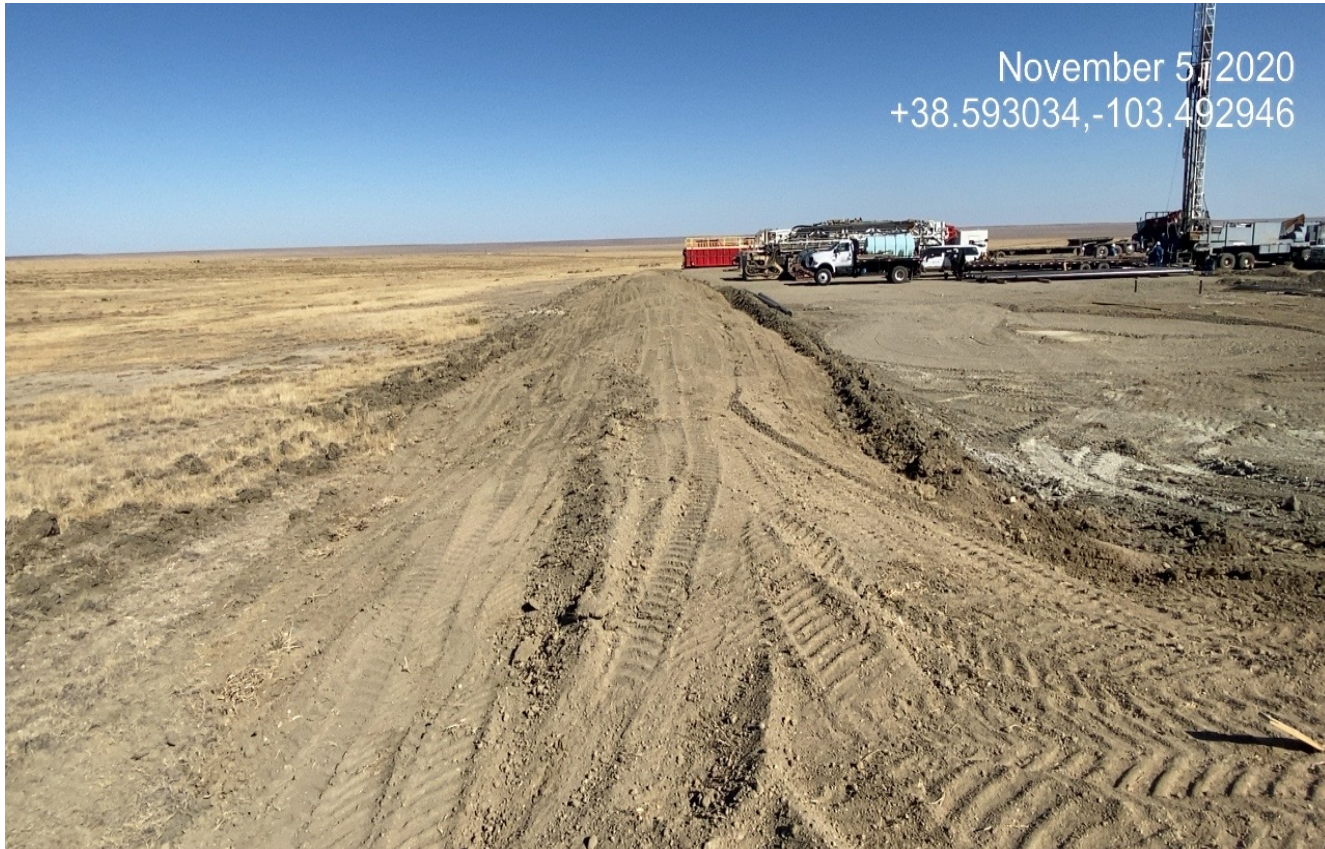
Photo 7. Facing northeast at the west side of the location.

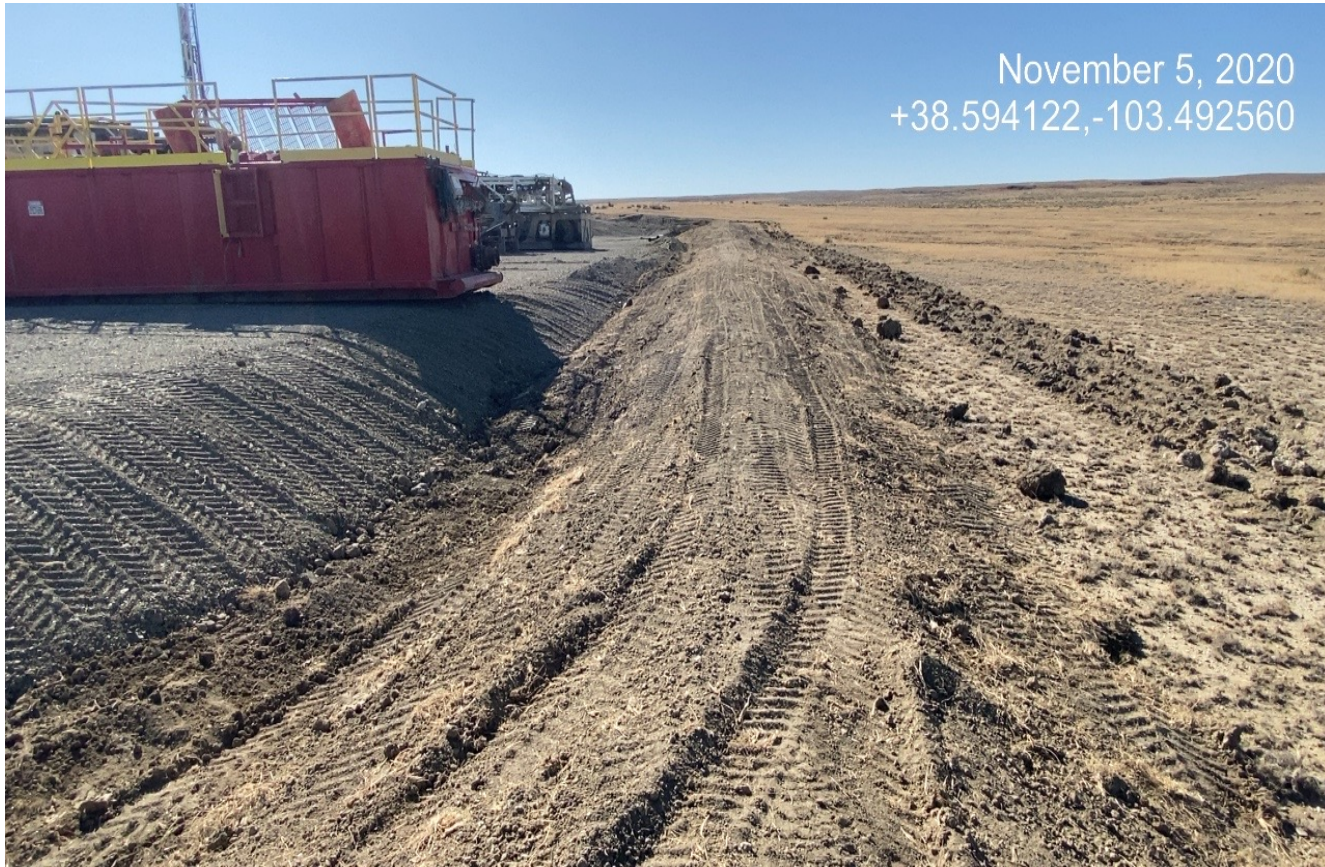
Photo 8. Facing northeast at the west side of the location.
