# Inspection Photos

API: 071-07680

Operator: TIMBER CREEK OPERATING LLC

Inspection Date: 11/10/2020

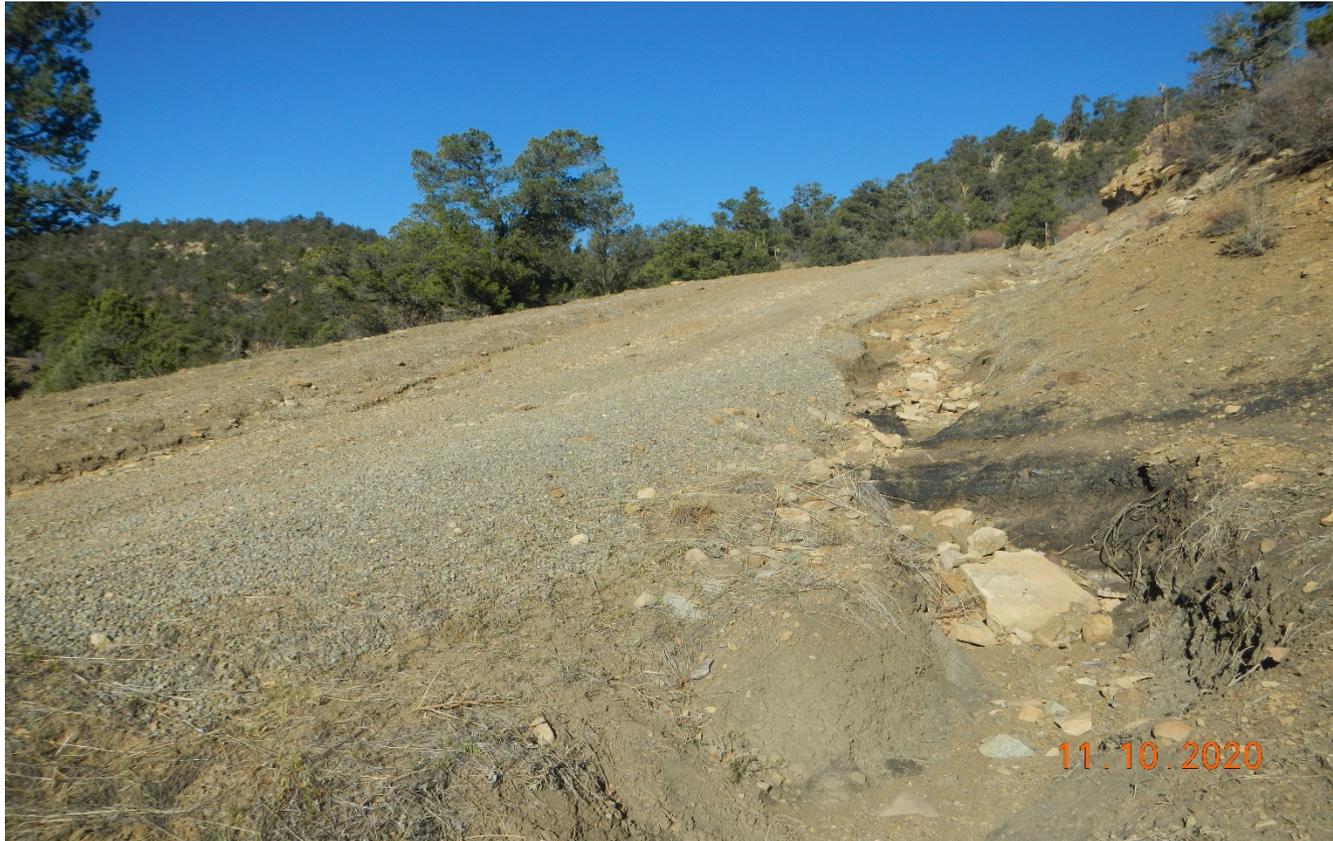
**Photo 1.** Facing northwest toward the access road. There is erosion along the access road at Lar/Long: 37.15772,-104.88855. This area need to be repaired and stabilized.

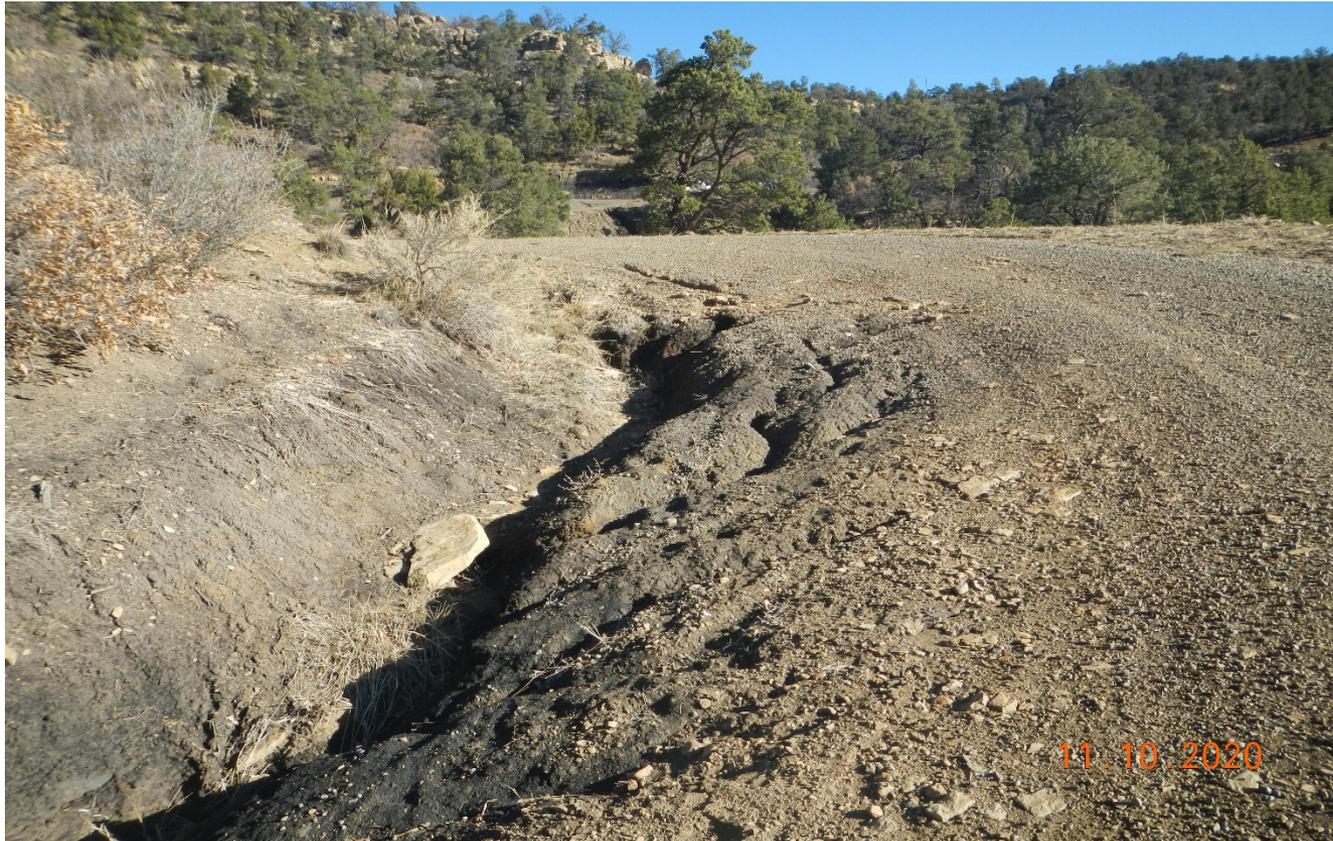
**Photo 2.** Facing northeast along the access road. There is erosion along the access road at Lar/Long: 37.15877,-104.88882. This area need to be repaired and stabilized.

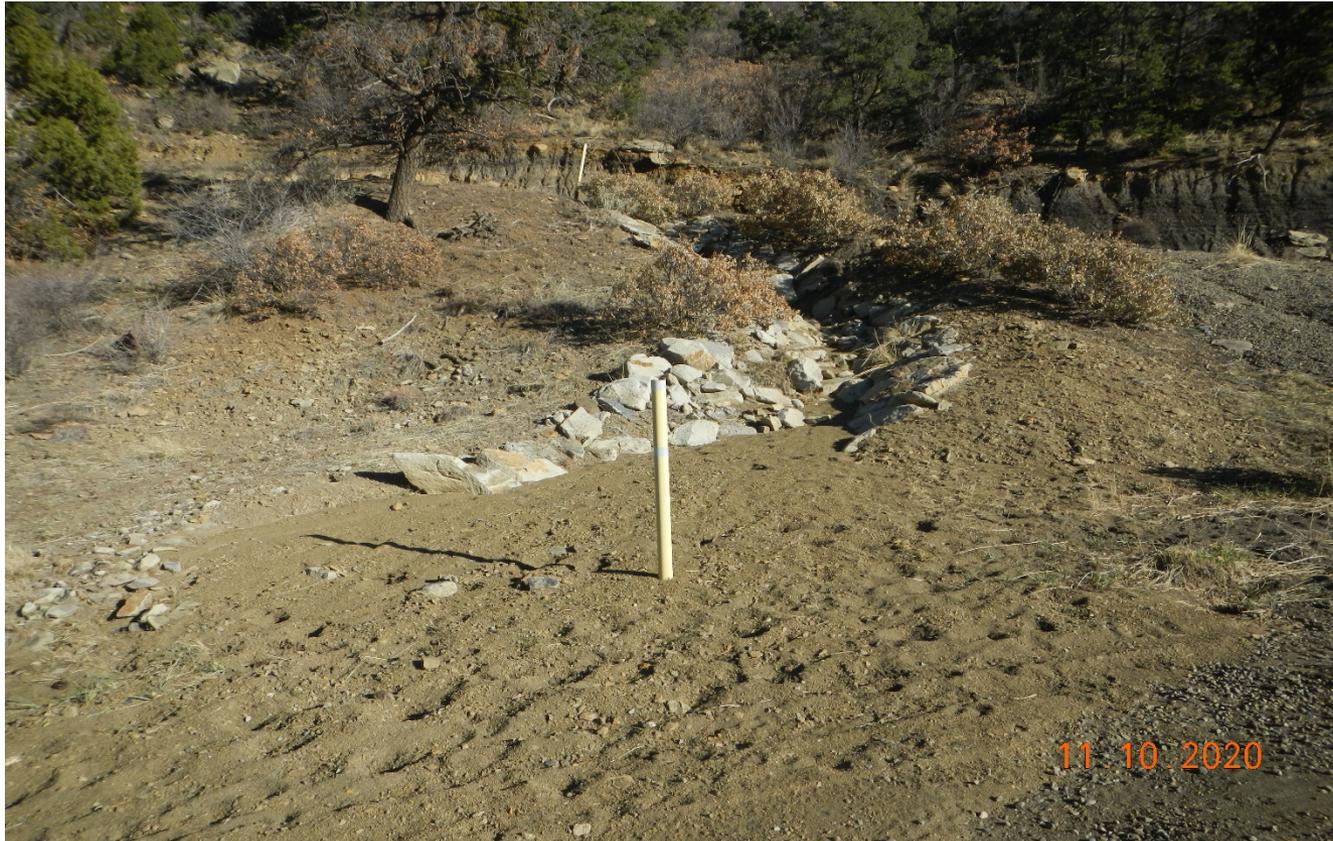
**Photo 3.** The culvert along the access road is filled in with sediment. Approx. Lat/Long:37.15953,-104.88851.

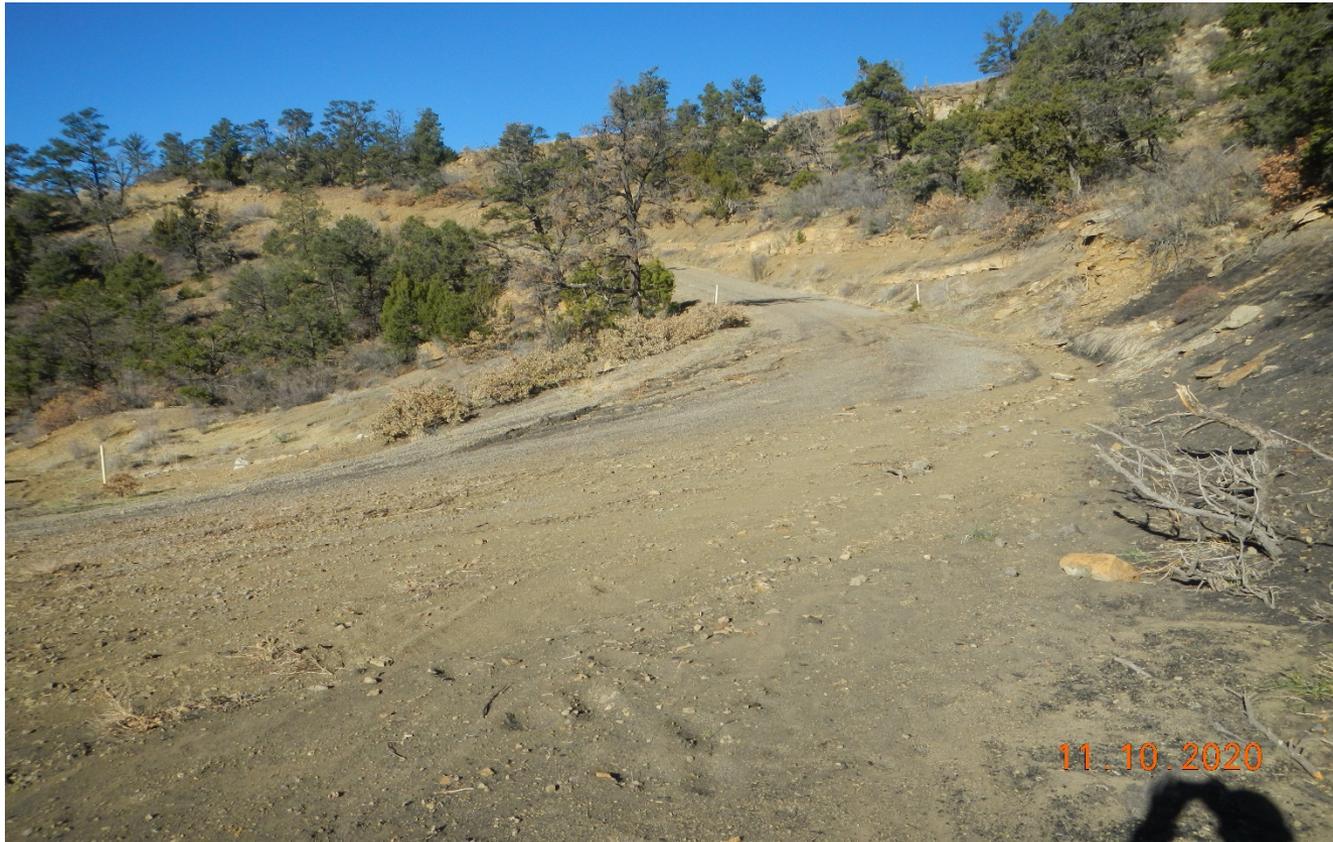
**Photo 4.** Facing northeast toward the access road. Stormwater is not flowing toward the culvert and is going across the road creating erosion shown in next photo. Previous corrective action has not been performed.

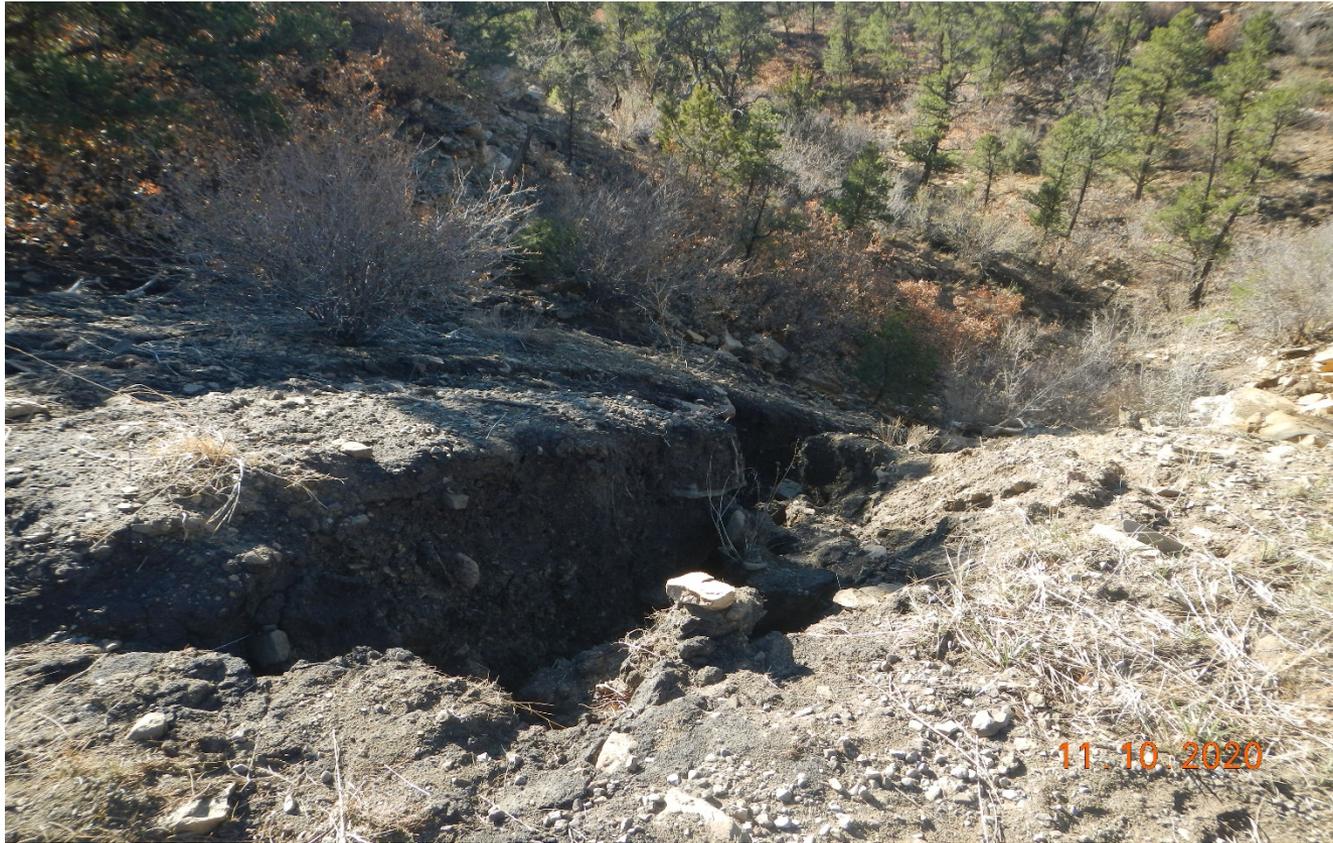
**Photo 5.** There is erosion occurring off the fill slope from stormwater flowing across the road shown in previous photo.
