Inspection Photos

API: 071-07778

Operator: TIMBER CREEK OPERATING LLC

Inspection Date: 11/10/2020

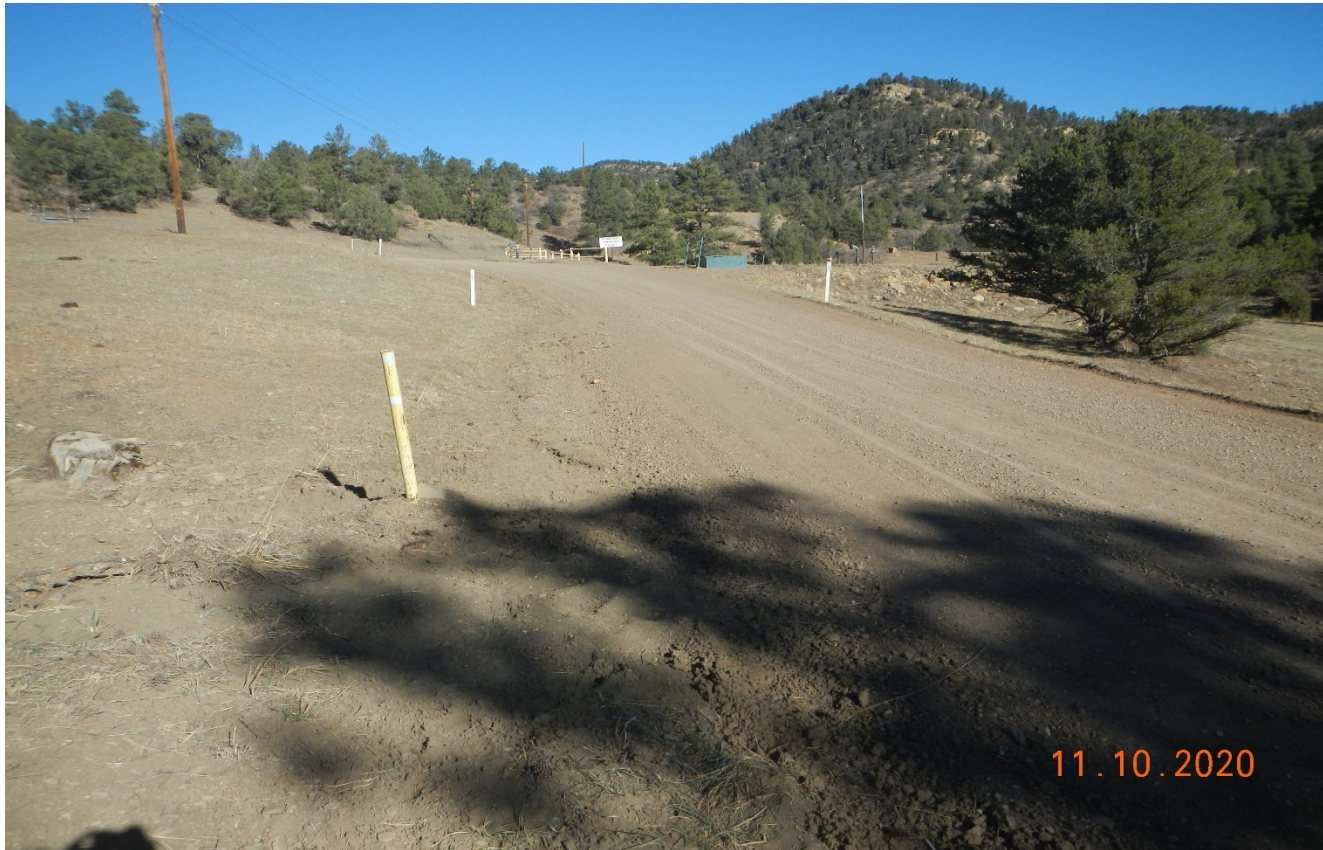
Photo 1. Facing northwest along the main access road. The culvert along the access road is filled in with sediment. Approx. Lat/Long:37.15036,-104.88730.

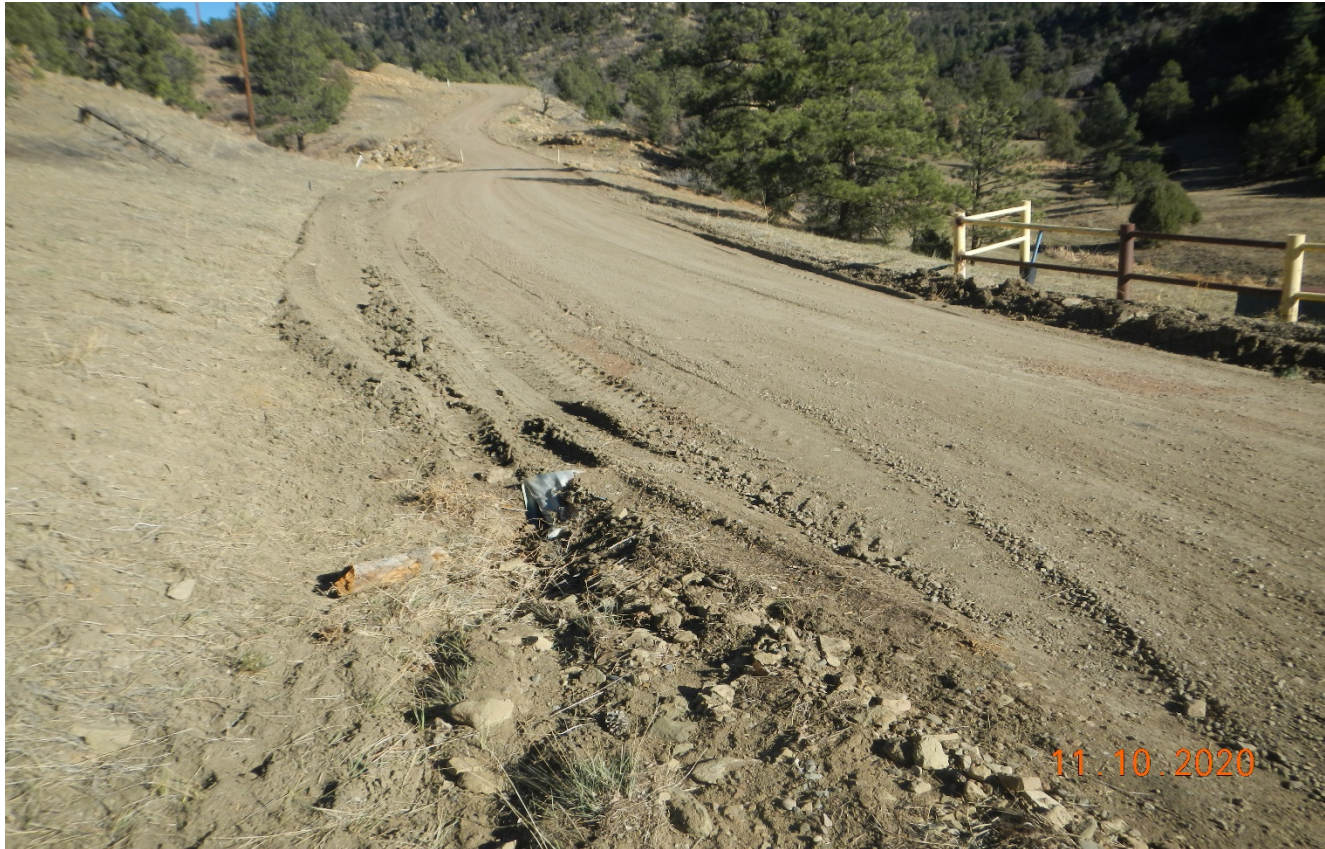
Photo 2. Facing north along the main access road. The culvert along the road is damaged. Lat/Long:37.15100,-104.88755.

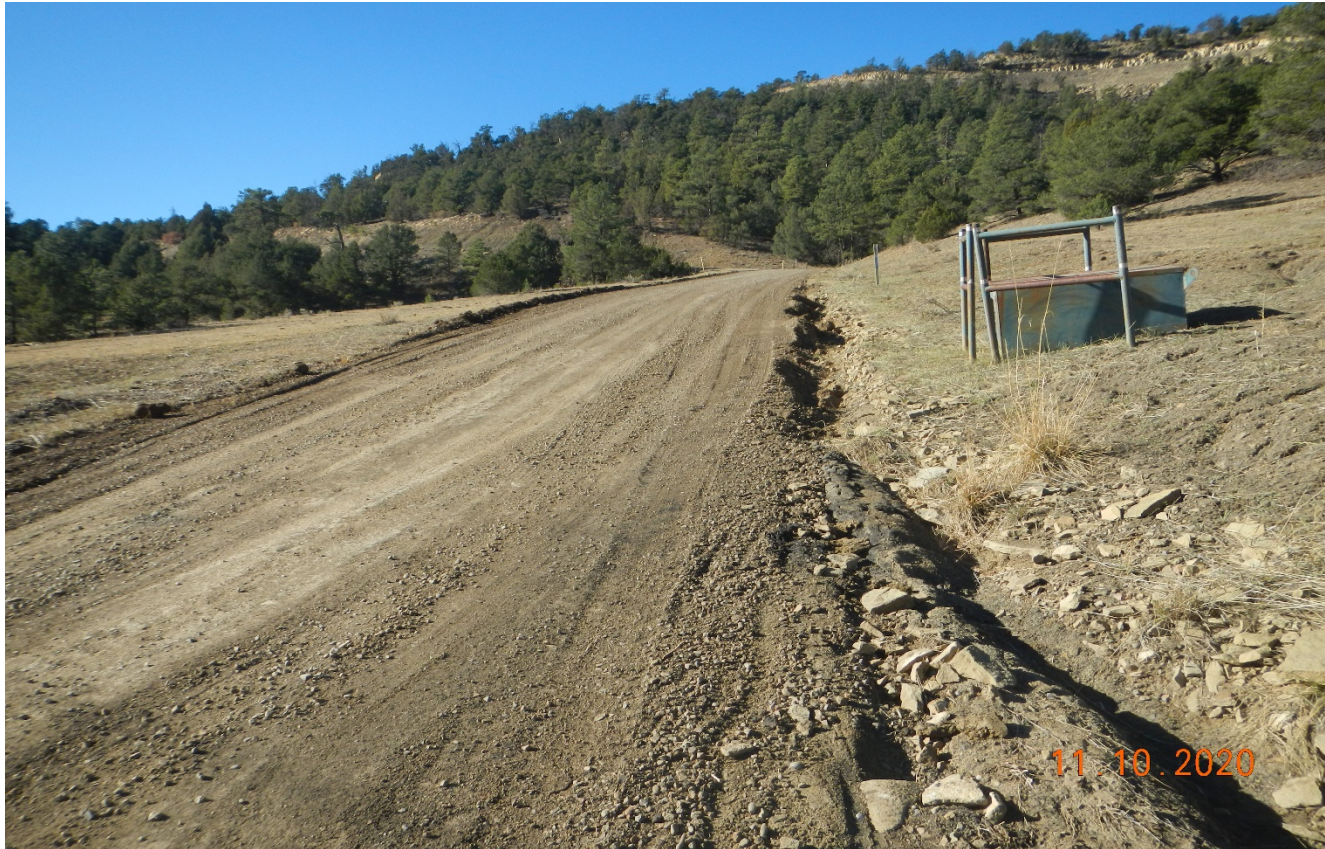
Photo 3. Facing southwest along the access road ascending the hillside. The road has been regraded. Additional BMP's are needed along the road side to prevent erosion.

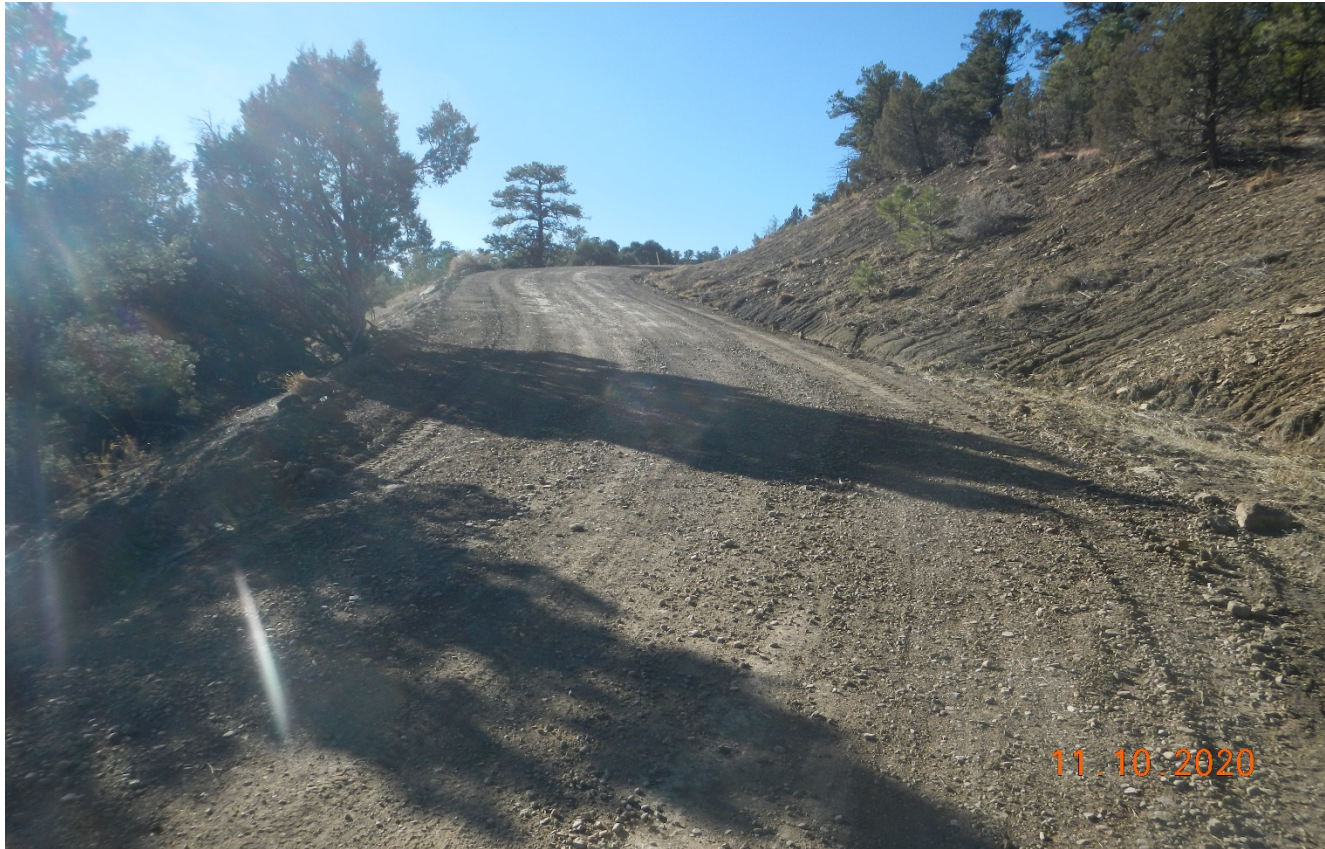
Photo 4. Facing south along the access road ascending the hillside.

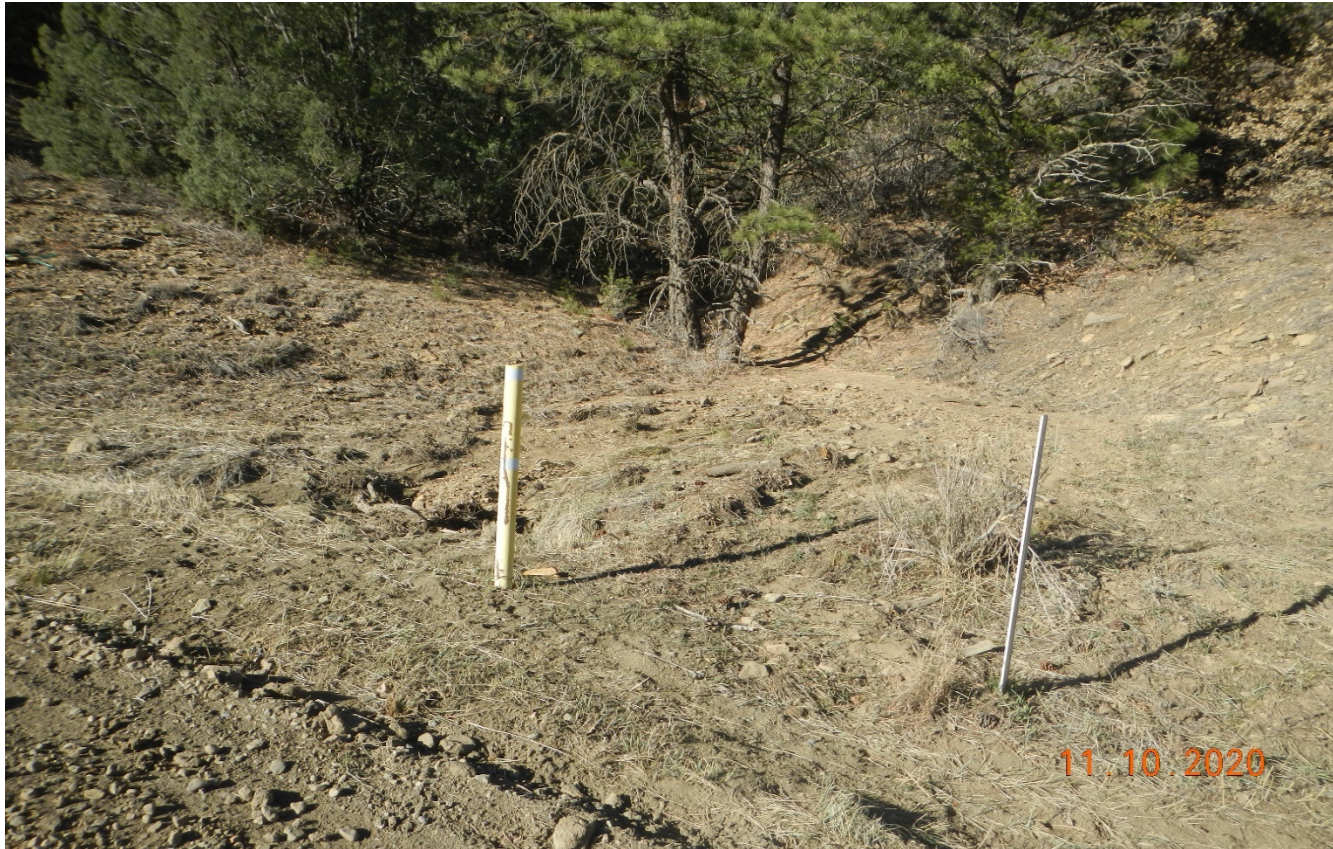
Photo 5. The culvert along the access road is filled in with sediment. Approx. Lat/Long:37.15042,-104.88852.

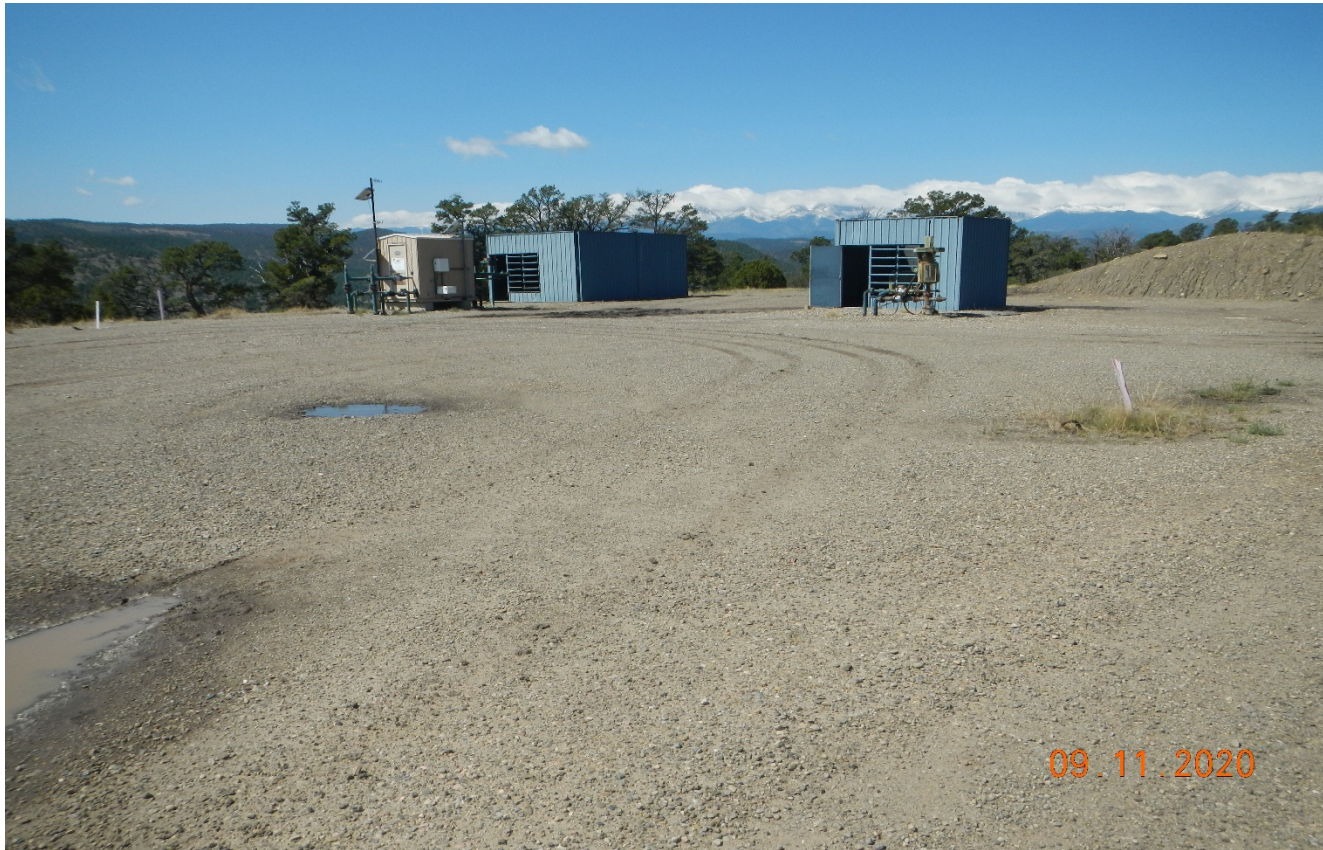
Photo 6. Facing west toward the location.
