TEP
RMV 237-28
Location # 335130

COLORADO
Oil & Gas Conservation
Commission
Department of Natural Resources

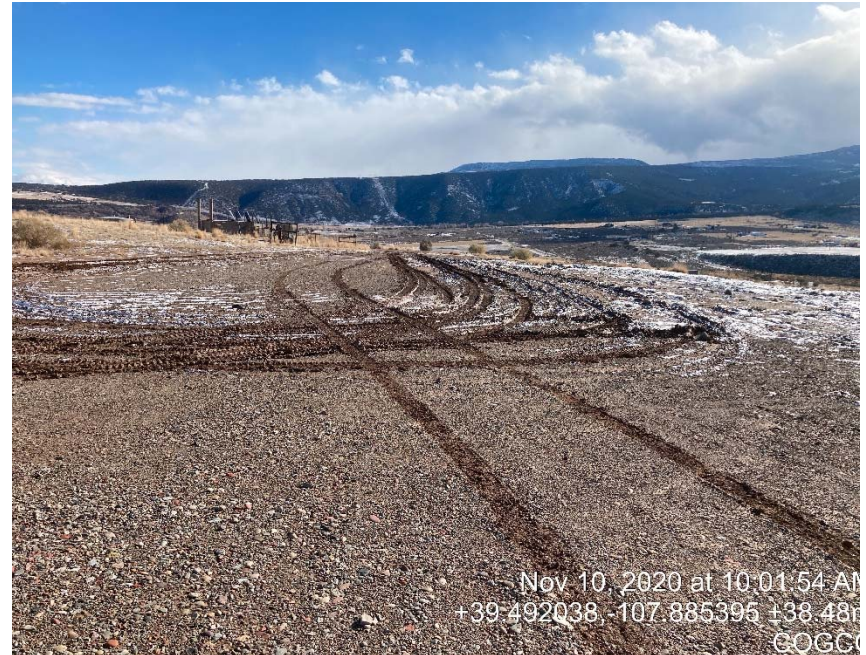
Rutting

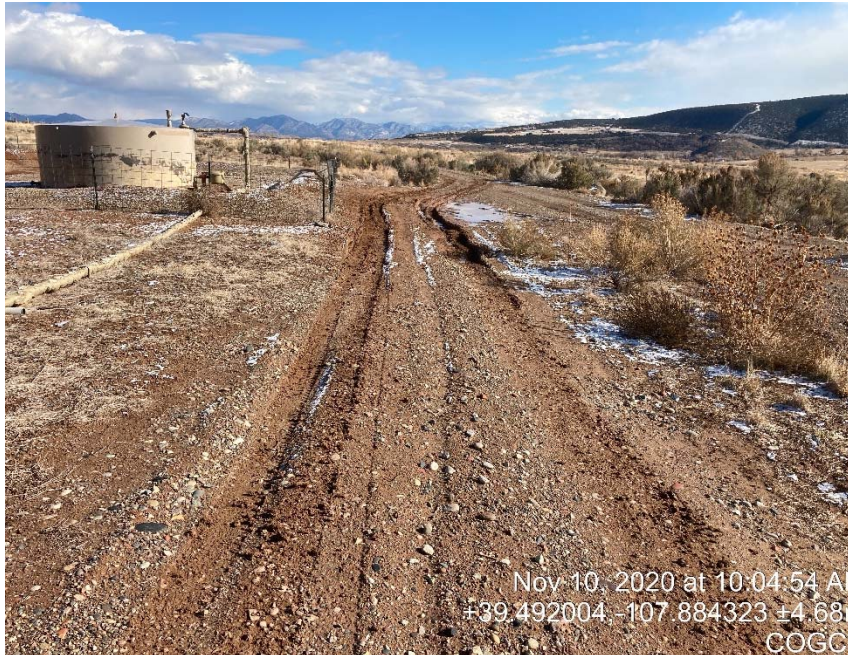
Rutting

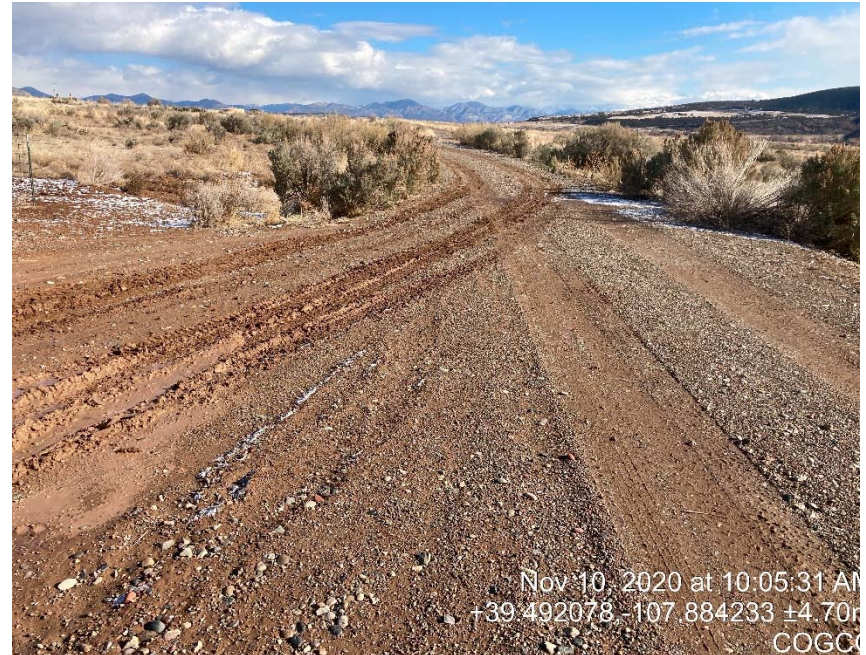
Rutting/ Lack of tracking controls

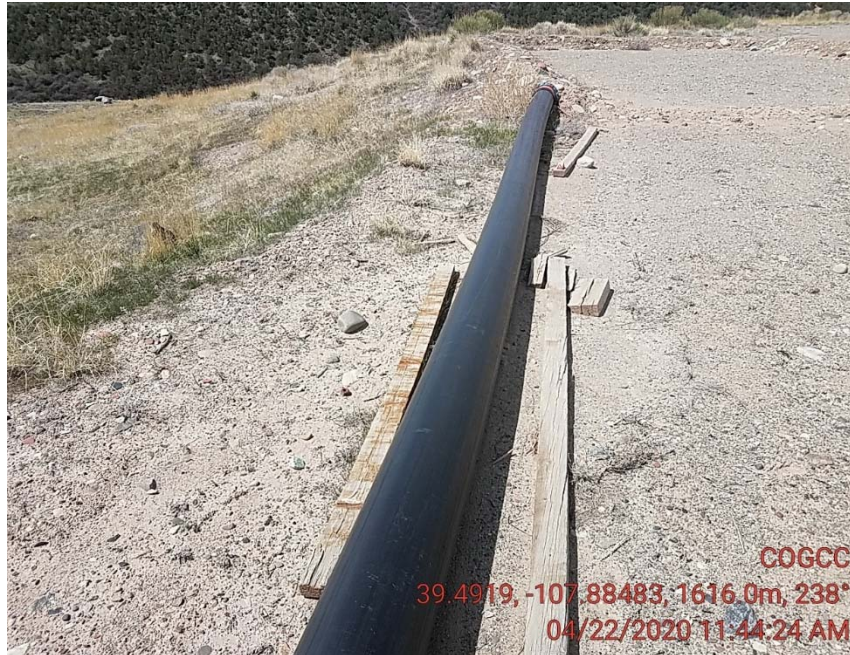
Previous inspection photo of piping

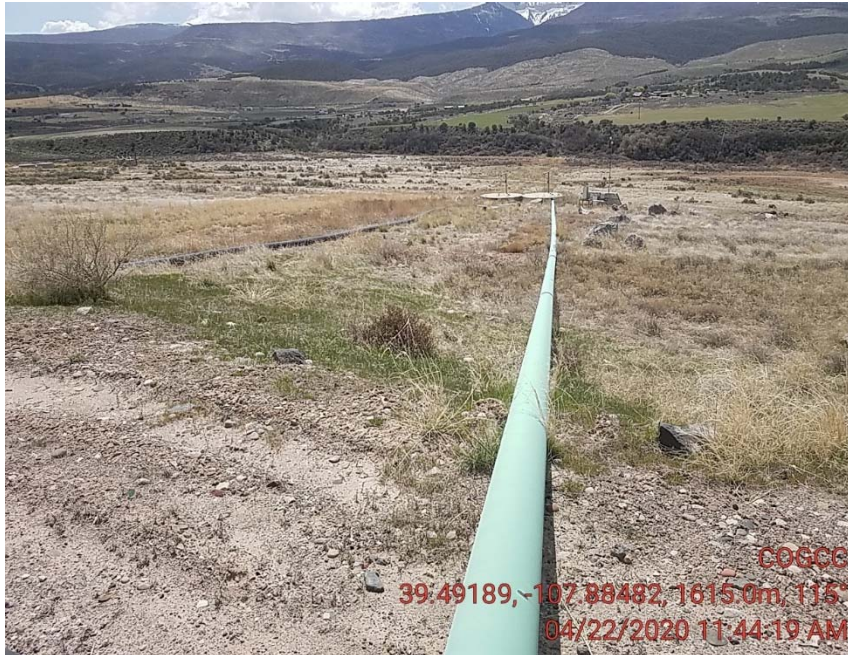
Previous inspection photo of piping
