Inspection Photos

API: 071-08234

Operator: EVERGREEN NATURAL RESOURCES

Inspection Date: 11/13/2020

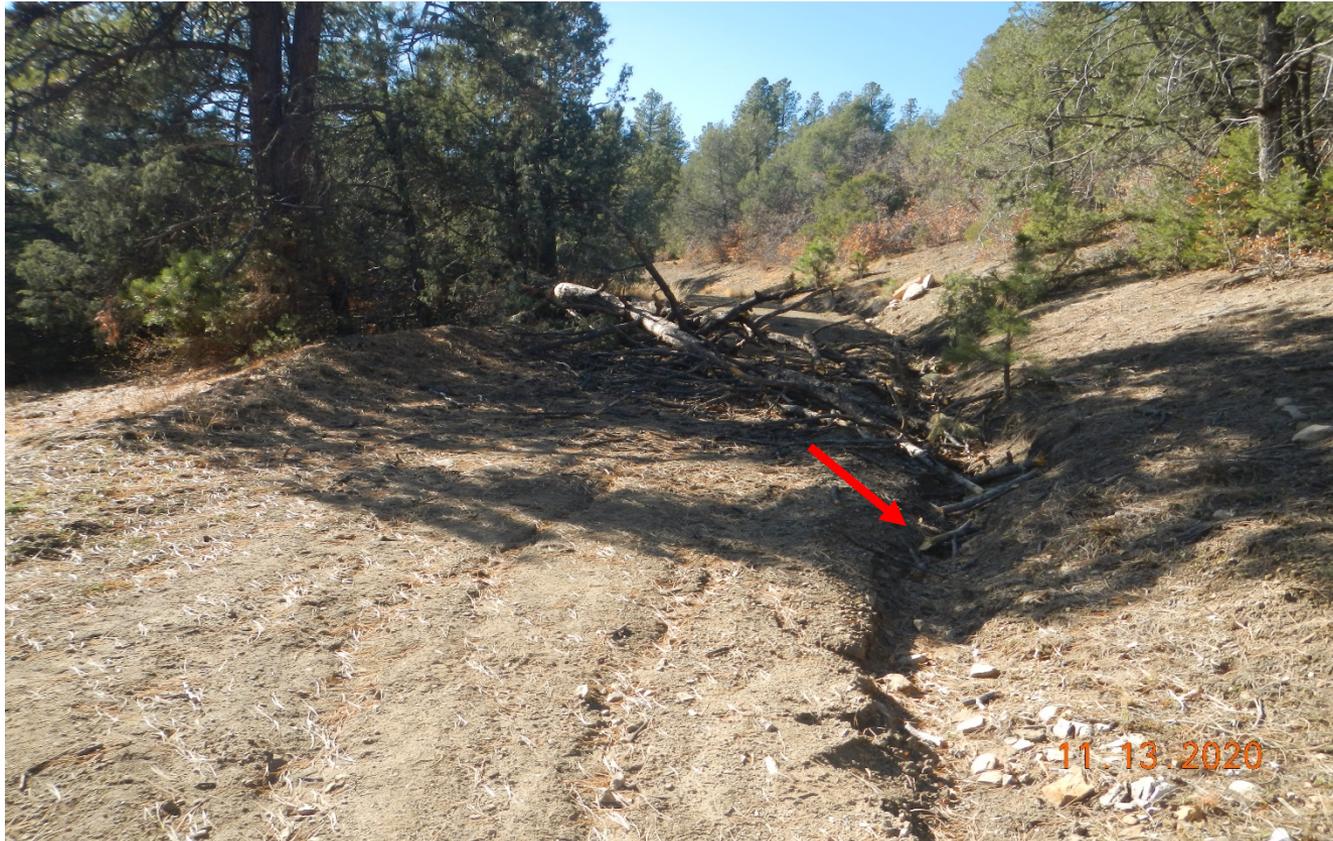
Photo 1. Facing southwest the beginning of the access road. The access road has not been recontoured and reclaimed. There are signs of erosion occurring down the road.

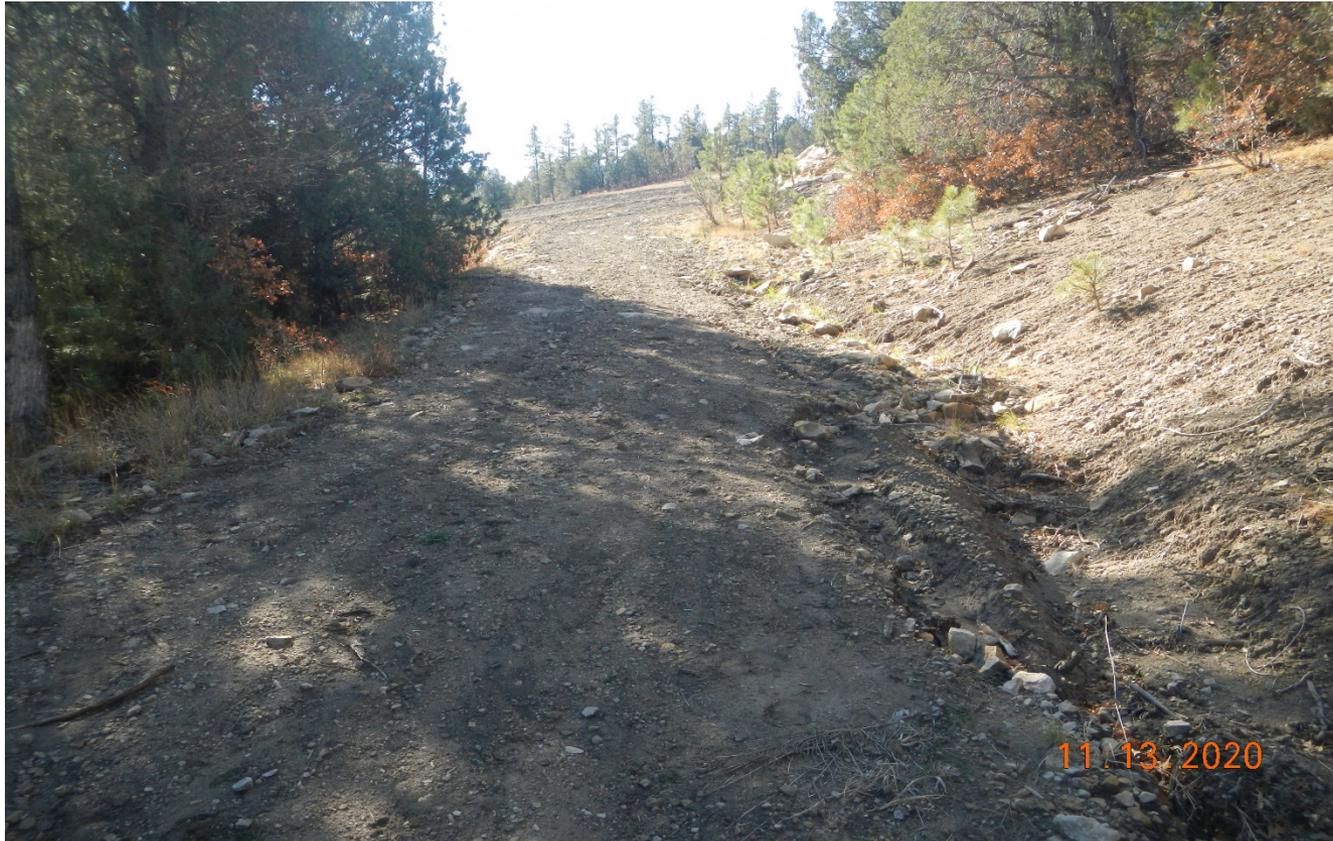
Photo 2. Facing south. The access road has not been recontoured and reclaimed.

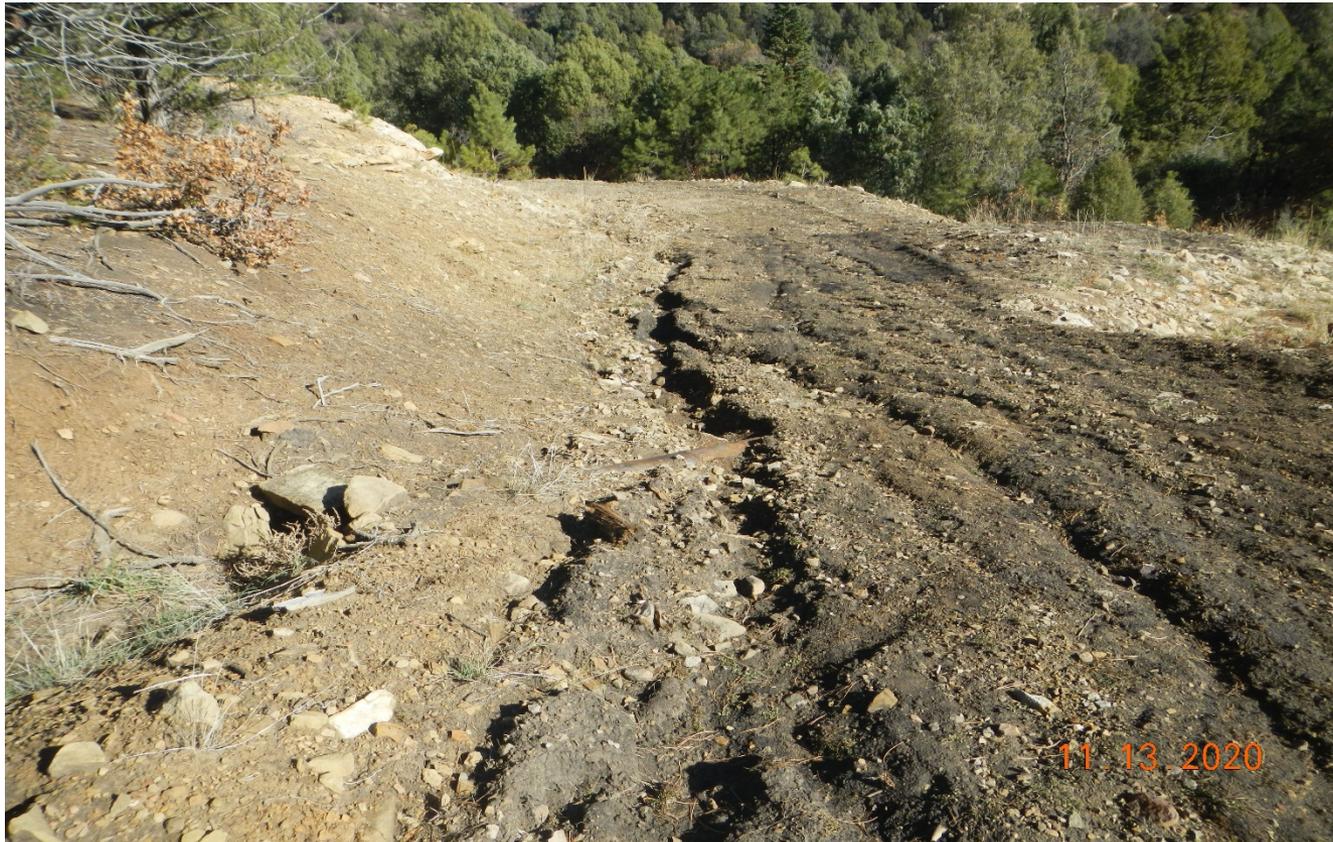
Photo 3. Facing northeast toward the access road. The culvert remains and erosion is occurring down the road.

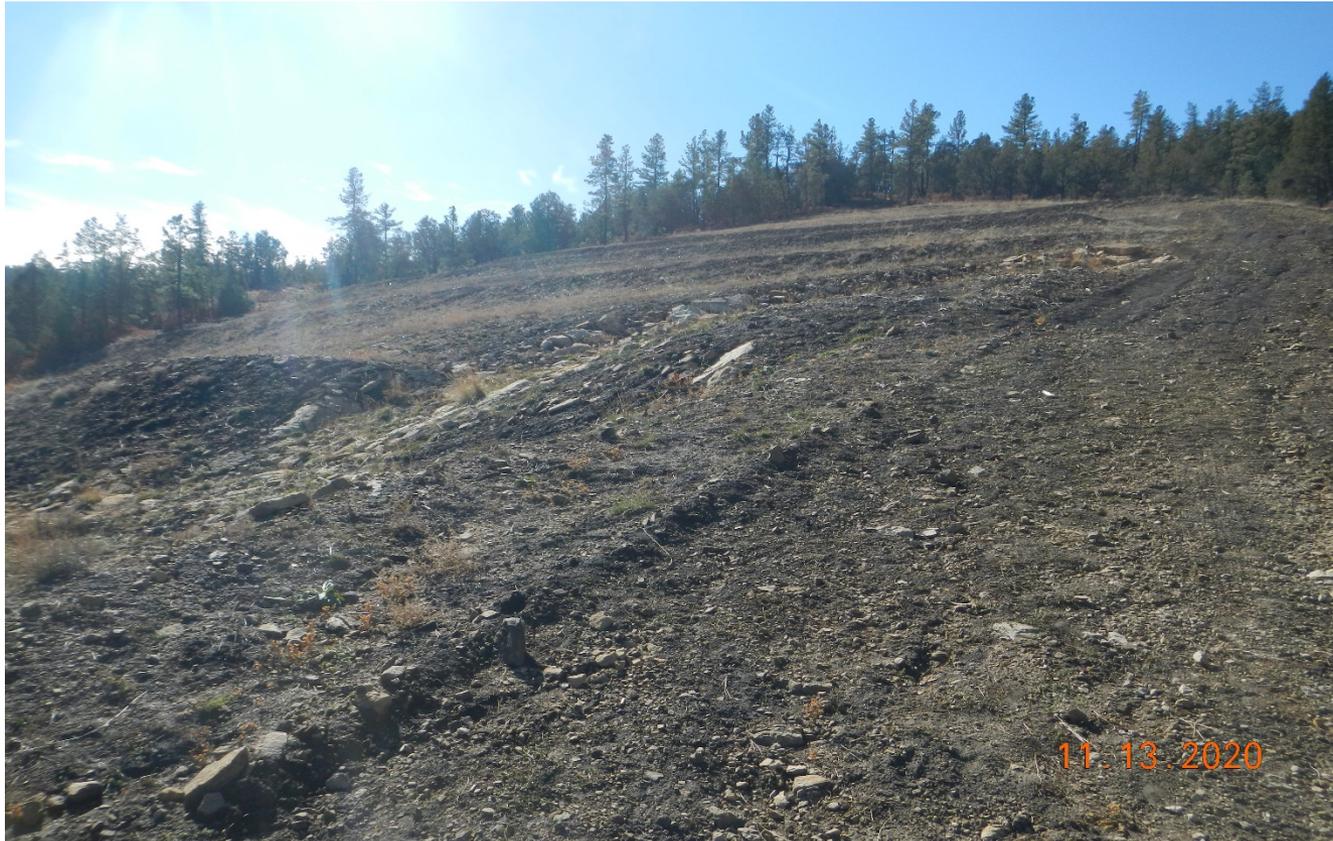
Photo 4. Facing southwest toward the location. The location has been recontoured however it has been terraced which does not match the original contours of the terrain.

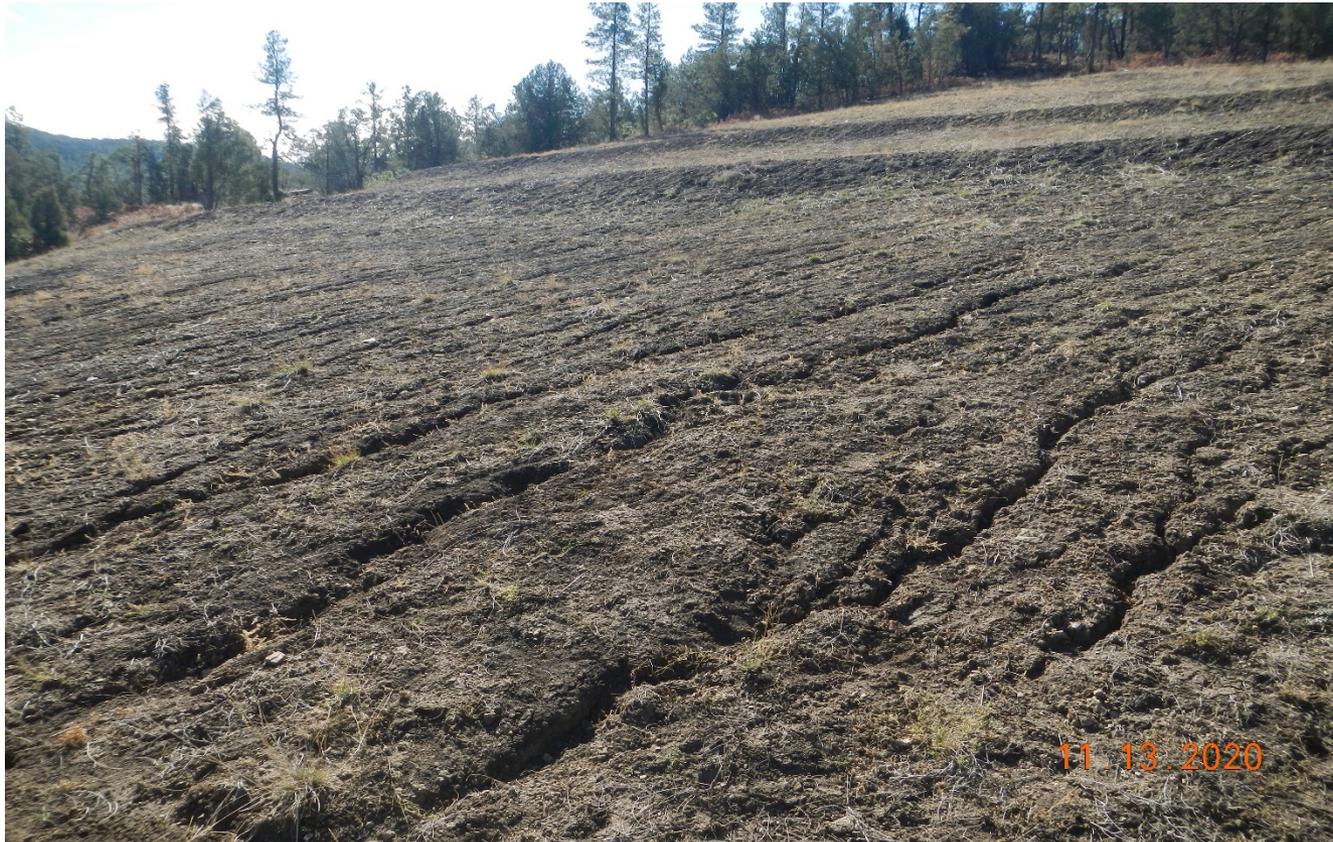
Photo 5. Facing south at the location. The location is not stabilized and there are signs of erosion.

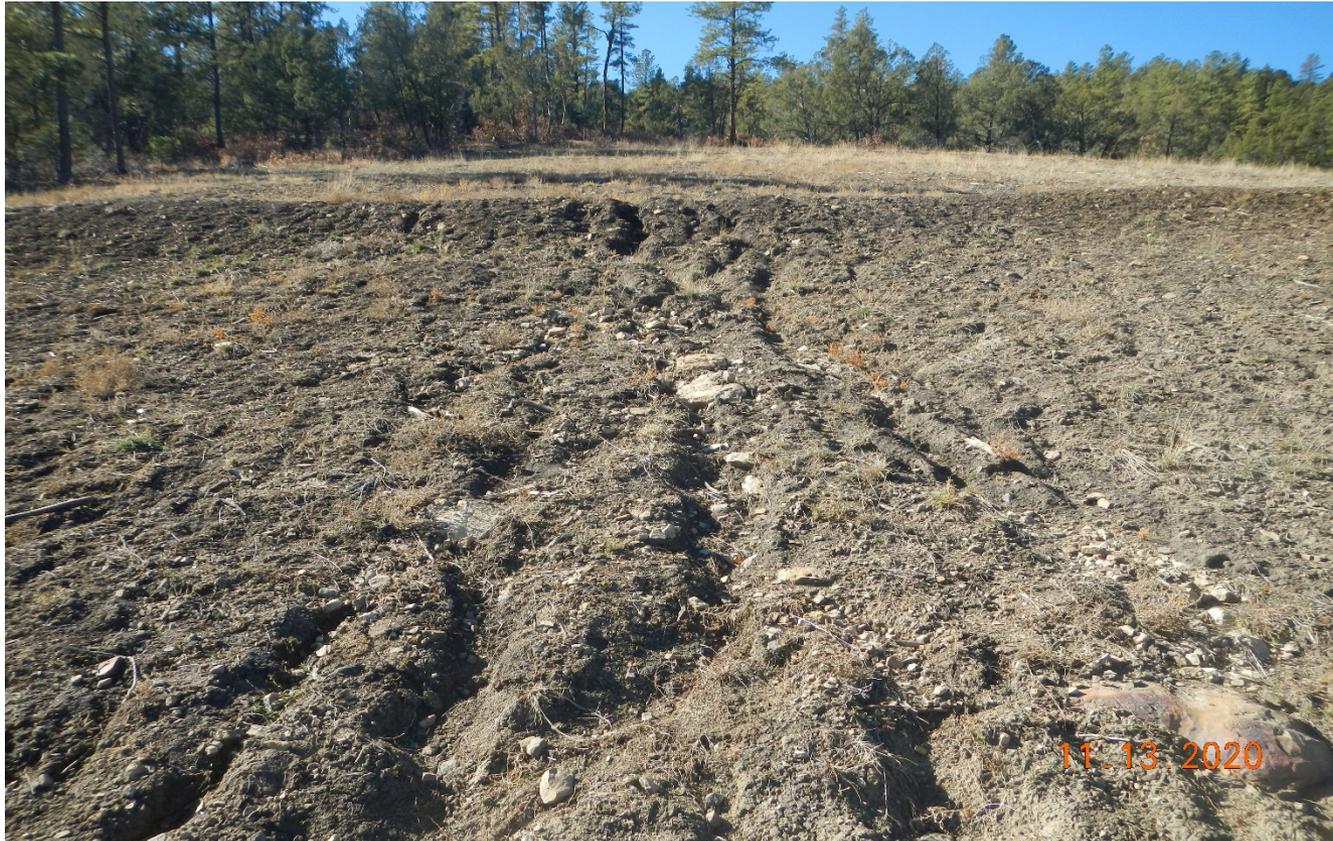
Photo 6. Facing west toward the location. The berms along the slope have failed causing stormwater to concentrate down areas of the location.

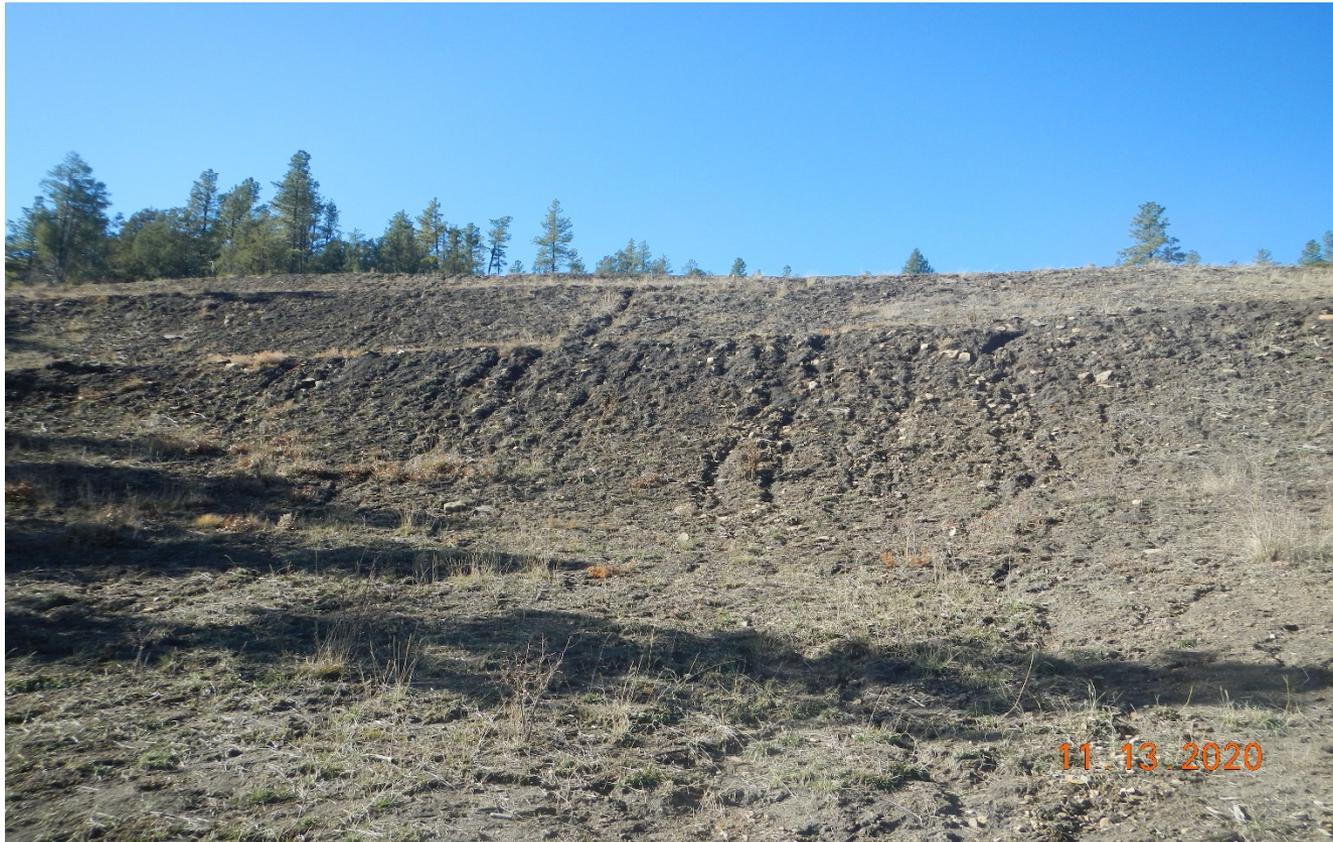
Photo 7. Facing west toward the location standing at the bottom of the slope. It appears the terracing performed has increased the degree of slope. The location appears rounded and should have been sloped down and tapered to reduce the slope.
