Inspection Photos
Operator: BP America
API: 067-08645
Date: 11/13/2020

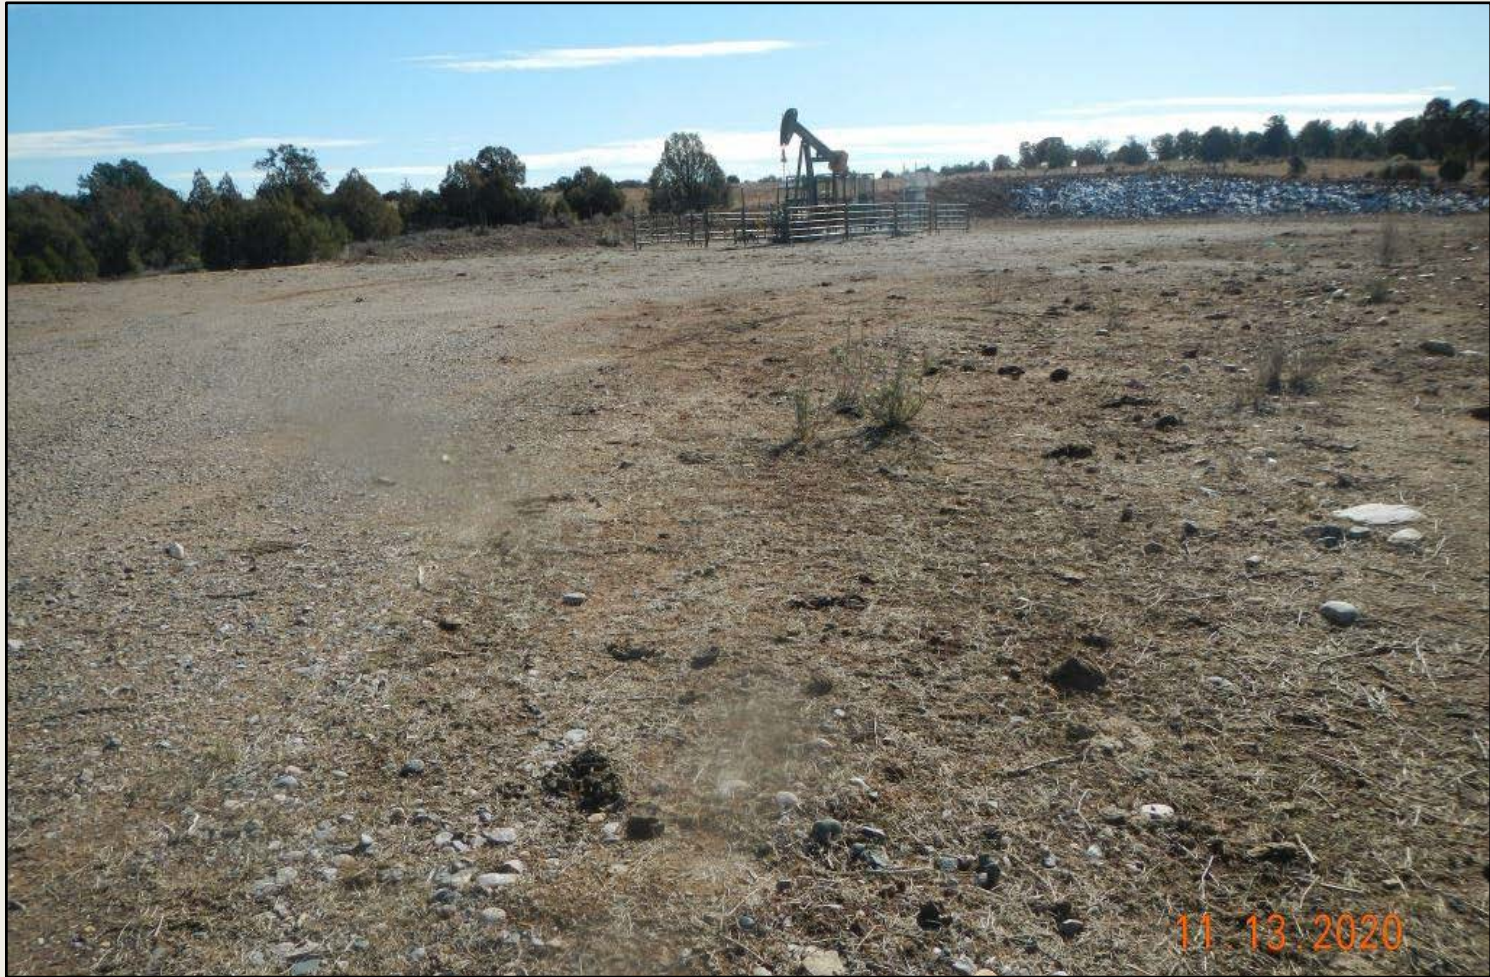
Photo 1. View of the project area from the well pad entrance facing center.

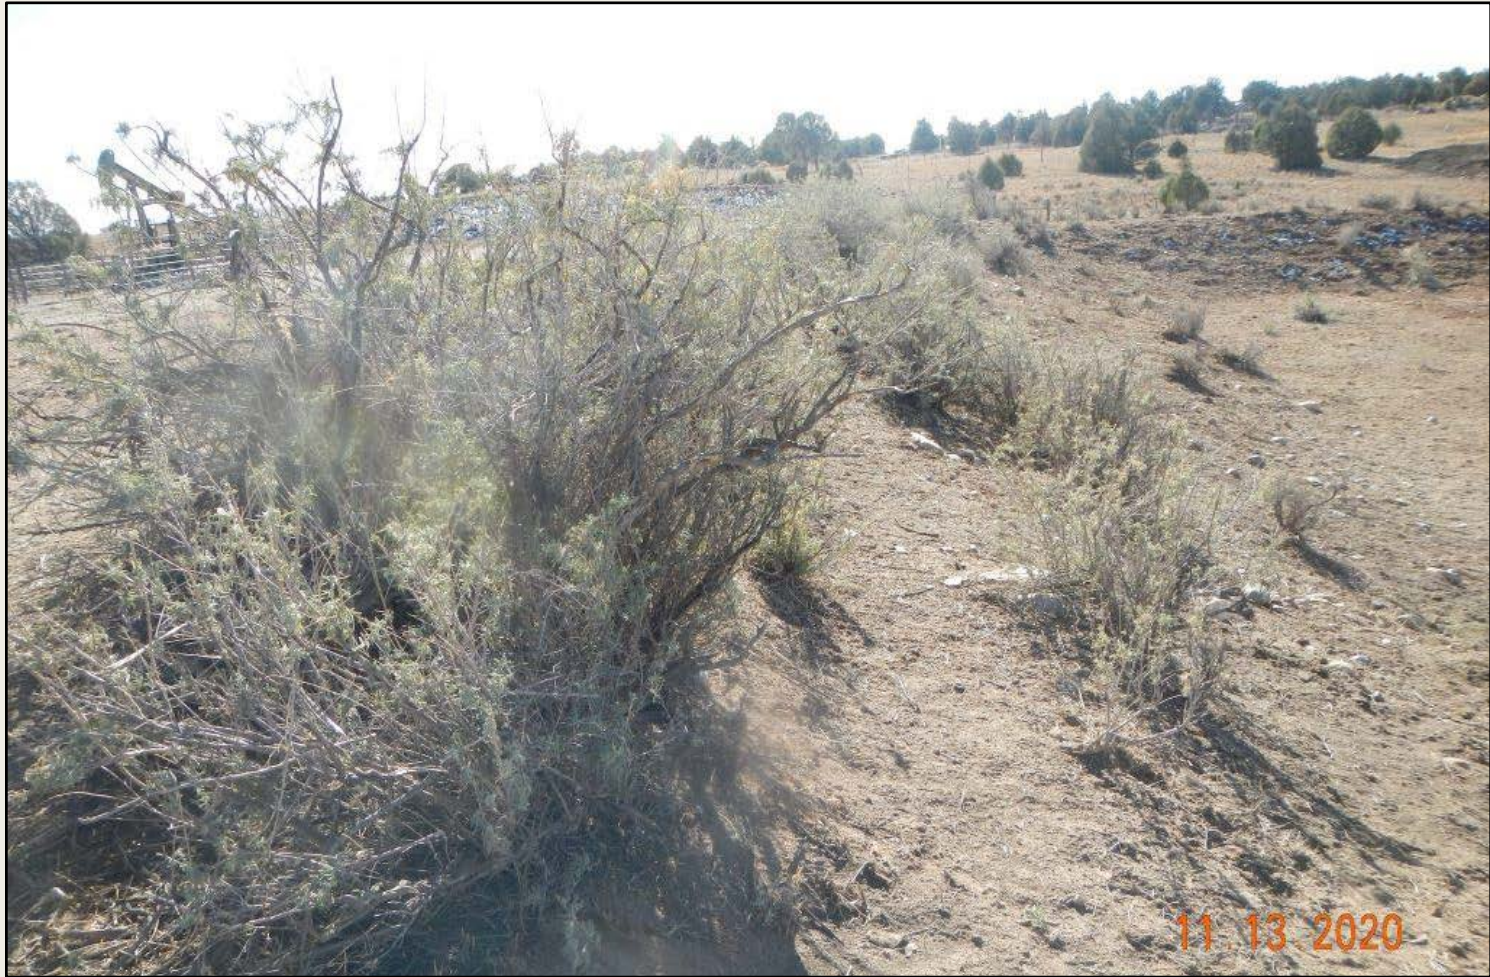
Photo 2. View of the western project area from the southwestern corner facing southward. Revegetation is in a grazed condition, and appears progressing with fourwing saltbush, crested wheatgrass, and western wheatgrass. Monitoring and potential livestock exclusion are needed to ensure grazed vegetation recovers.

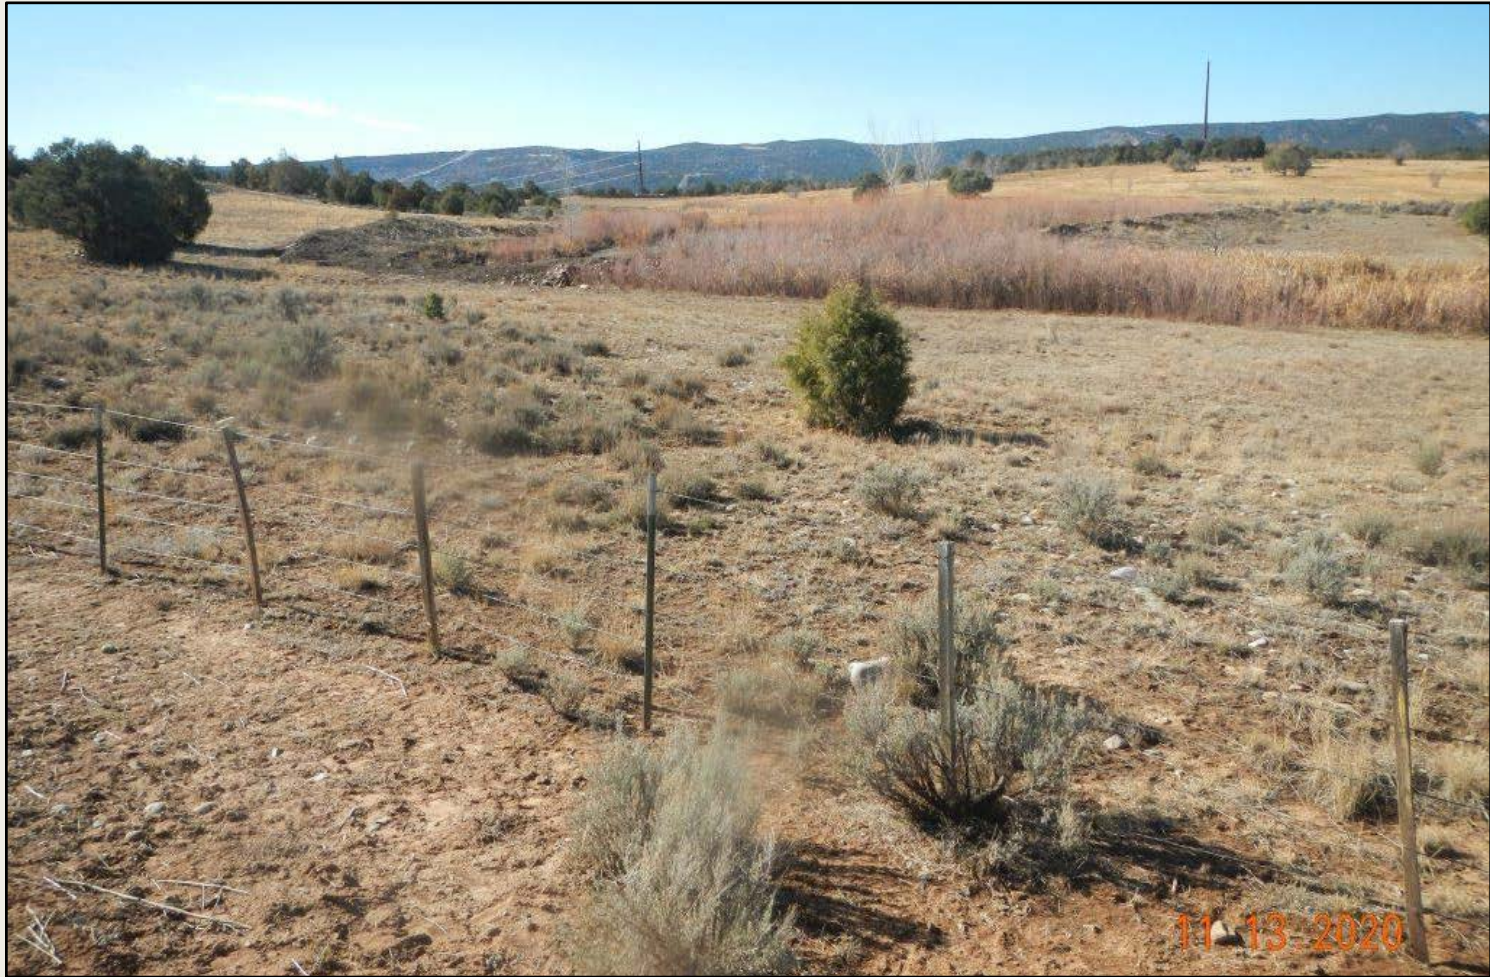
Photo 3. View of reference area mosaic of irrigated and non-irrigated grass and shrub fields with black sage, Indian ricegrass, western wheatgrass, and James galleta.

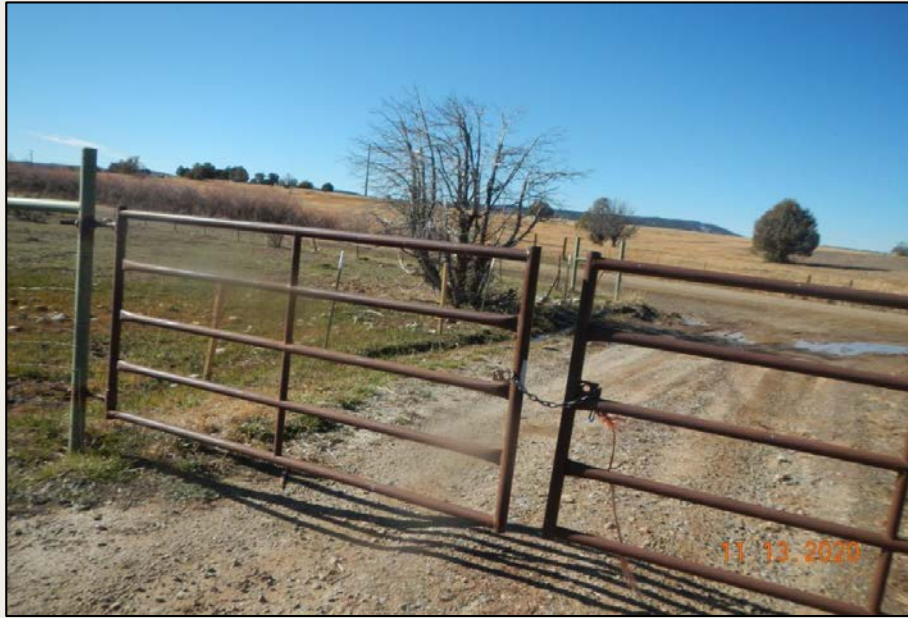
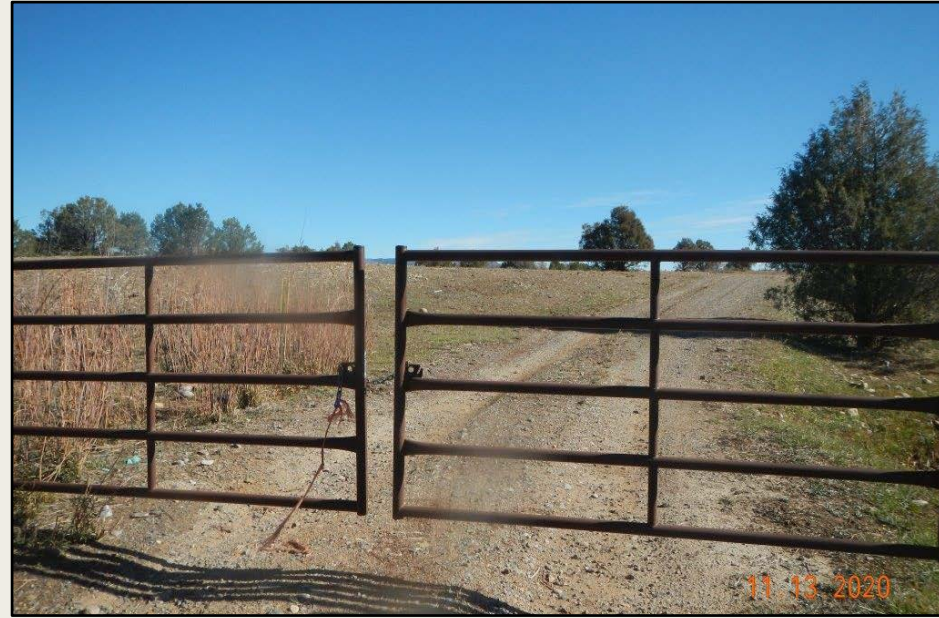
Photos 4/5. View of closed gates after entering (left) and leaving (right) location.
