**TEP ROCKY MOUNTAIN LLC**  
**Federal SG 43-28**  
**Location ID: 334978**

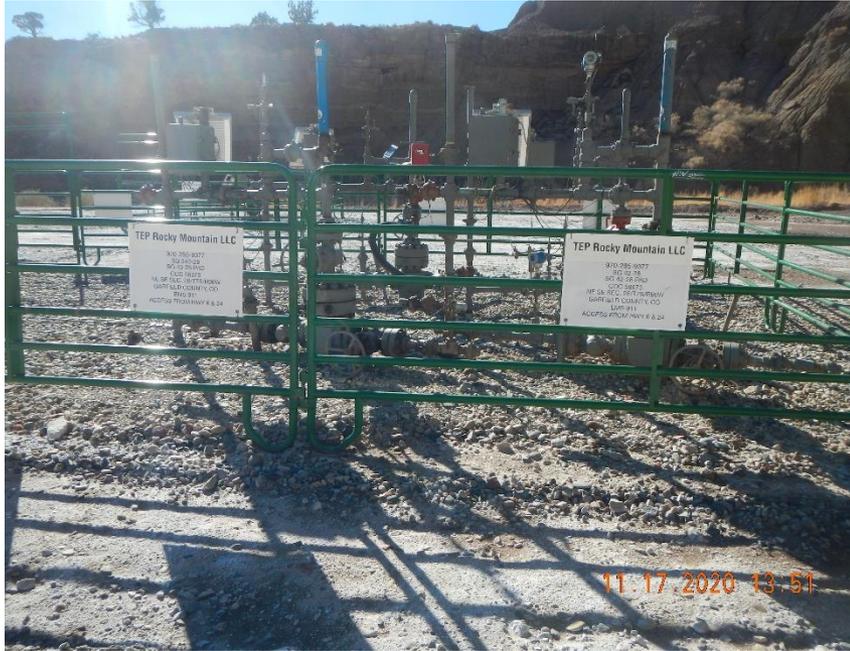
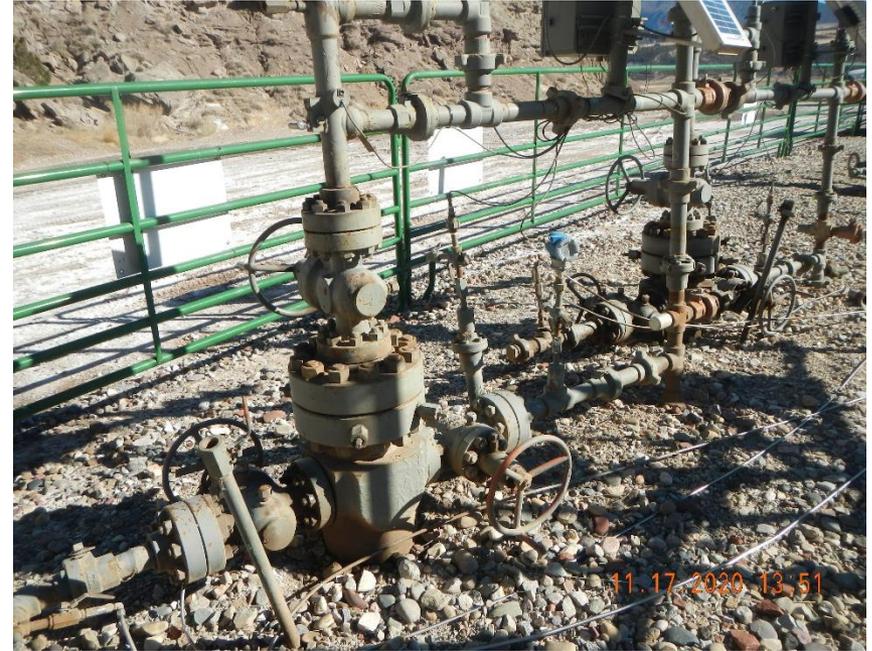
**Staining around SG 42-28 and SG 342-28  
has been cleaned up.**

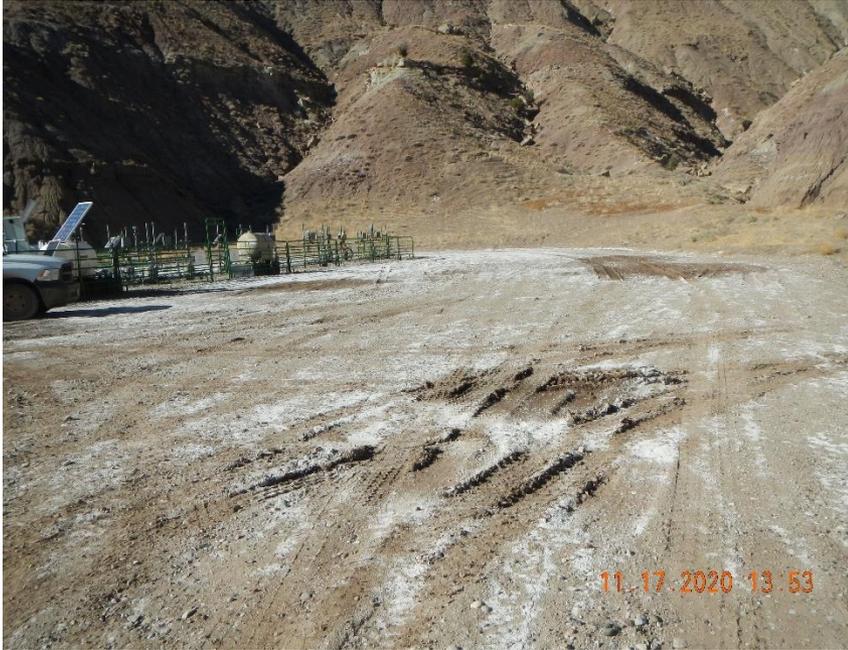
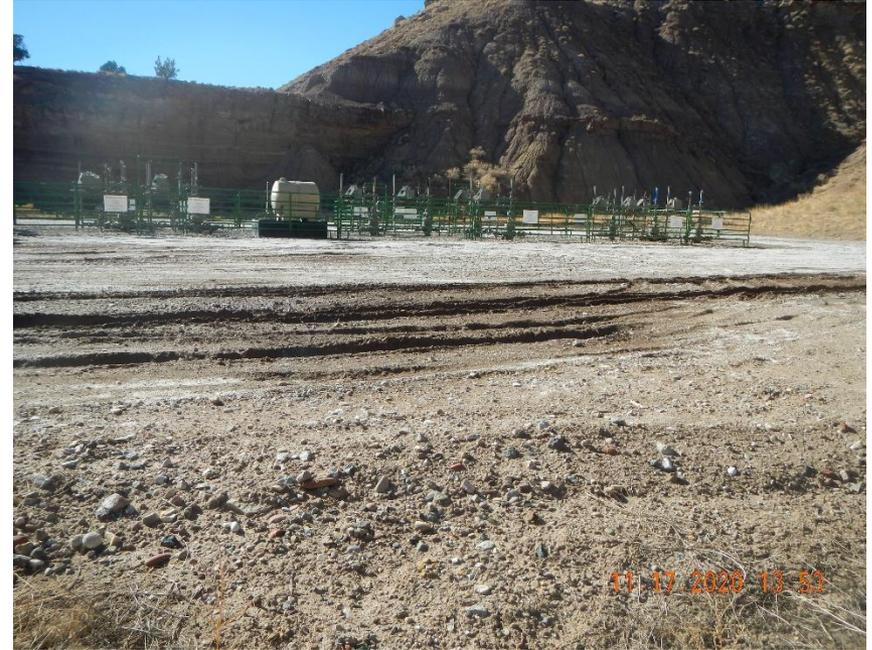
**Soft compacted pad is wet and rutting.**

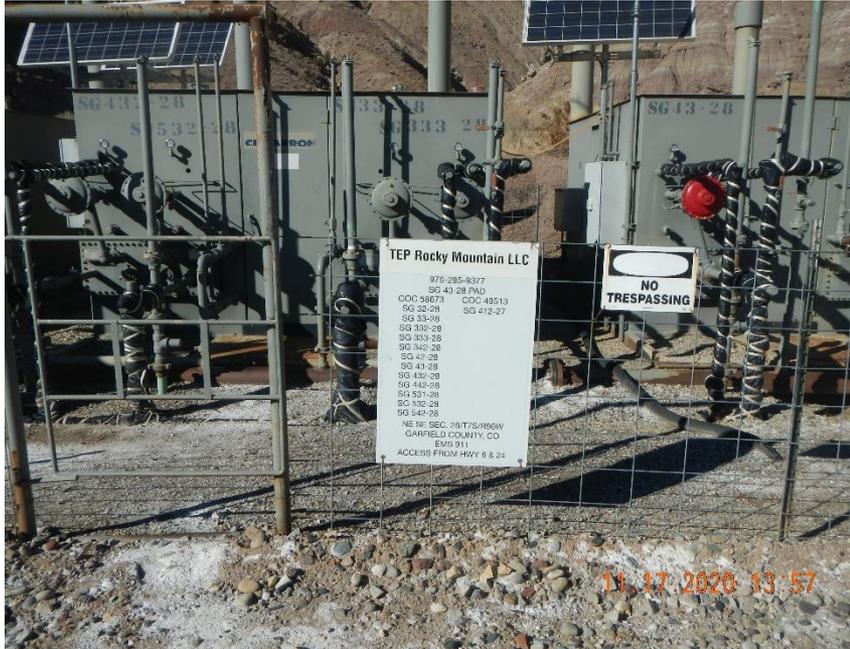
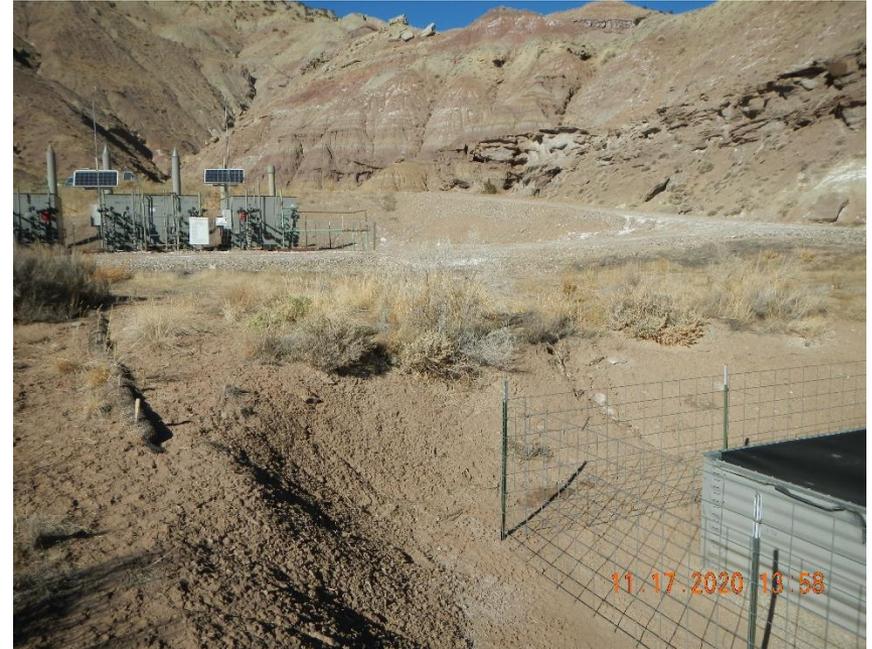
**Riling of soft cut slope around tank battery.**

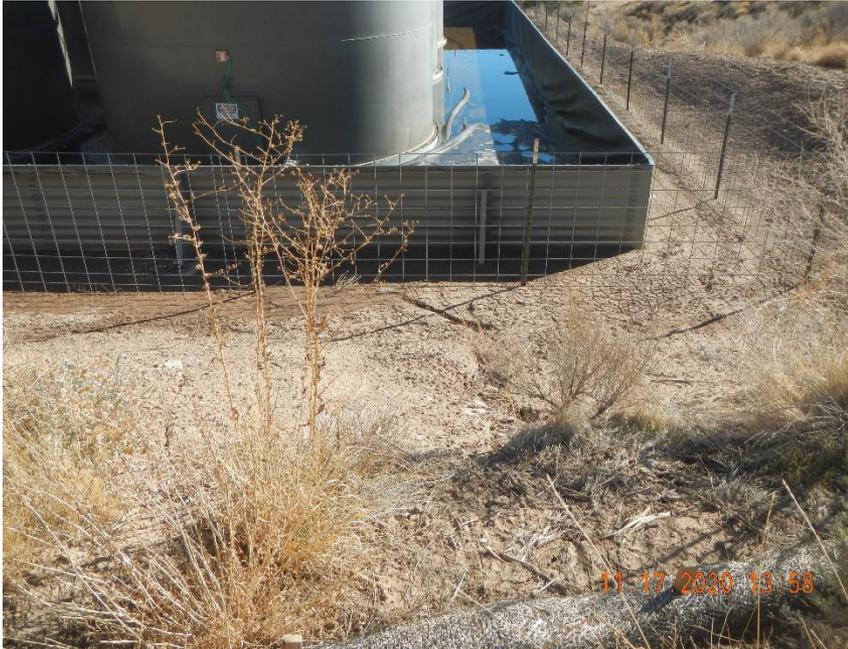
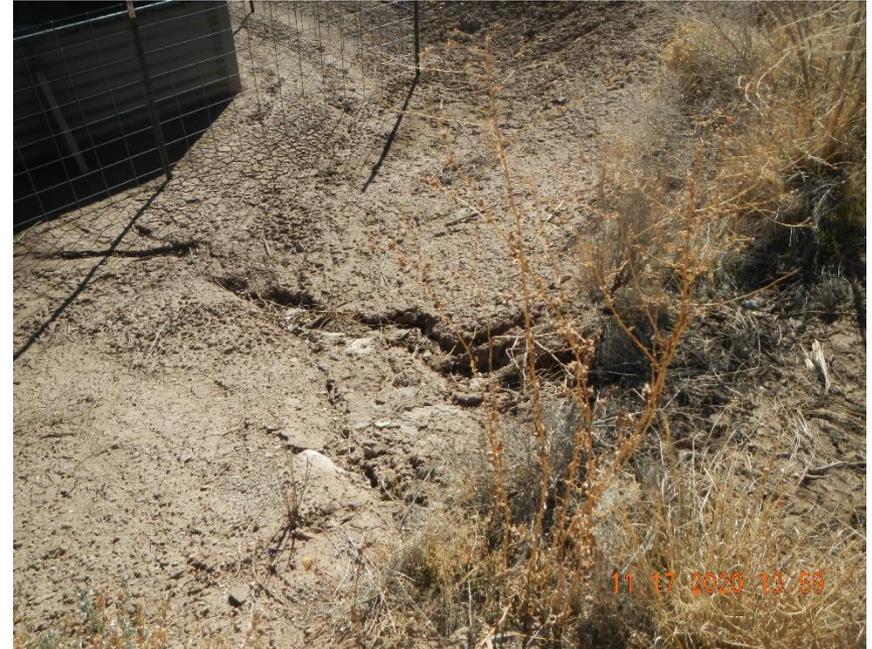
**Rill of soft cut slope around tank battery.**

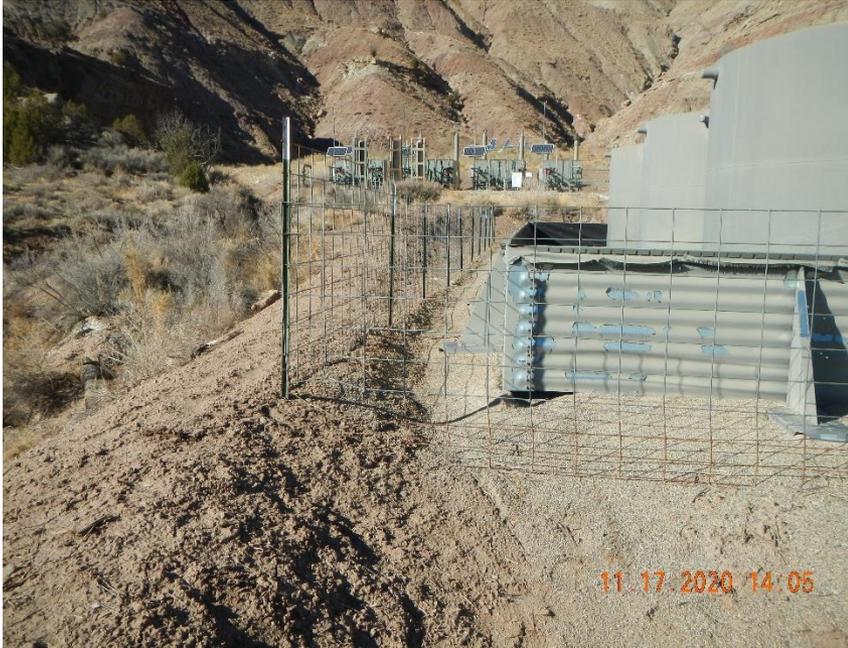
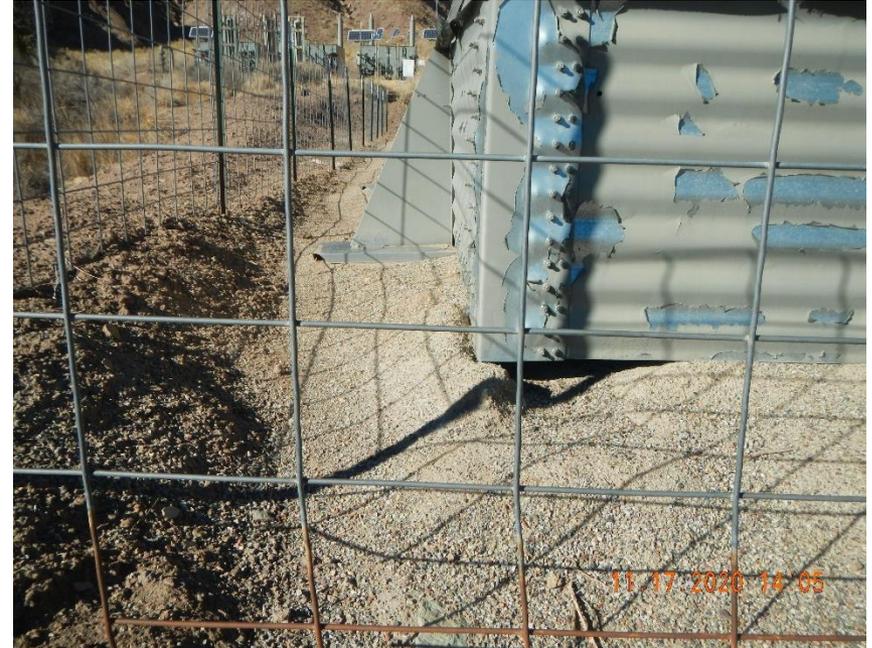
**Movement of storm water is washing away base under tank battery berm.**

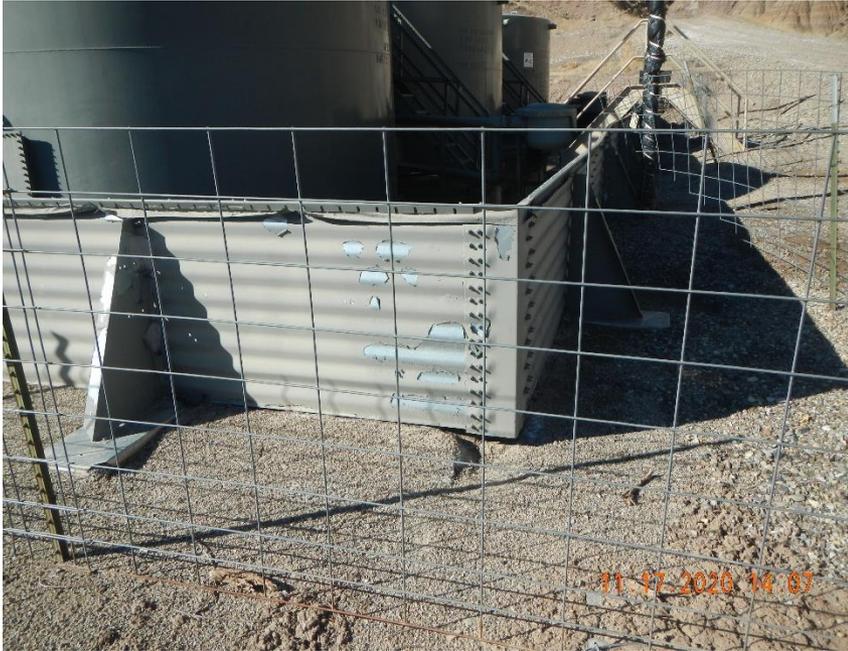
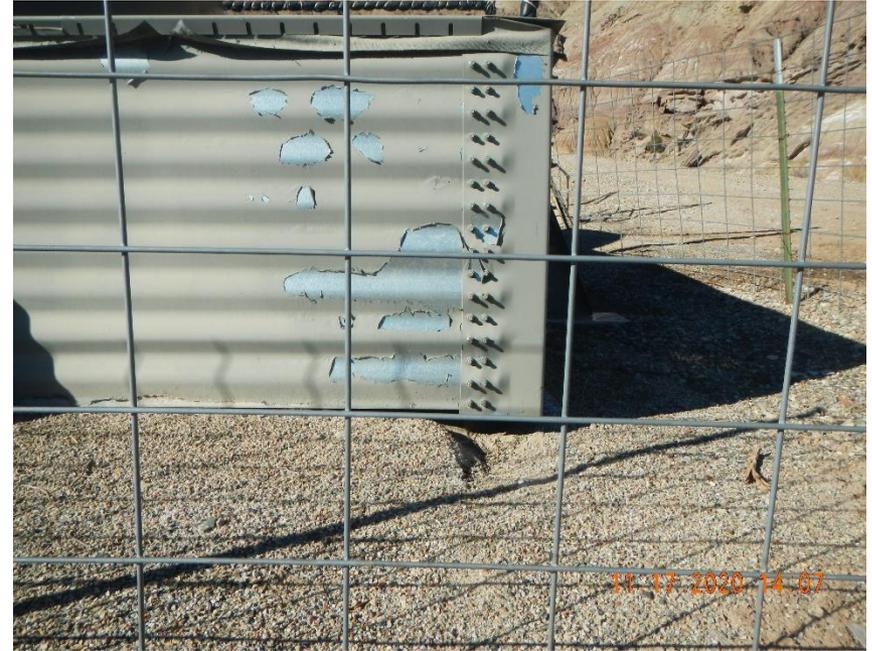
**Movement of storm water is washing away  
base under tank battery berm.**

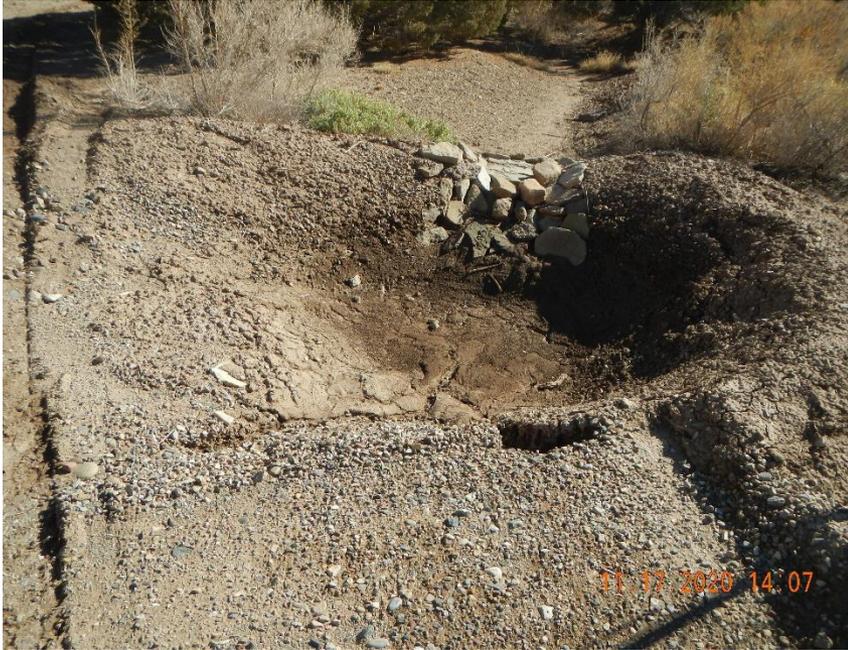
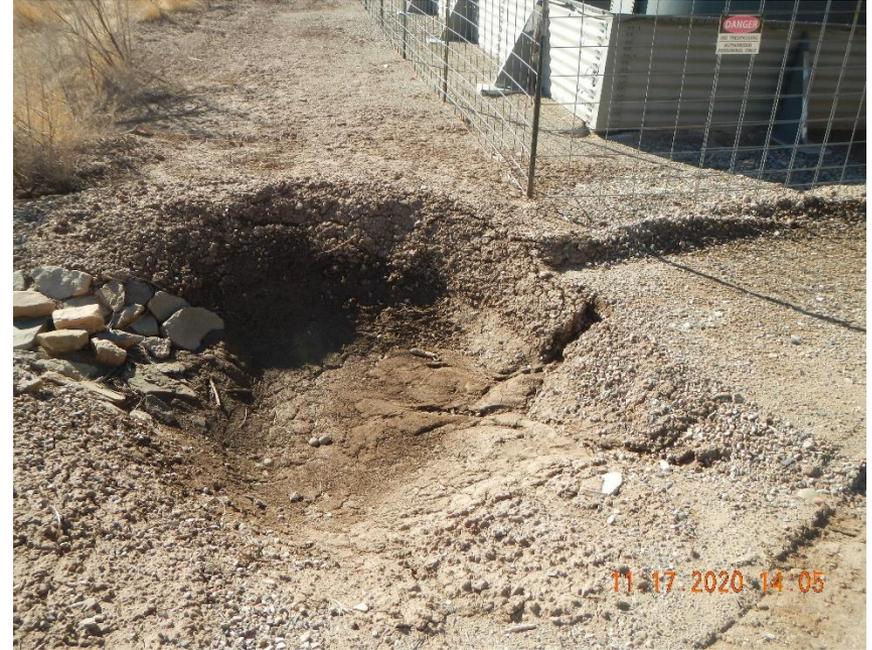
**Soft compacted check dam is riling.**

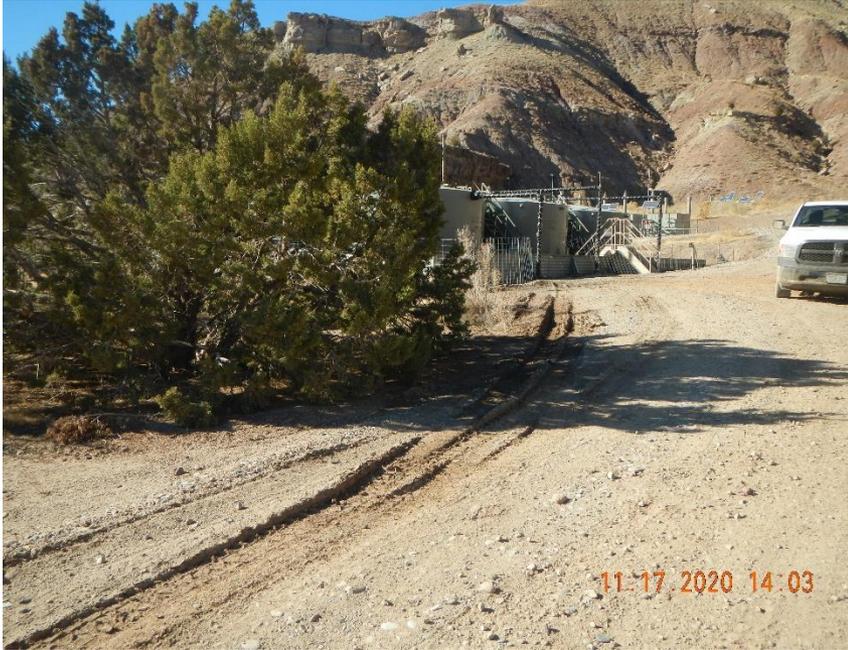
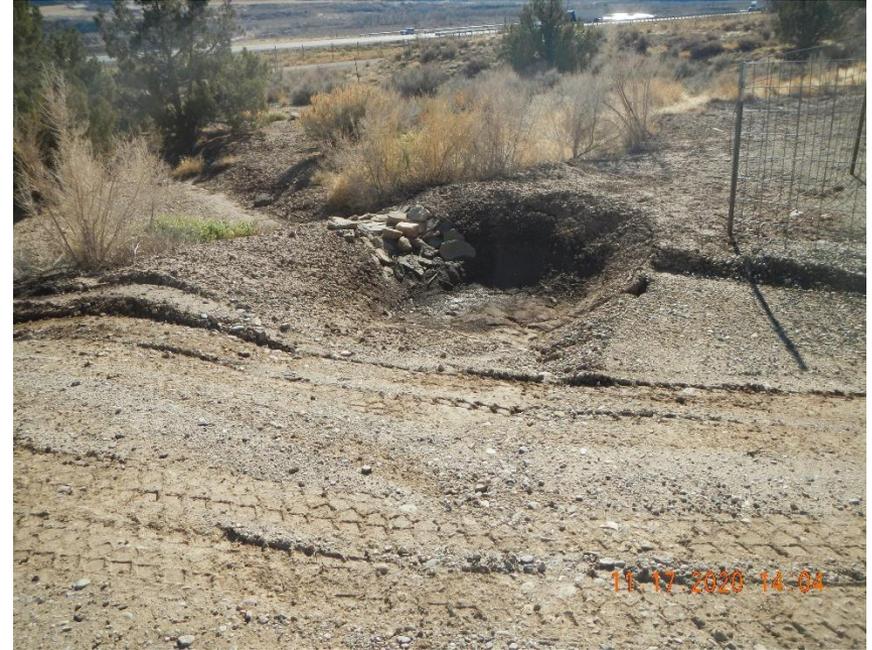
**Wheel ruts starting from check dam at tank battery.**
