Inspection Photos

API: 043-05088

Operator: JAVERNICK OIL

Inspection Date: 11/17/2020

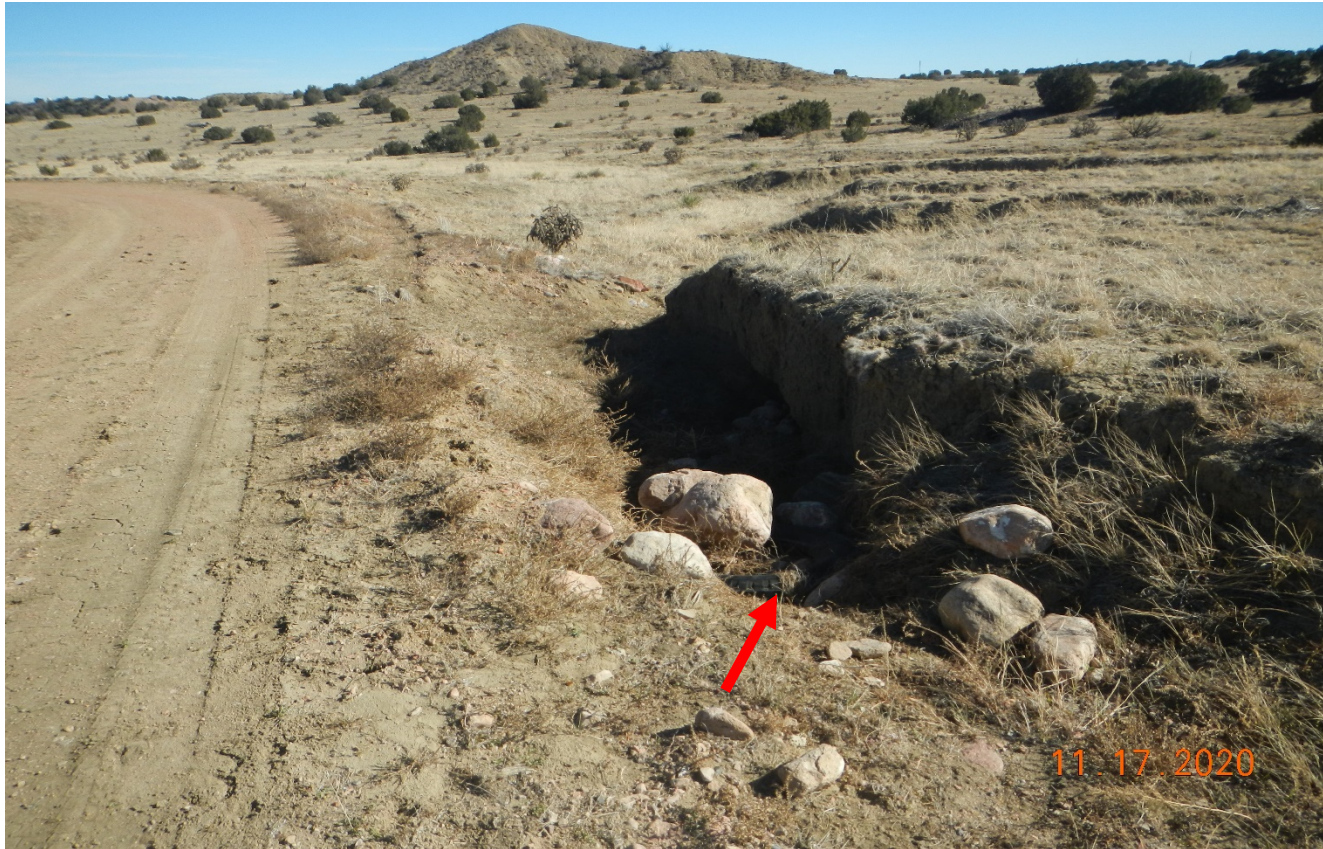
Photo 1. Facing east along the access road. The gully erosion along the road has not been repaired and stabilized. There is a tire placed in gully shown at red arrow which needs to be removed. A few rocks scattered in the gully is insufficient.

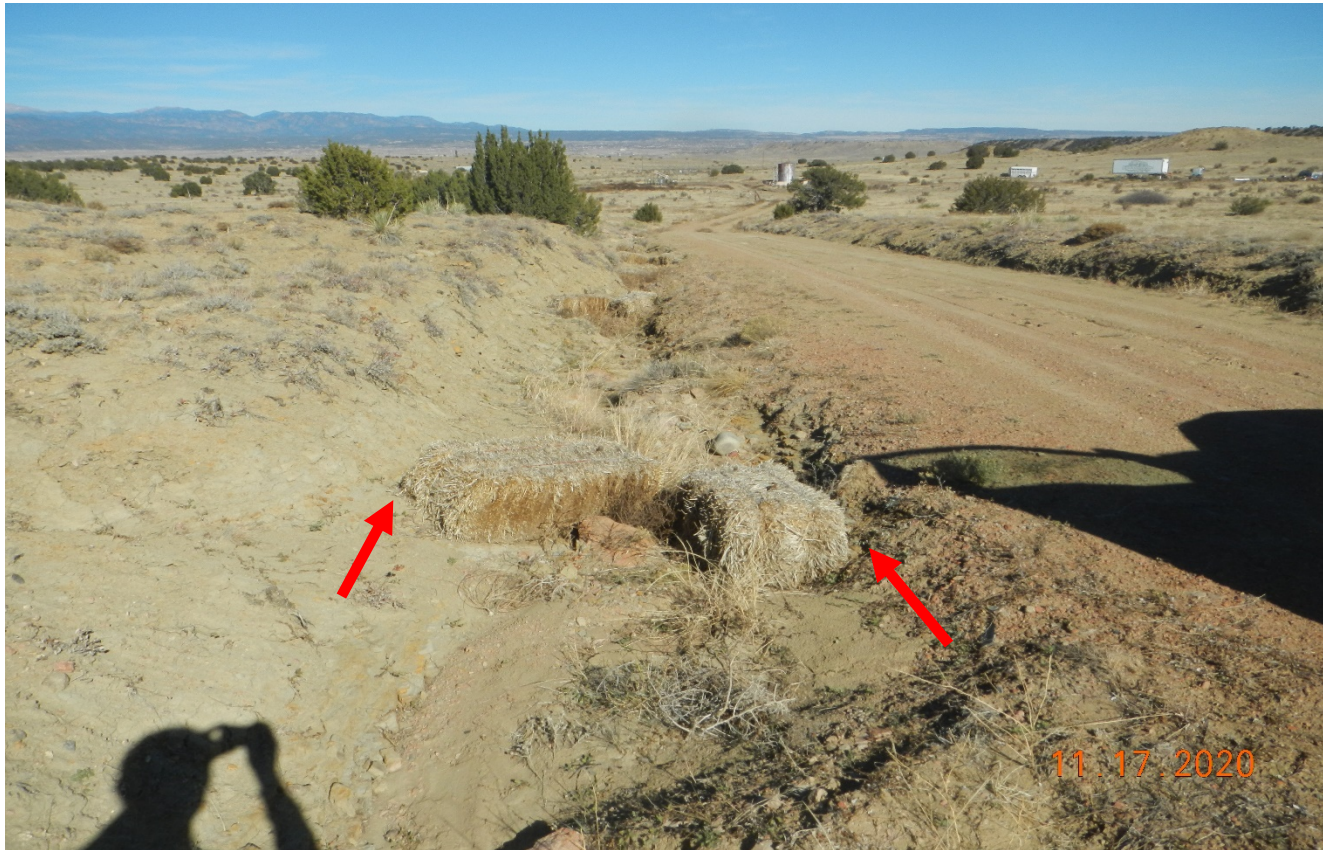
Photo 2. Facing northeast along the access road where erosion is occurring along the road. There are straw bales that are placed along the side of the road which are insufficient. Stormwater can flow around the bales show at red arrows.

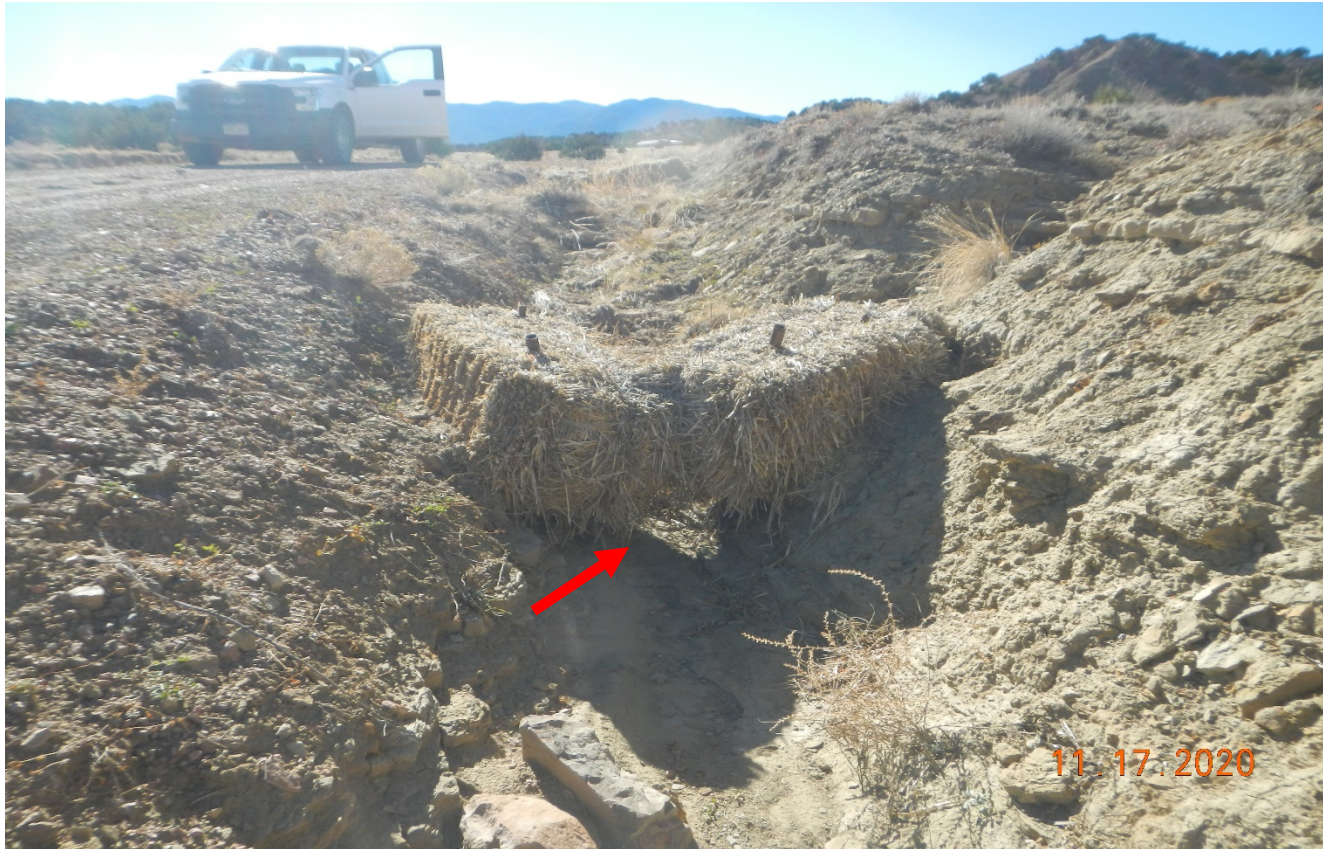
Photo 3. The bales are not installed correctly and stormwater is causing erosion underneath the bales which essentially is not working.

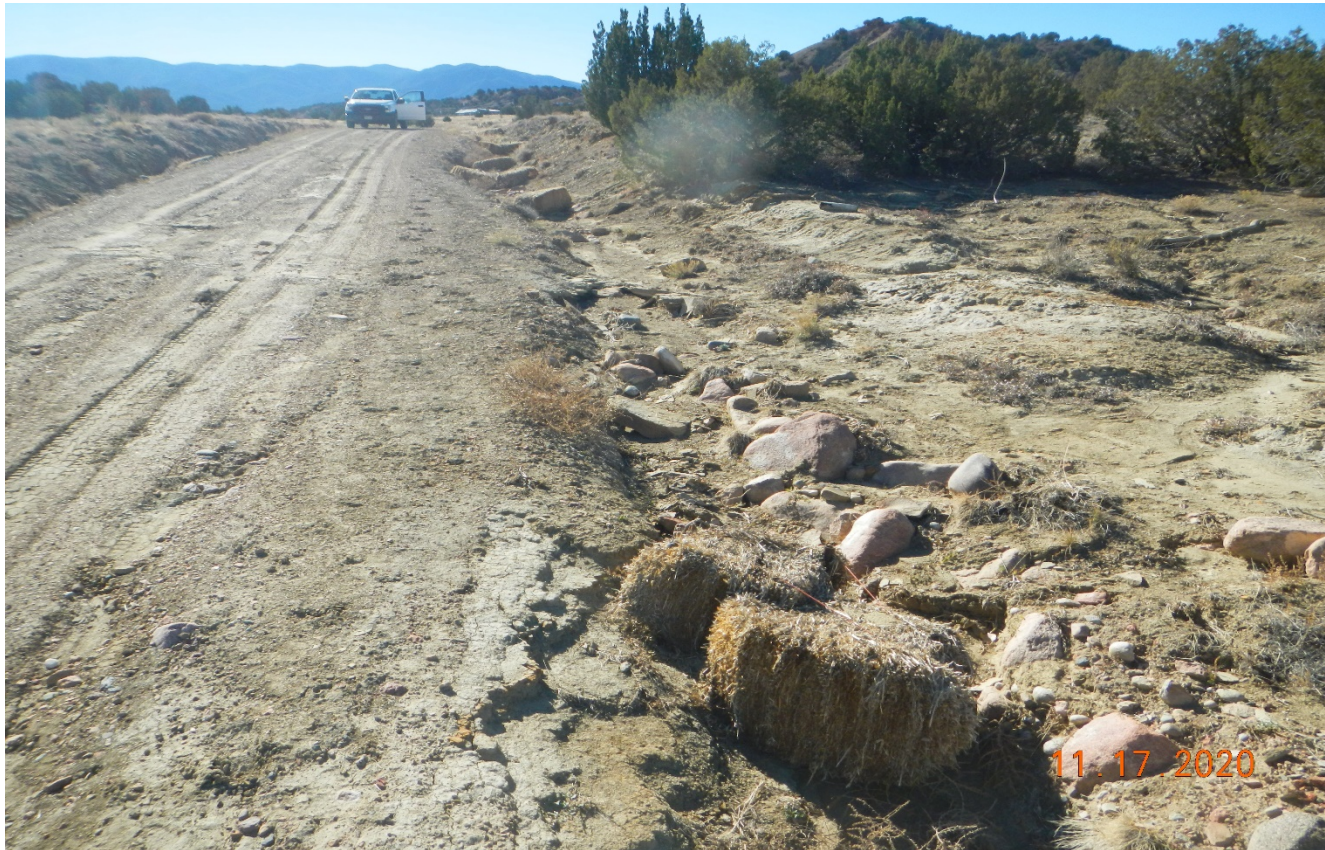
Photo 4. Facing southwest along the road. This straw bales is displaced. Stormwater erosion is not controlled along the roadside.

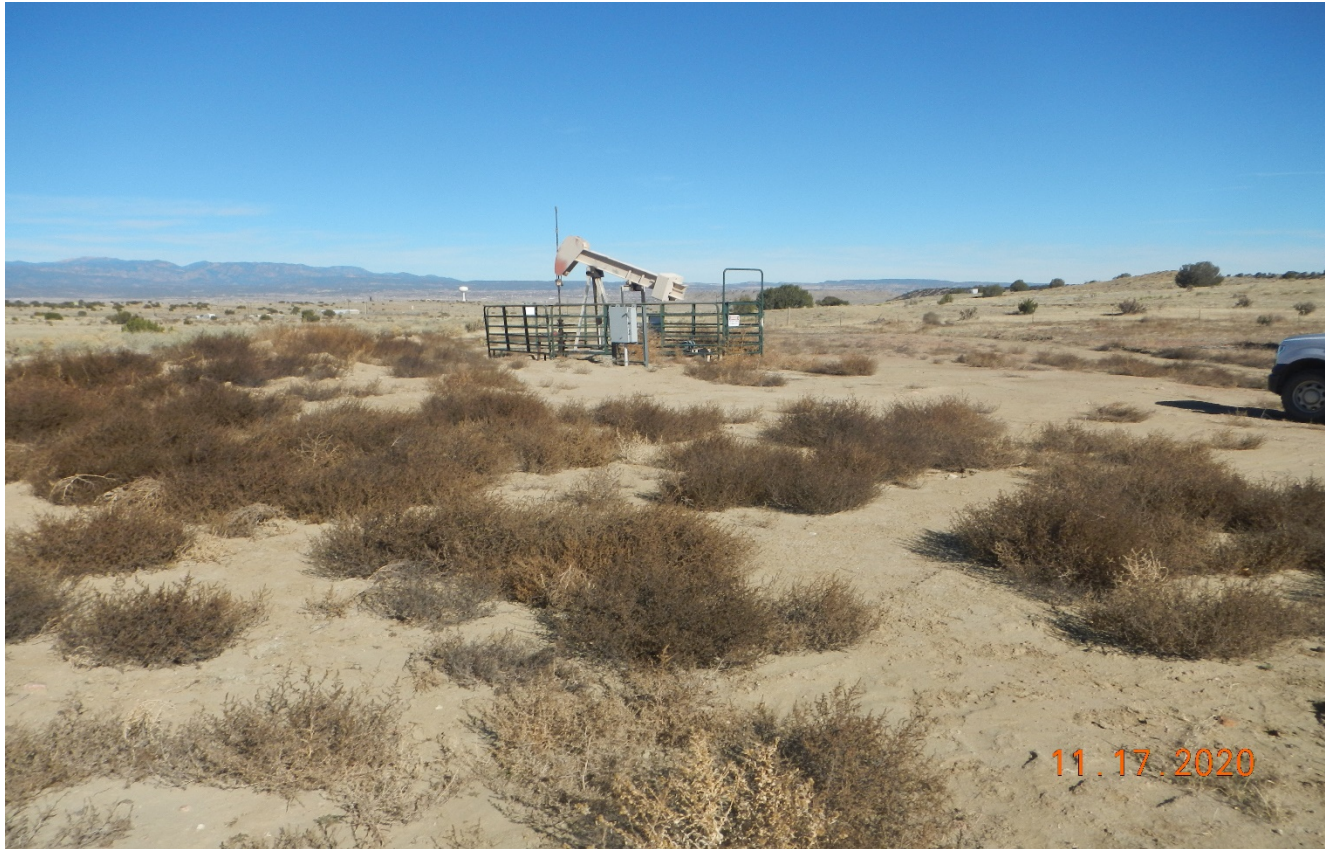
Photo 5. Facing north toward the well. This area needs to be reclaimed. There are undesirable weeds that need to be controlled.

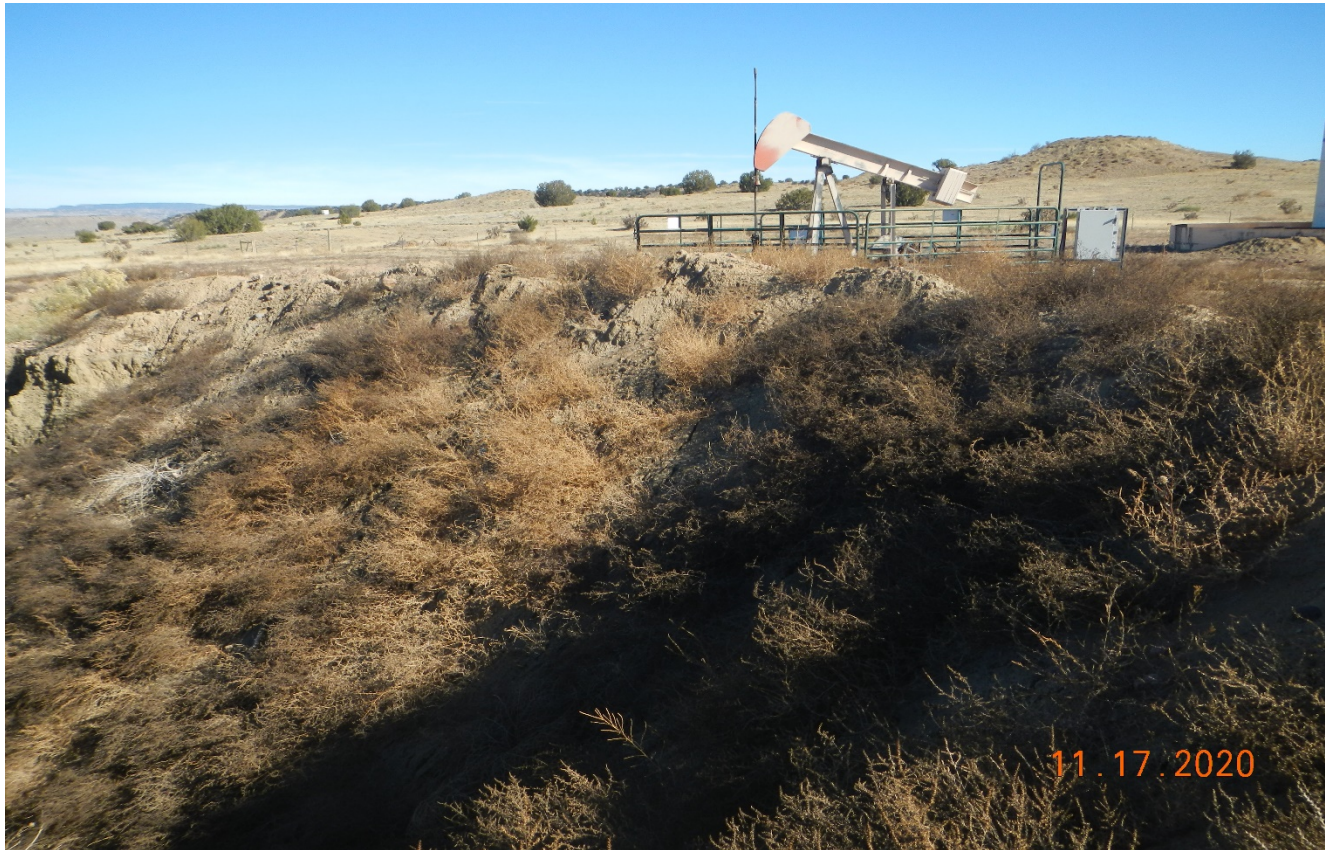
Photo 6. Facing northwest toward the embankment near the well. This area has not been stabilized and is covered with weeds (Russian thistle).

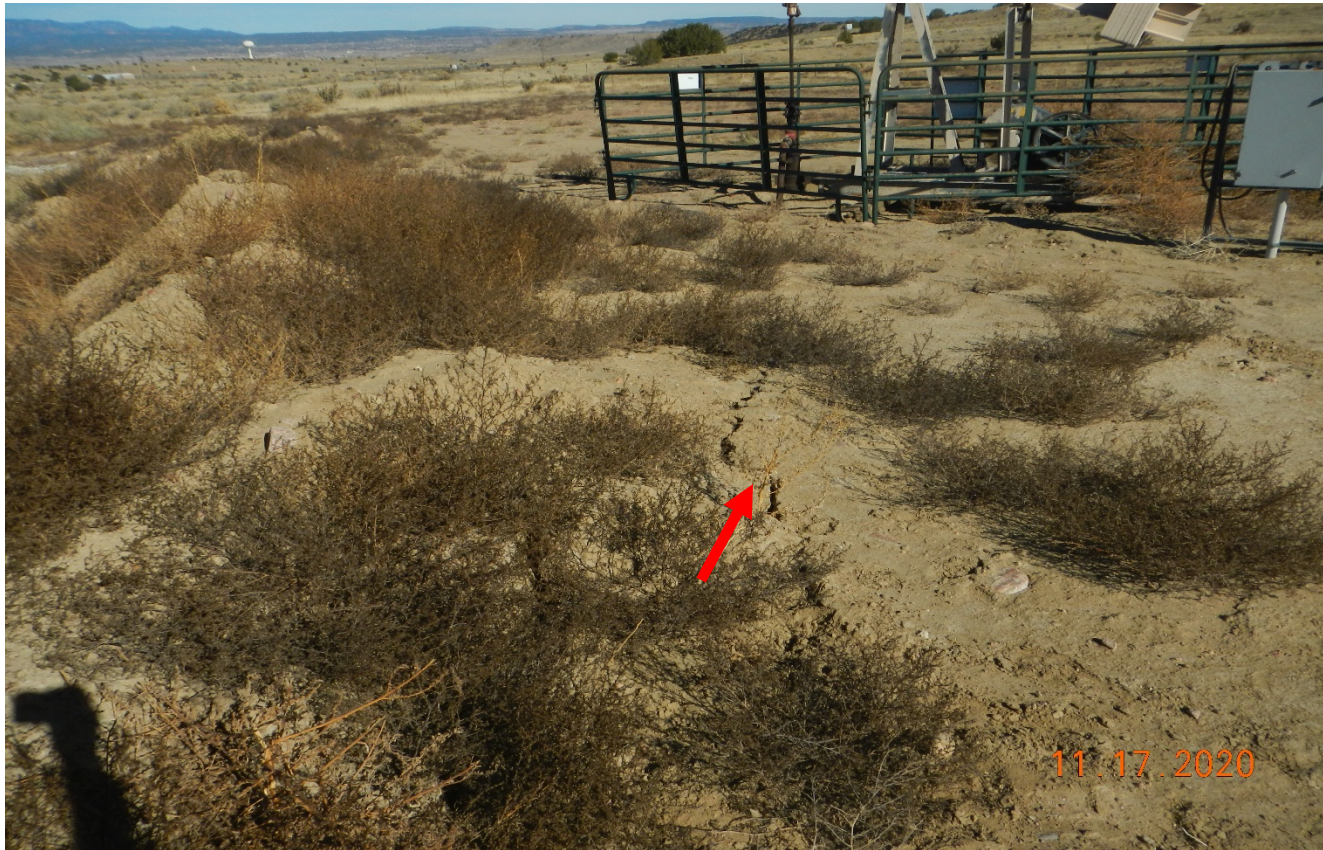
Photo 7. This crack in the soil surface near the well is an indication of potential soil sloughing. This area needs to be stabilized.

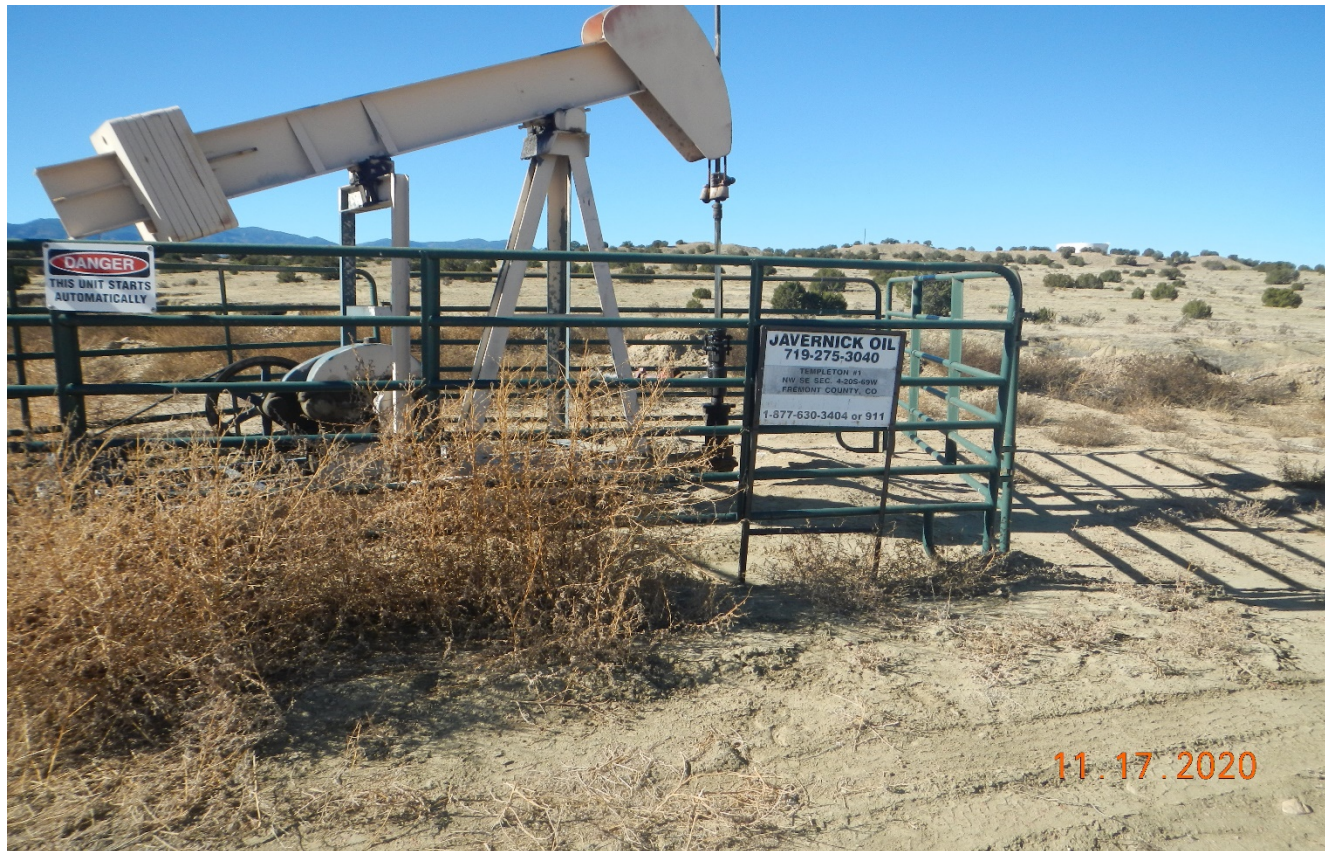
Photo 6. The well sign is posted at pumpjack.
