Inspection Photos

Operator: BP America
API: 067-08352
Date: 11/17/2020

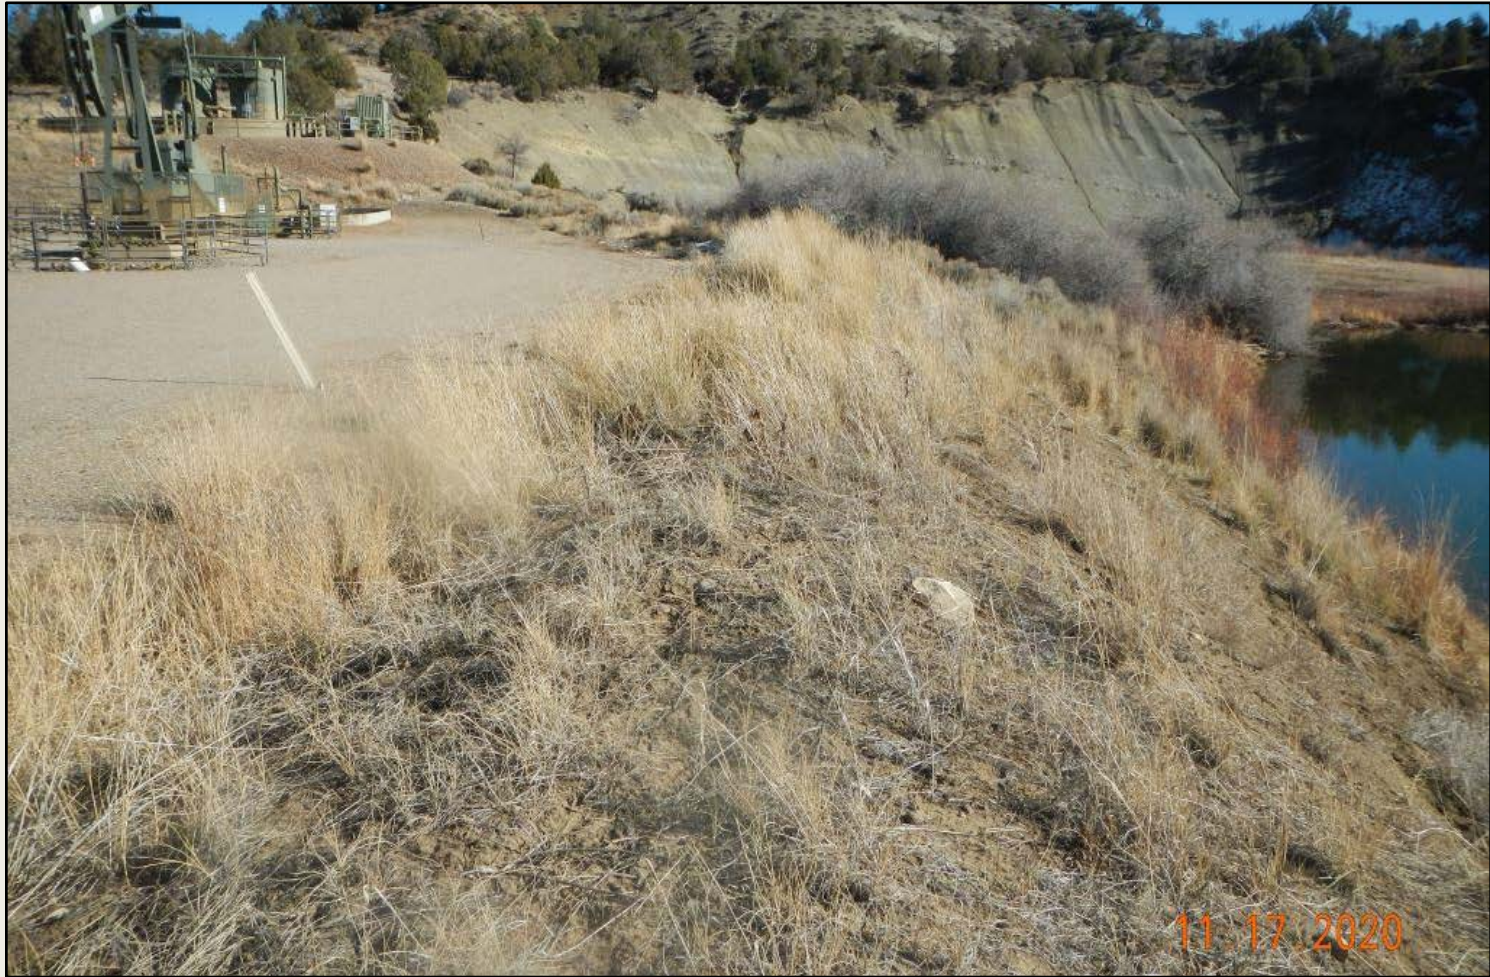
Photo 2. View of the southern fill slope from the southwestern corner facing eastward. Revegetation is progressing within the project area with thickspike wheatgrass, crested wheatgrass, rubber rabbitbrush, and smooth brome.

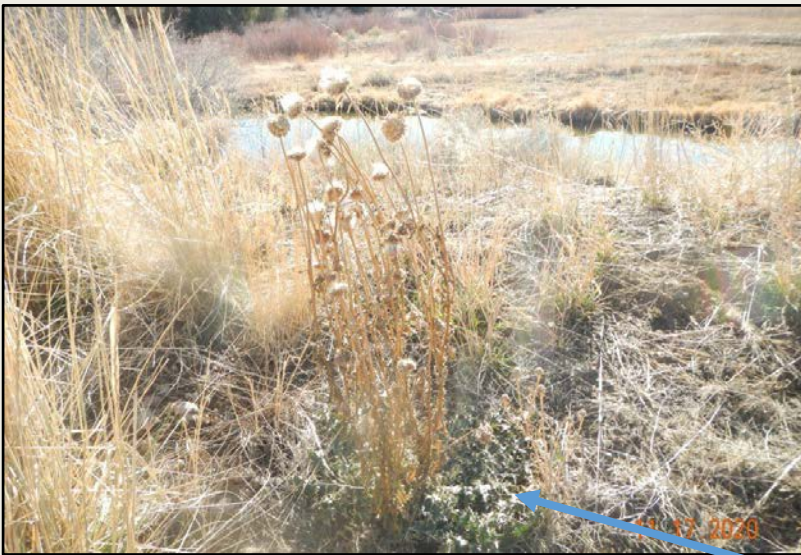
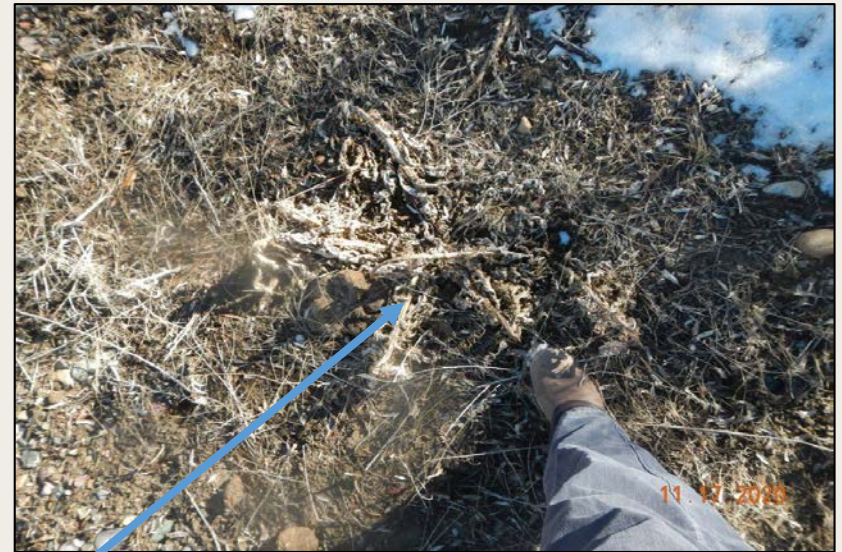
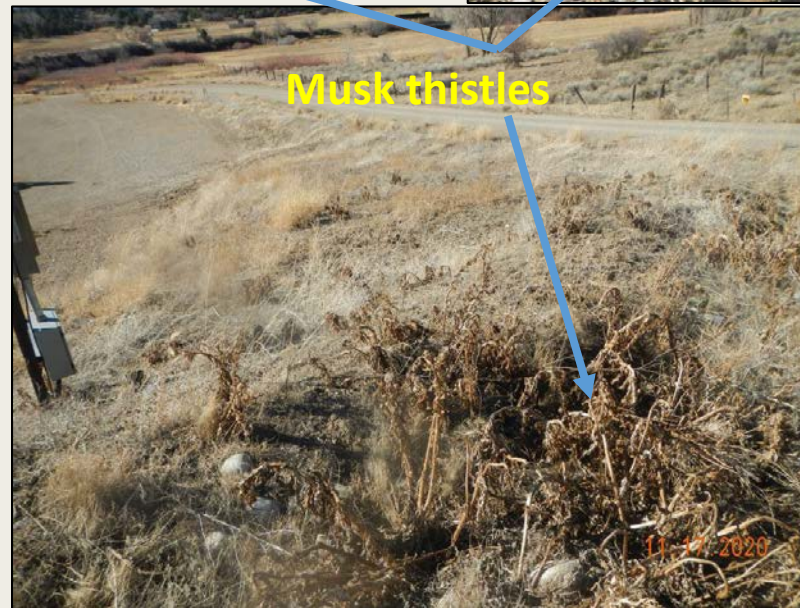
Photos 3-5. View of musk thistles within the project area, appear to be partially treated. Surviving individuals remain. Evidence of significant infestation remains.
