Inspection Photos
Operator: BP America
API: 067-09267
Date: 11/17/2020

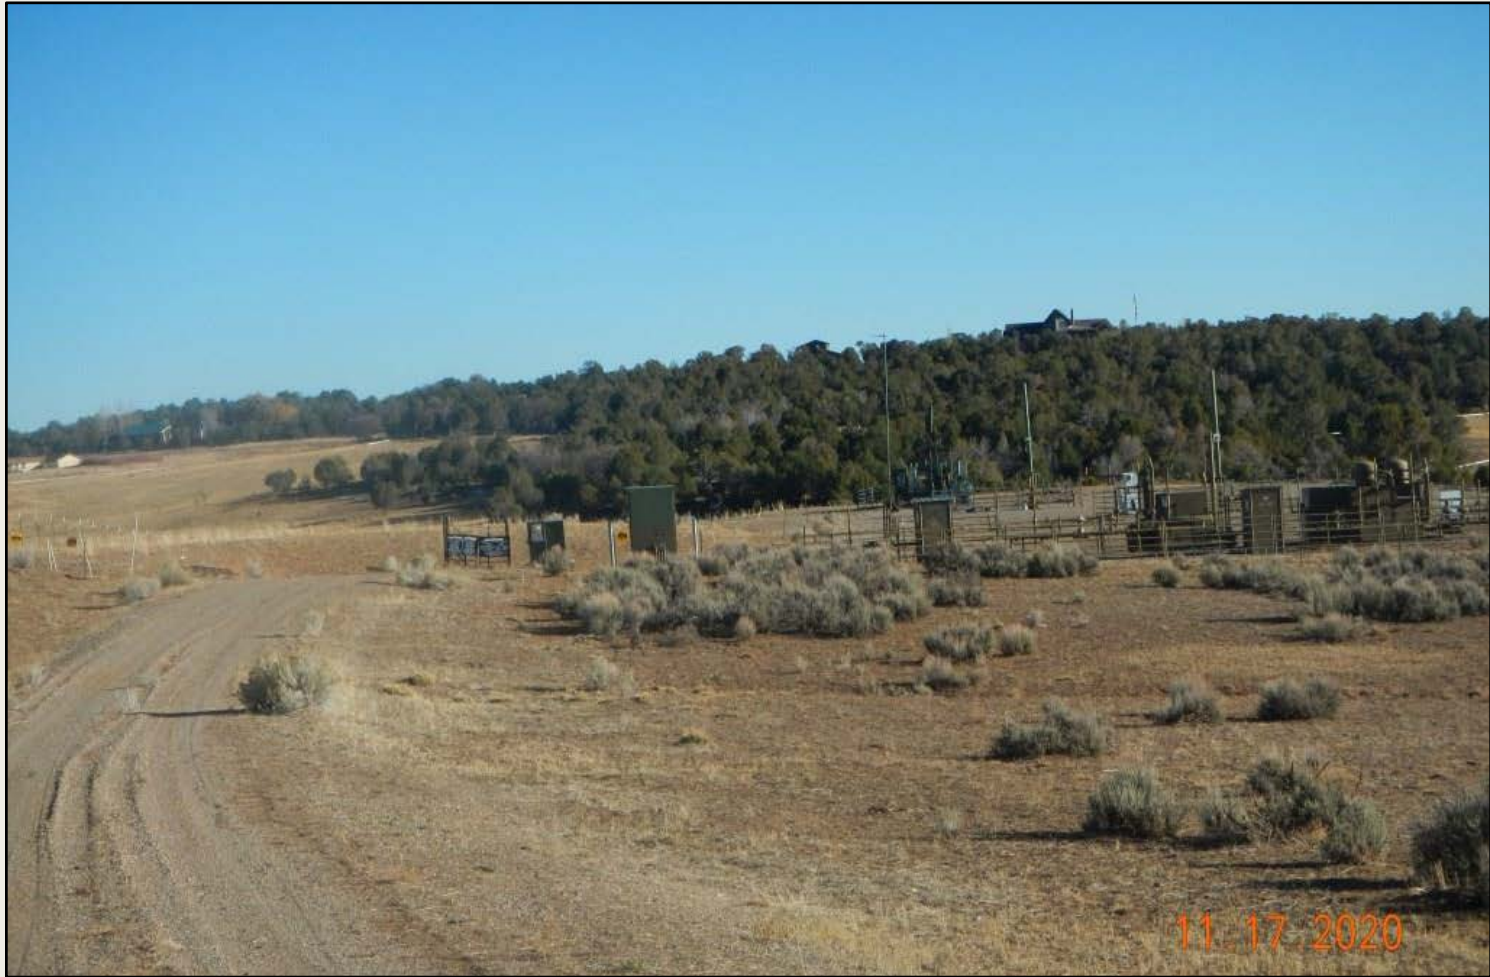
Photo 1. View of the project area from the access entrance facing center.

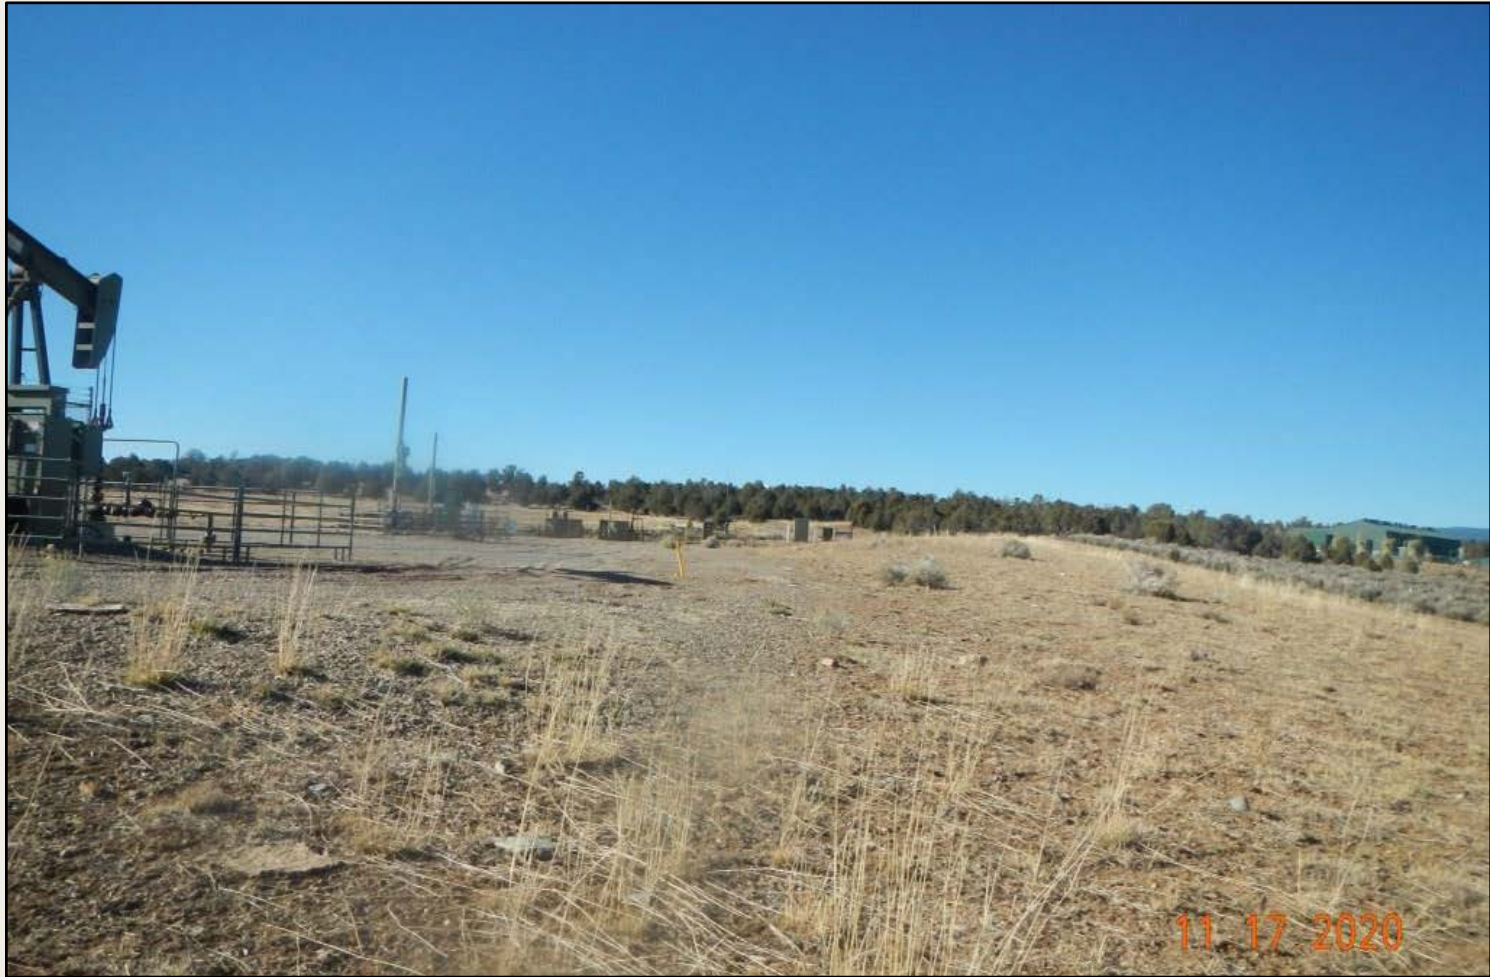
Photo 2. View of the northern project area from the northeastern corner facing westward. Revegetation is progressing with grasses, largely in a grazed condition, with crested wheatgrass and intermediate wheatgrass.

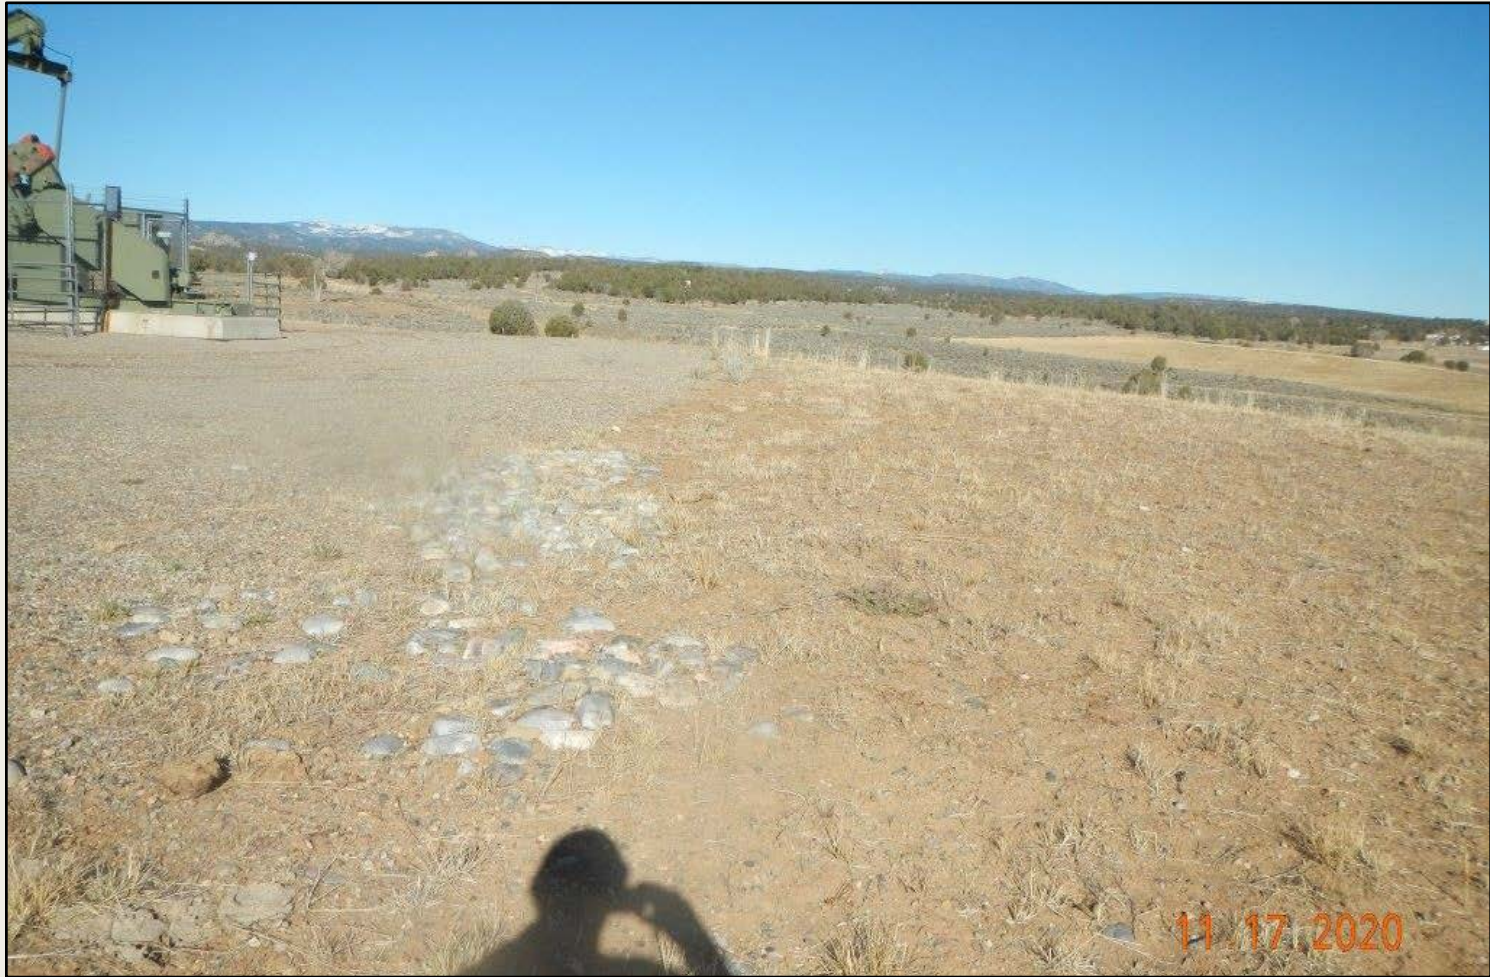
Photo 3. View of the eastern project area from the southeastern corner facing northward.

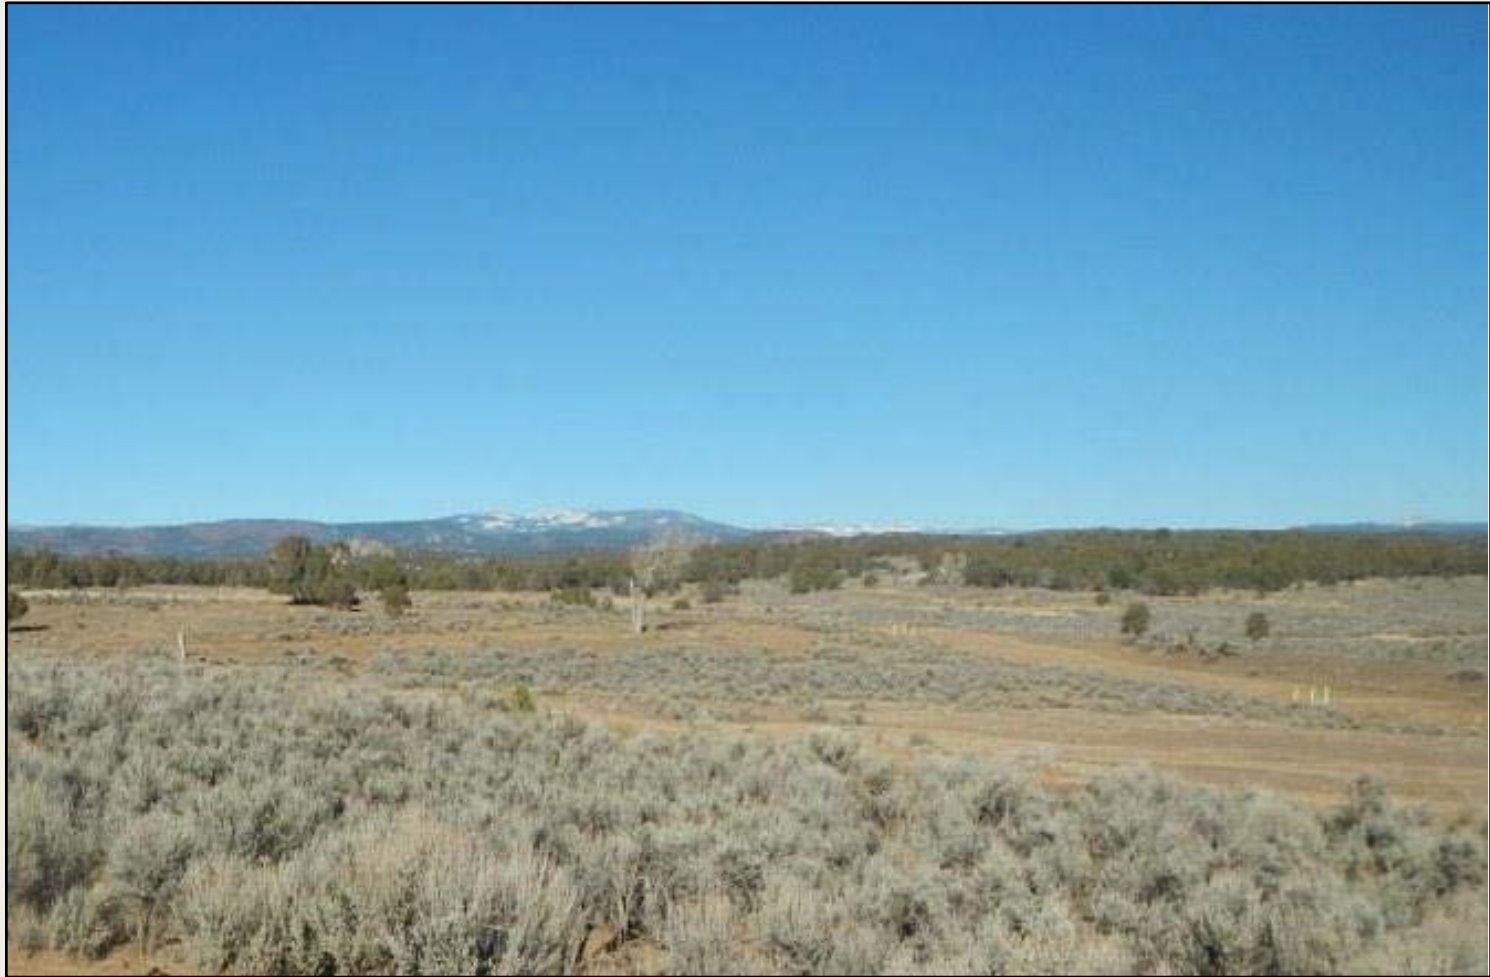
Photo 4. View of reference area comprised of sagebrush shrubland with scattered pinyon and juniper trees and understory of western wheatgrass, prickly pear, and blue grama.

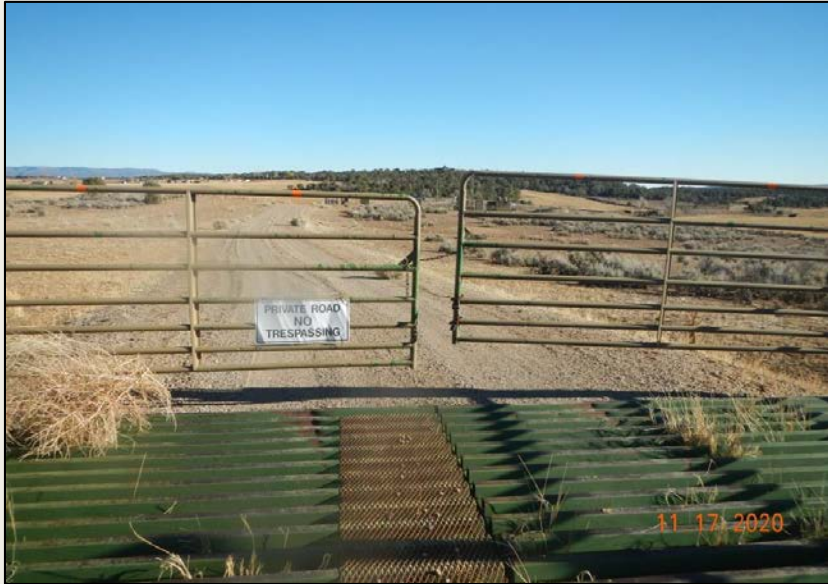
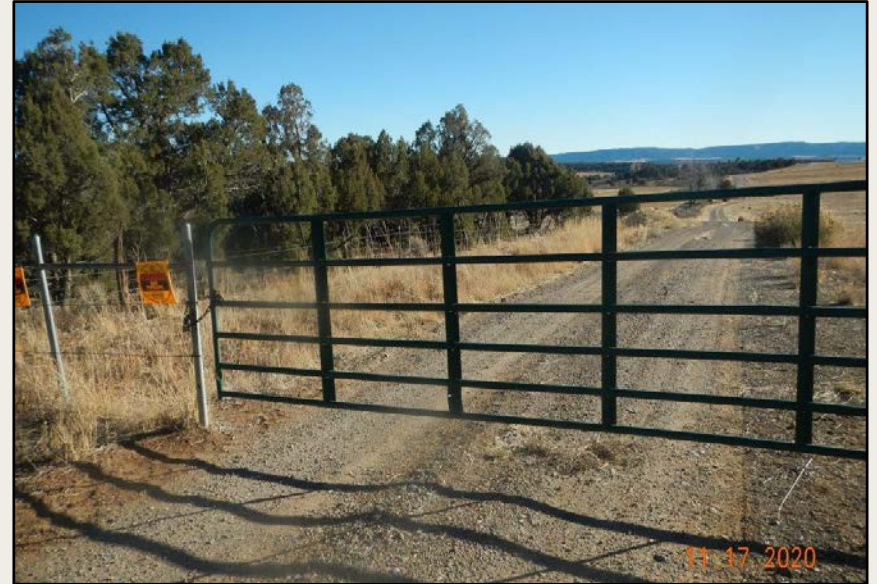
Photos 4/5. View of closed gates (2) after leaving location.
