Inspection Photos
Operator: BP America
API: 067-08346
Date: 11/17/2020

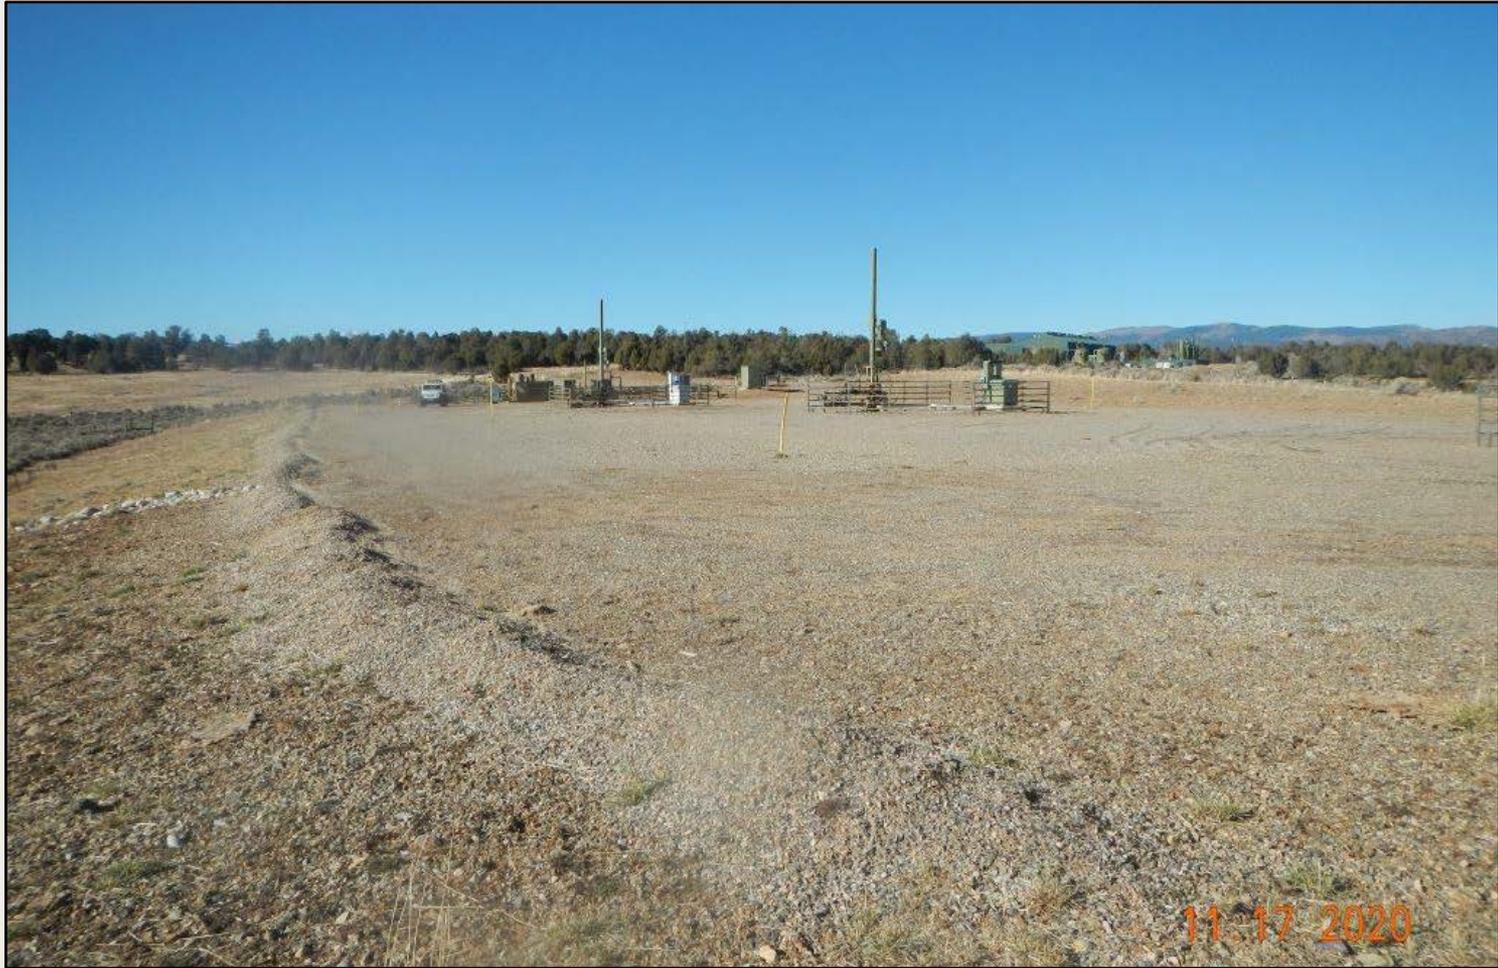
Photo 1. View of the project area from the southeastern corner facing center.

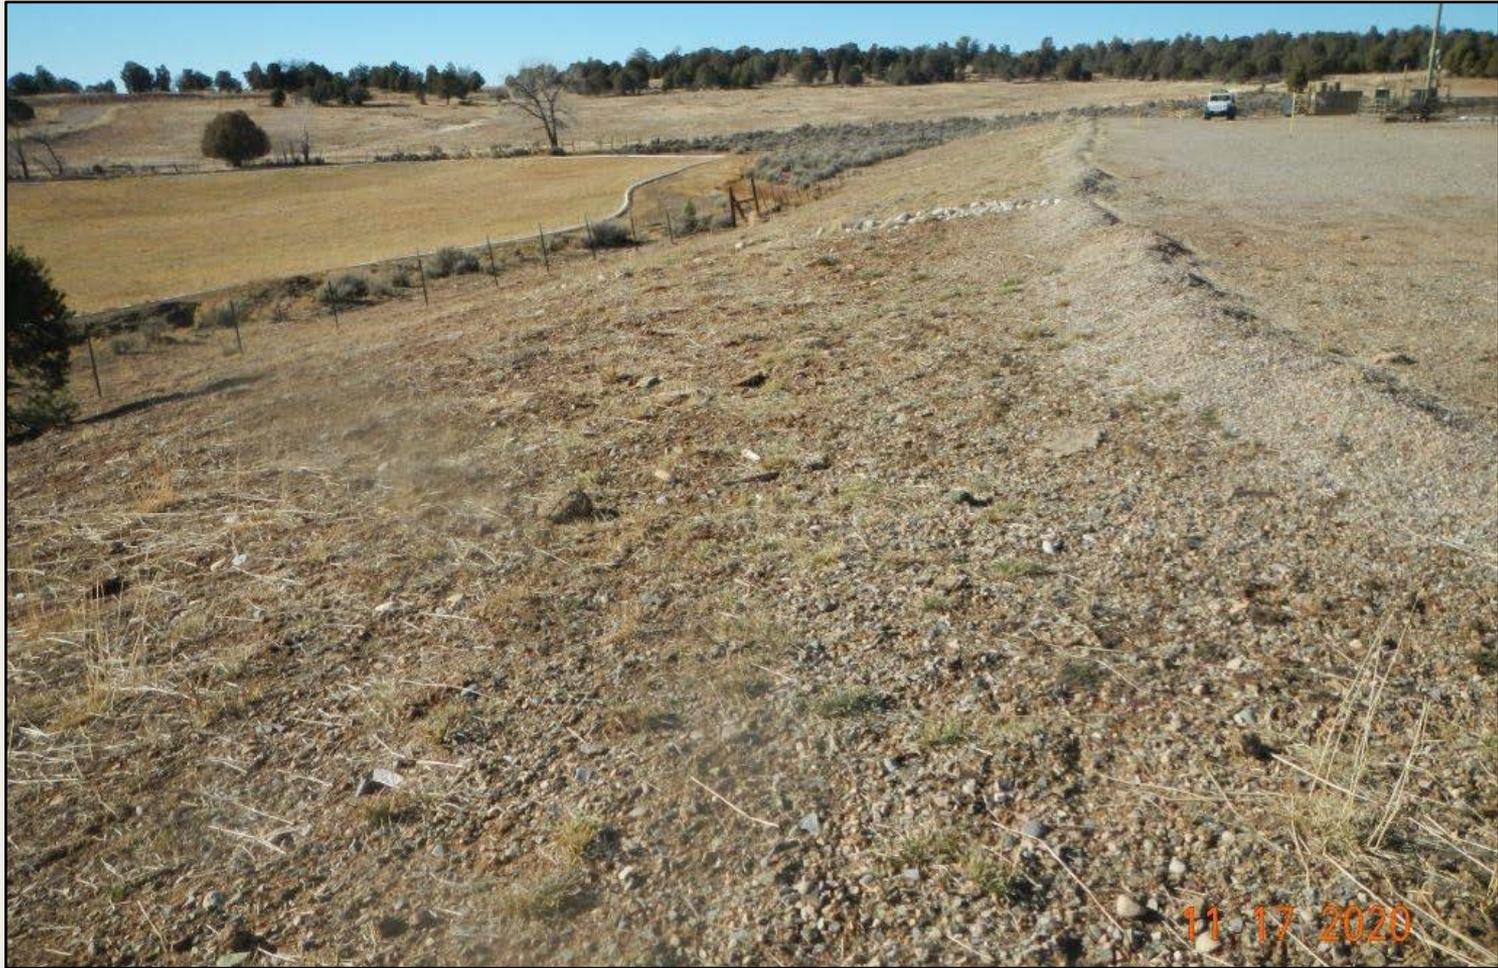
Photo 2. View of the southern fill slope from the southeastern corner facing westward. Revegetation is progressing with grasses, largely in a grazed condition, with crested wheatgrass and intermediate wheatgrass.

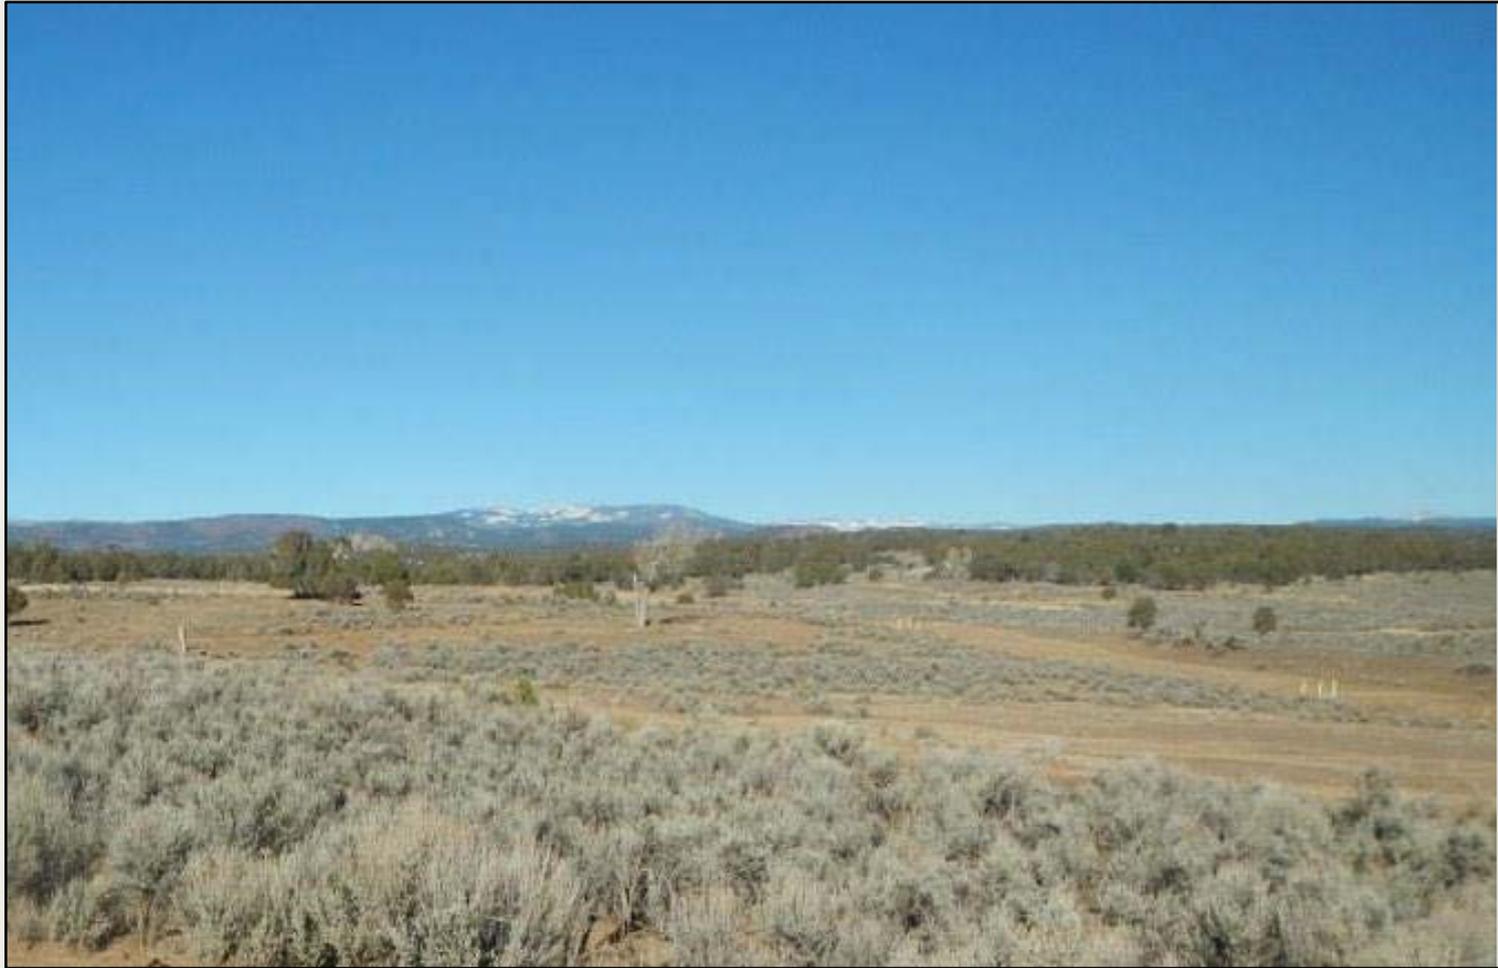
Photo 3. View of reference area comprised of sagebrush shrubland with scattered pinyon and juniper trees and understory of western wheatgrass, prickly pear, and blue grama.

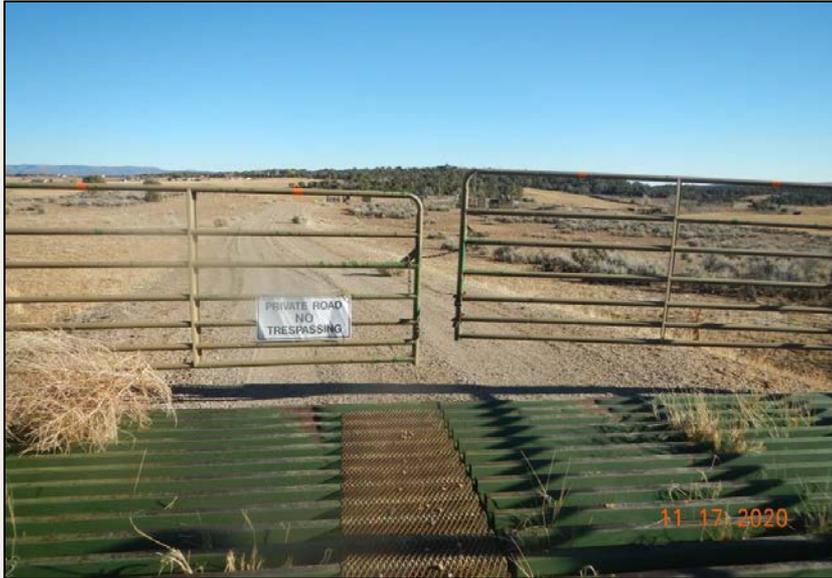
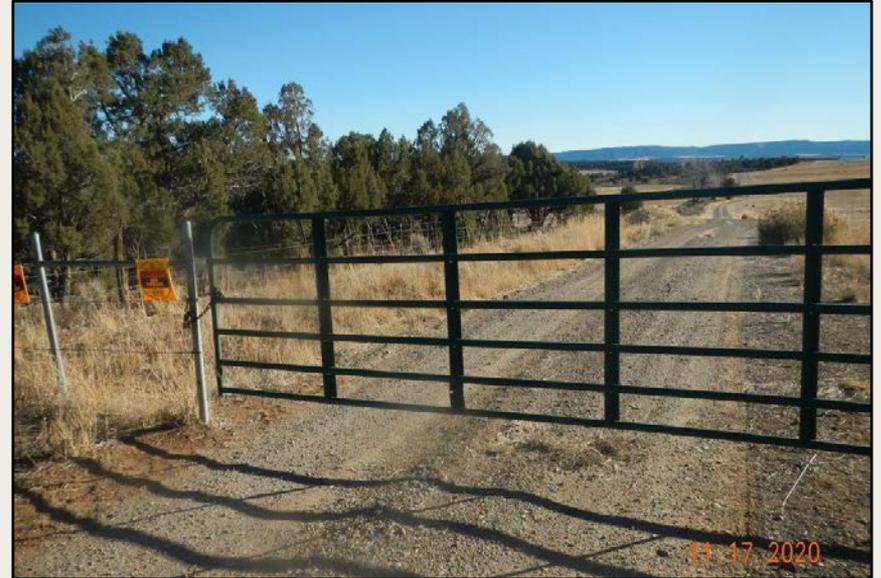
Photos 4/5. View of closed gates (2) after leaving location.
