Inspection Photos
Operator: BP America
API: 067-08347
Date: 11/17/2020

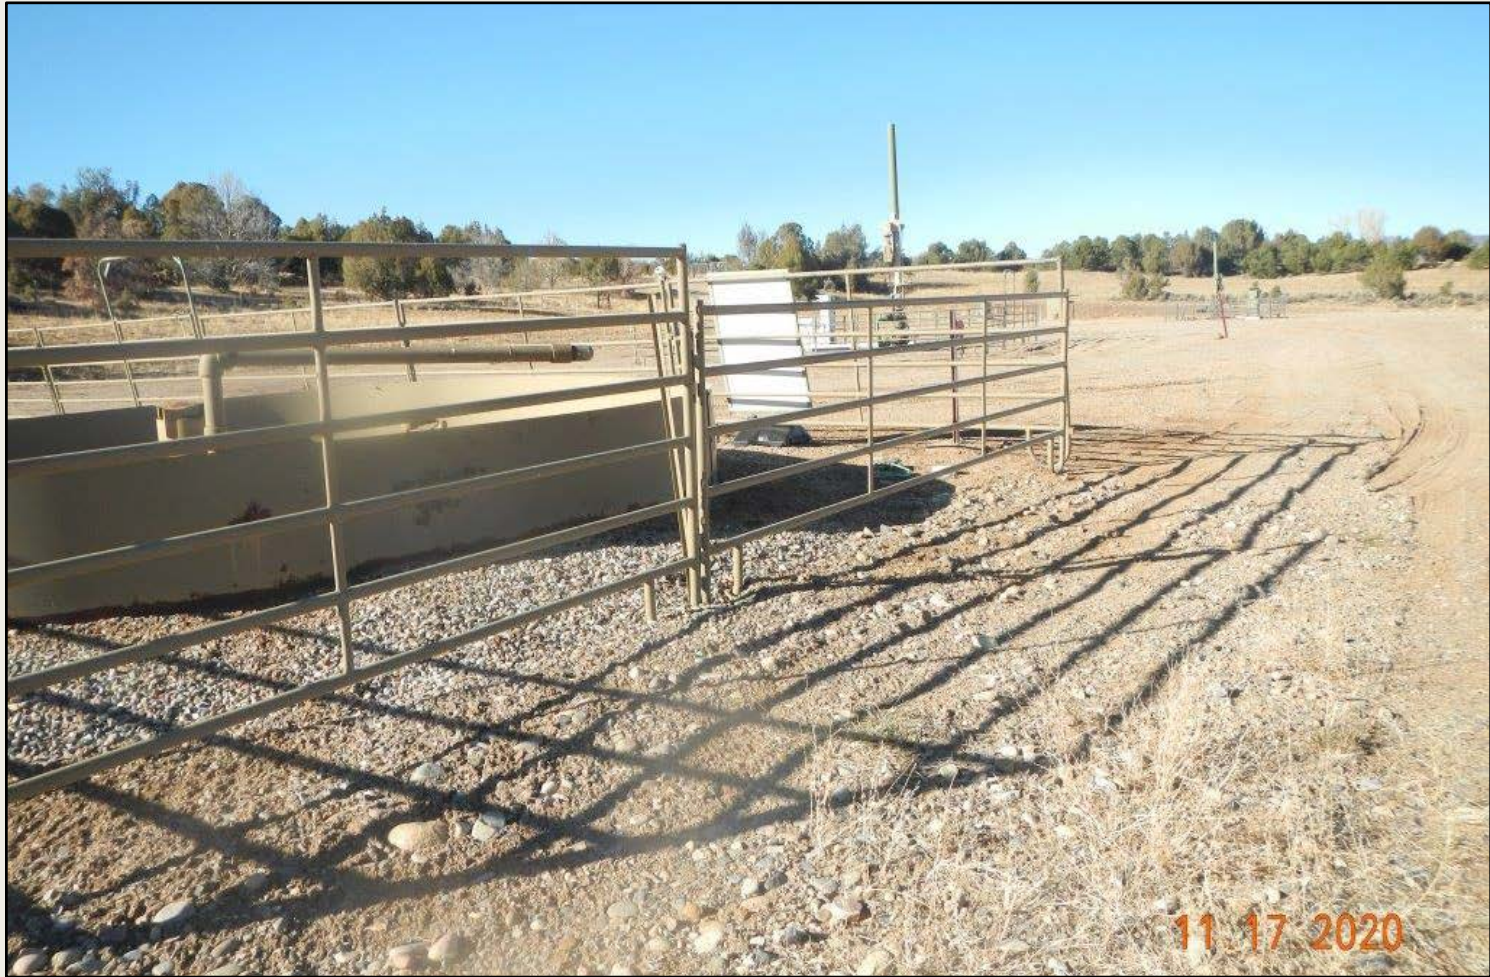
Photo 1. View of the project area from the southeastern corner facing center.

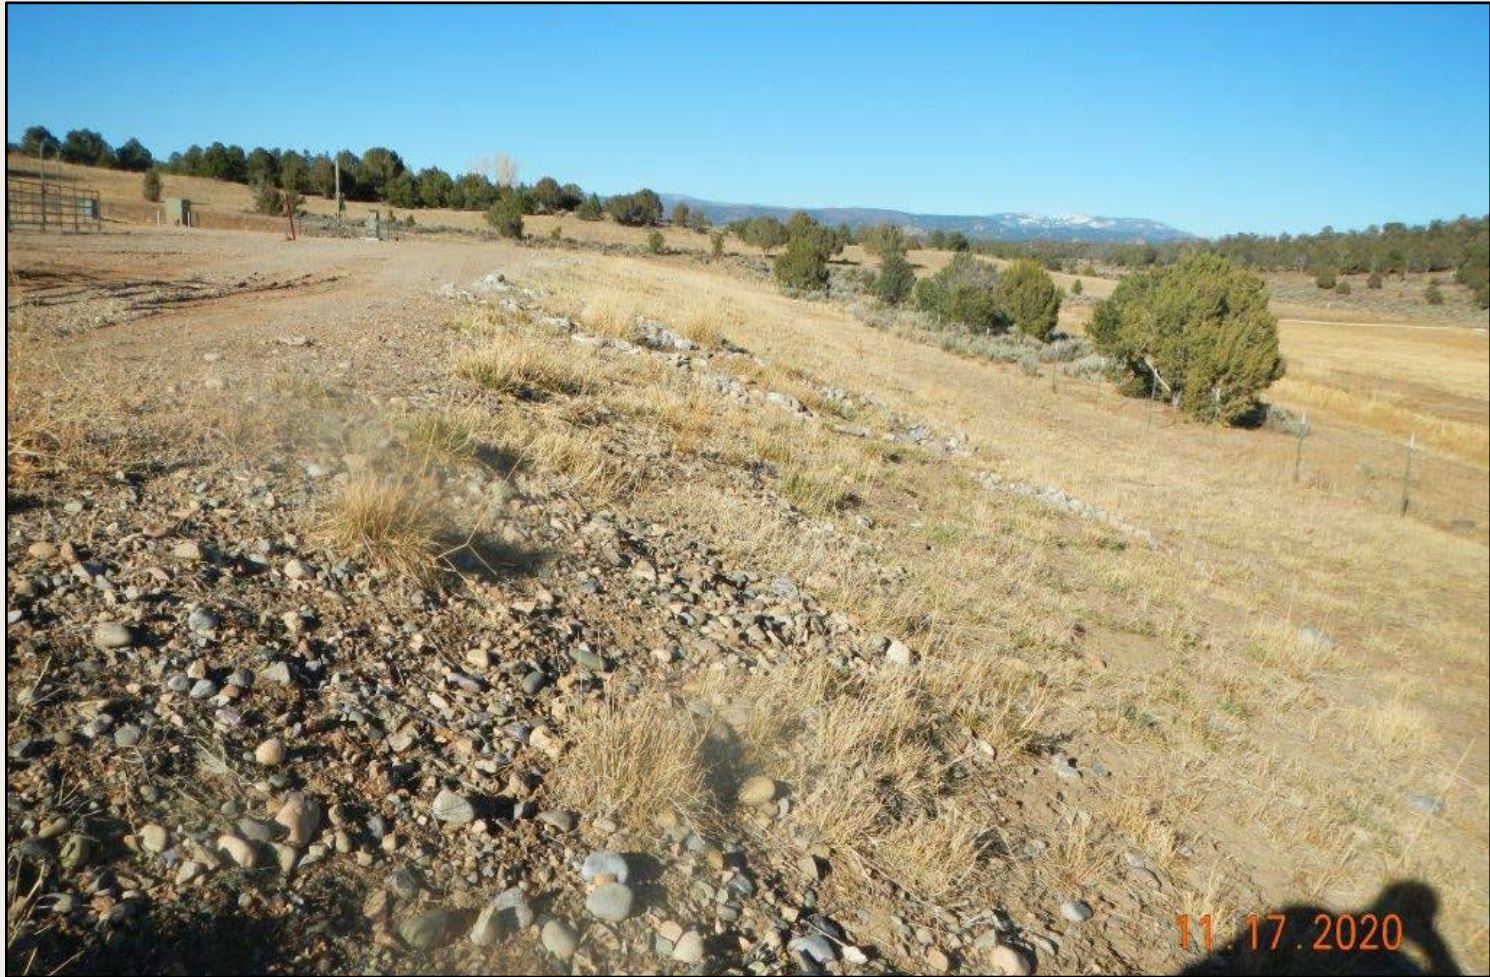
Photo 2. View of the eastern fill slope from the southeastern corner facing northward. Revegetation is progressing with grasses such as crested wheatgrass and western wheatgrass.

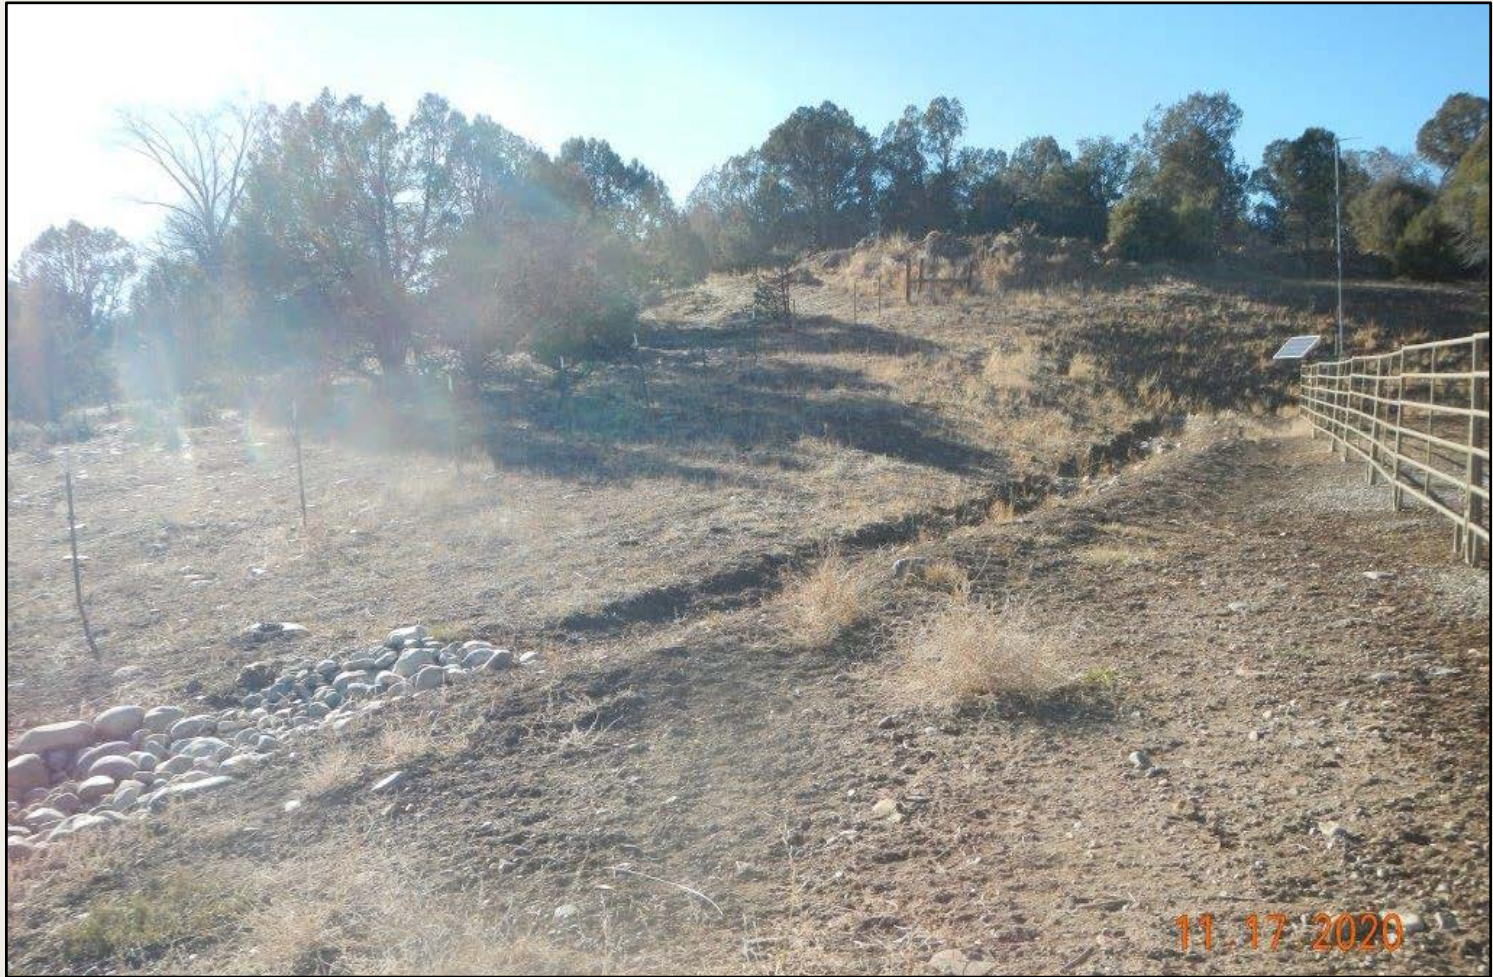
Photo 3. View of the southern project area from the southeastern corner facing westward.

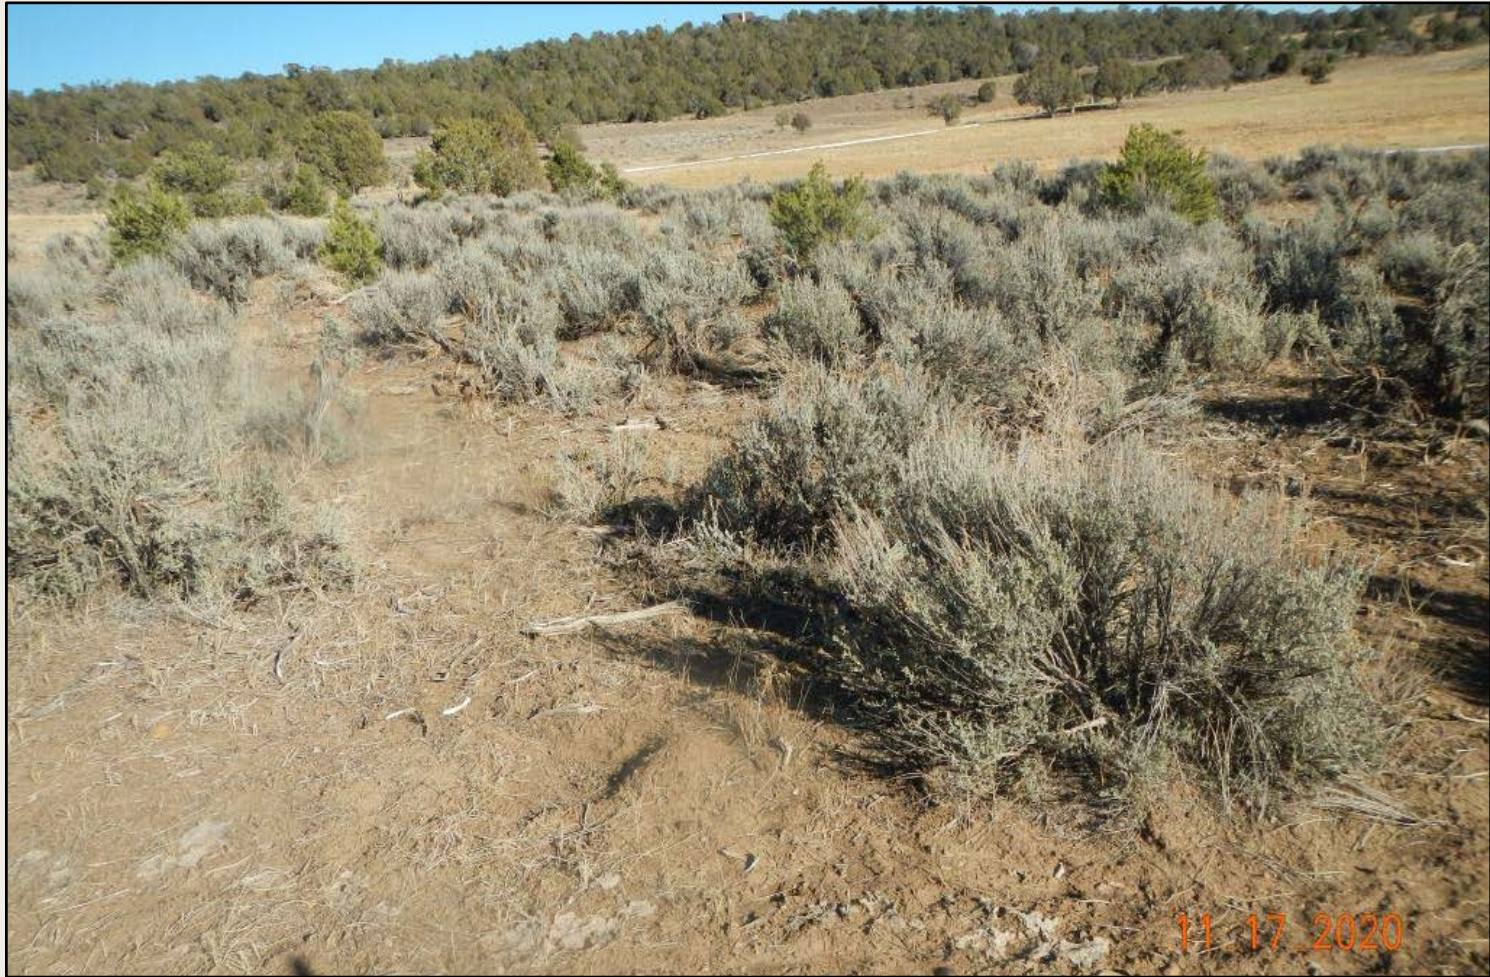
Photo 4. View of the reference area comprised of sagebrush shrubland with scattered pinyon and juniper trees and understory of grasses and forbs such as western wheatgrass and snakeweed.

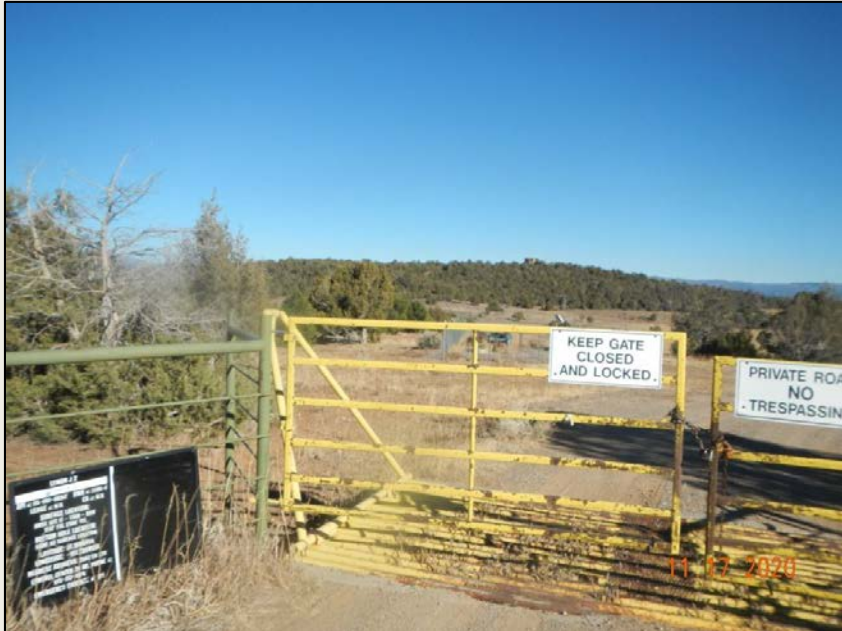
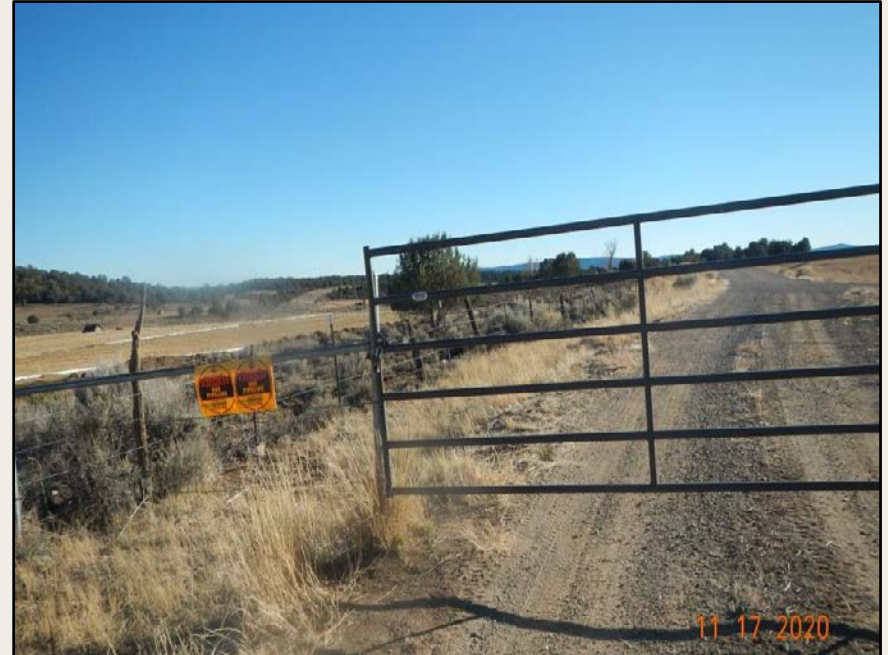
Photos 5/6. View of closed gates (2) after leaving location.
