TEP  
RMV 39-16  
Location # 335788

**COLORADO**  
Oil & Gas Conservation  
Commission  
Department of Natural Resources

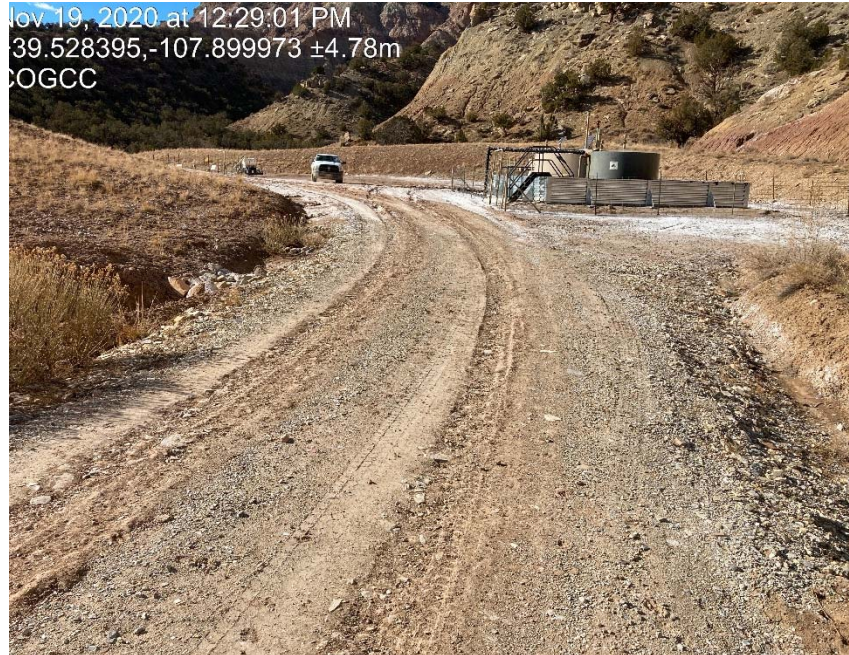
**Lack of stabilization**

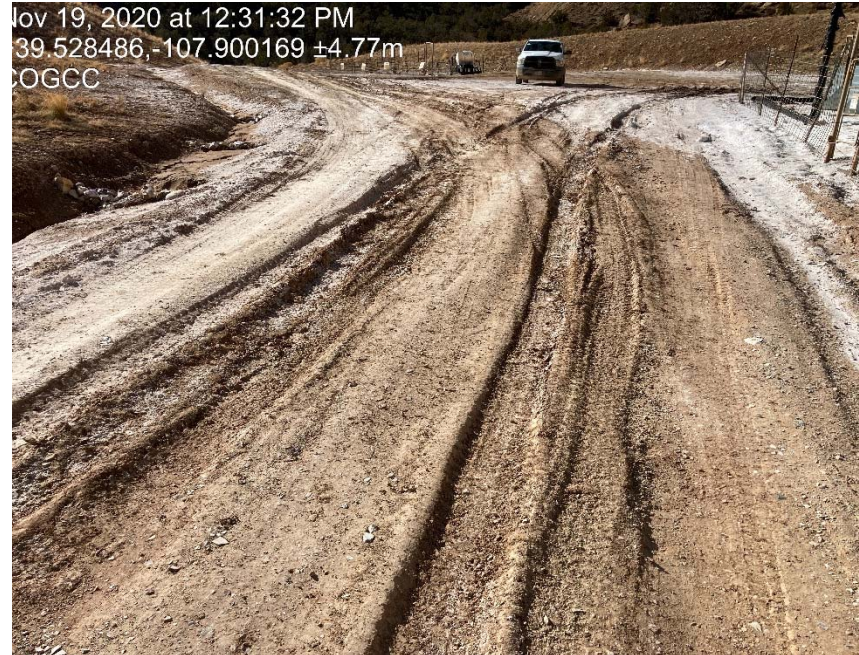
**Lack of stabilization**

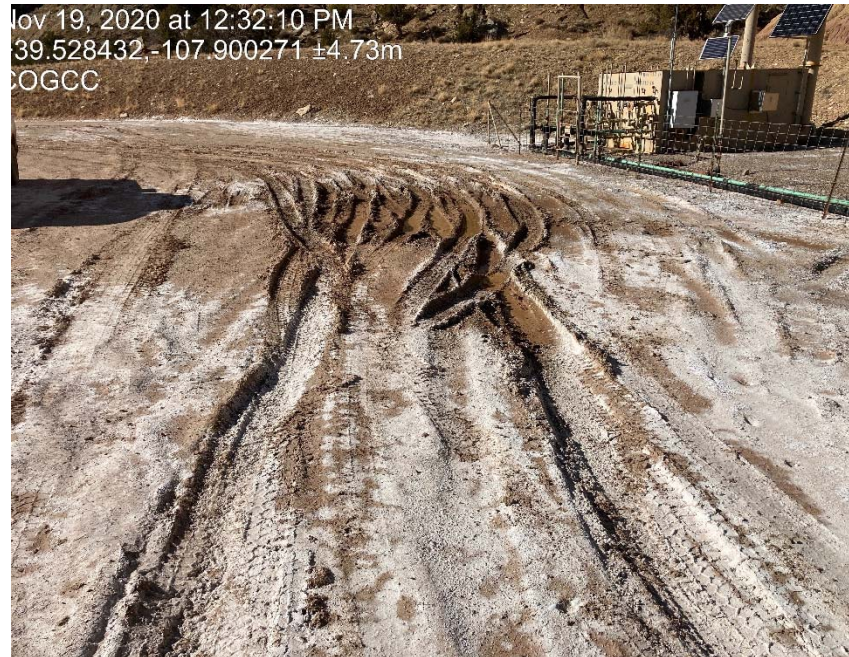
**Lack of stabilization**

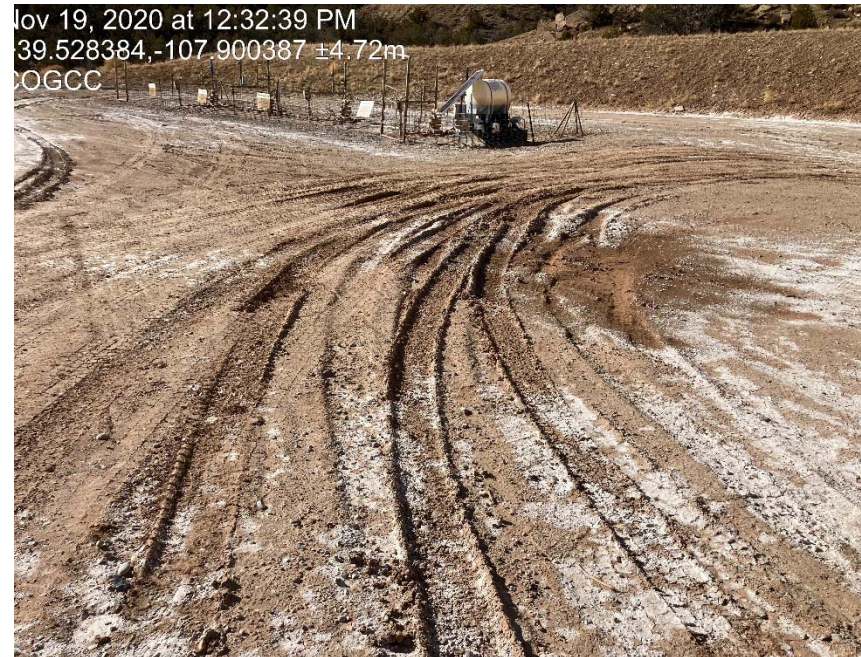
**Lack of stabilization**

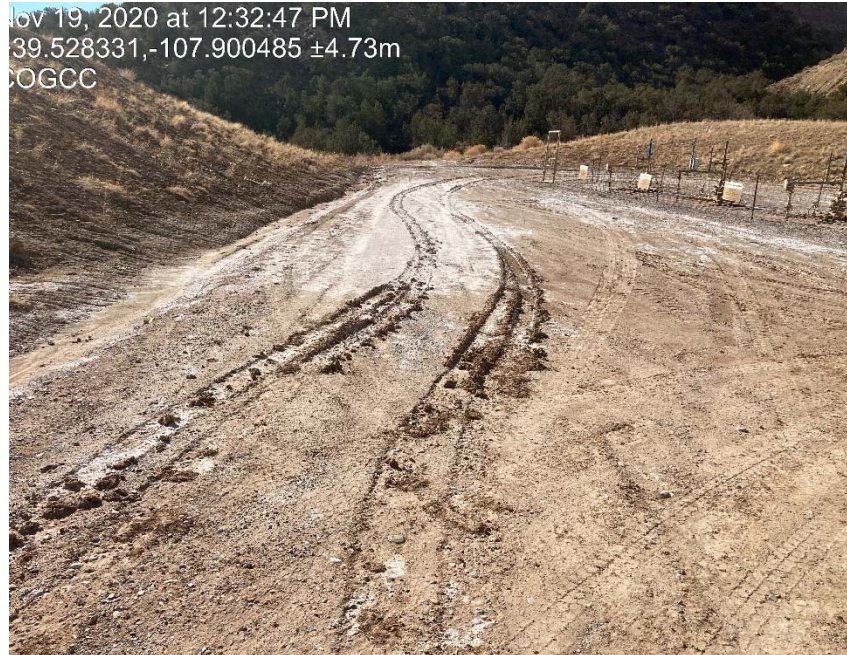
**Lack of stabilization**

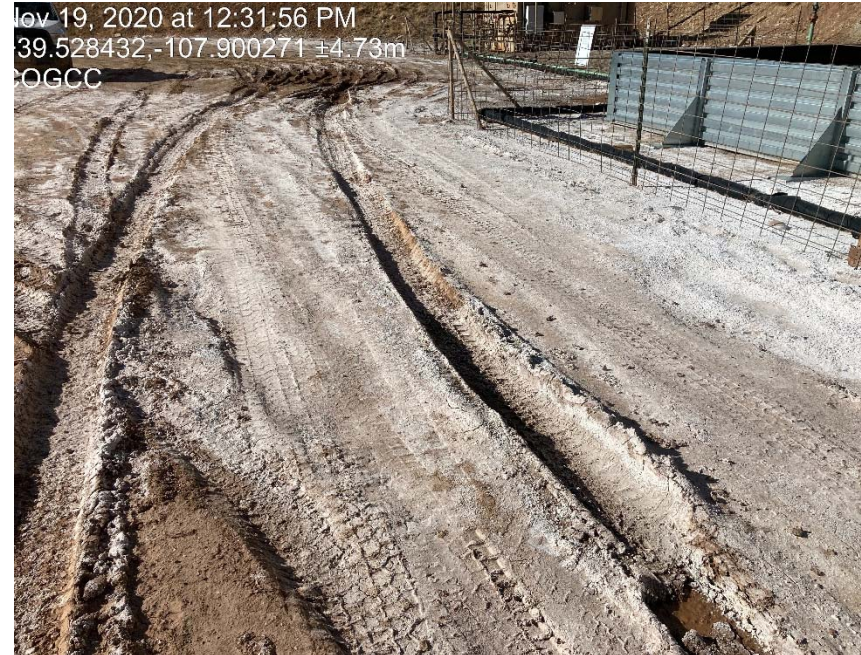
**Lack of stabilization**
