TEP  
RWF 53-17  
Location # 335777

**COLORADO**  
Oil & Gas Conservation  
Commission  
Department of Natural Resources

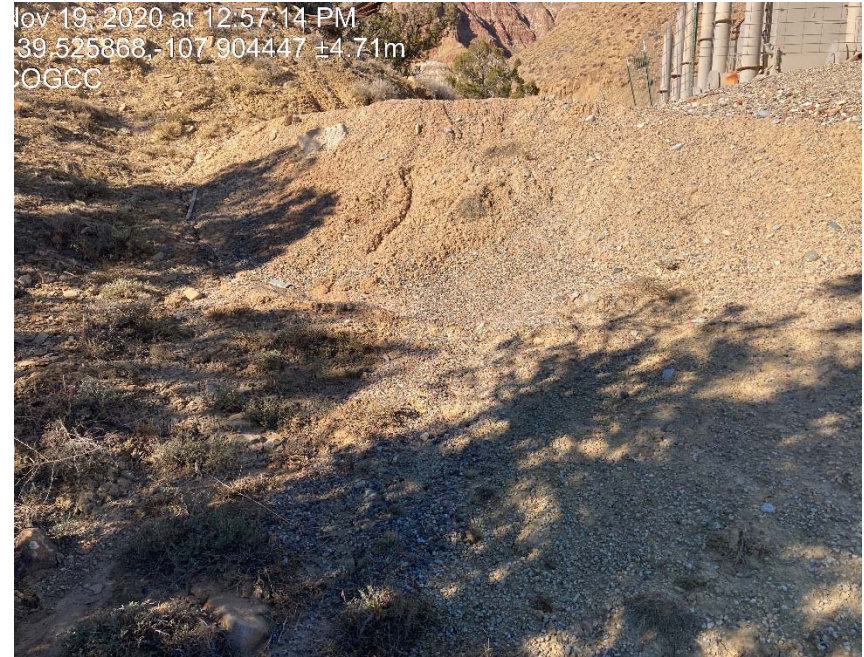
**Follow up photo still no stabilization and sediment migration, old waddle is still in place**

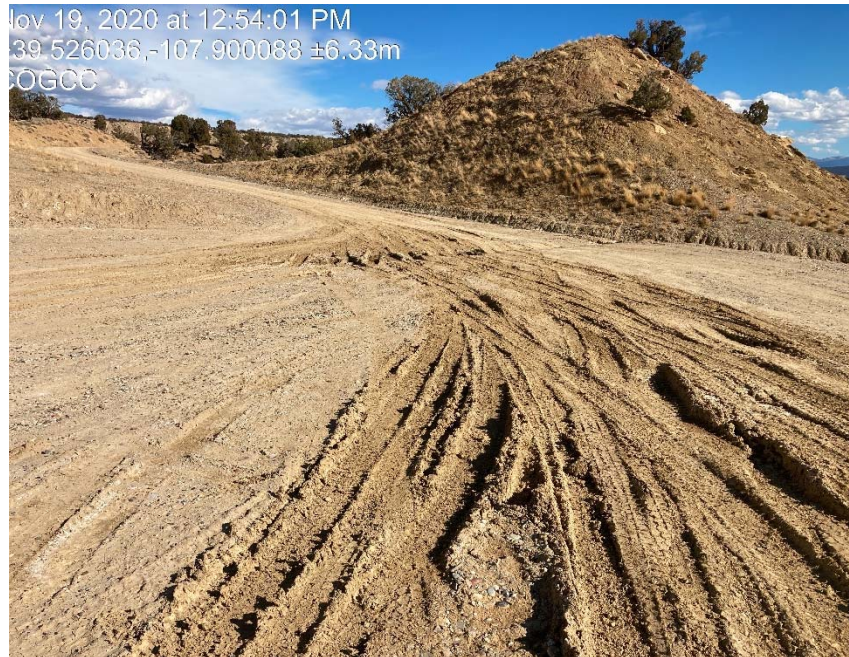
**lack of stabilization**

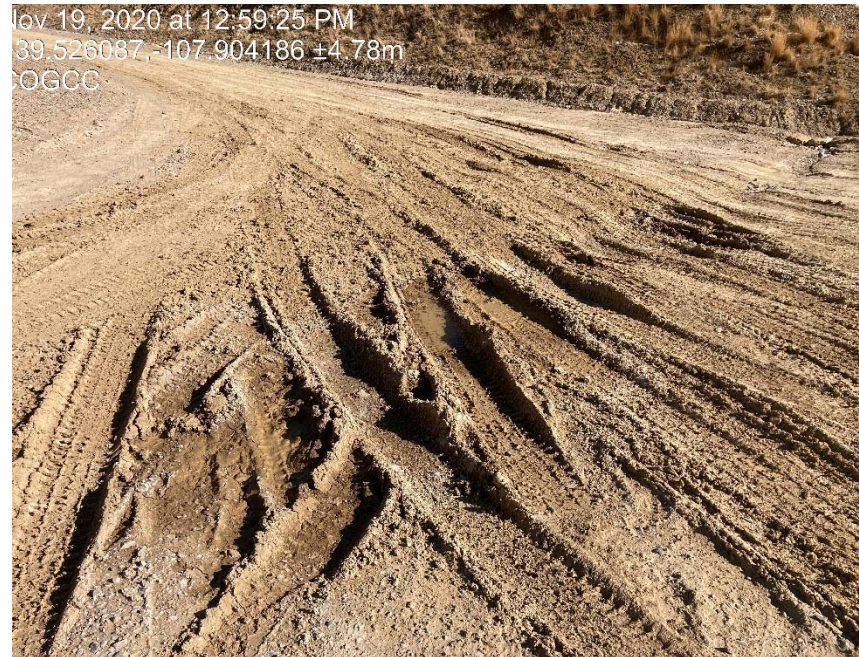
**lack of stabilization**

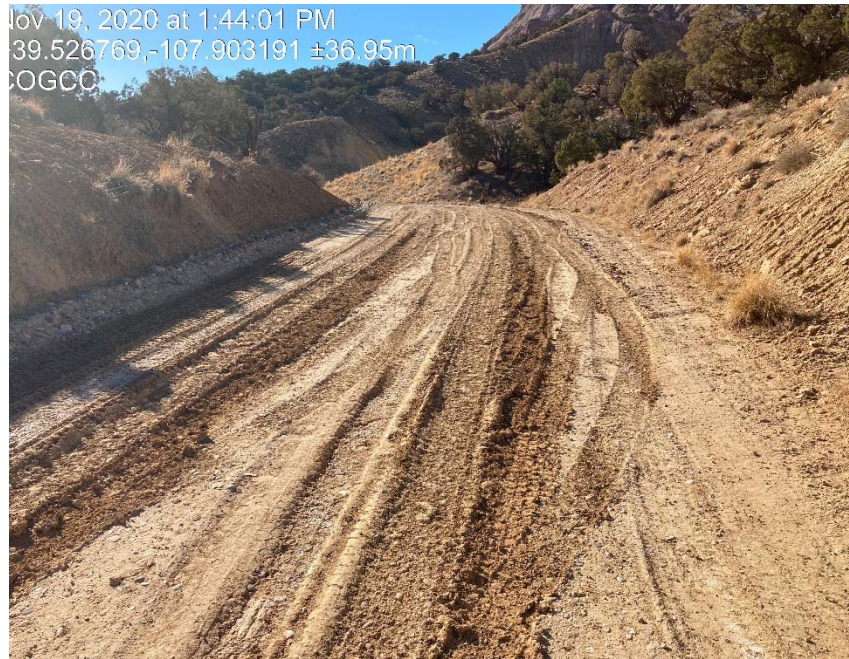
**Access road has lack of stabilization**

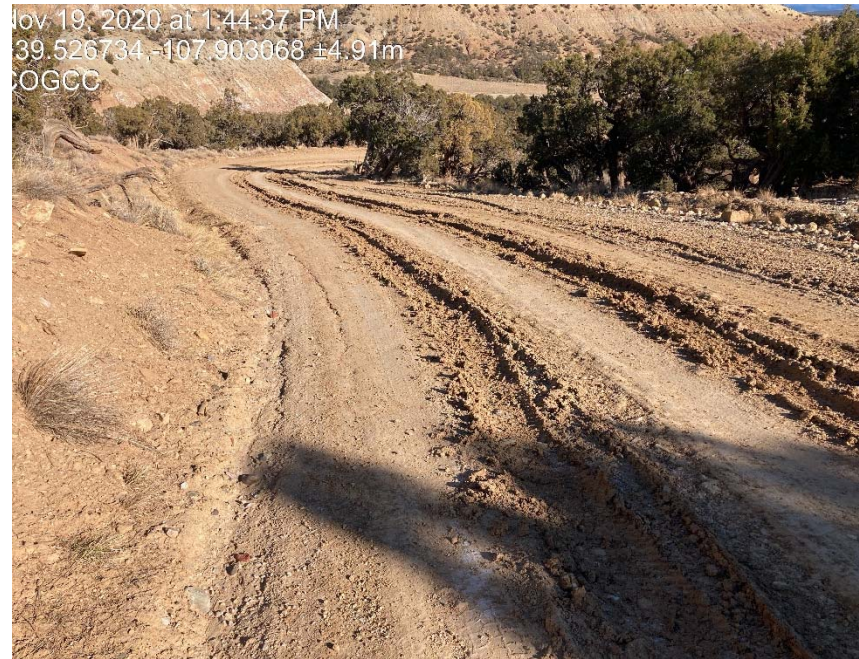
**Access road has lack of stabilization**

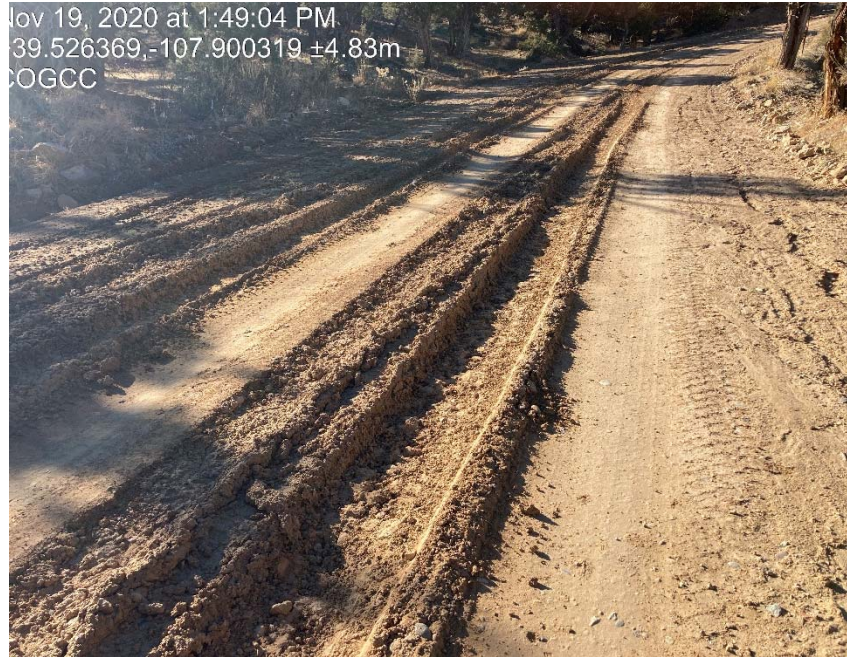
**Access road has lack of stabilization**

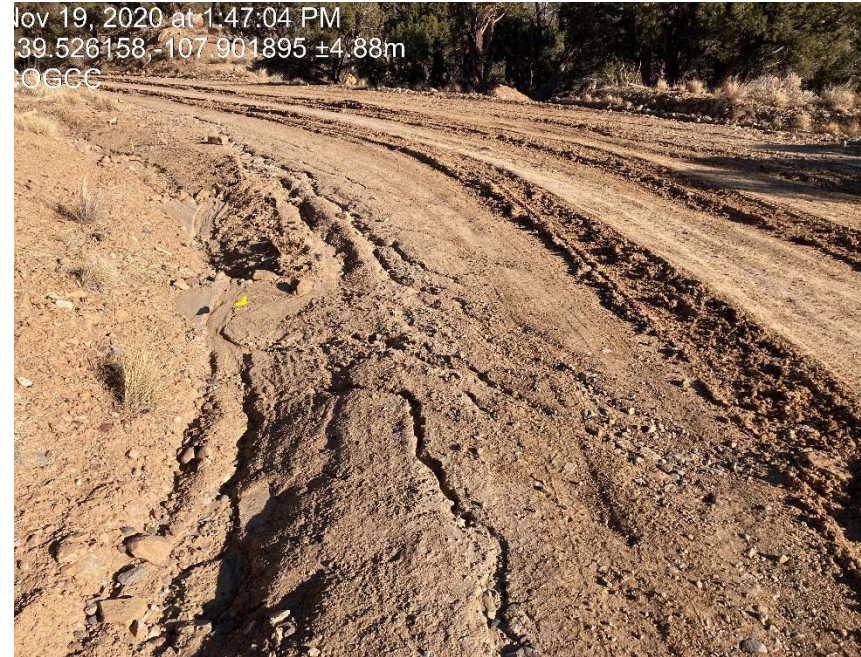
**Access road has lack of stabilization**

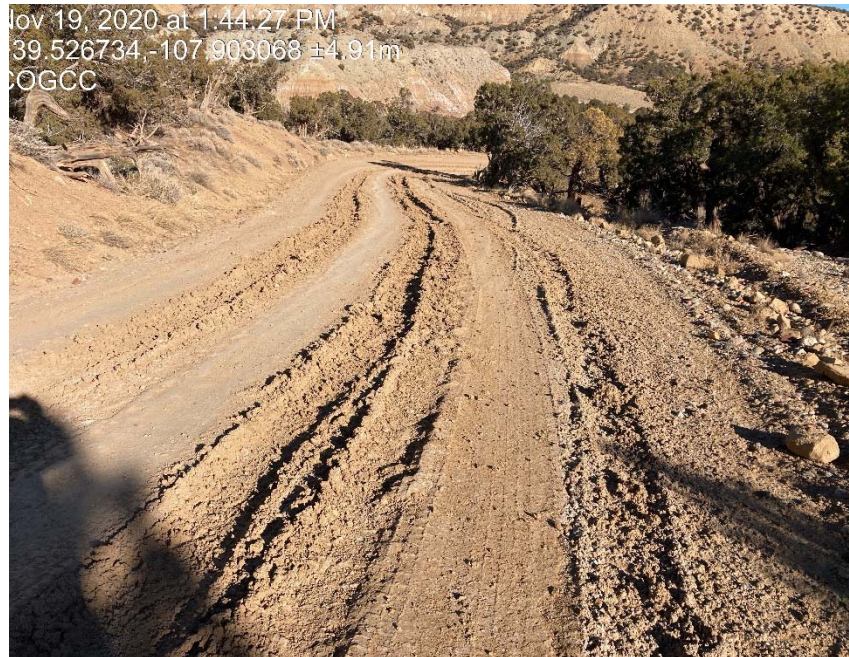
**Access road has lack of stabilization**

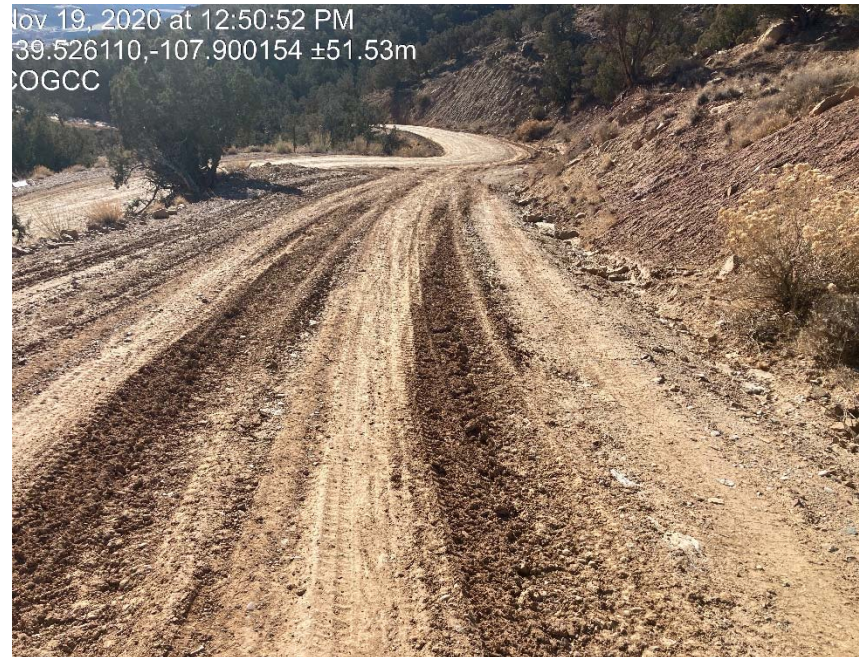
**Access road has lack of stabilization**
