Inspection Photos
Location Name: Hubert Morrison A #1
API: 05-067-06899

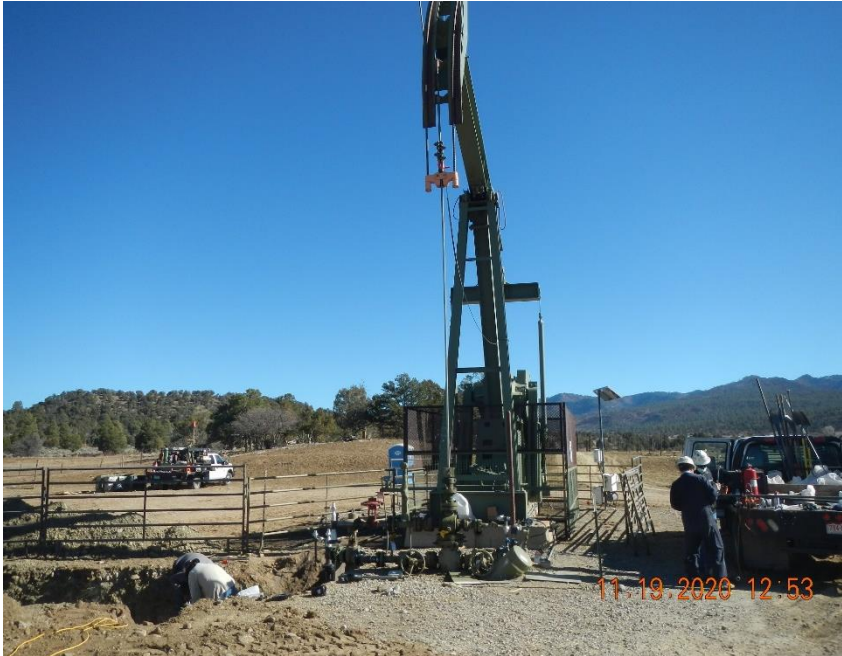
Hubert Morrison A #1 well head and pump jack.

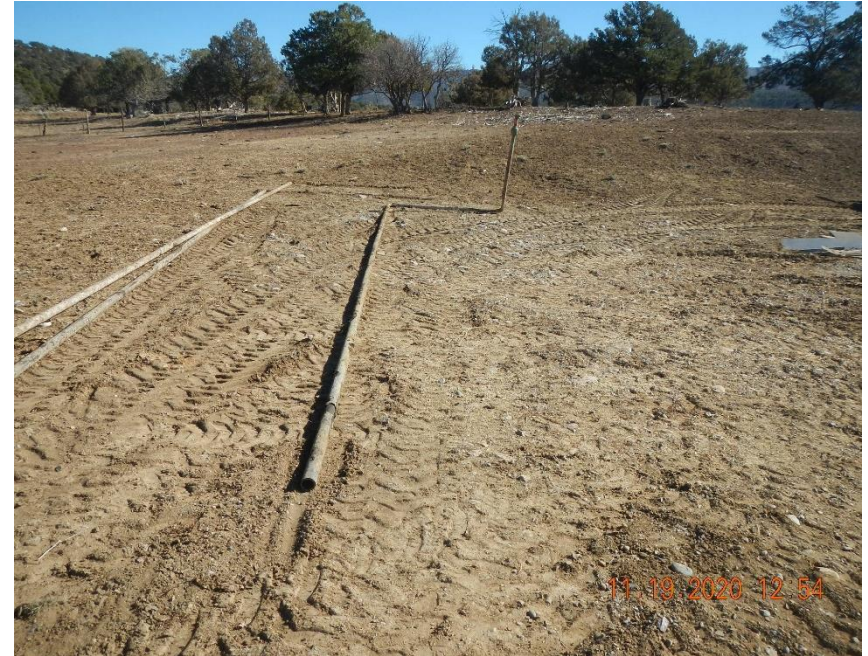
Steel flow lines being replaced with poly pipe.

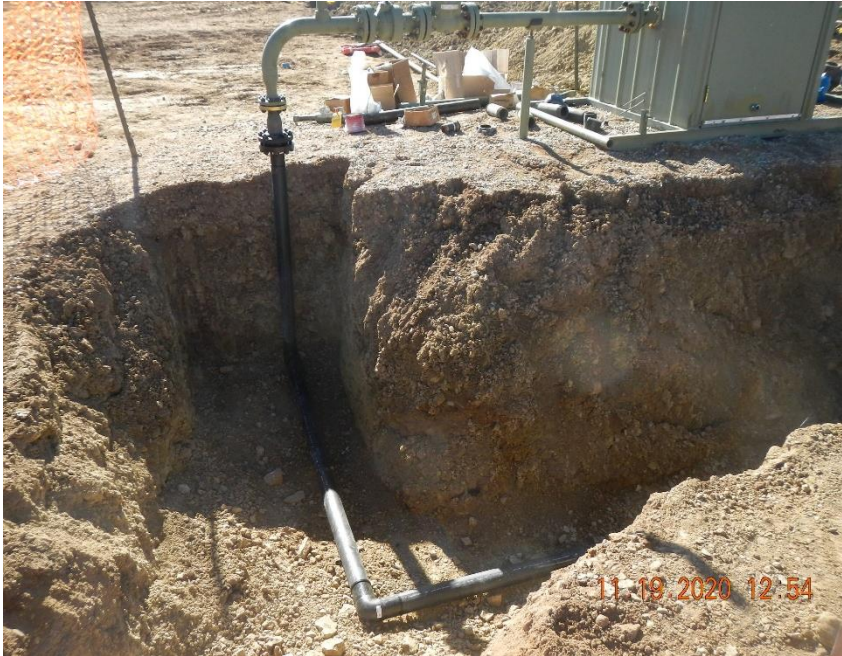
Steel to poly transition at separator.

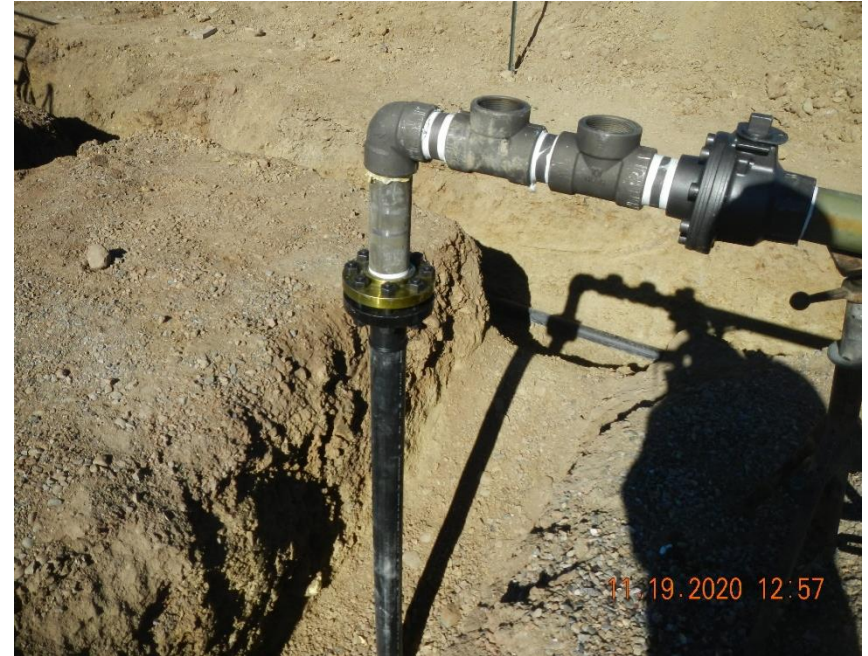
Poly to steel transition upstream of separator.

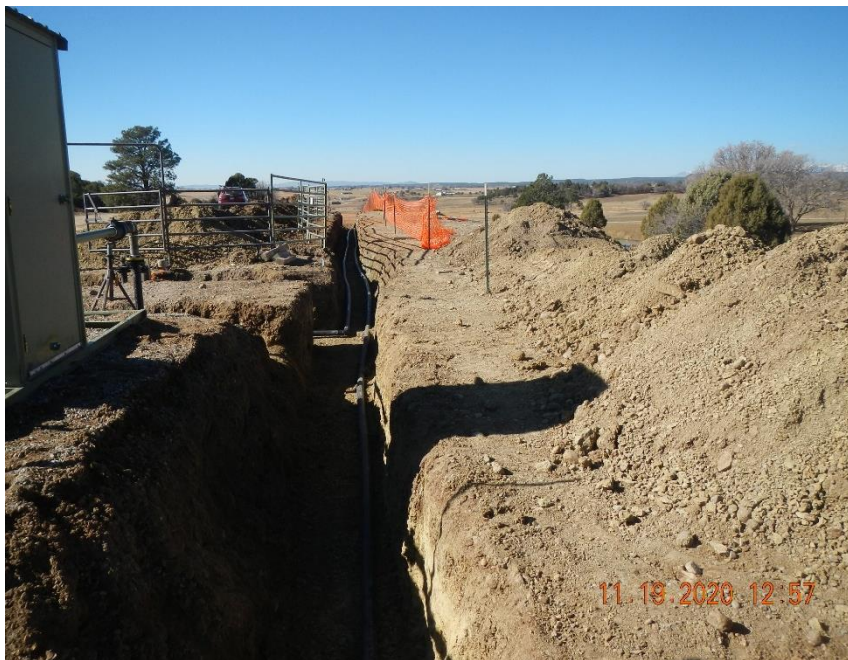
Poly flow lines in open excavation.

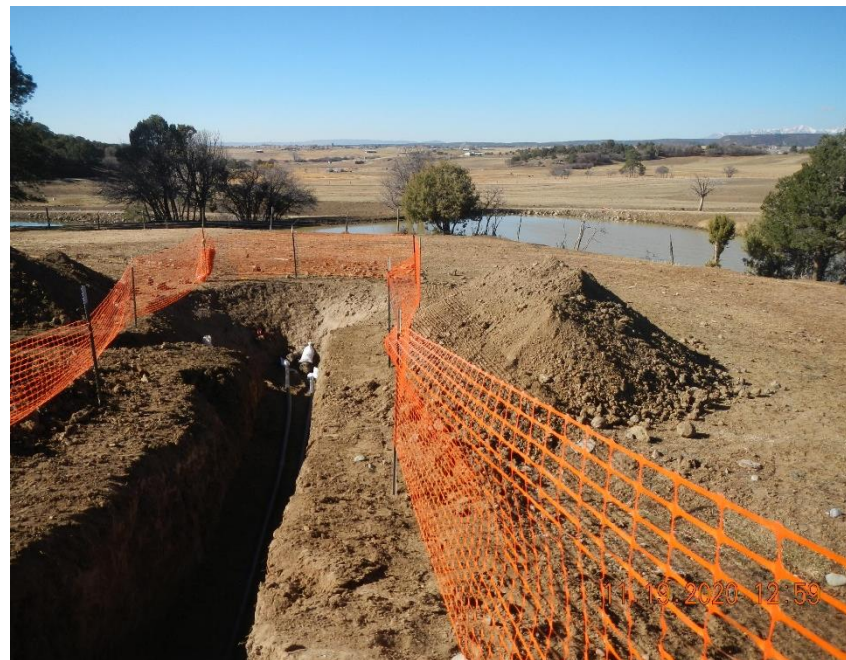
Present termination of newly installed poly flow lines.

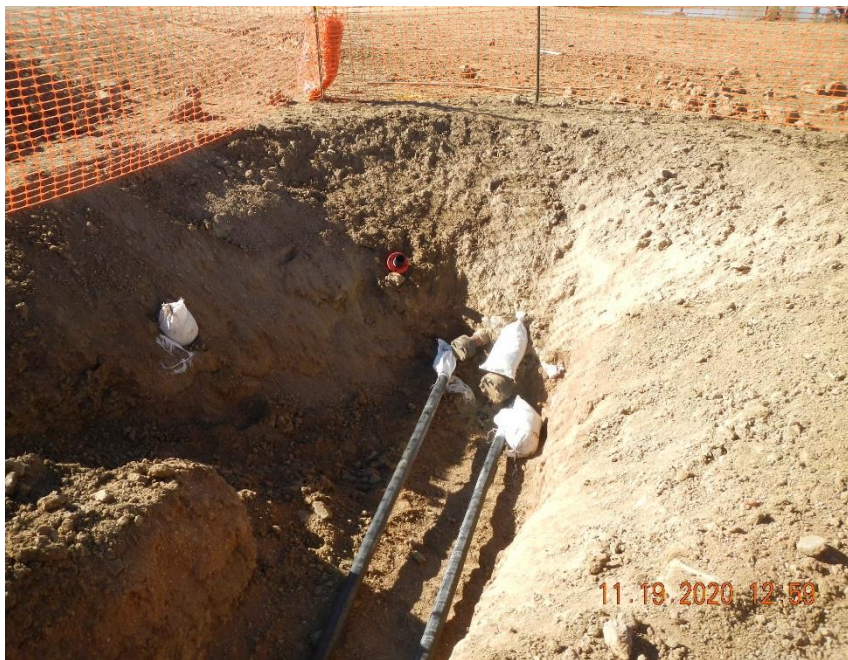
Eventual poly to steel transition.

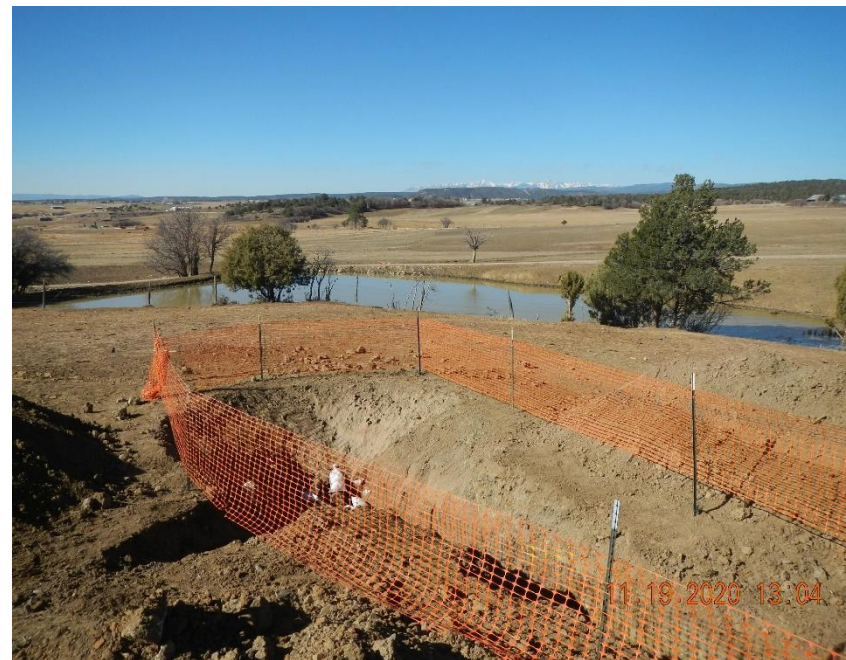
Photo taken from approximate location of Spill/Release Point ID #476772.
