**Inspection Photos**  
**Location Name: GUNNISON ENERGY LLC FEDERAL-610S90W /32SWSE**  
**Location ID: 324459**

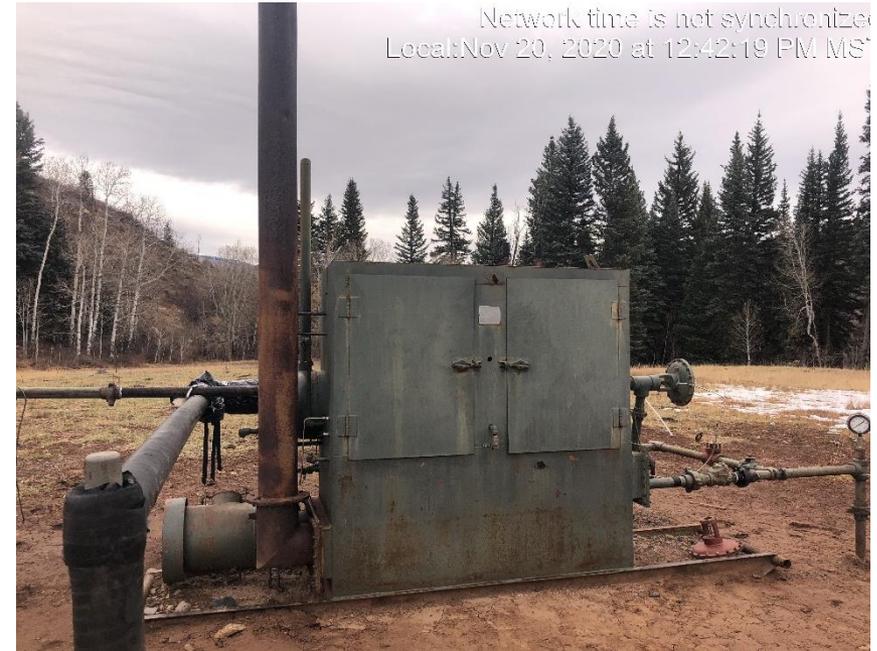
**Photo #2299 Separator with small gas leak.**

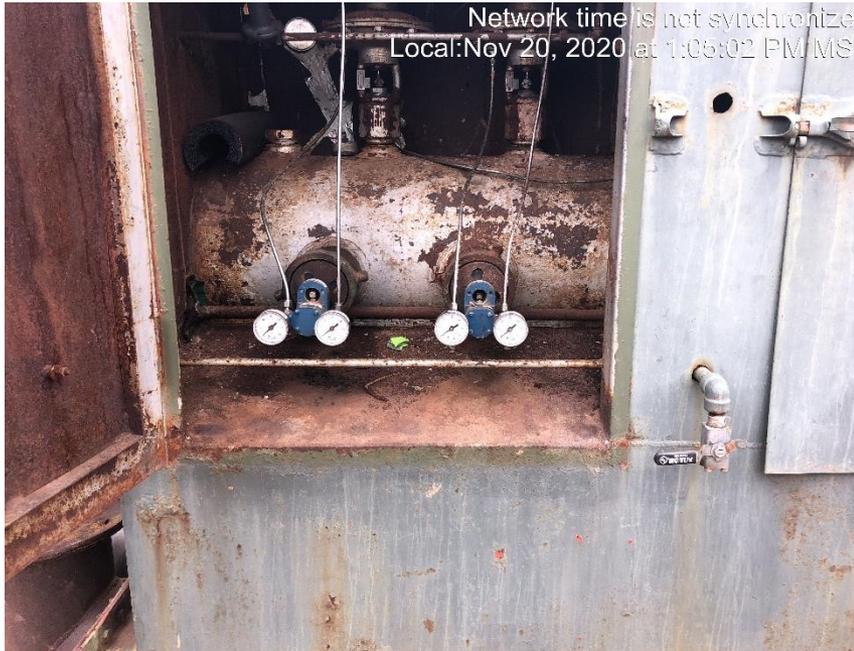
Photo #2300 gas leaking from a dump controller mixer inside the separator.
