Inspection Photos

API: 071-06128

Operator: TIMBER CREEK OPERATING
OGRIS OPERATING LLC

Inspection Date: 11/19/2020

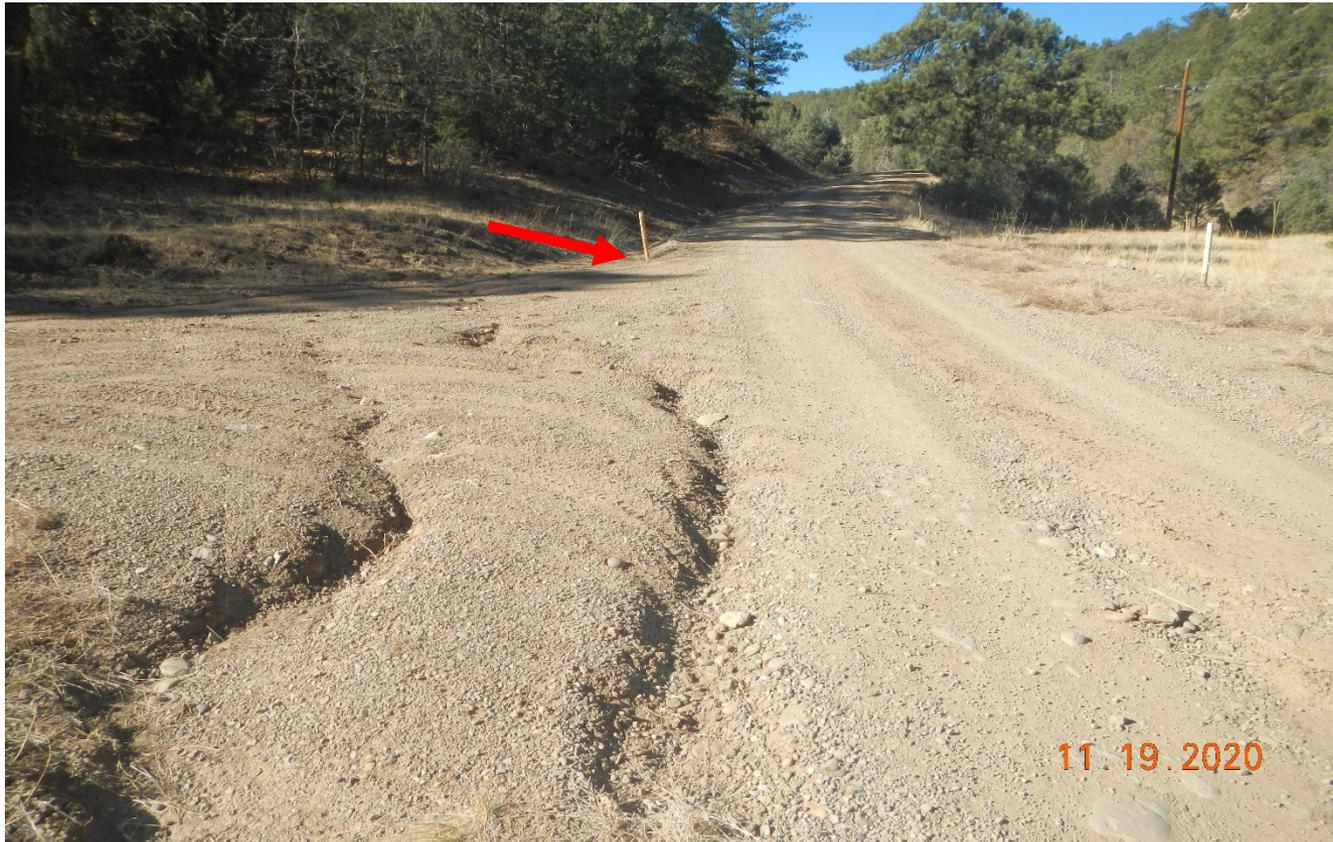
Photo 1. There is a plugged culvert along the main road (red arrow) causing stormwater to flow down the road. Lat/Long:37.09178,-104.93688. Corrective action was not completed.

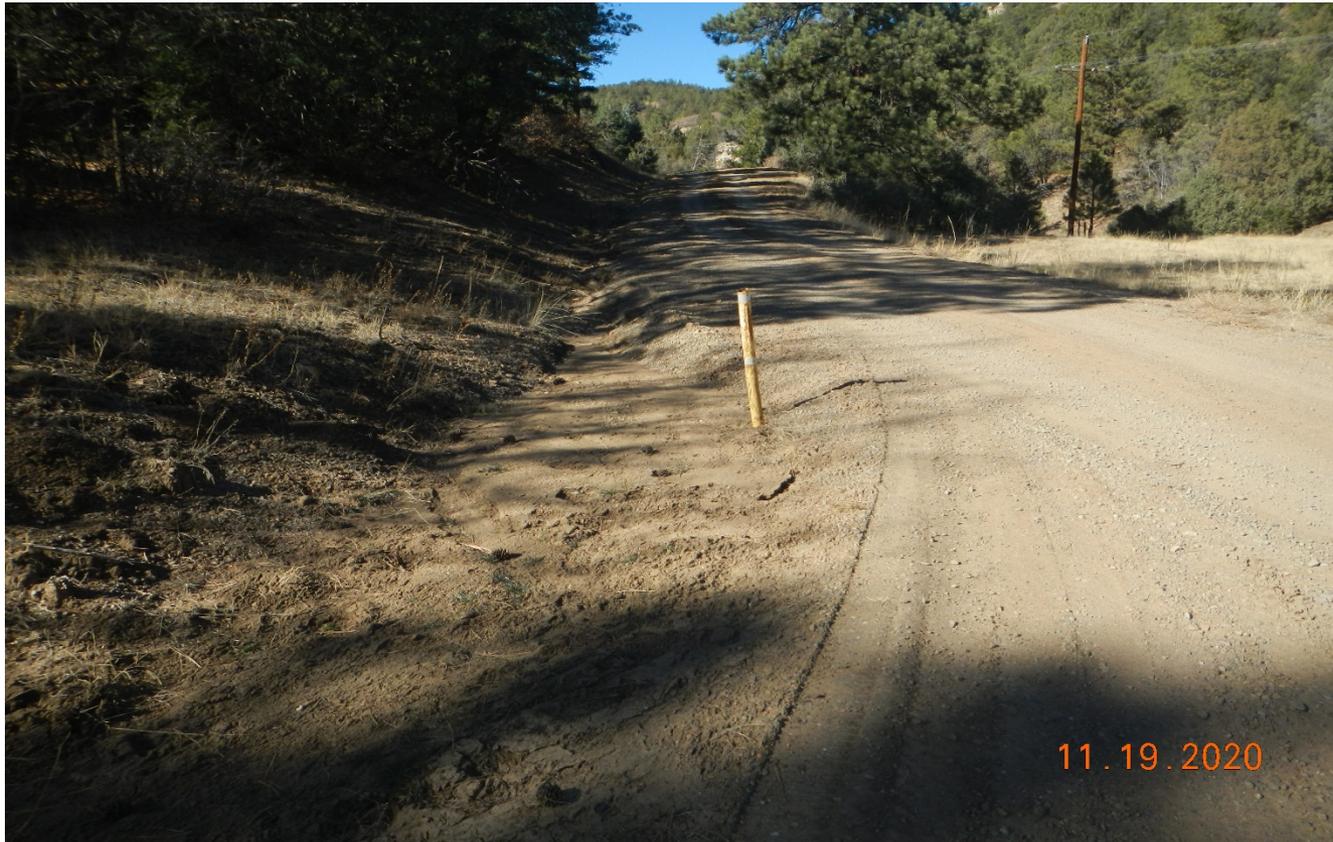
Photo 2. The culvert is filled in with sediment causing stormwater to flow down the road. All culverts need to be maintained. Previous corrective action was not performed.

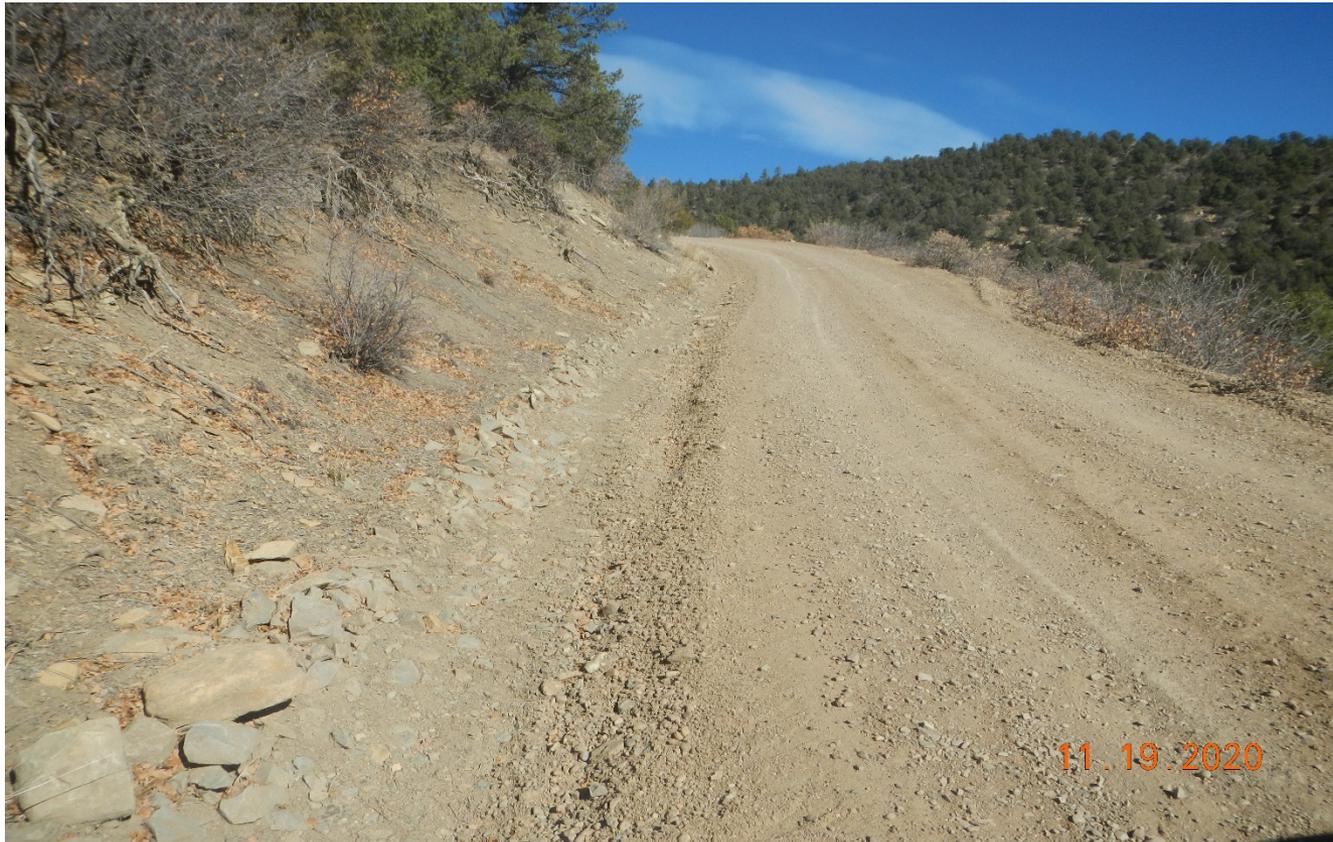
Photo 3. There is a long stretch of road with no BMP's to prevent erosion which was previously observed. Rock along the side could be used for check dams to slow stormwater velocity.

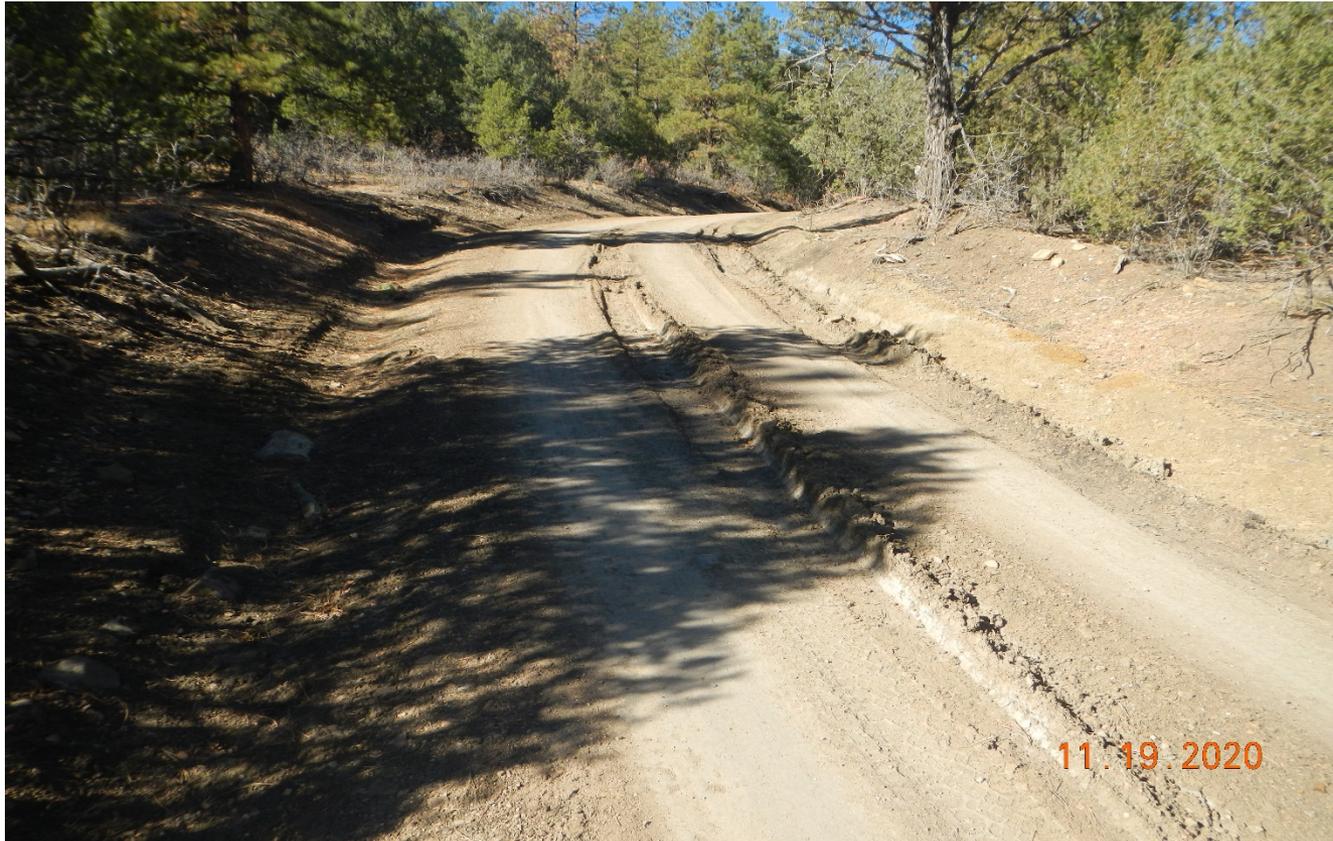
Photo 4. There is vehicle ruts occurring after repairs had been performed. BMP's such as gravel is needed to prevent rutting and road degradation.
