Inspection Photos

API: 071-08482

Operator: TIMBER CREEK OPERATING
OGRIS OPERATING LLC

Inspection Date: 11/19/2020

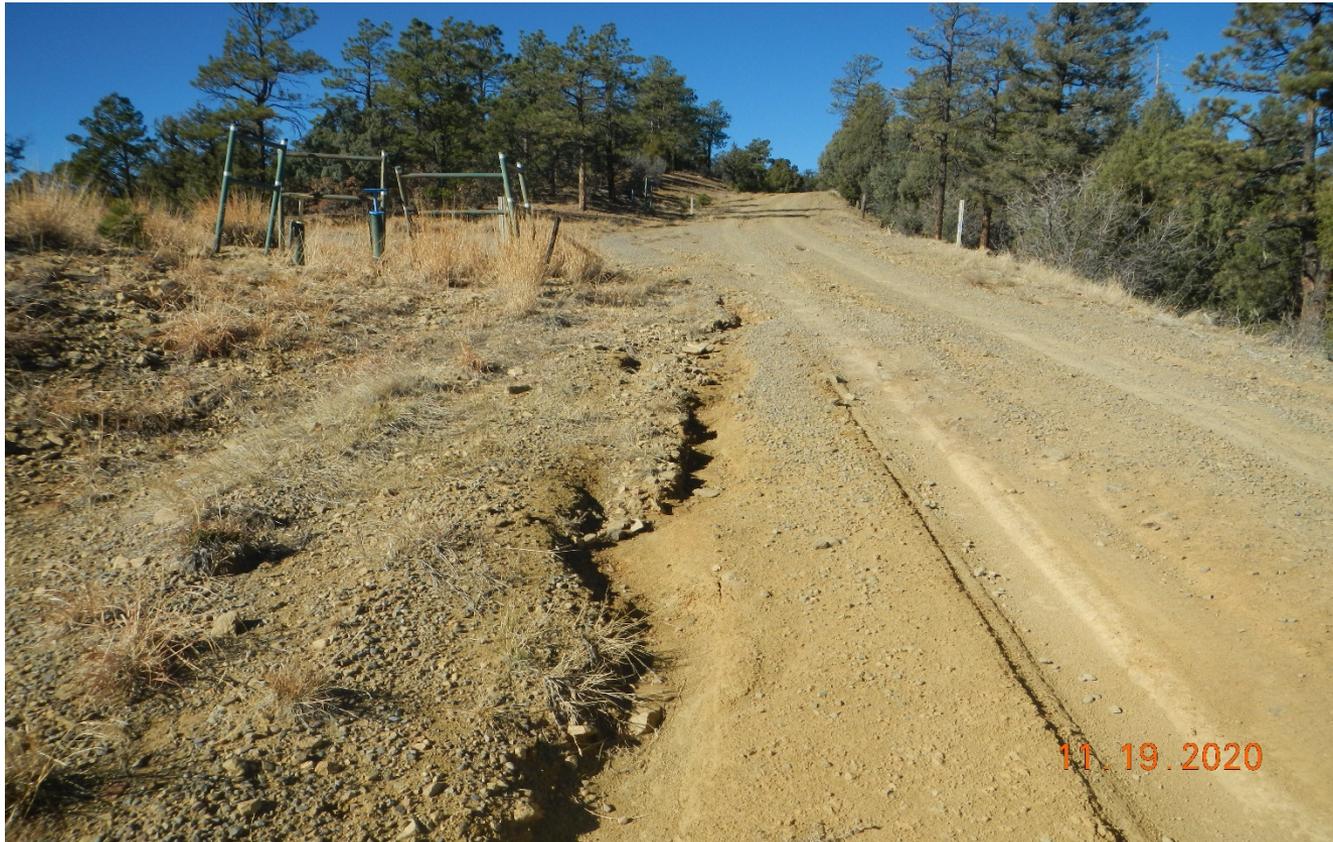
Photo 1. Storm water erosion is occurring down the side of the road. BMP's need to be installed to prevent erosion.

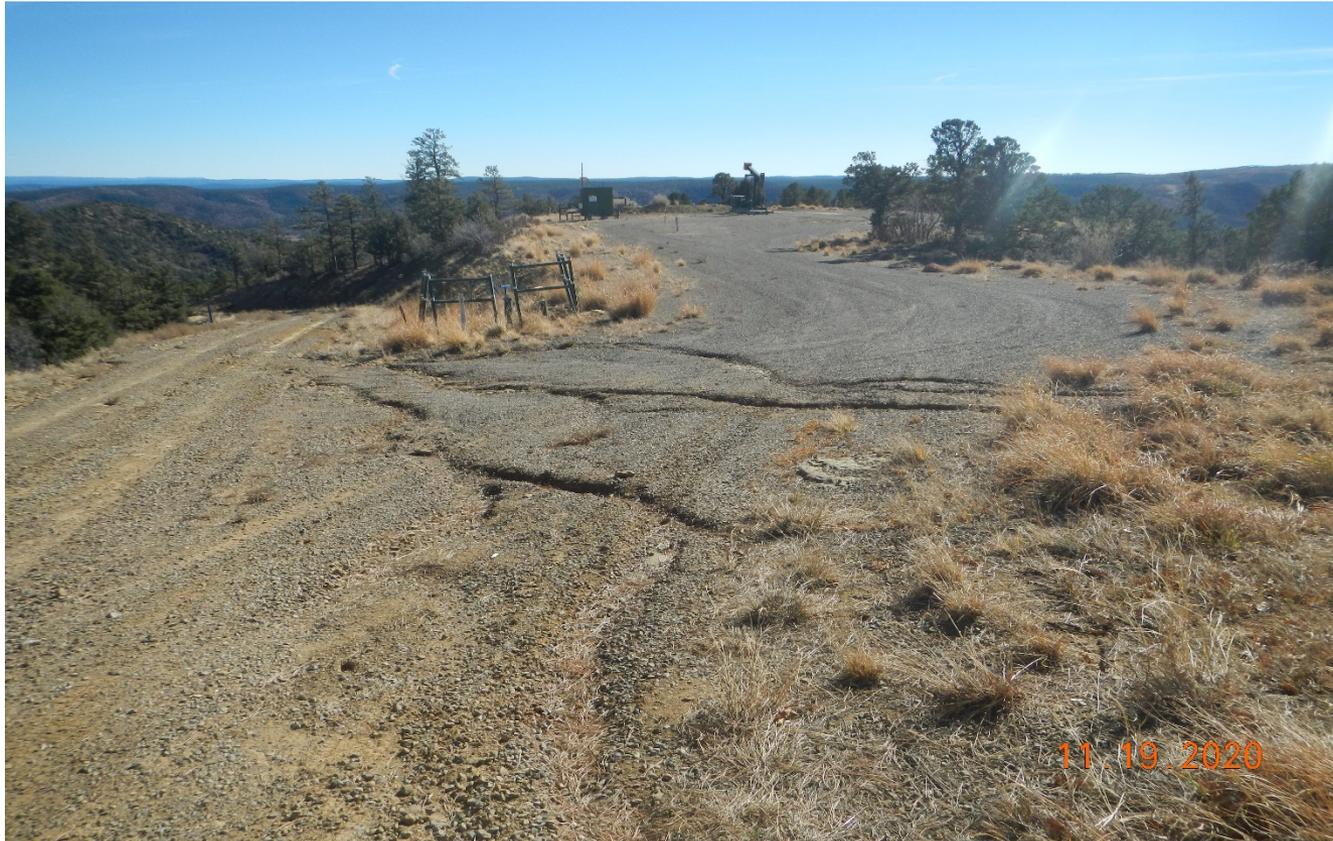
Photo 2. Facing southeast toward the location. Stormwater is causing erosion across and down the road.

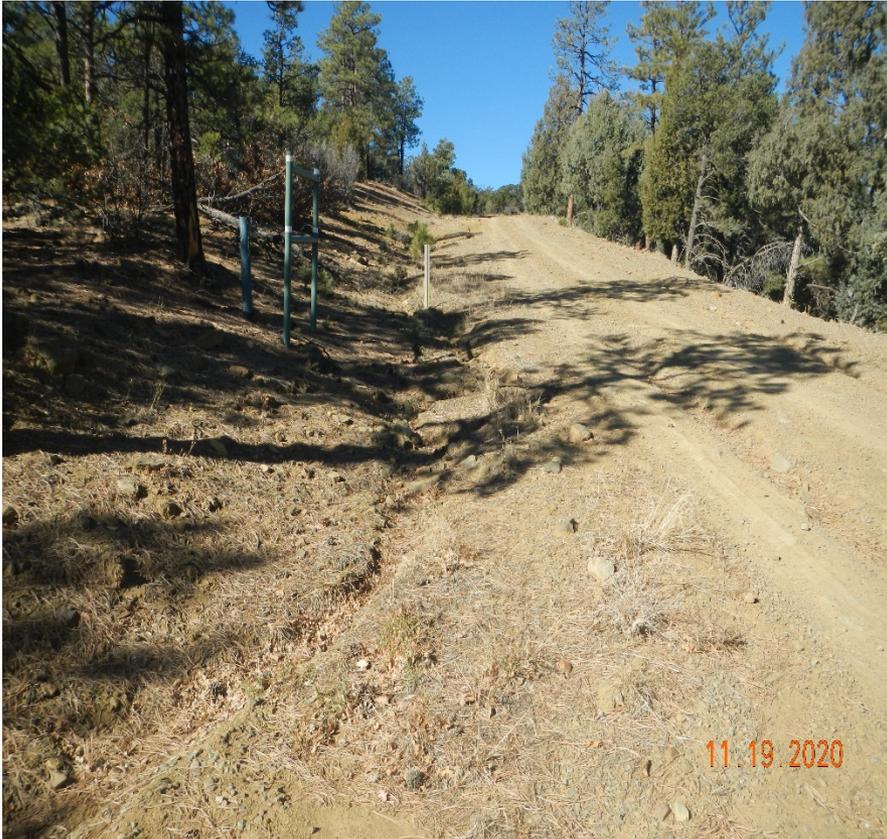
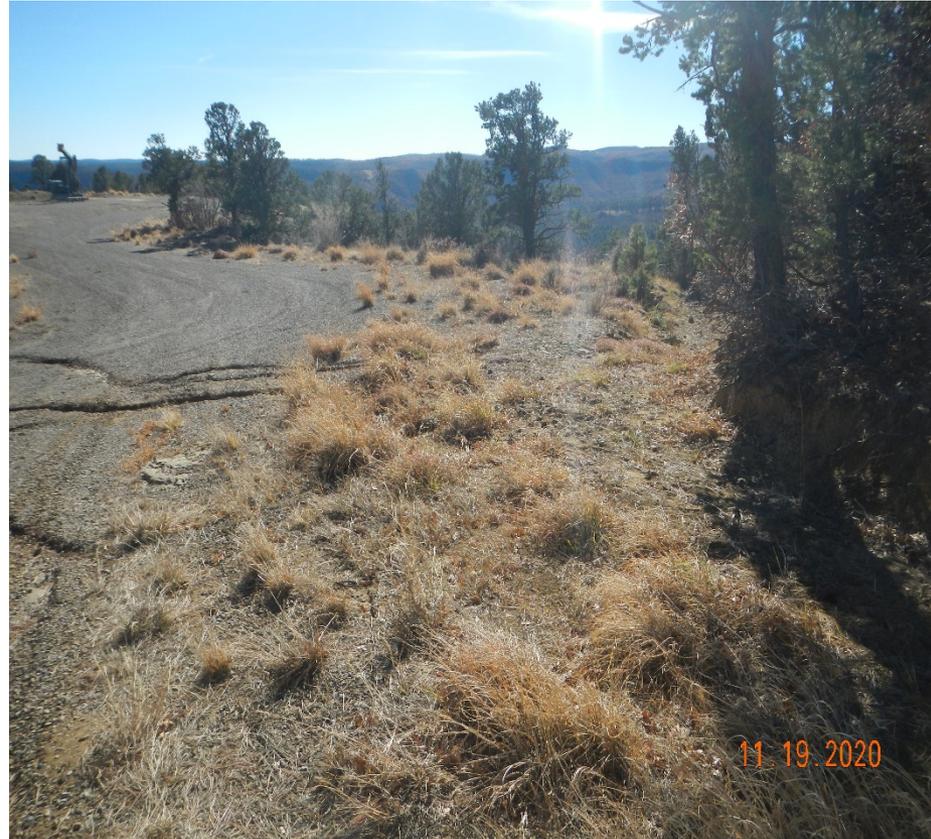
Photo 3. Erosion shown in previous photo is caused by stormwater coming from the road past the location. Photo on the right shows that the diversion ditch is filled in causing stormwater to flow down the road. Proper diversion should be installed along with BMP's to slow stormwater velocity e.g. sediment trap, check dams.
