# Inspection Photos

API: 071-08481

Operator: TIMBER CREEK OPERATING  
OGRIS OPERATING LLC

Inspection Date: 11/19/2020

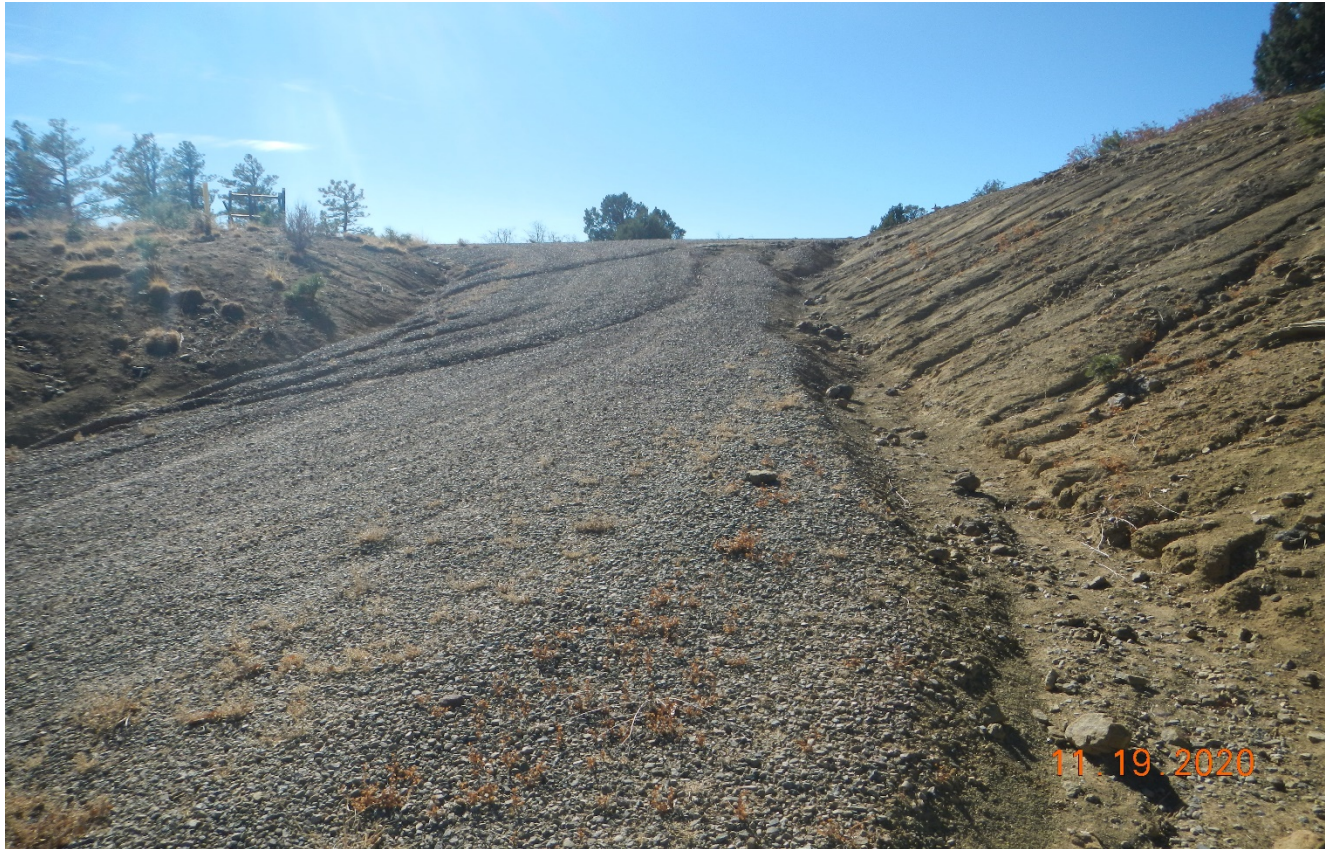
**Photo 1.** Facing south at the beginning of the access road. There is erosion occurring down the road and the side of the road is not stabilized. Stormwater directed down the road is causing erosion which is shown in the next photo.

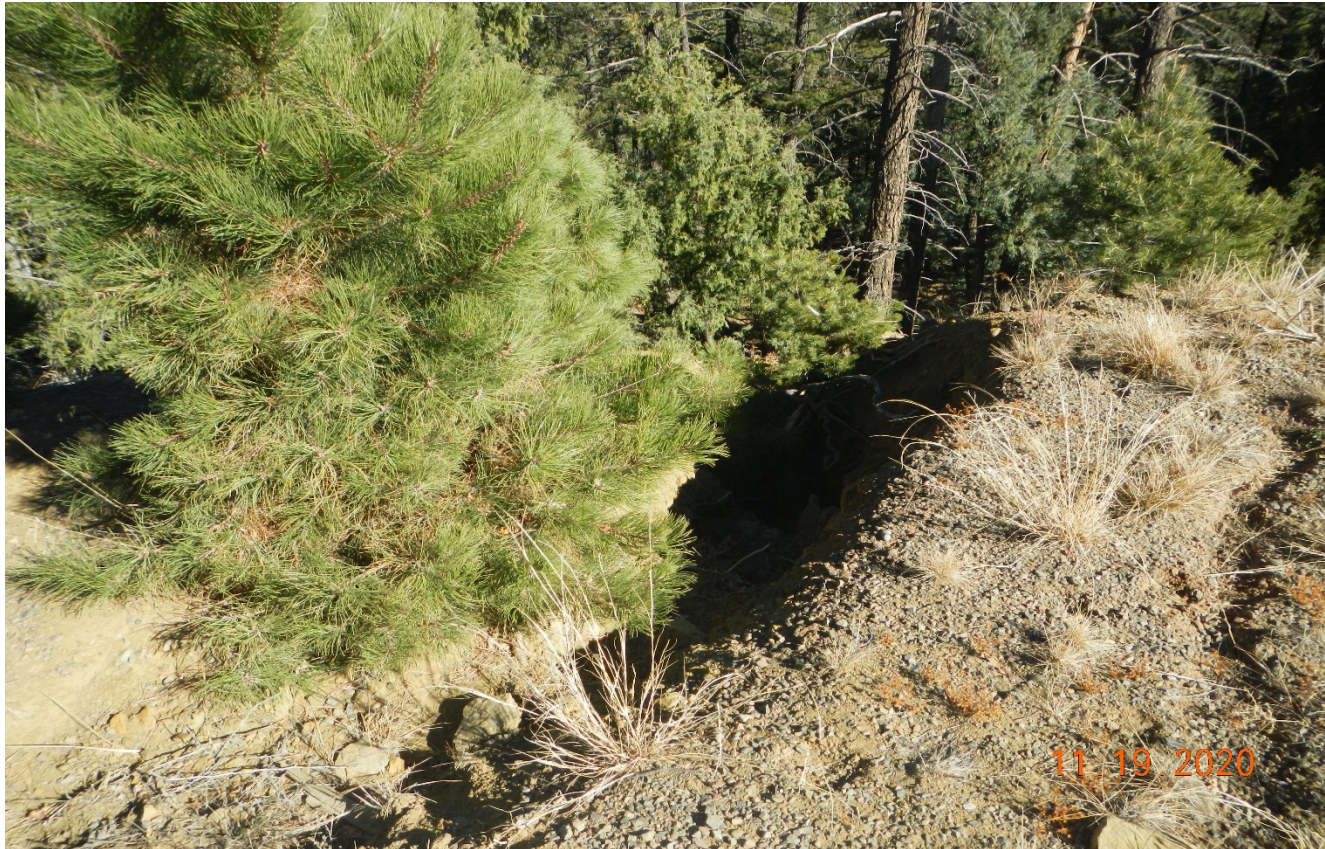
**Photo 2.** This erosion has occurred from stormwater directed down the road. This is also depositing sediment down the road below shown on photo 5.

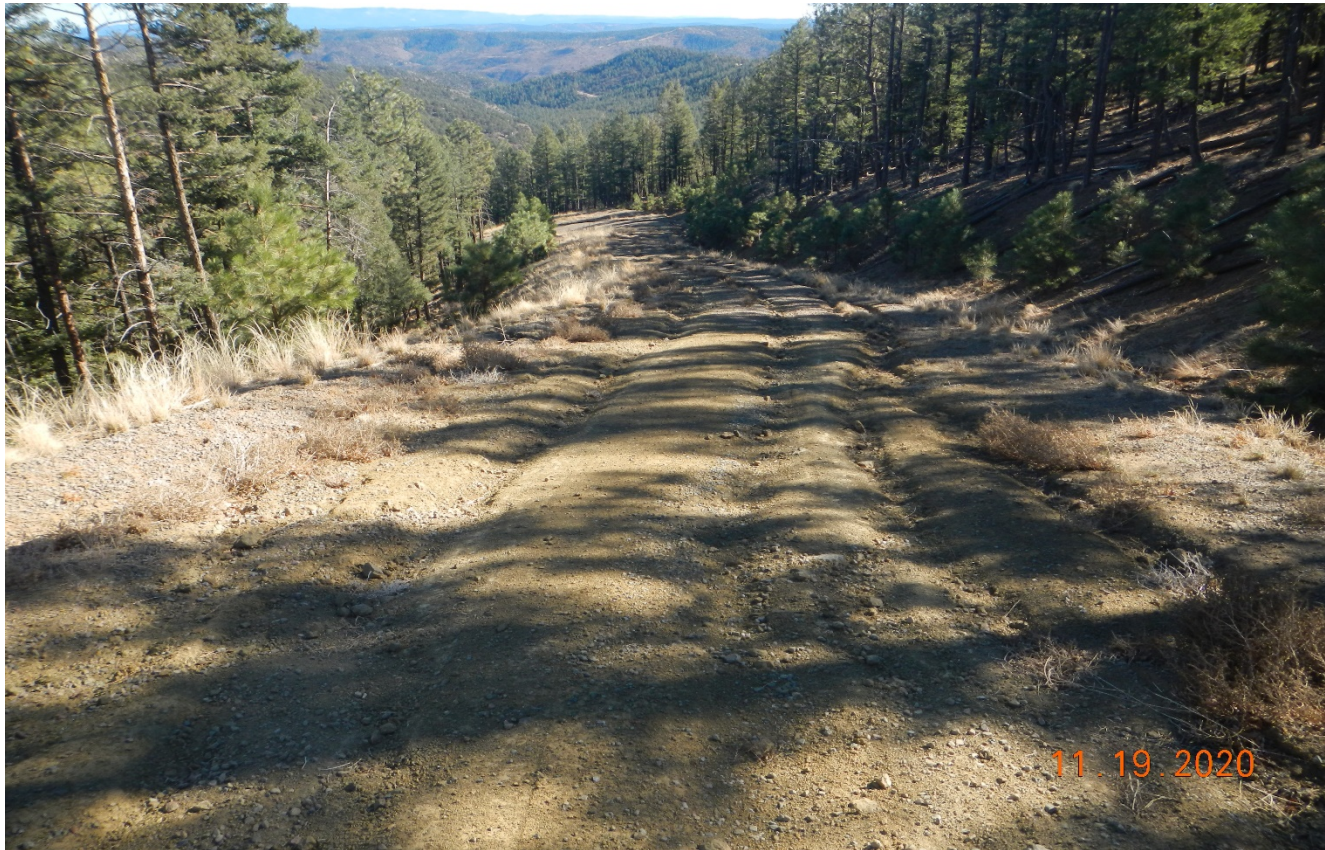
**Photo 3.** Stormwater is causing erosion down the road.

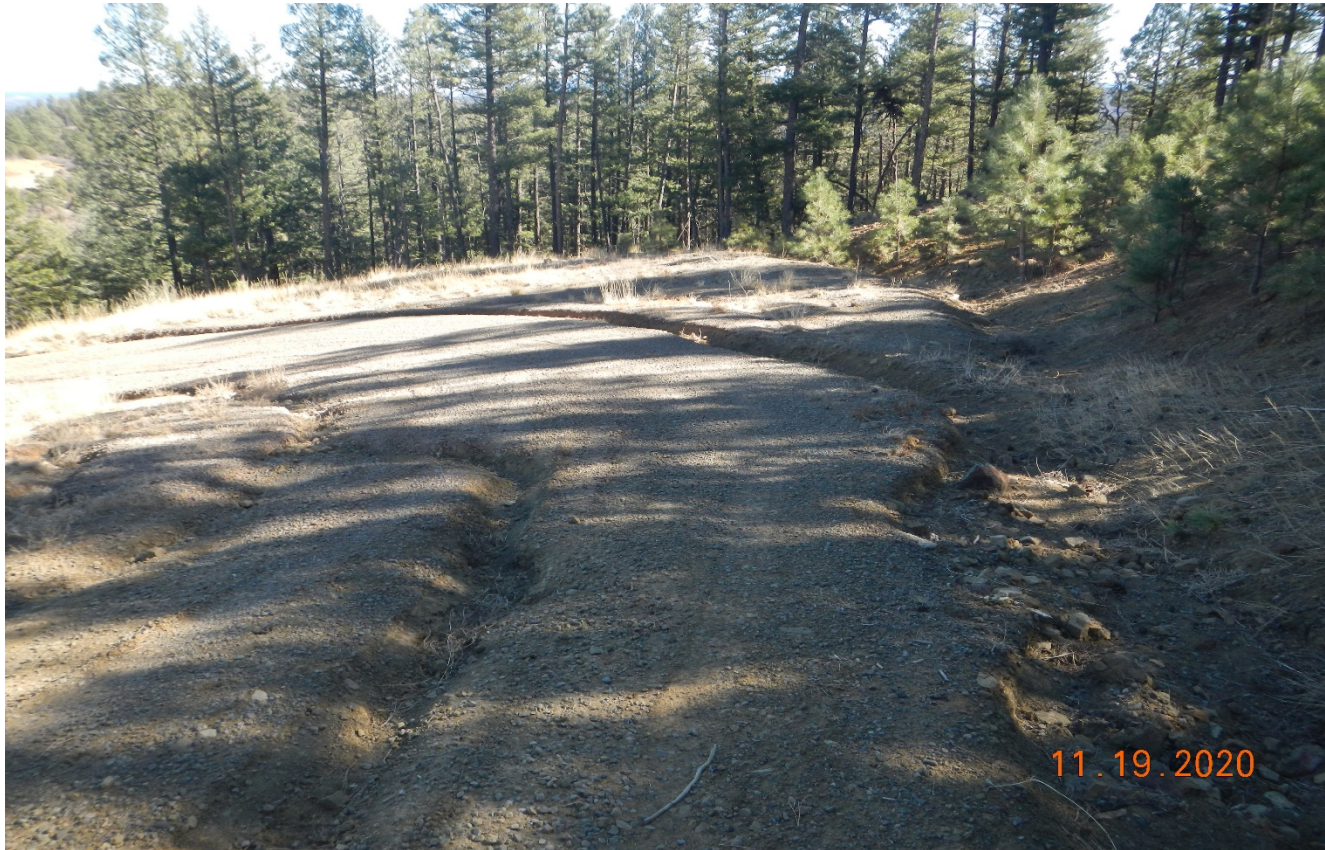
**Photo 4.** There is deep erosion channel in the road caused from stormwater flowing down the road. Stormwater needs to be properly diverted with ditches, water bars, ect. and velocity needs to controlled with check dams sediment traps ect.

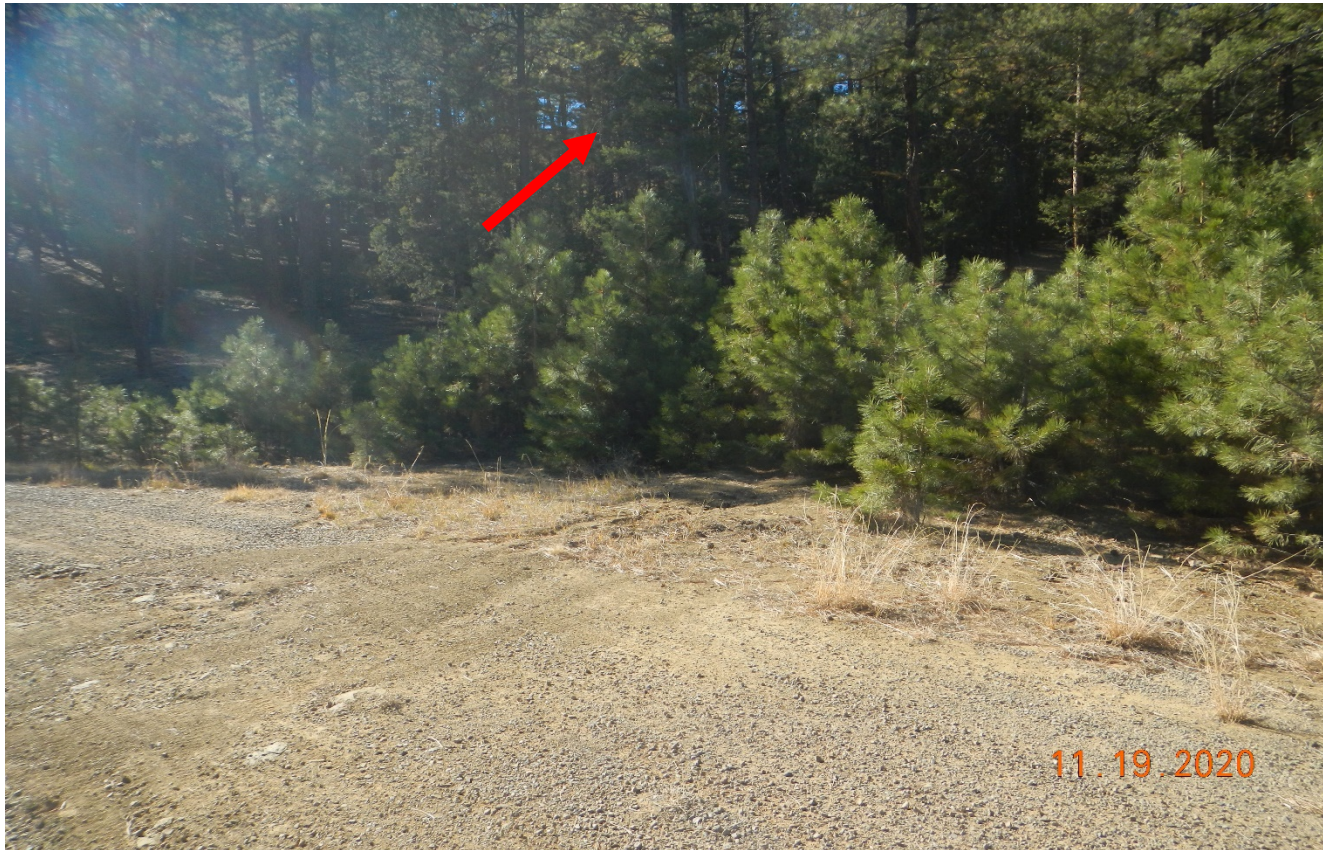
**Photo 5.** The arrow points to the area shown in photo 3. Stormwater is directed to this area from the access road above.

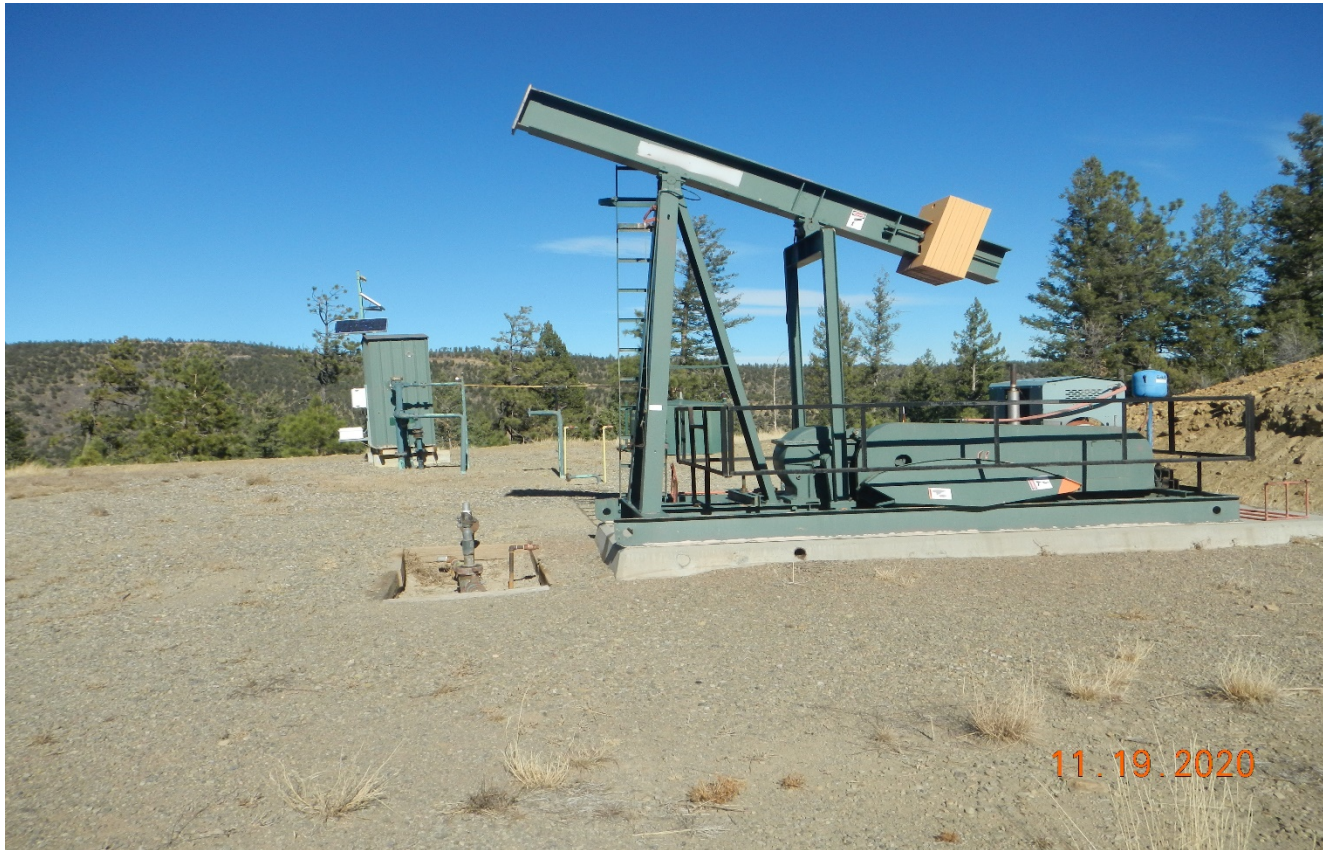
**Photo 6.** Facing north toward the location.
