Inspection Photos

API: 071-07204

Operator: TIMBER CREEK OPERATING
OGRIS OPERATING LLC

Inspection Date: 11/19/2020

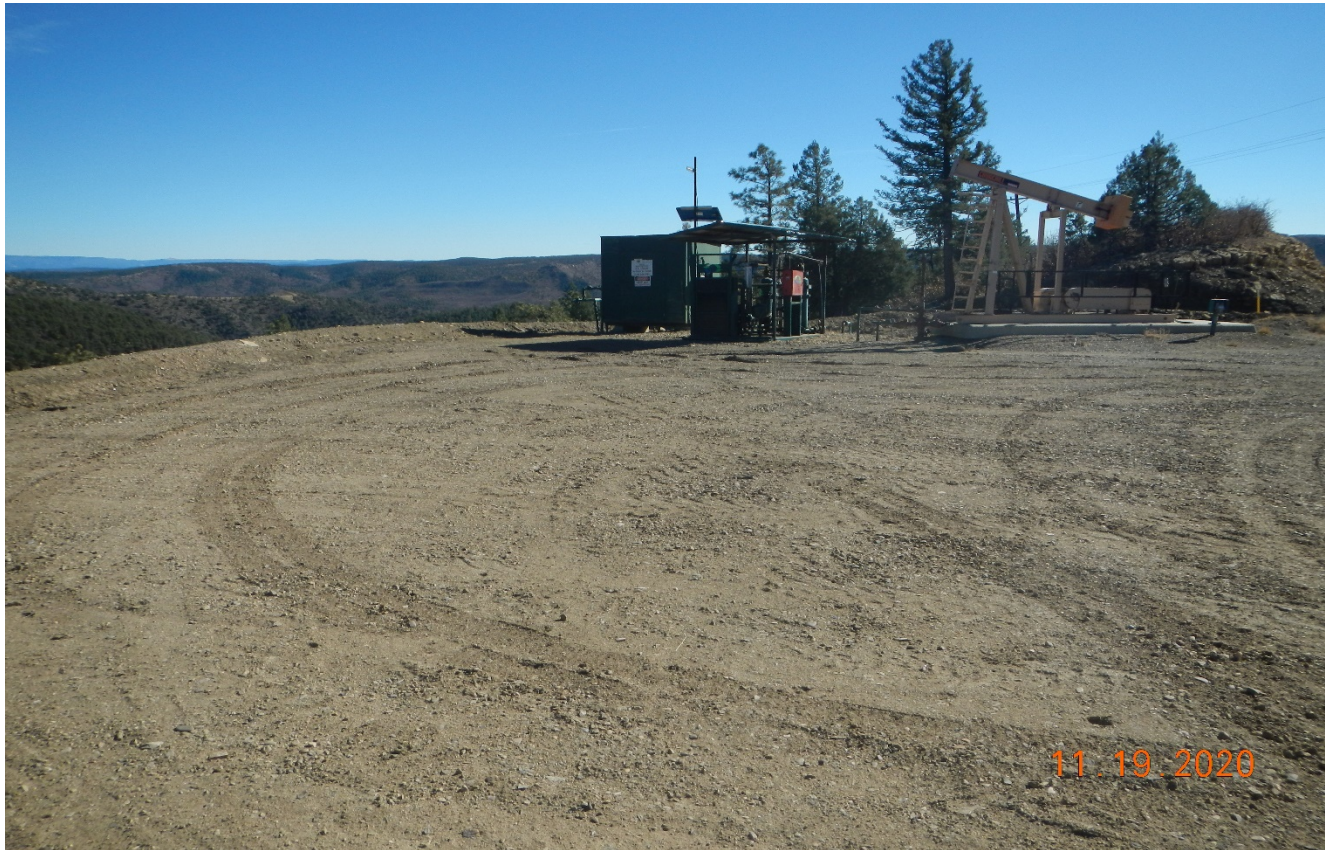
Photo 1. Facing toward the location.

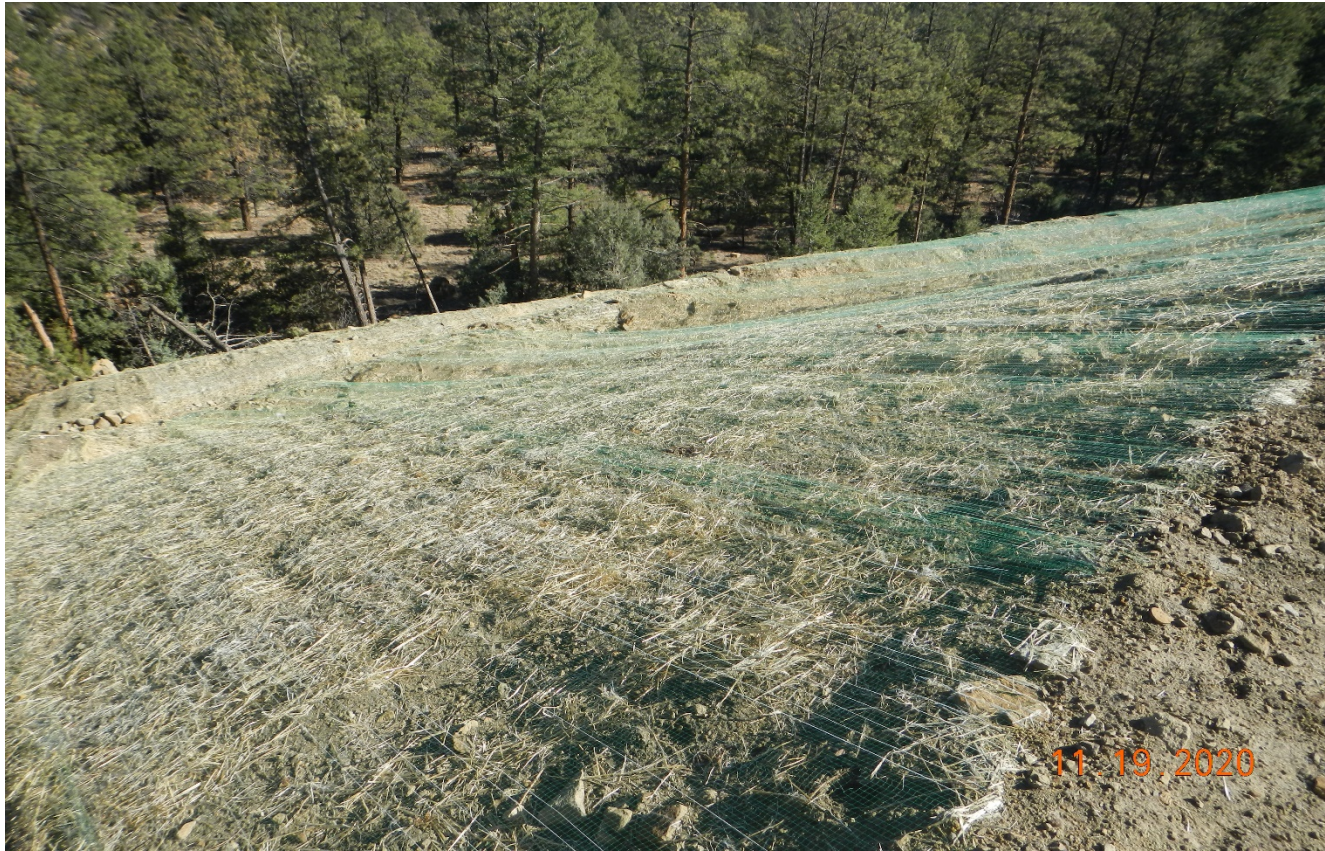
Photo 2. The pad which had sloughed has been recontoured and straw blanket was installed.

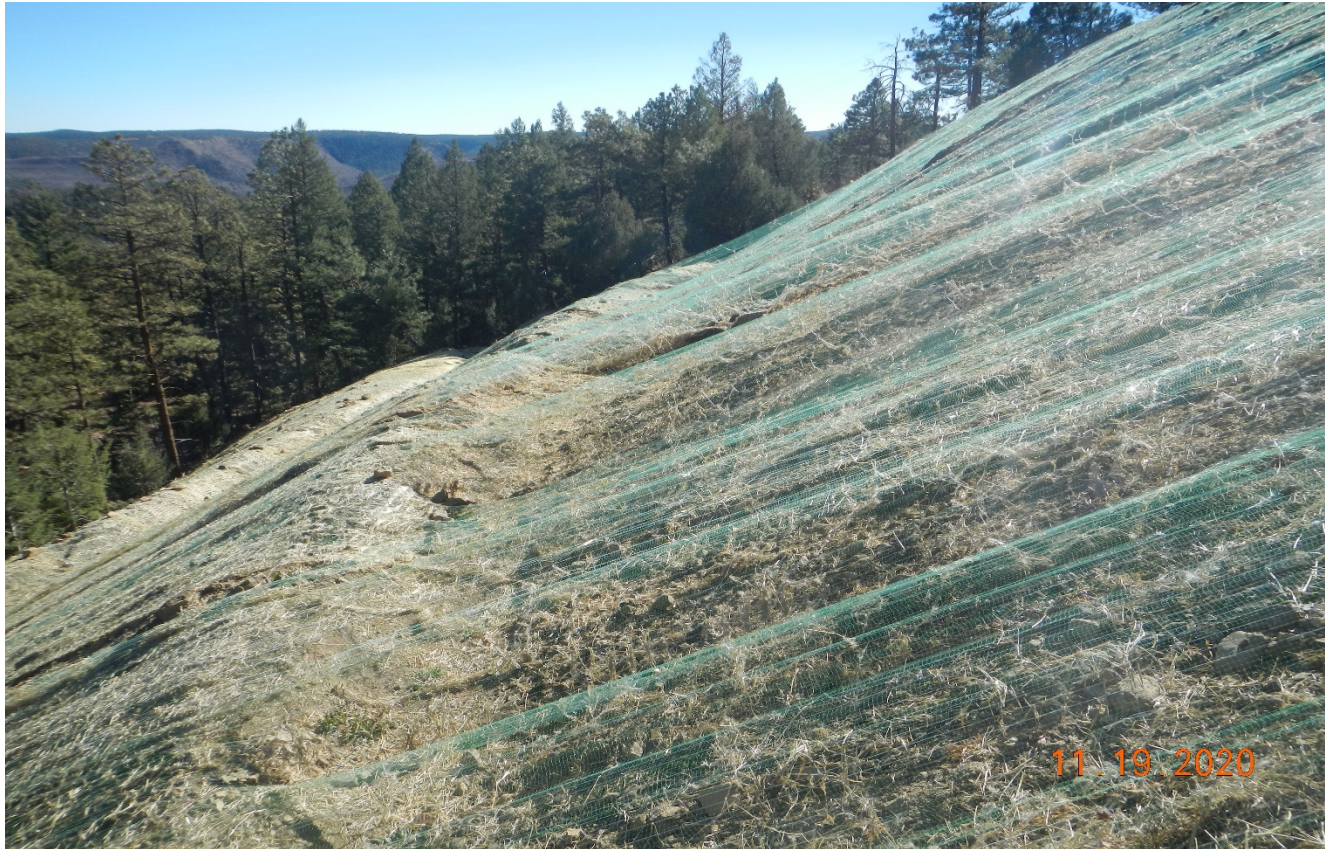
Photo 3. The straw blanket is stretched out likely due to soil movement.

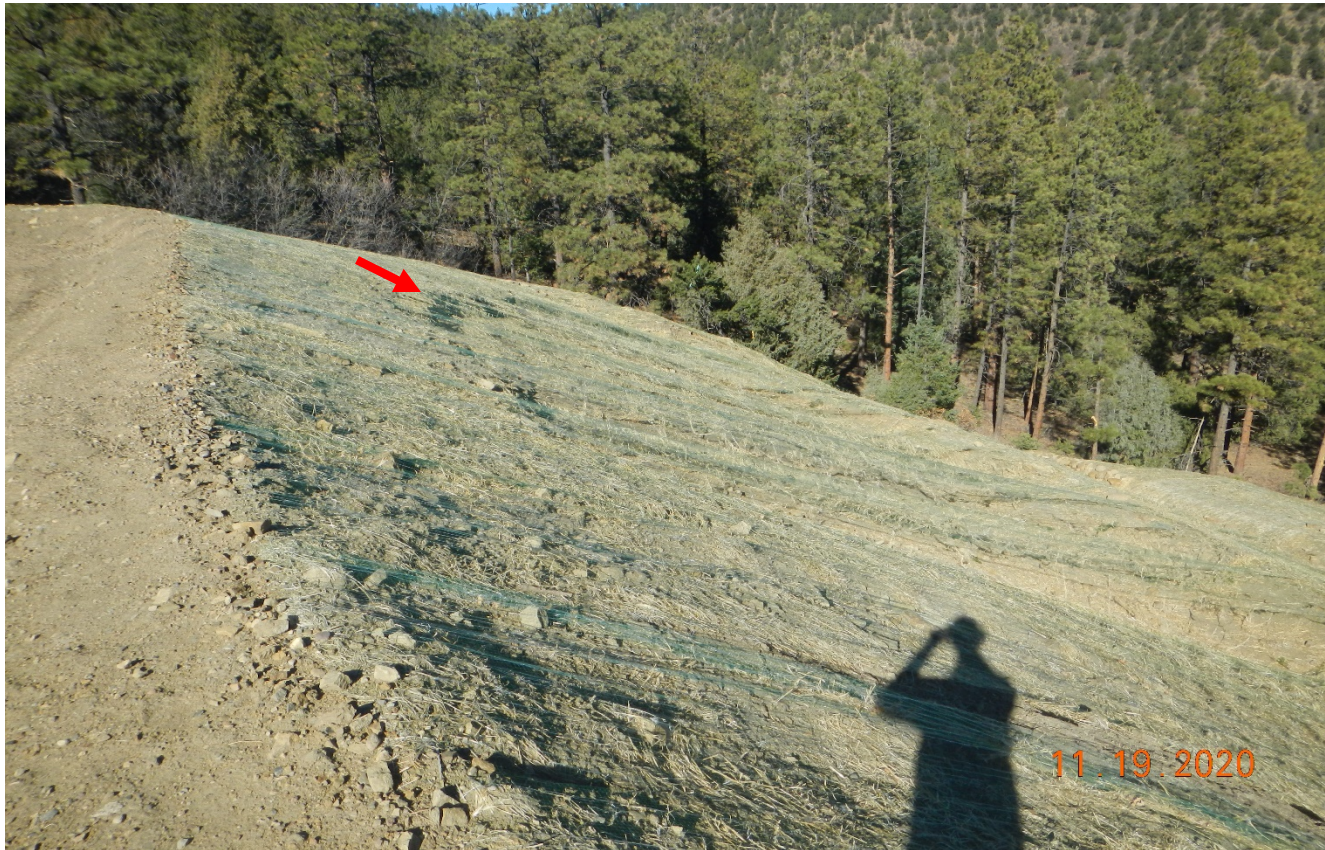
Photo 4. Facing northeast. The arrow points to an outline in the embankment which appears soil has moved. This area needs to be monitored for stabilization.

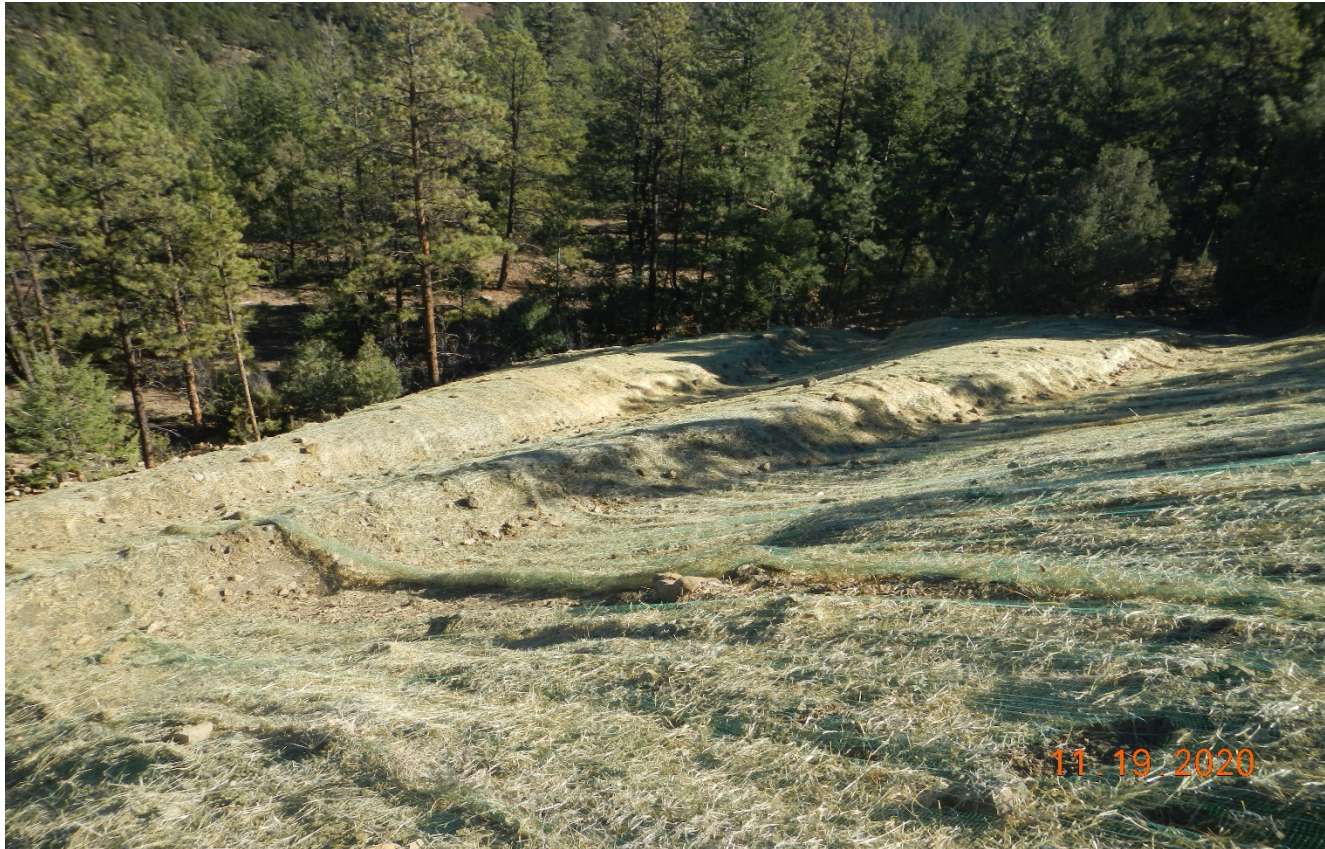
Photo 5. Facing southeast toward the fill slope of the pad.
