**FOUR CORNERS ENERGY LLC – 10754**  
**API# 05-033-06063 SANTA FE CANYON-FEDERAL #42-14**  
**Inspection Date 11/19/2020**

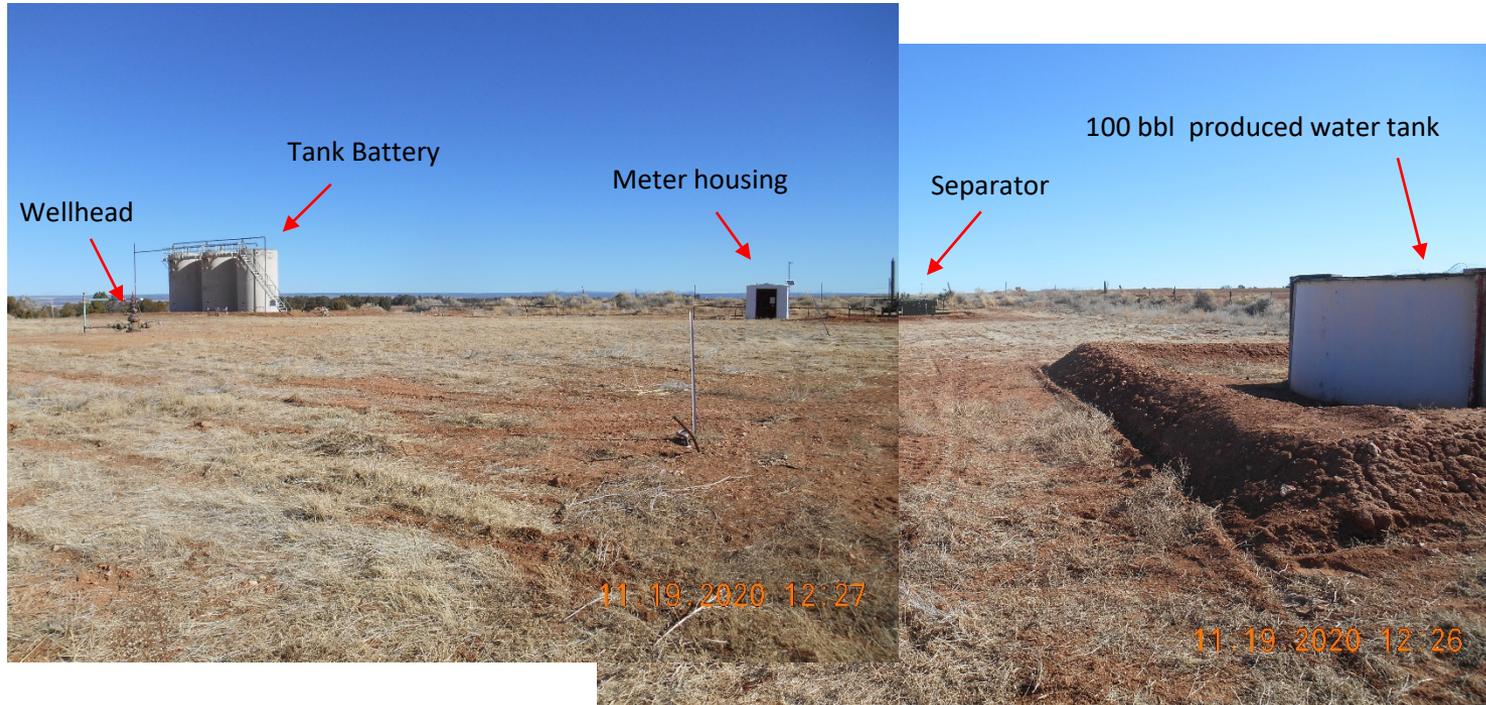
**Location overview from SW anchor marker looking NE (left) to SE (right)**

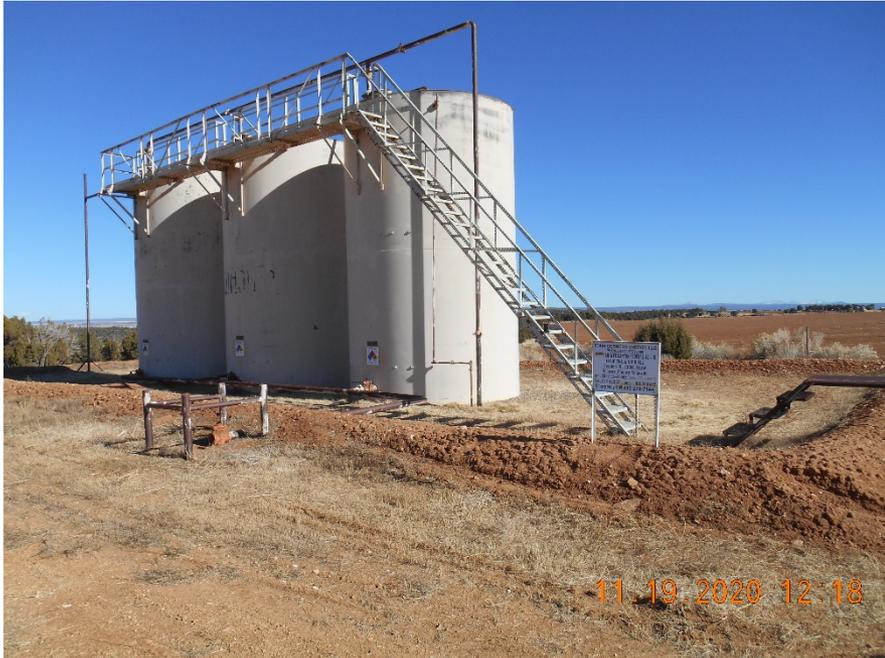
**Sign at SW corner of tank battery.  
Operator information updated**

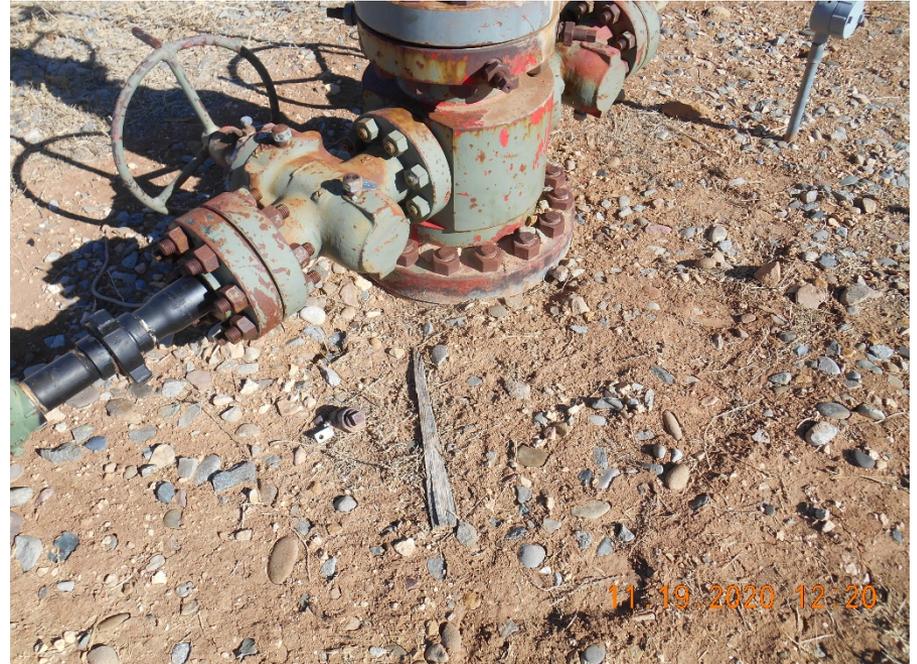
**Shut in wellhead.  
Bradenhead valve plumbed to surface.**

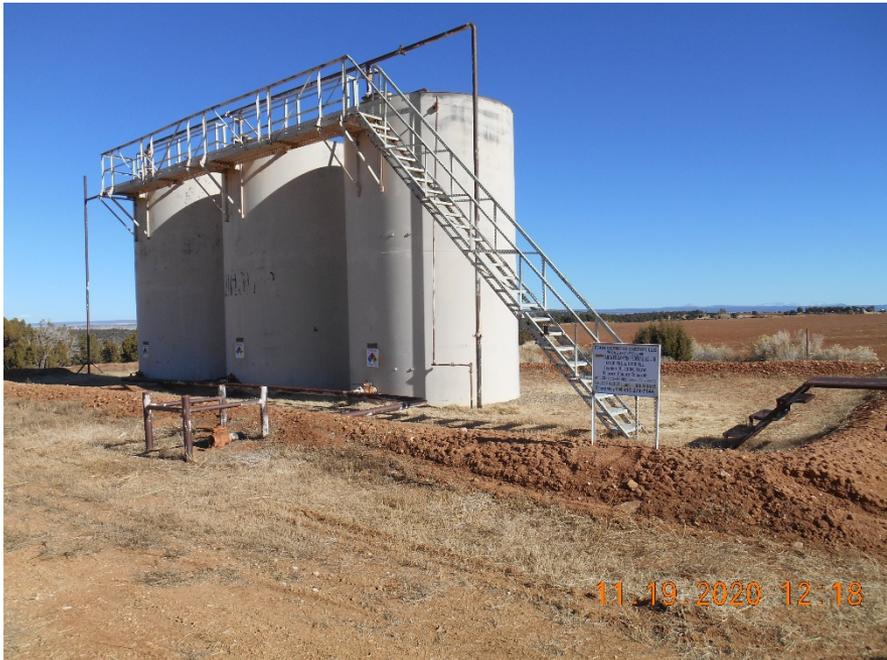
**Tank Battery with earth berms.  
Weeds removed.**

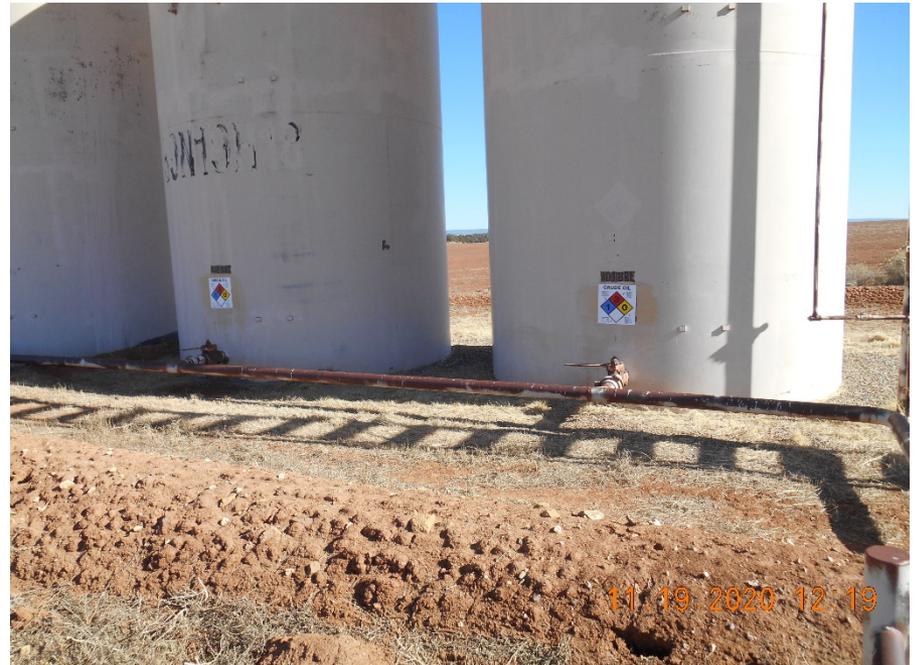
**Tank Battery with proper tank labels.**

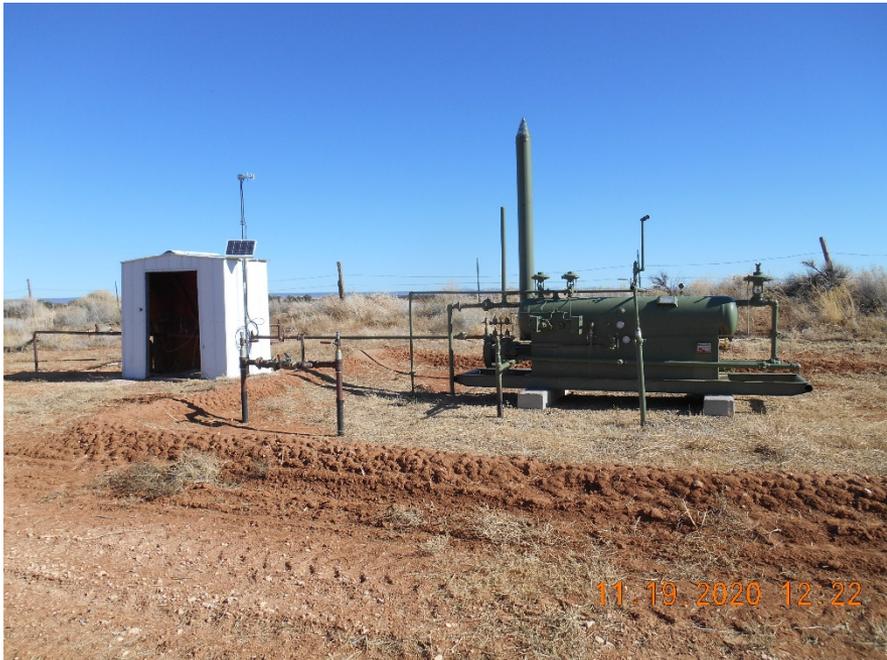
**Separator with earth berms.**  
**Weeds removed.**

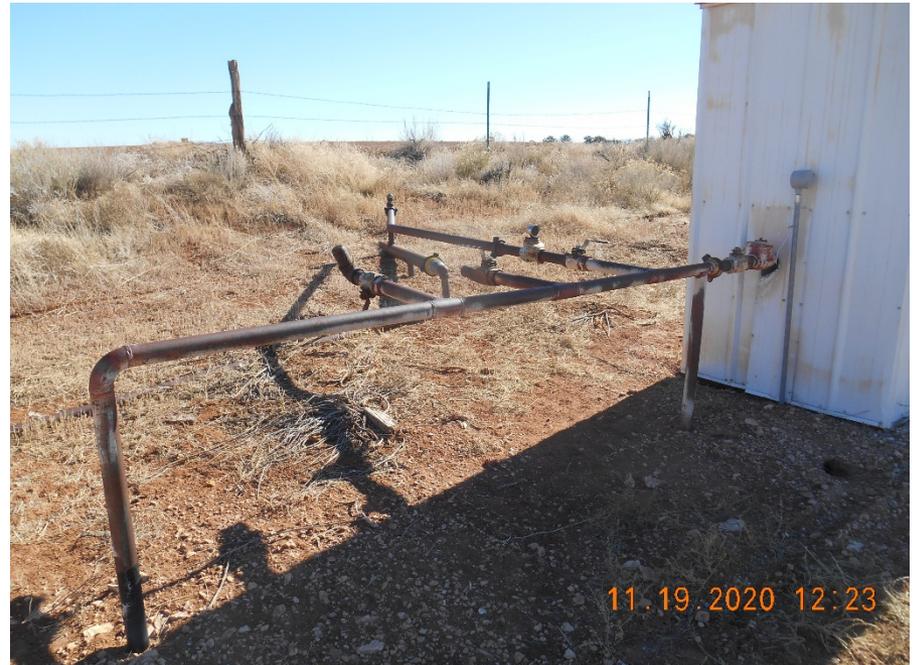
**Meter housing and off location flowlines**

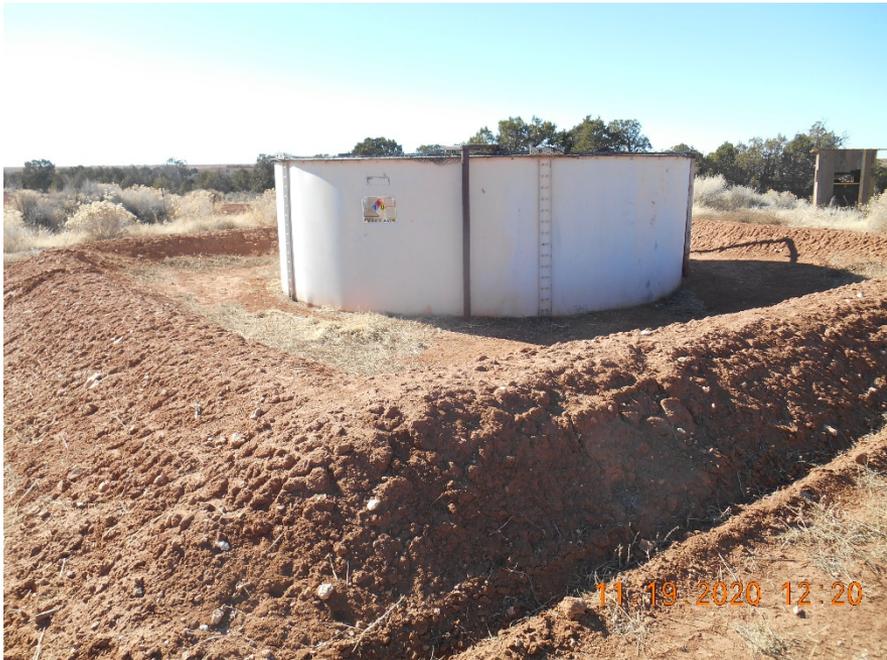
**100 bbl produced water tank ½+ full of oil/water.  
Berms repaired.**

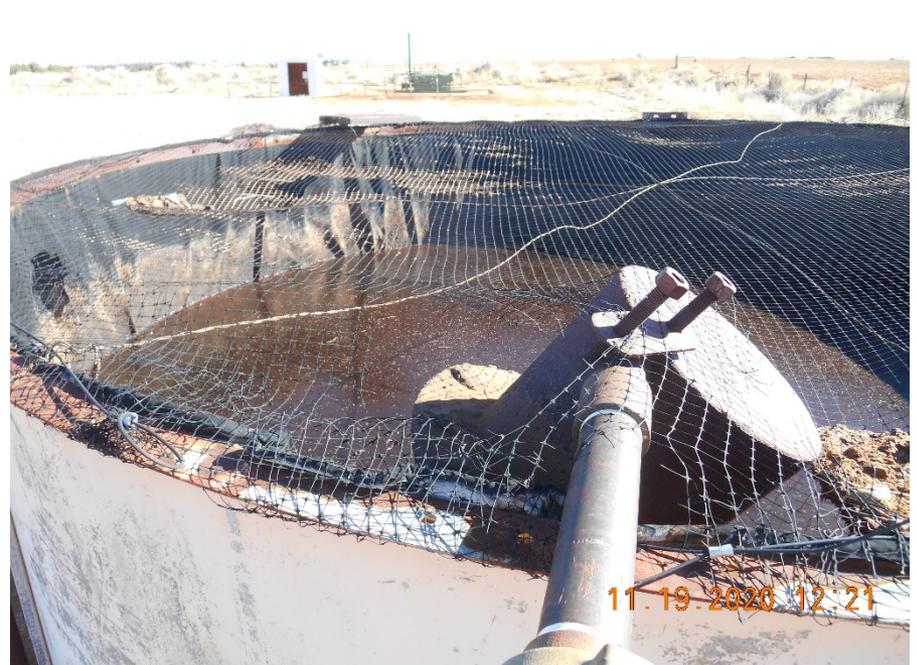
**Oil/water level in produced water tank  
wth less than 2 feet freeboard.**

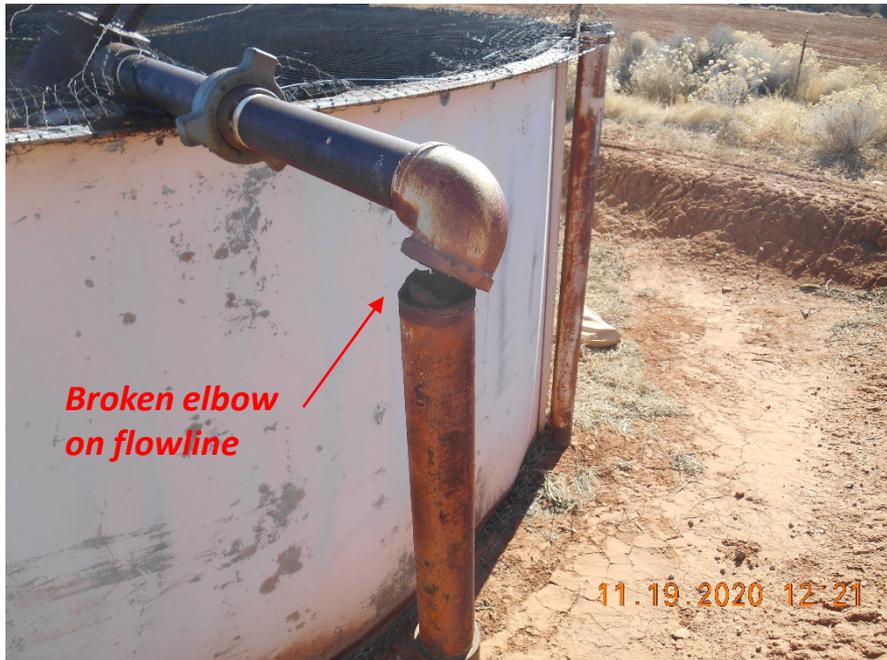
**Close up of Broken elbow on flowline.**
