Inspection Photos

11/19/2020

Operator: SG INTERESTS I LTD # 77330

Location ID: 418697

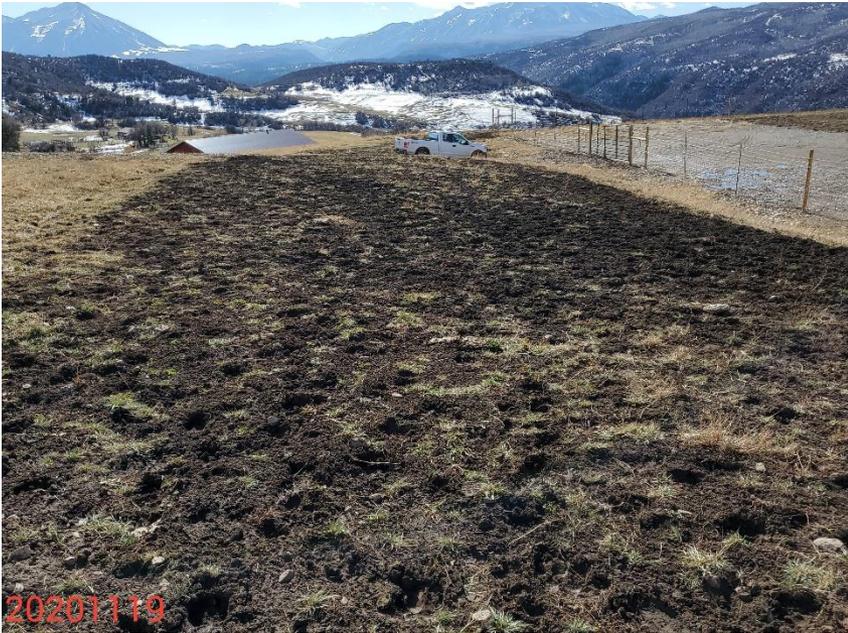
Photo 1: Photo taken from the north east corner of the Location, facing south. Photos 1-3 provide an overview of the Location from south, southwest to west.

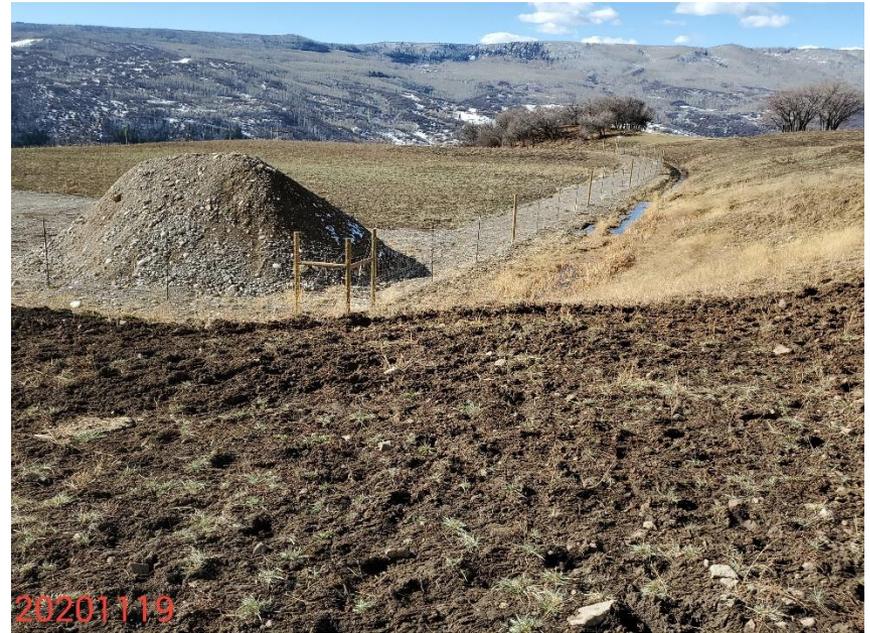
Photo 2: See comments under photo 1.

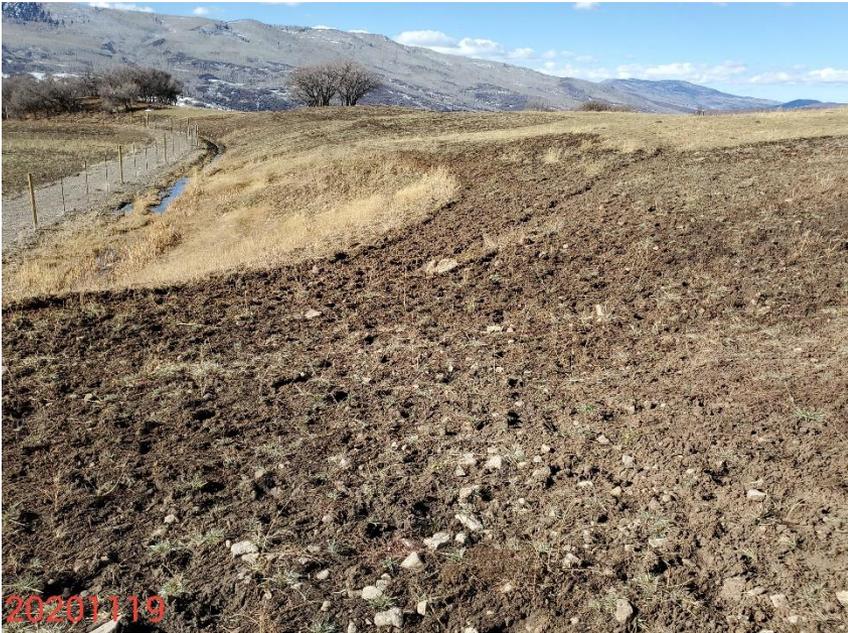
Photo 3: See comments under photo 1.

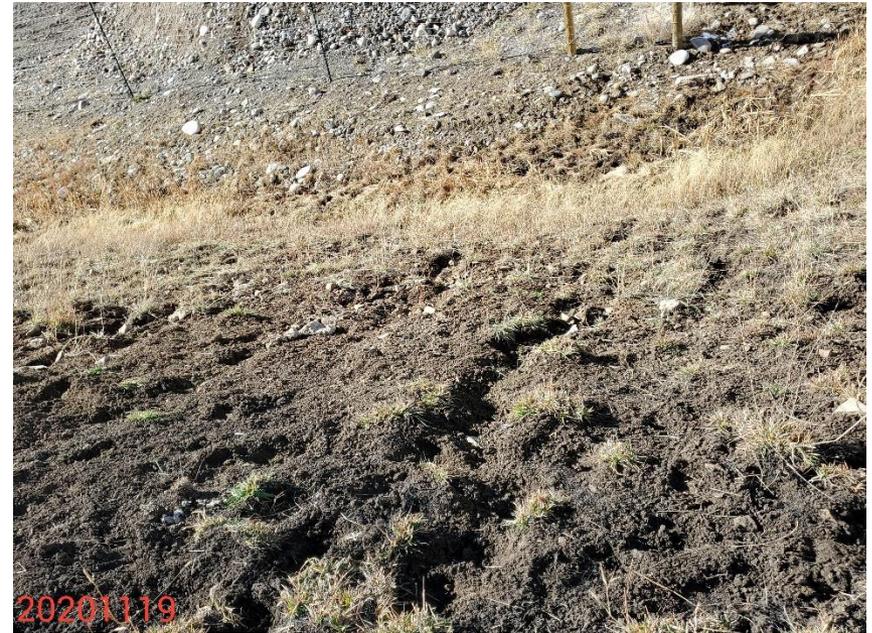
Photo 4: Photo taken from the cut slopes on the northeast corner of the Location. Photo shows BMPs remain missing or insufficient to stabilize and protect slopes.

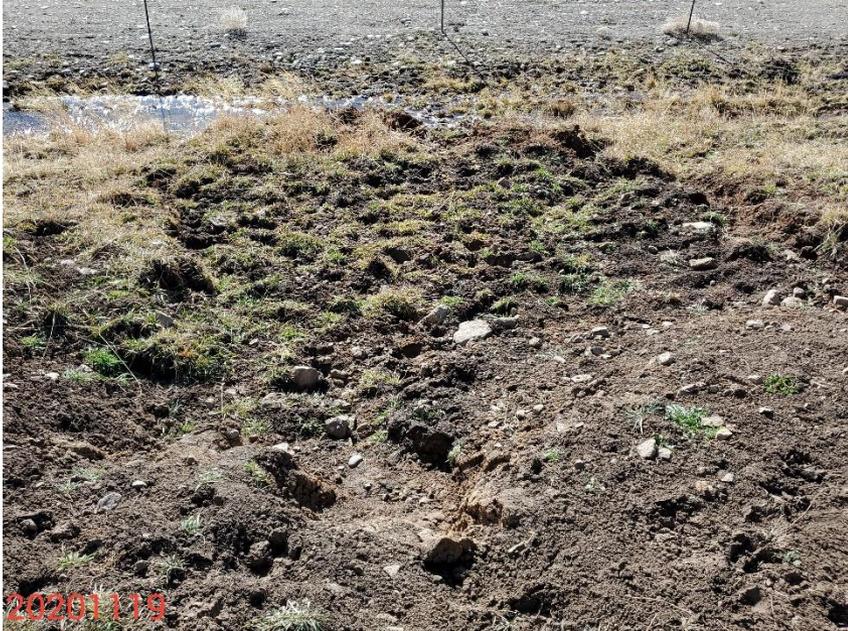
Photo 5: Photo taken from the slopes on the north end of the Location. Photo shows erosion degradation on the northern cut slope. BMPs remain missing or insufficient to stabilize and protect slopes.

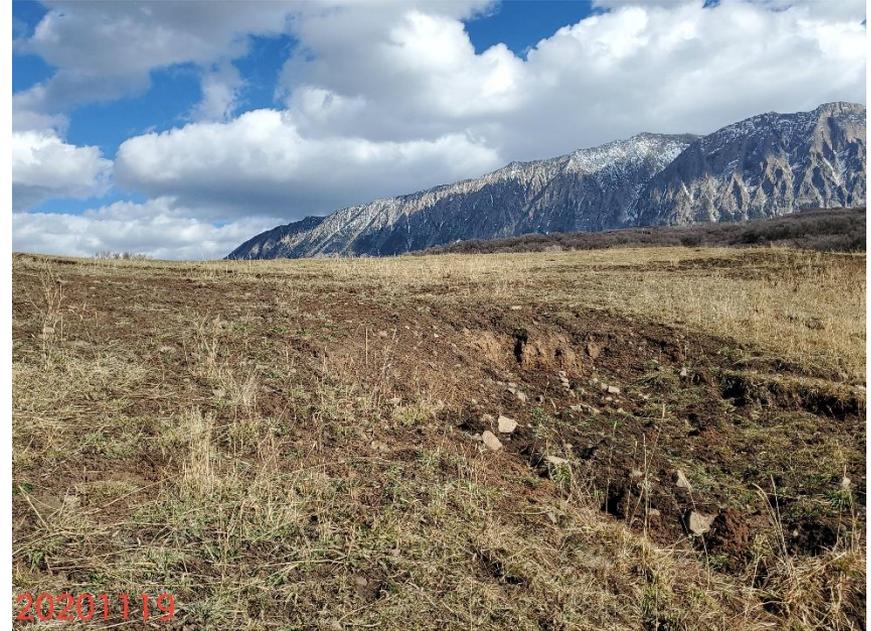
Photo 6: Photo taken from the slopes on the north end of the Location, facing northwest. Photo shows erosion degradation on the northern cut slope. BMPs remain missing or insufficient to stabilize and protect slopes.

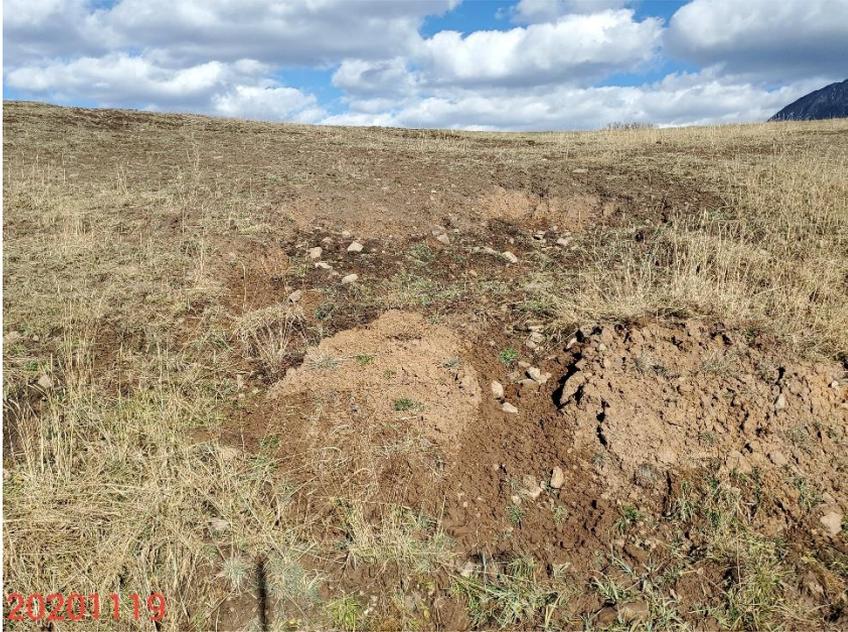
Photo 7: Photo taken from the slopes on the north end of the Location, facing north. Photo shows erosion degradation on the northern cut slope. BMPs remain missing or insufficient to stabilize and protect slopes.

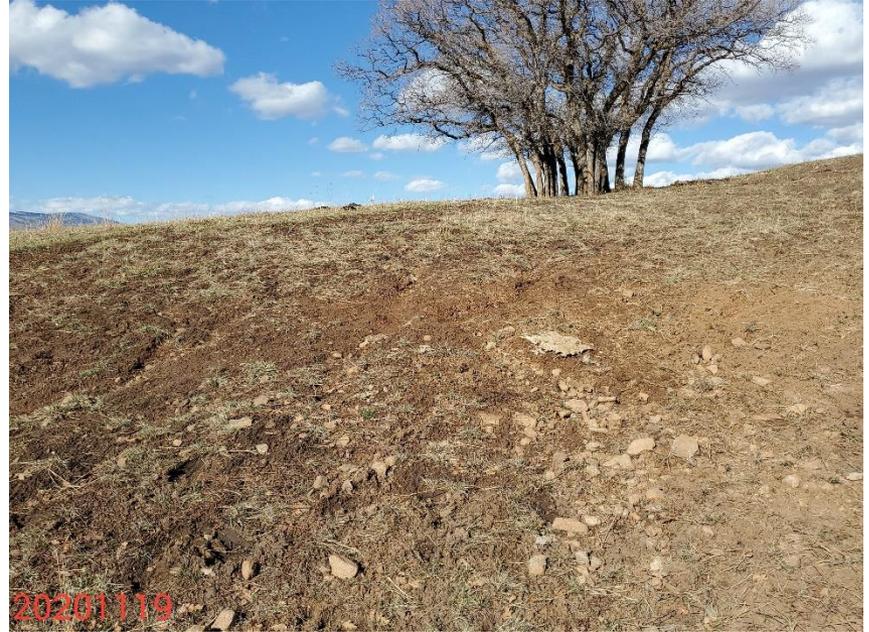
Photo 8: Photo taken from the slopes on the northeastern area of the Location, facing northwest. Photo shows erosion degradation on the northern cut slope. BMPs remain missing or insufficient to stabilize and protect slopes.

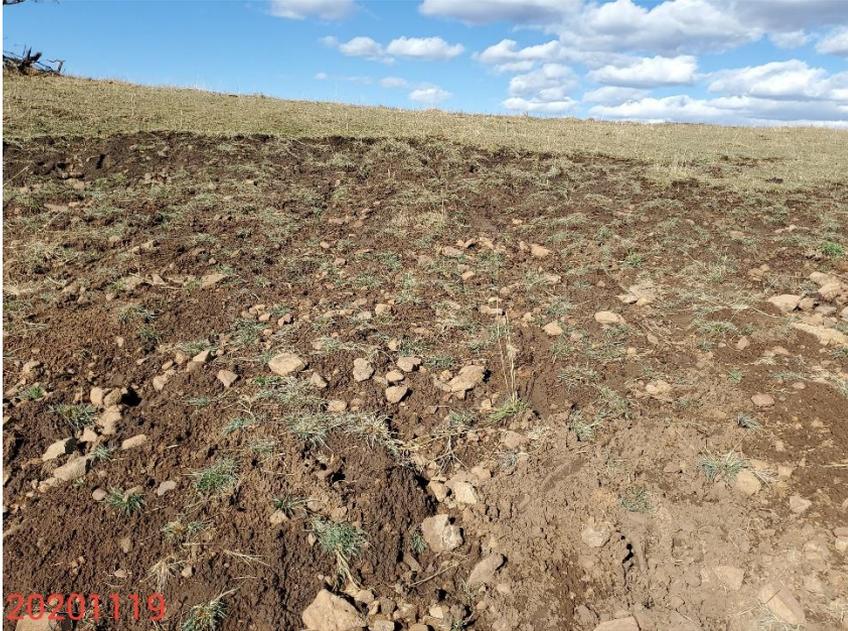
Photo 9: Photo taken from the slopes on the northwestern area of the Location, facing north. Photo shows erosion degradation on the northern cut slope. BMPs remain missing or insufficient to stabilize and protect slopes.

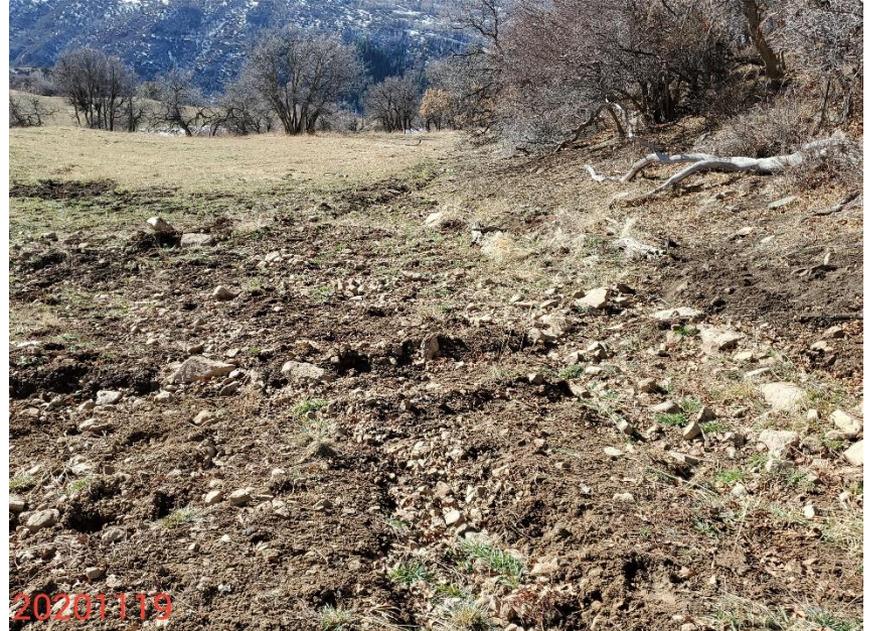
Photo 10: Photo taken from the northwestern end of the Location, facing west. Photo shows ditch BMPs. Photo shows ditch has not been constructed in accordance with good engineering practices. No outlet observed to allow for sediment laden-free stormwater discharge.

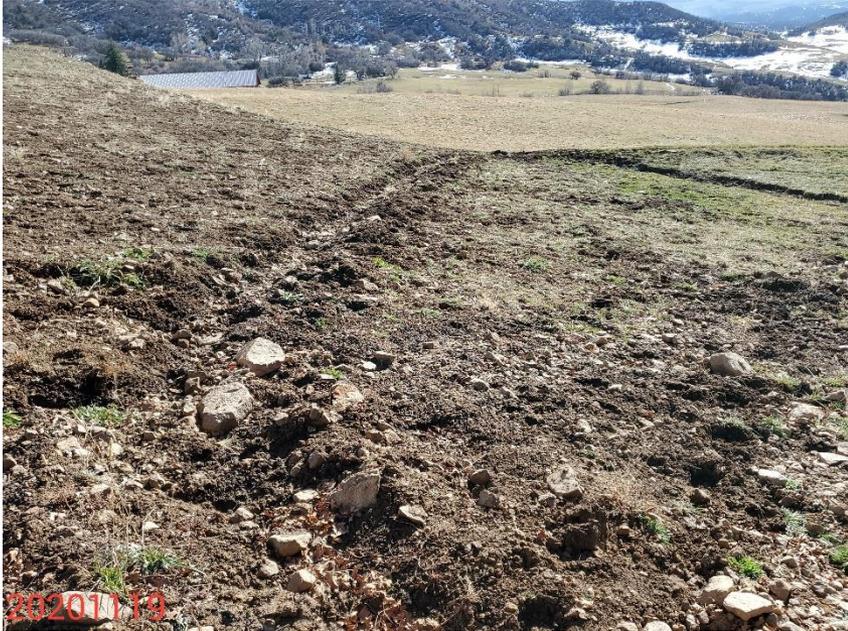
Photo 11: Photo taken from the northwestern end of the Location, facing south. Photo shows ditch BMPs. Photo shows ditch has not been constructed in accordance with good engineering practices.

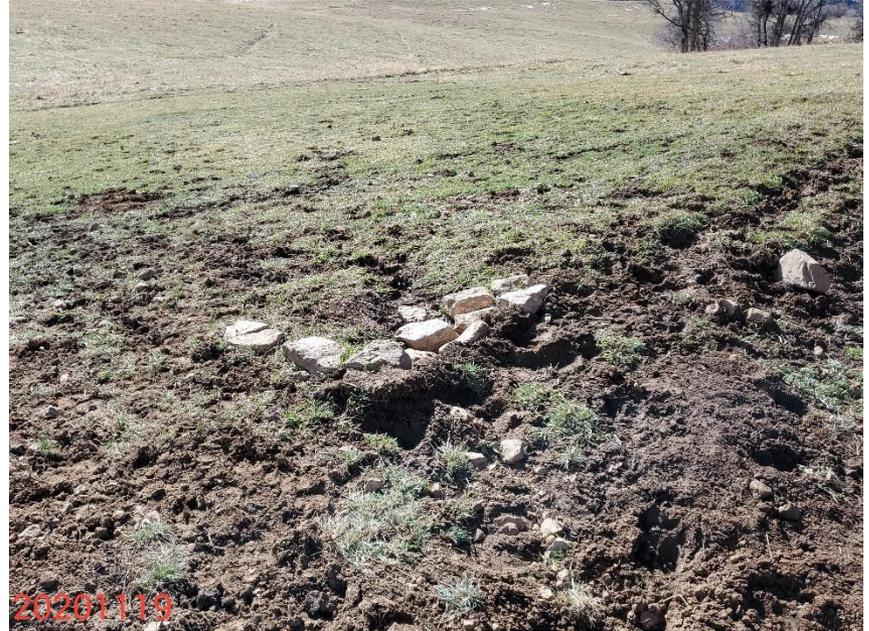
Photo 12: Continued from photo 11. Photo shows outlet at ditch. BMP insufficient as an appropriate outlet to allow for sediment laden-free stormwater discharge.

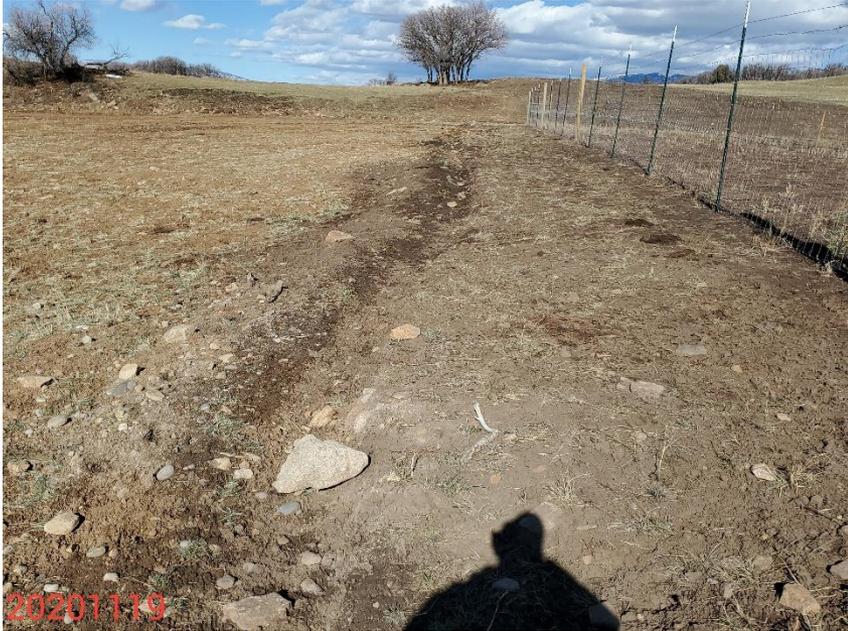
Photo 13: Photo taken from the southwest corner of the Location, facing north. Photo shows perimeter stormwater ditch. Ditch BMP has not been constructed in accordance with good engineering practices; BMP ends on the southwest end of the location and does not have a sufficient outlet to allow for sediment laden-free stormwater discharge.

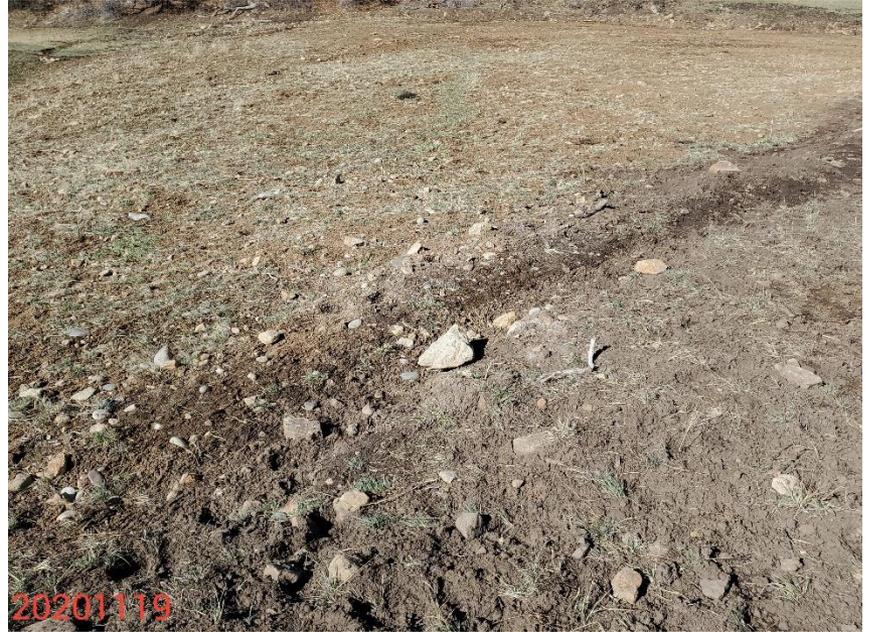
Photo 14: See comments under photo 13.

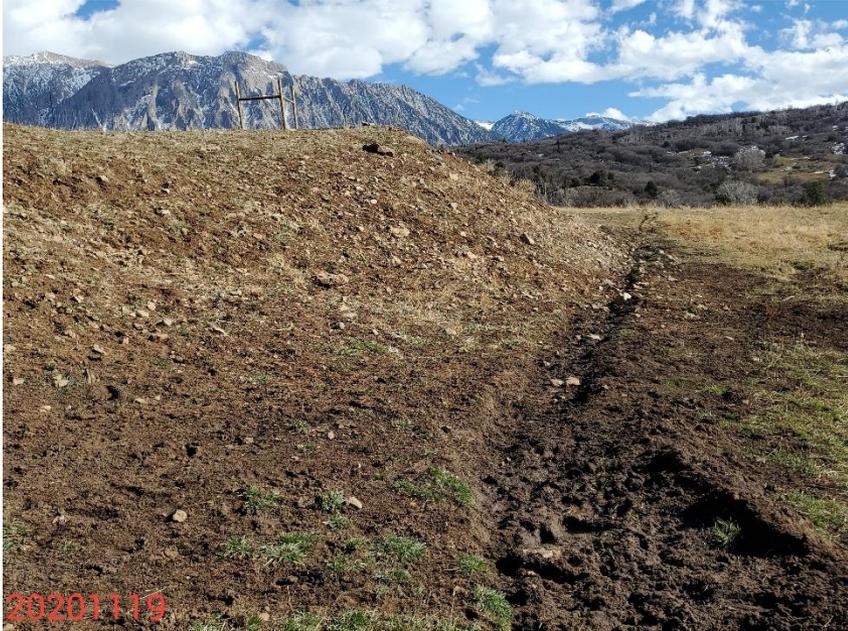
Photo 15: Photo taken from the southwest end of the Location, facing east. Photo shows fill slopes below ditch (photo 13). Photo shows BMPs remain missing or insufficient to protect slopes, and allow for sediment laden-free stormwater discharge from the ditch.

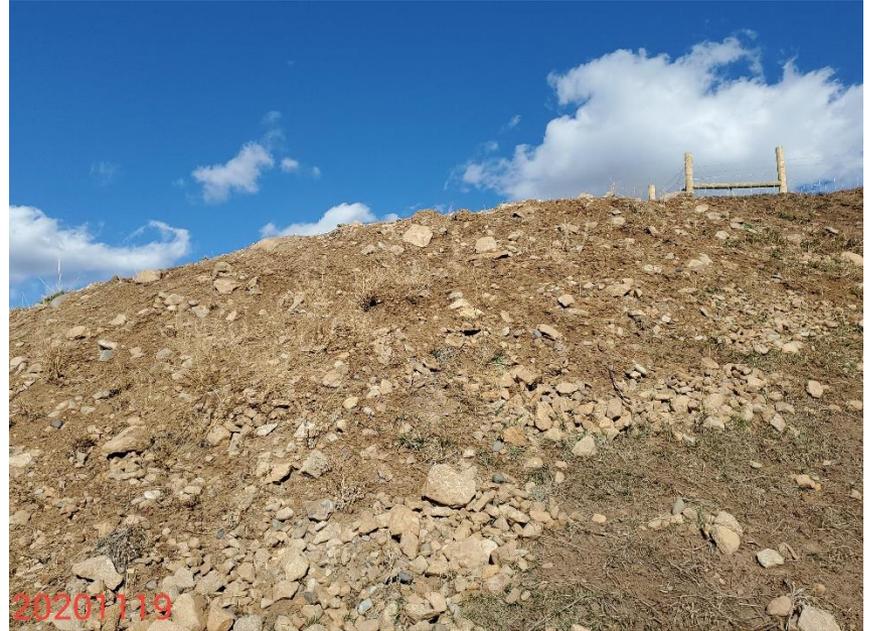
Photo 16: See comments under photo 15.
