Inspection Photos

11/19/2020

Operator: SG INTERESTS I LTD # 77330

Location ID: 429333

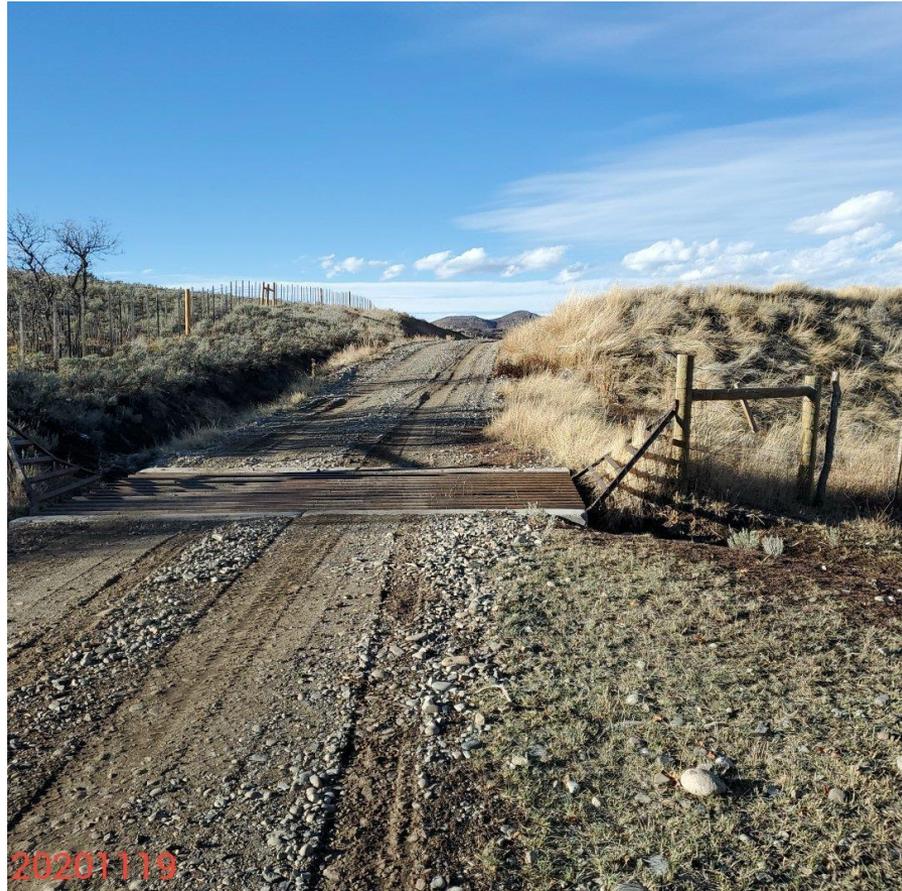
Photo 1: Photo taken from the Location entrance, facing north. Photo shows signage required per Delayed IR Form 4 #401721716 conditions has not been posted, or is not plainly visible.

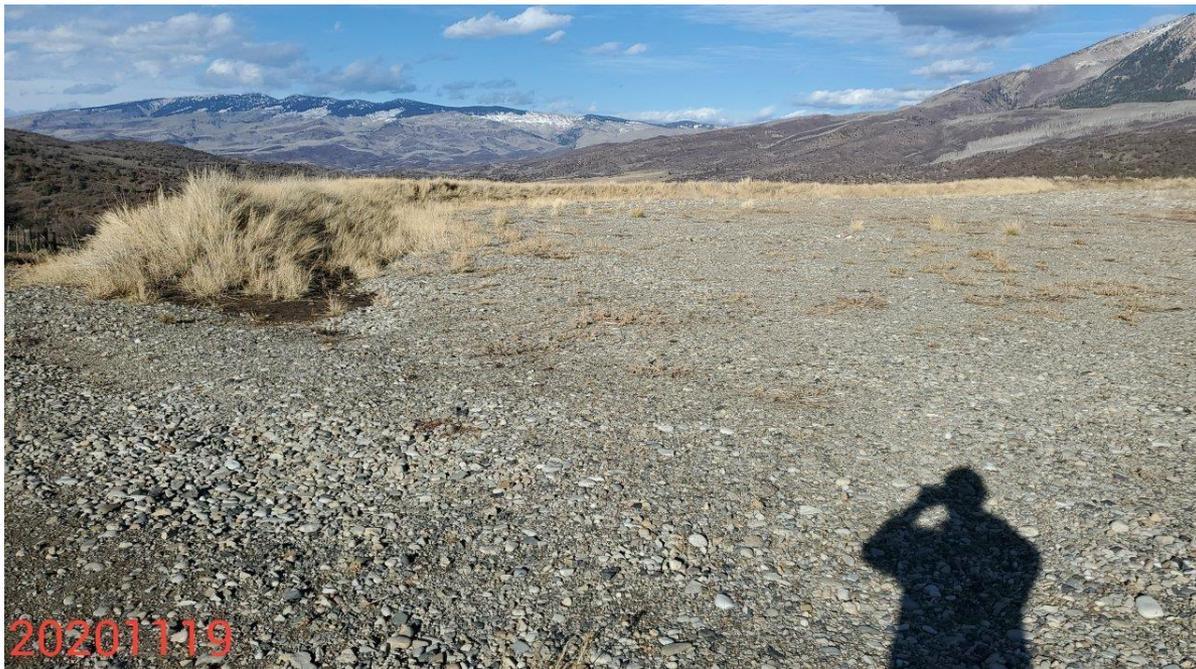
Photo 2: Photo taken from the northwest end of the Location, facing northeast. Photos 2-3 provide an overview of the Location from northeast, southeast to south.

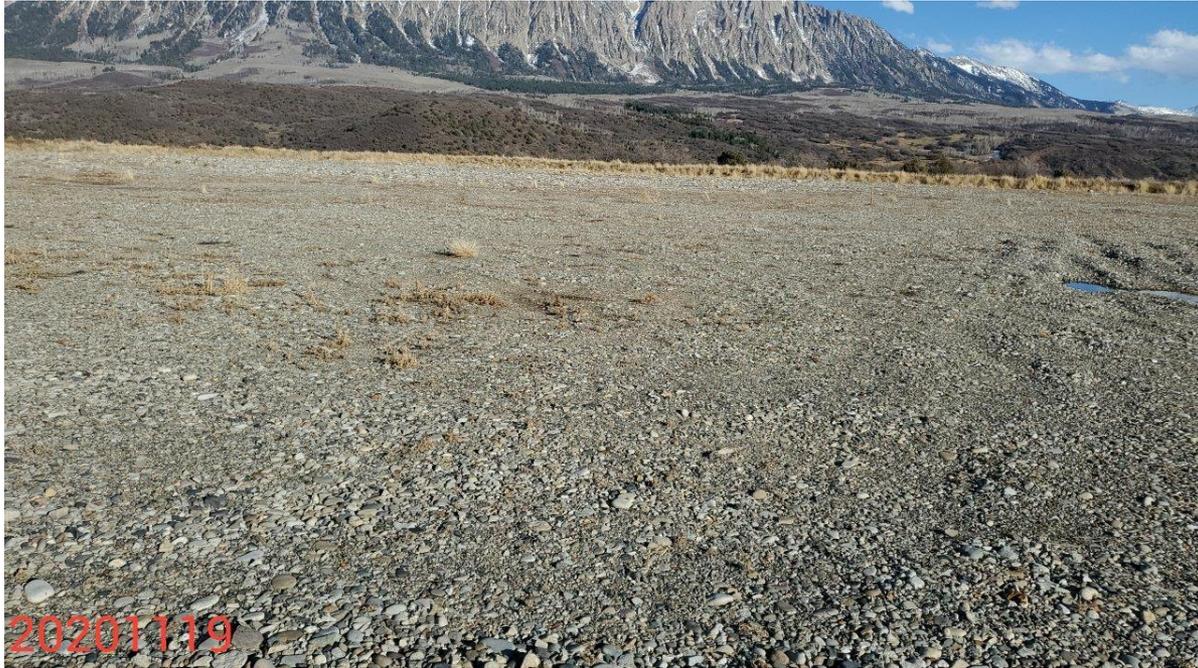
Photo 3: See comments under photo 2.

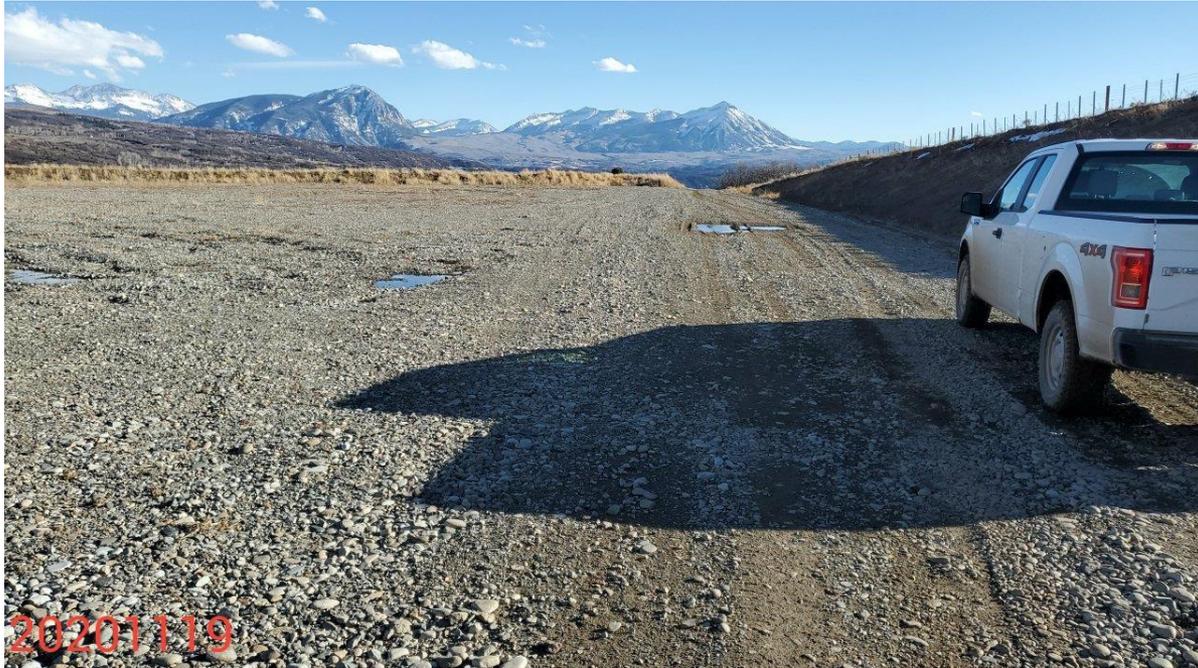
Photo 4: See comments under photo 2.

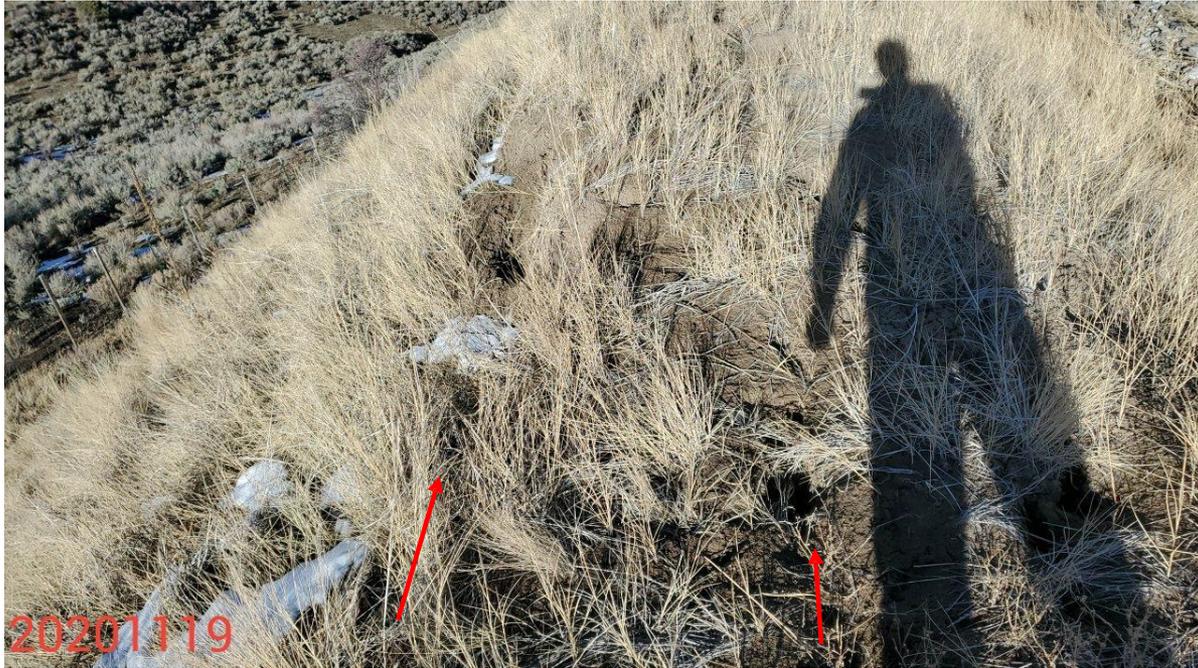
Photo 5: Photo taken from the top of the berm along the perimeter of the pad. Photo shows example of cracking/stabilization concerns that can be observed along the entire perimeter of the Location. Cracks were observed to exceed 30 inches in areas. Ongoing stormwater monitoring/management appears insufficient.

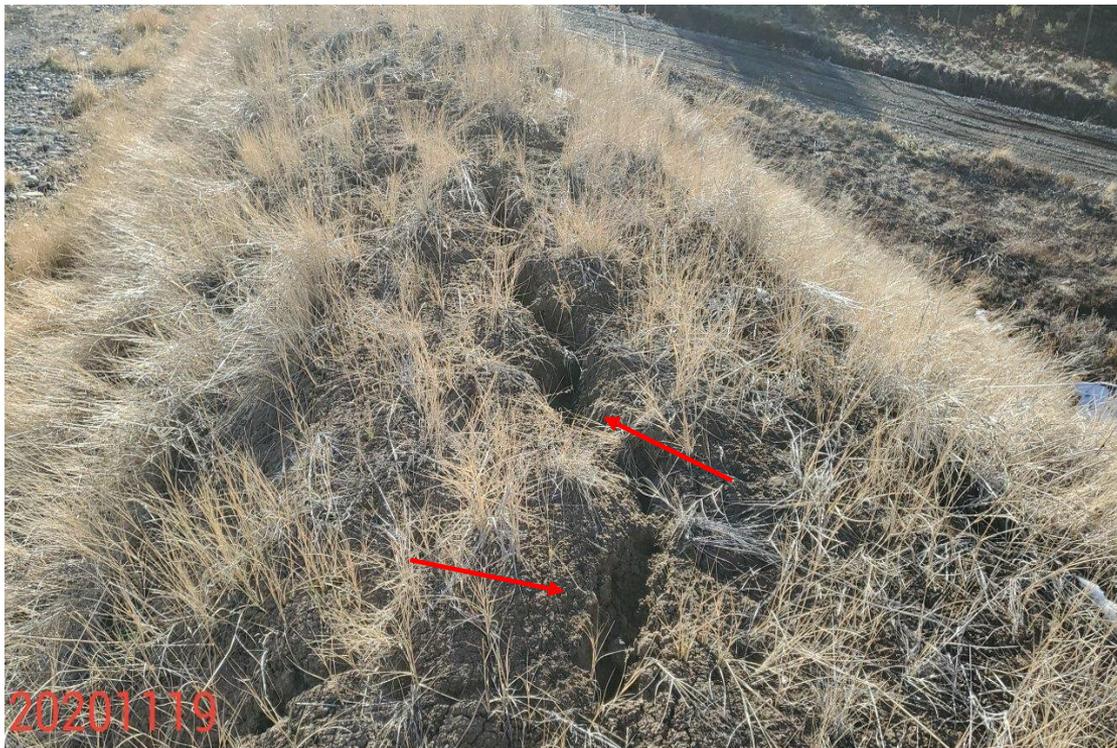
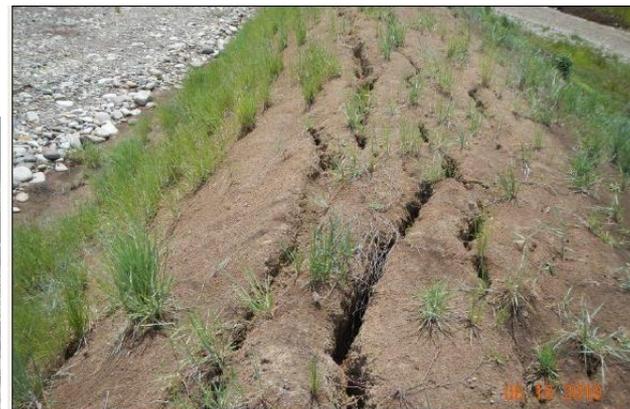
Photo 6: Photos taken from the top of the berm along the northern perimeter of the pad. Photo on right from the 6/18/2019 inspection. Side by side comparison shows that cracks observed along berms do not appear to have been repaired; Photo on left shows cracking/stabilization concerns remain evident along the perimeter of the Location. Cracks were observed to exceed 30 inches in areas. Ongoing stormwater monitoring/management appears insufficient.

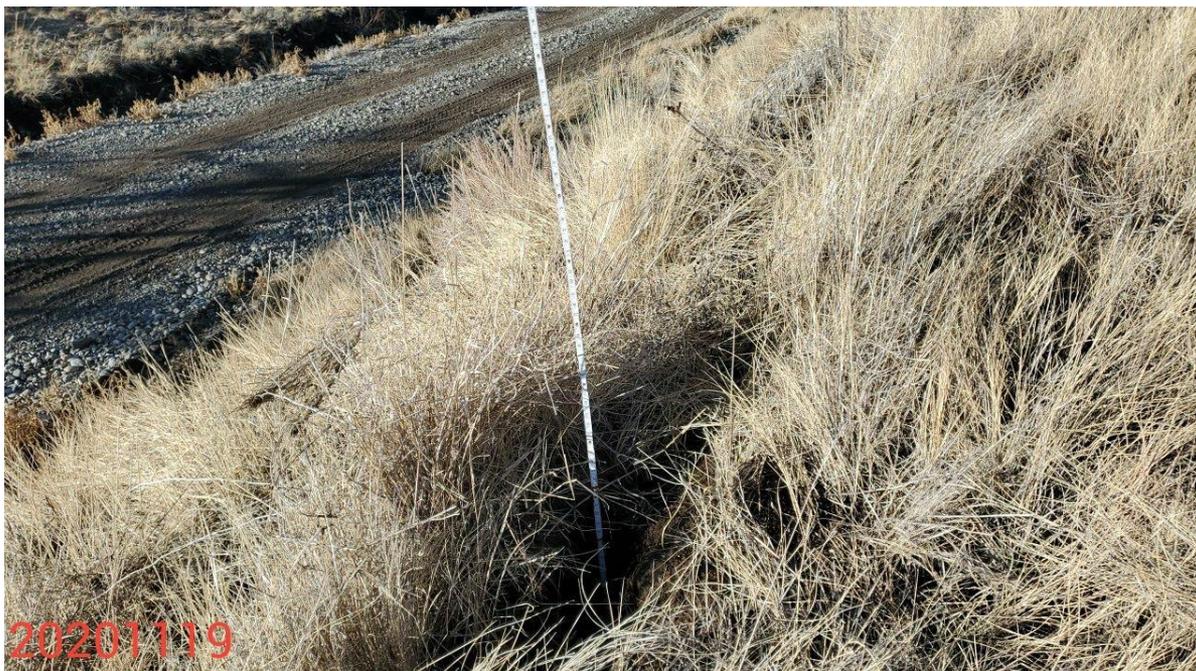
Photo 7: See comments under photo. Photo shows 6 foot measuring stick within a crack on top of the berm. Photo shows cracks were observed to exceed 30 inches in depth in some areas.

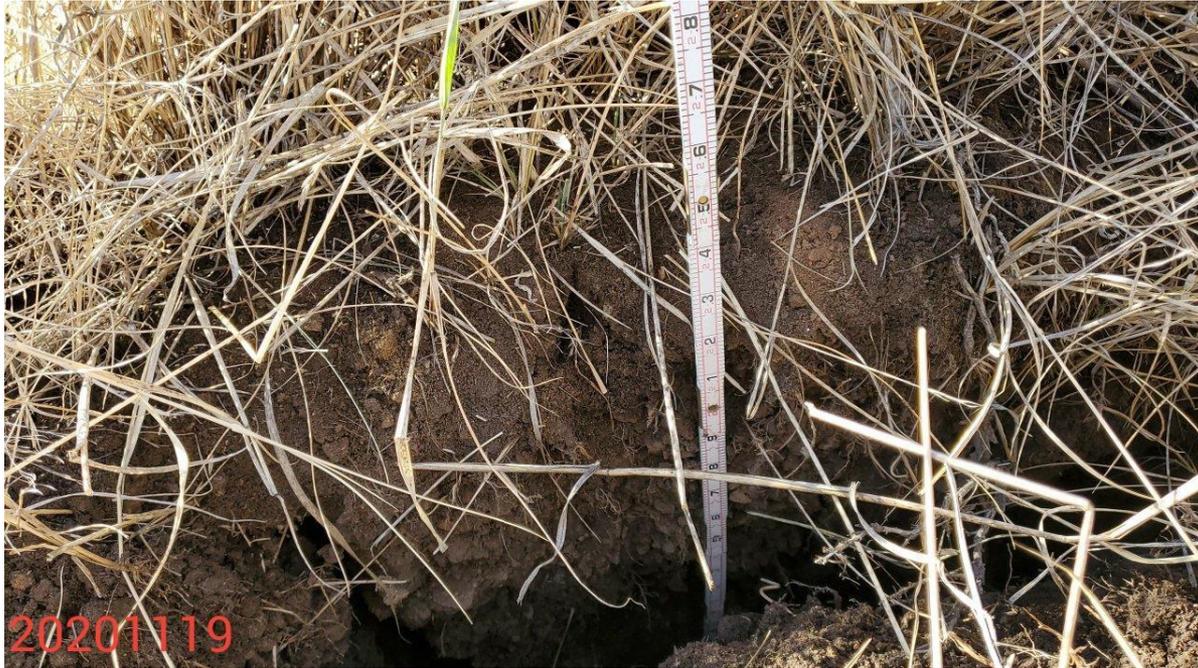
Photo 8: Continued from photo 7. Photo shows cracks were observed to exceed 30 inches in depth in some areas

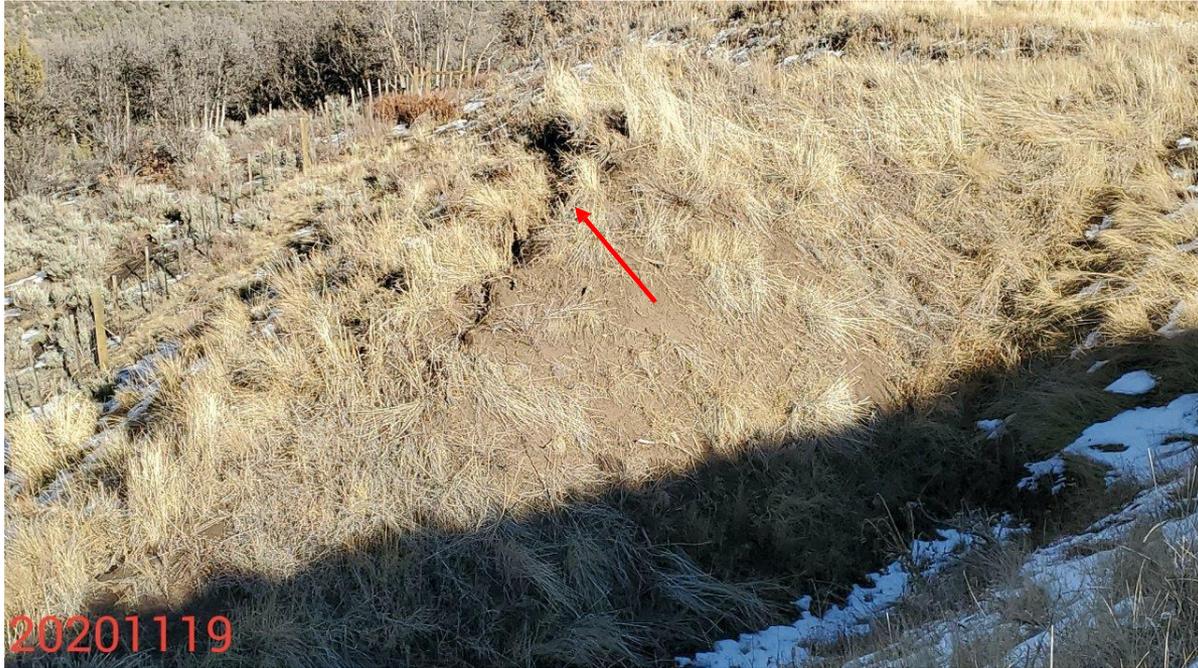
Photo 9: Photo taken from the north end of the Location, facing east. Photo shows areas where soils have not been sufficiently stabilized, and appear to be slipping.

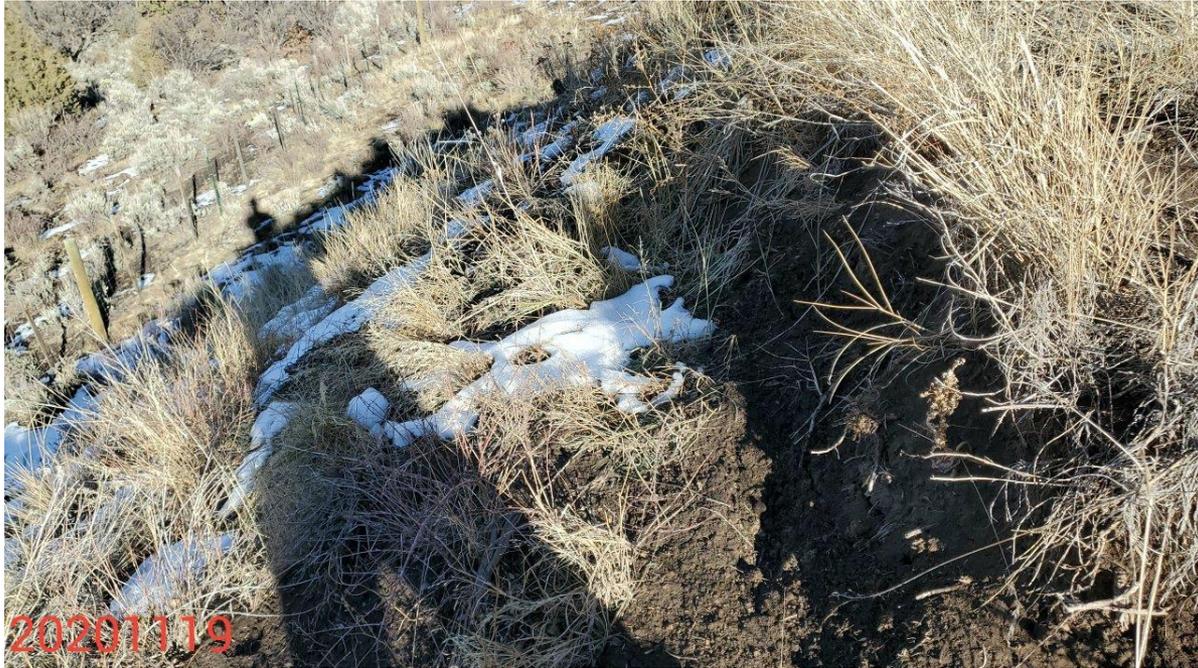
Photo 10: Continued from photo 9. Photo shows areas where soils have not been sufficiently stabilized, and appear to be slipping

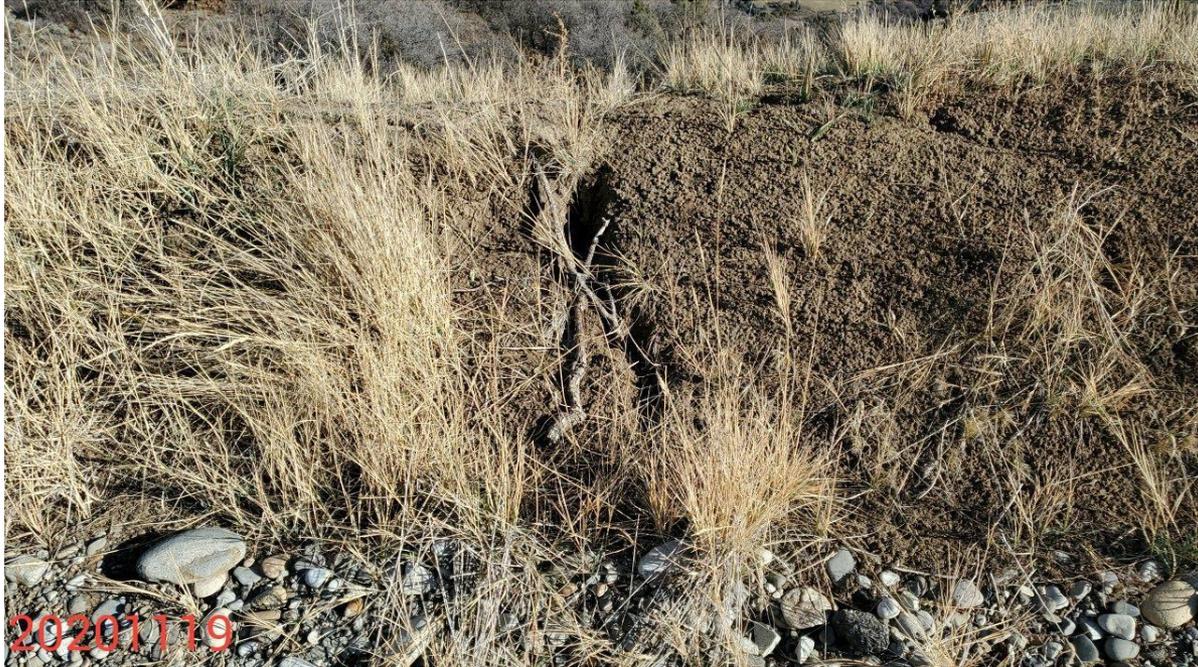
Photo 11: Photo taken from the berm on the east end of the Location. Photo shows example of cracking/erosion degradation that can be observed along the entire perimeter of the Location.

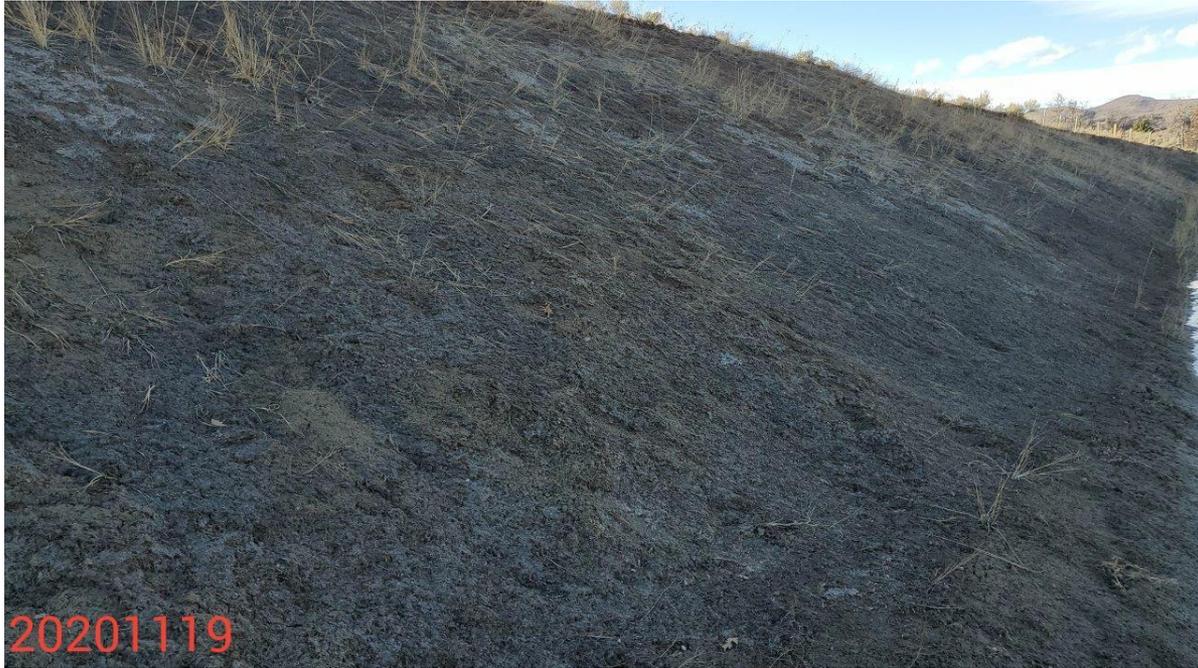
Photo 12: Photo taken from cut slopes on the west end of the Location. Operator has implemented hydromulch along cut slopes. BMP showing signs of degradation. Maintenance advised prior to failure of BMP.
