TEP ROCKY MOUNTAIN LLC
FEDERAL-67S96W 3SENW
Location ID: 334882

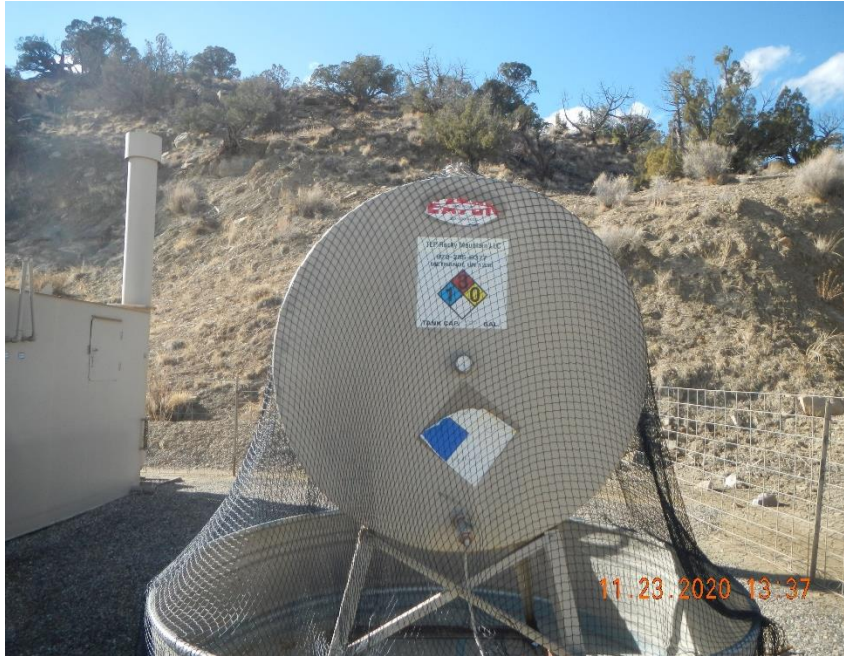
Capacity volume doesn't match font size on label.

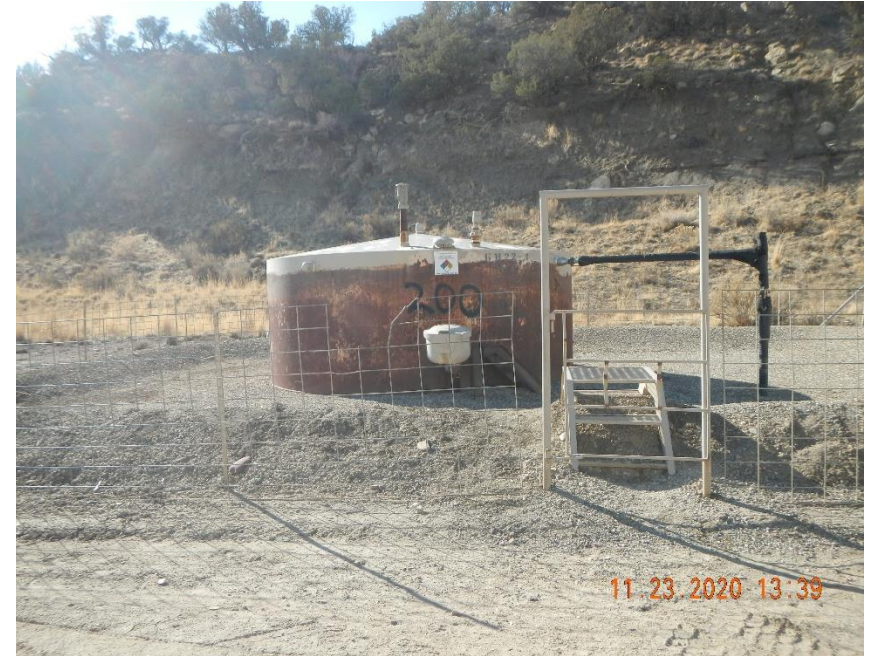
Unpainted tank is rusting.

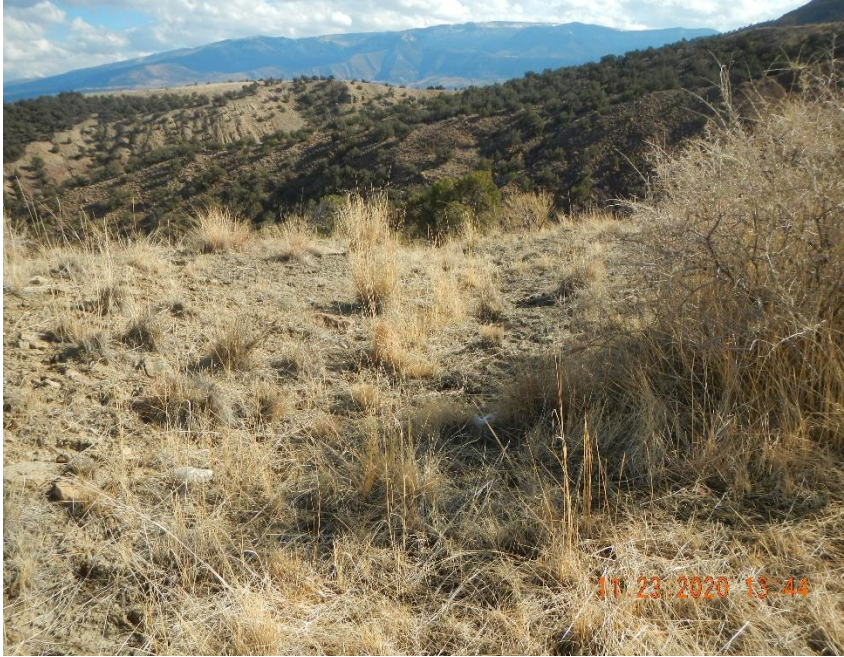
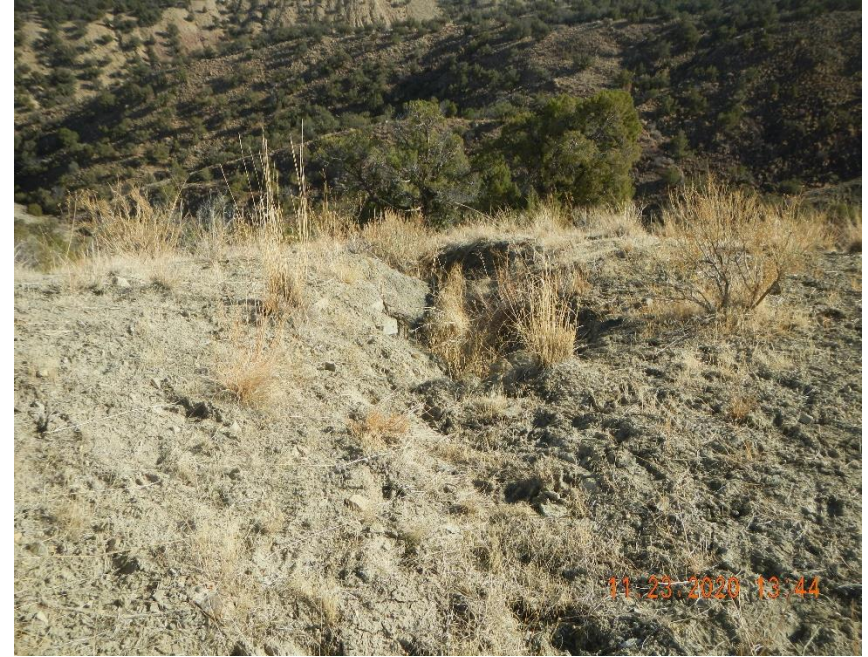
**Run off from diversion ditch over well pad
is creating deep erosion down hillside.**

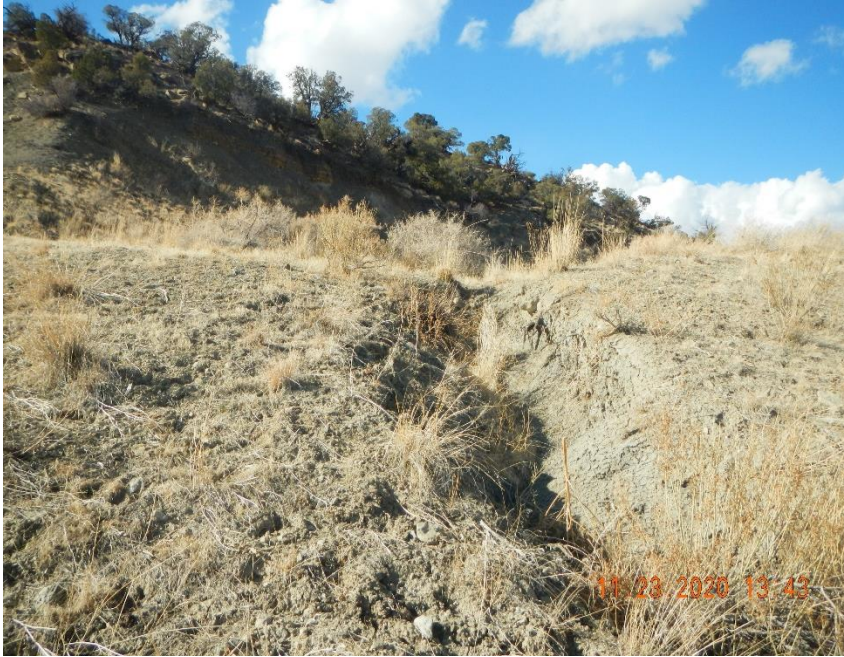
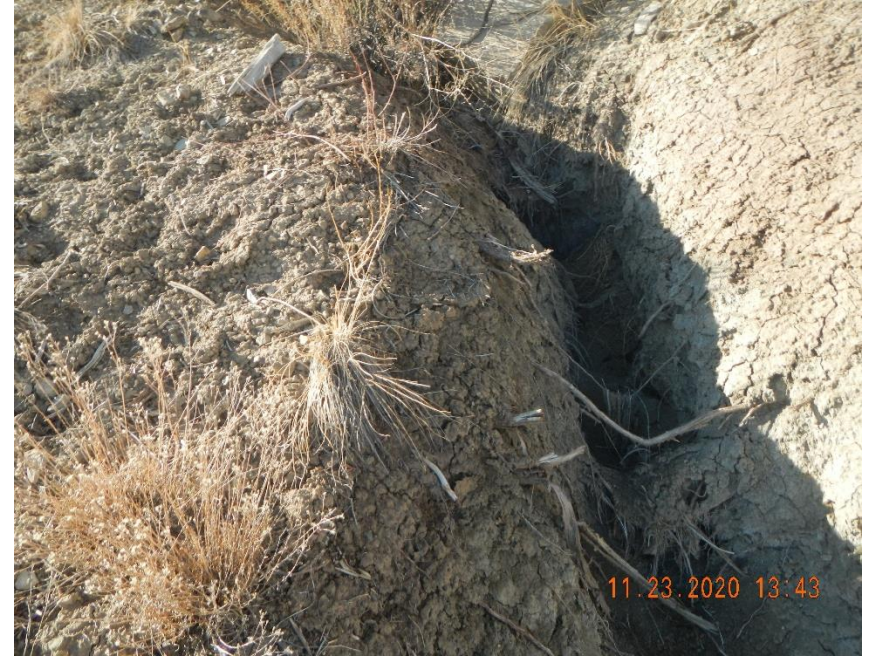
**Run off from diversion ditch over well pad
is creating deep erosion down hillside.**

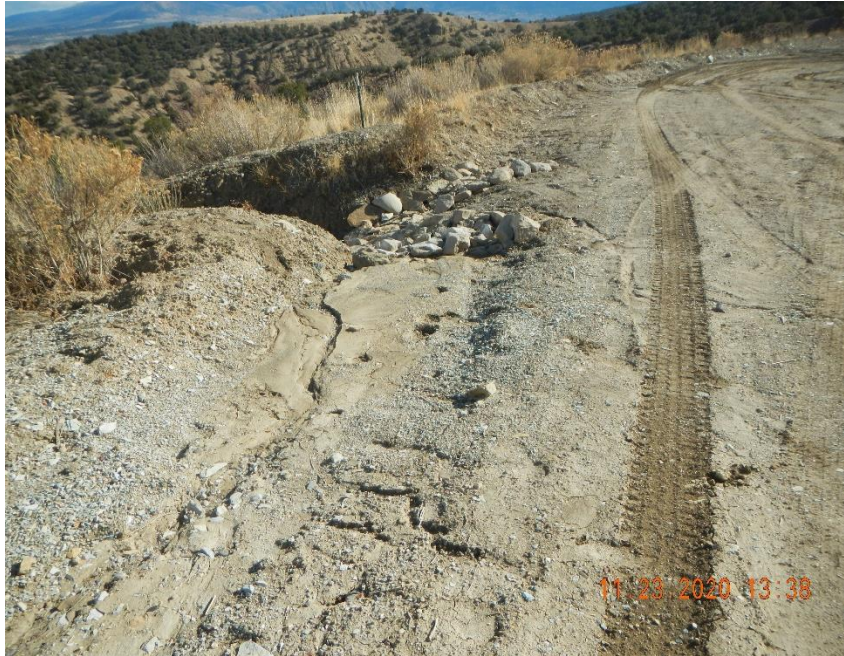
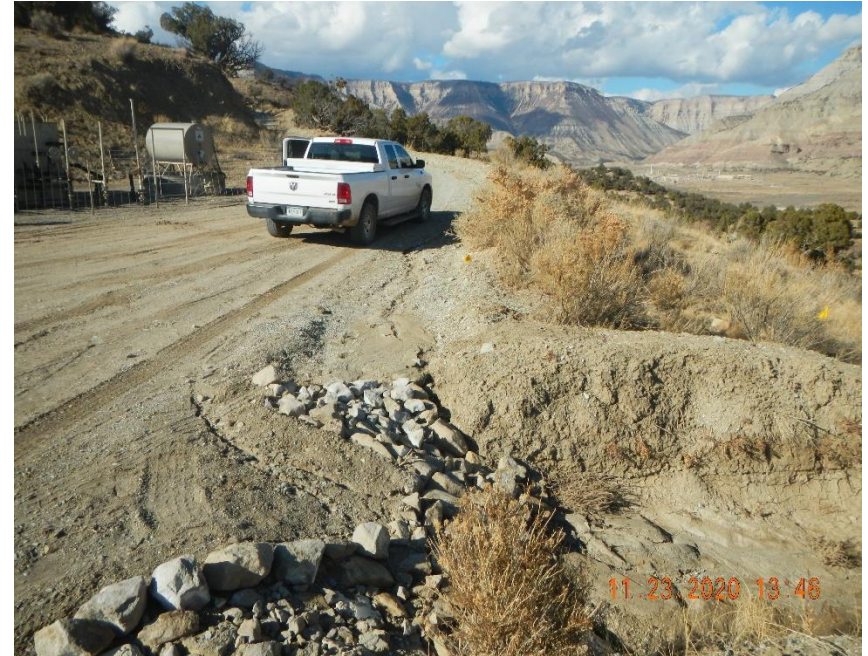
Check dam at entrance of location needs maintained.

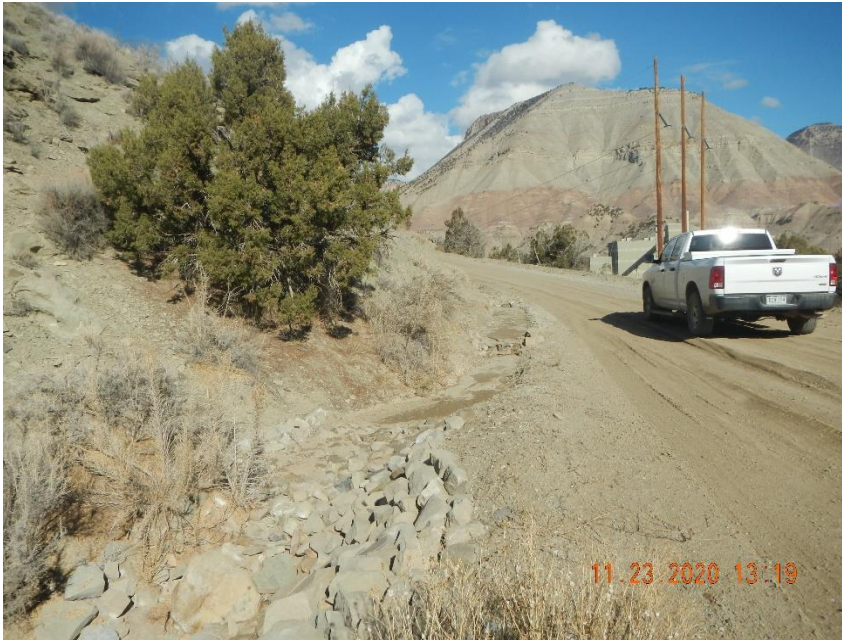
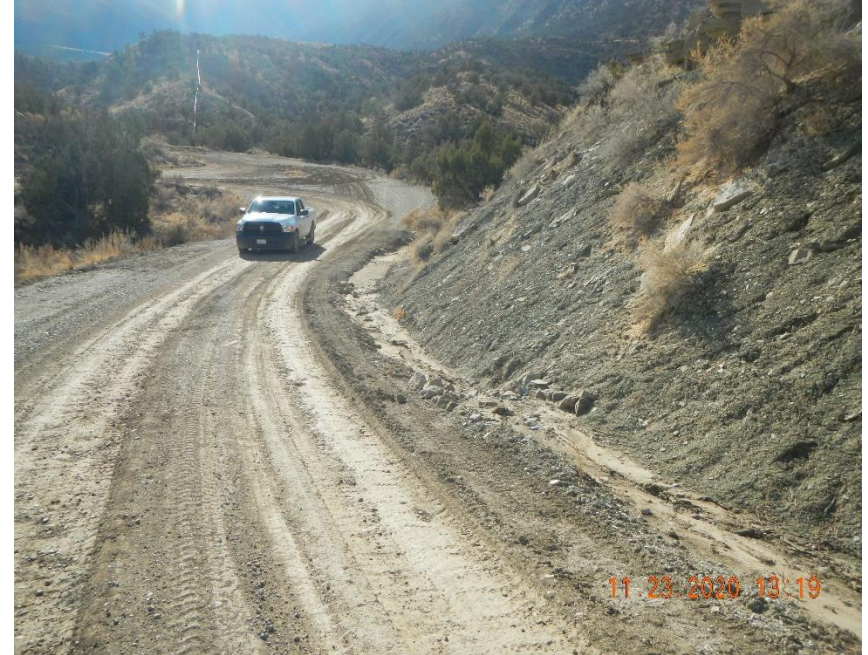
**Sediment movement and build up in ditch.
Coordinates 39.47074 W108.09431**

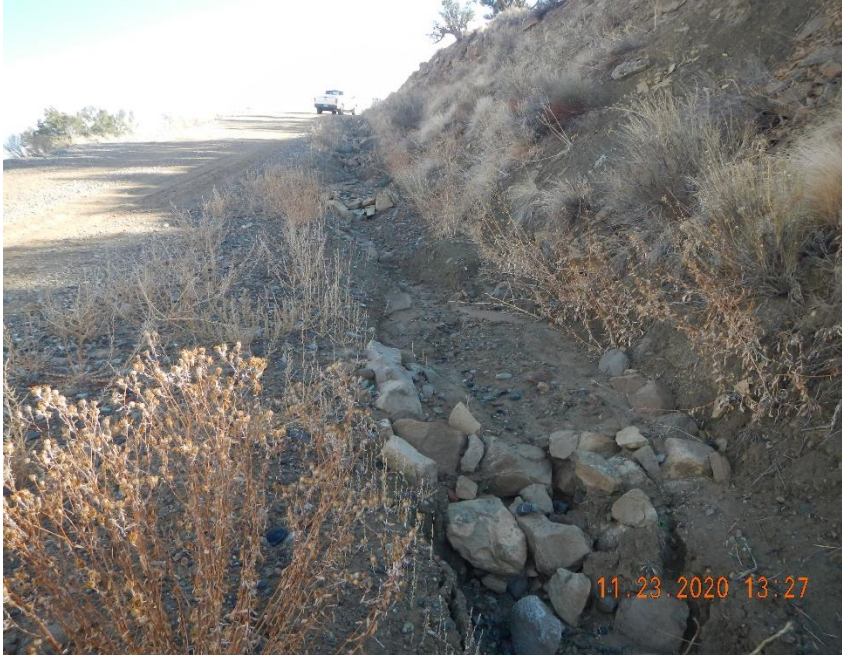
**Road ditch needs maintained.
Coordinates 39.47075 W108.10118**

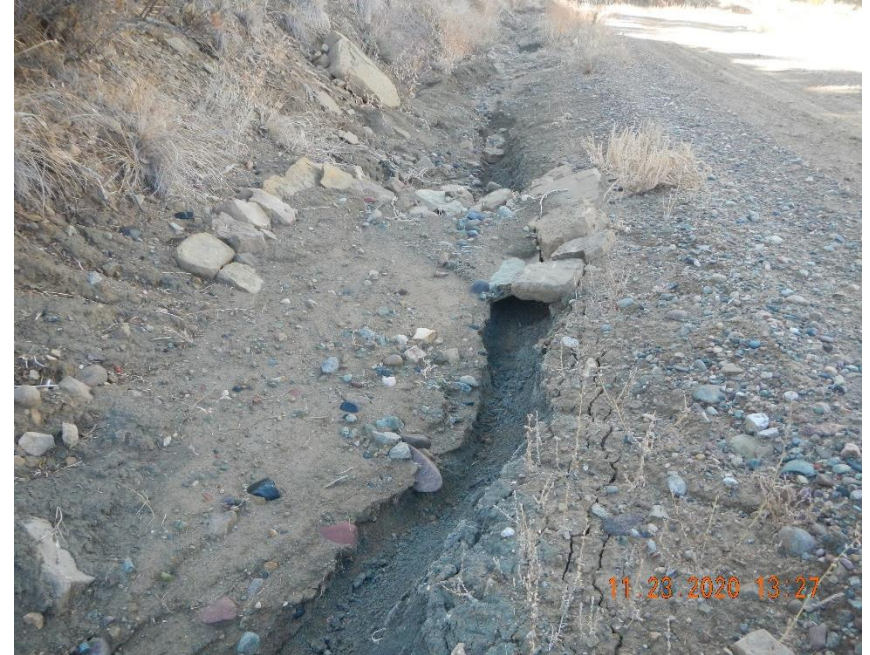
Channeling under rip rap in ditch.

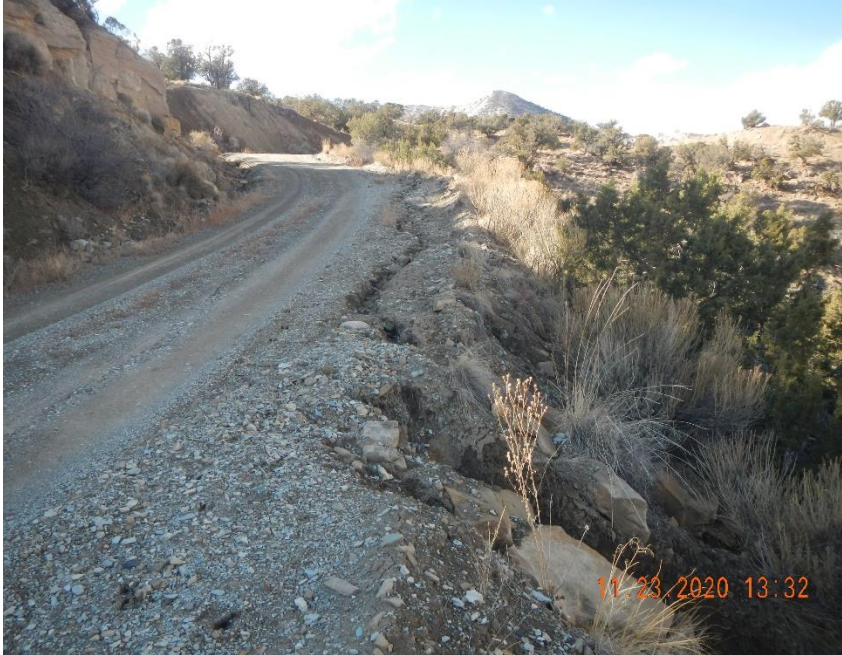
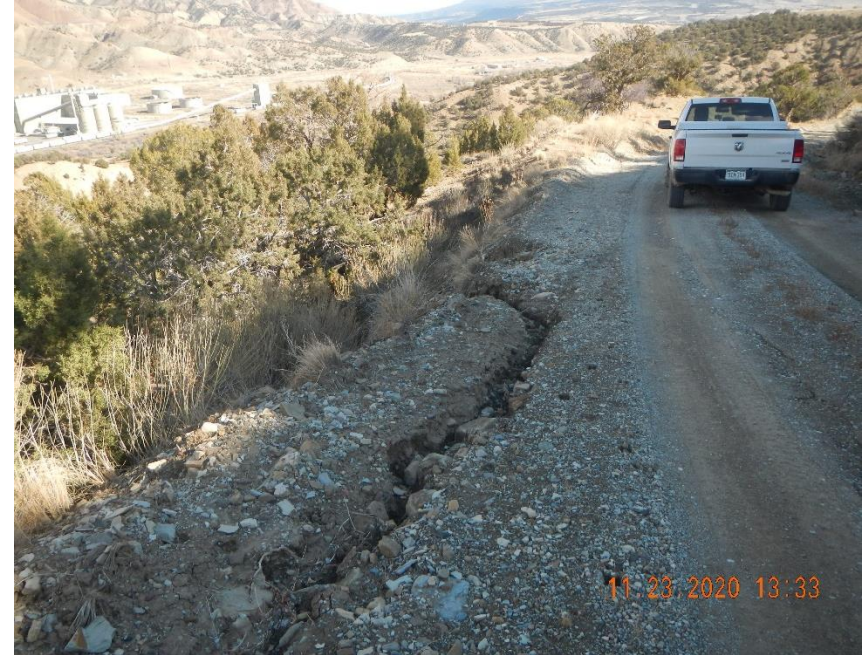
**Riling of road shoulder is washing away roadside.
Coordinates 39.46961 W108.09975**
