Inspection Photos  
Operator: Benson Montin Greer  
API: 067-06175  
Date: 11/5/2020

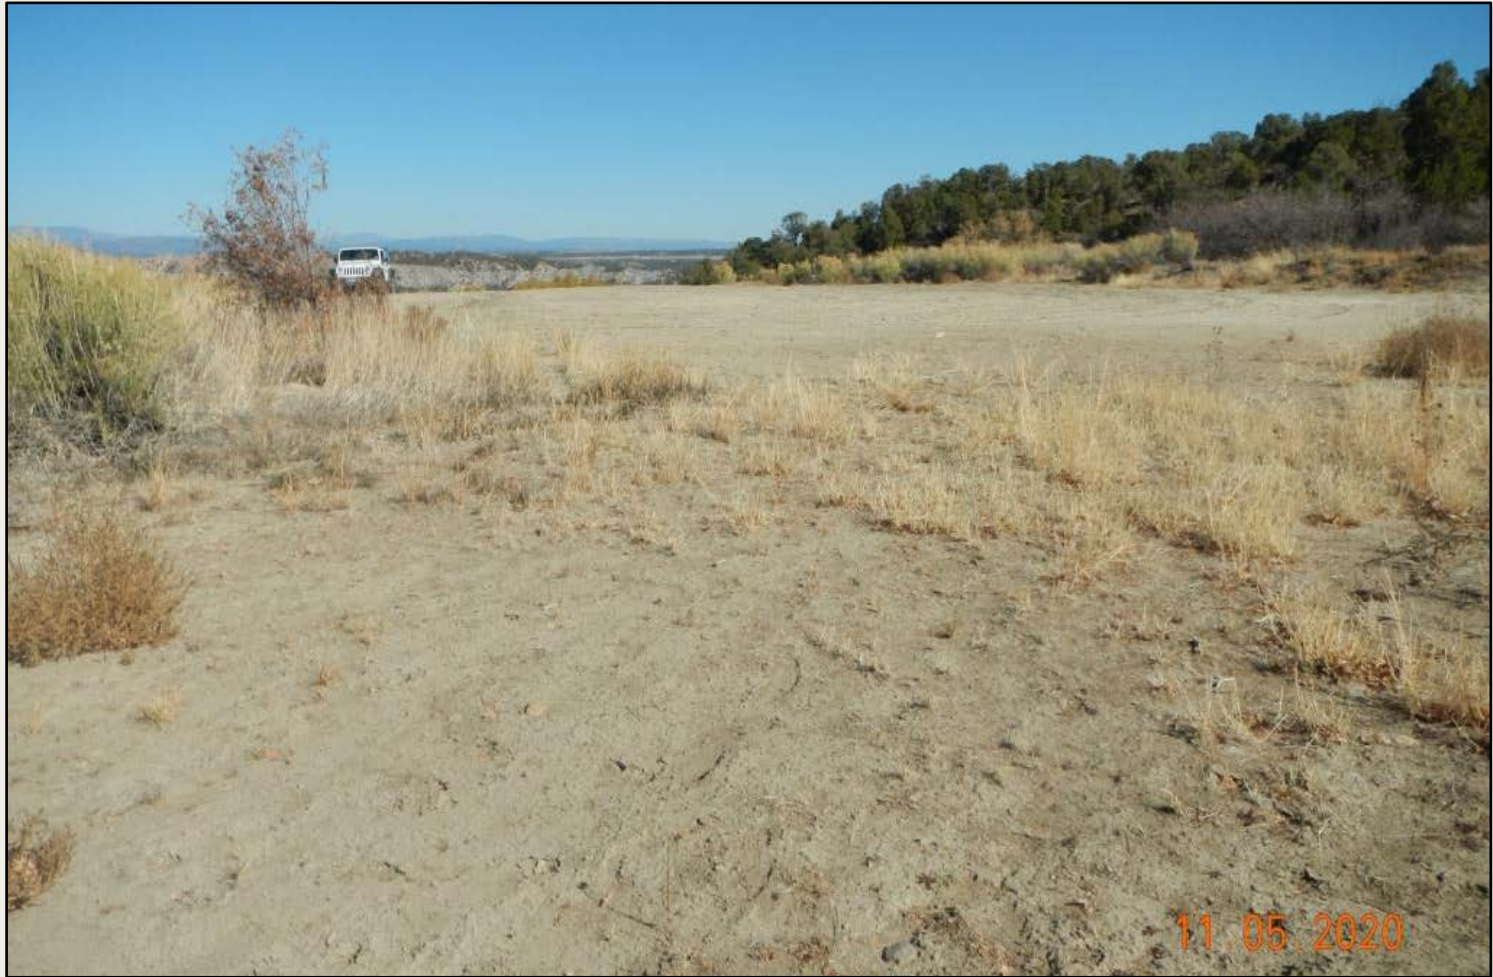
Photo 1. View of the project area from the southwestern corner facing center.

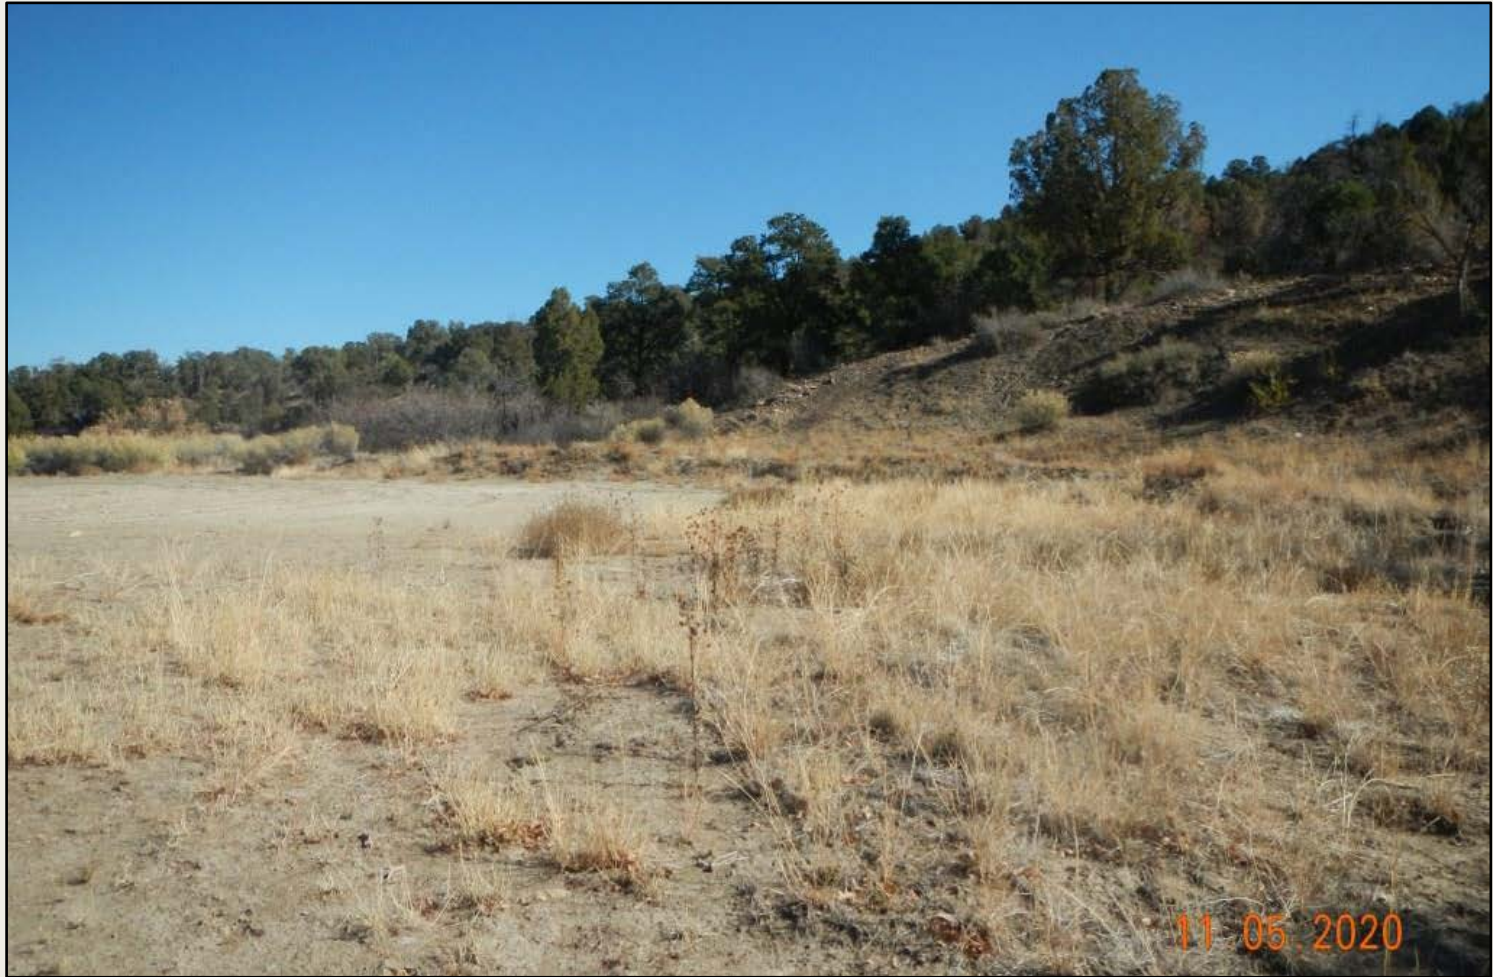
Photo 2. View of the southeastern project area from the southwestern corner facing northeastward. Erosional rilling occurring within the well pad cut-slope where sparse vegetation is present.

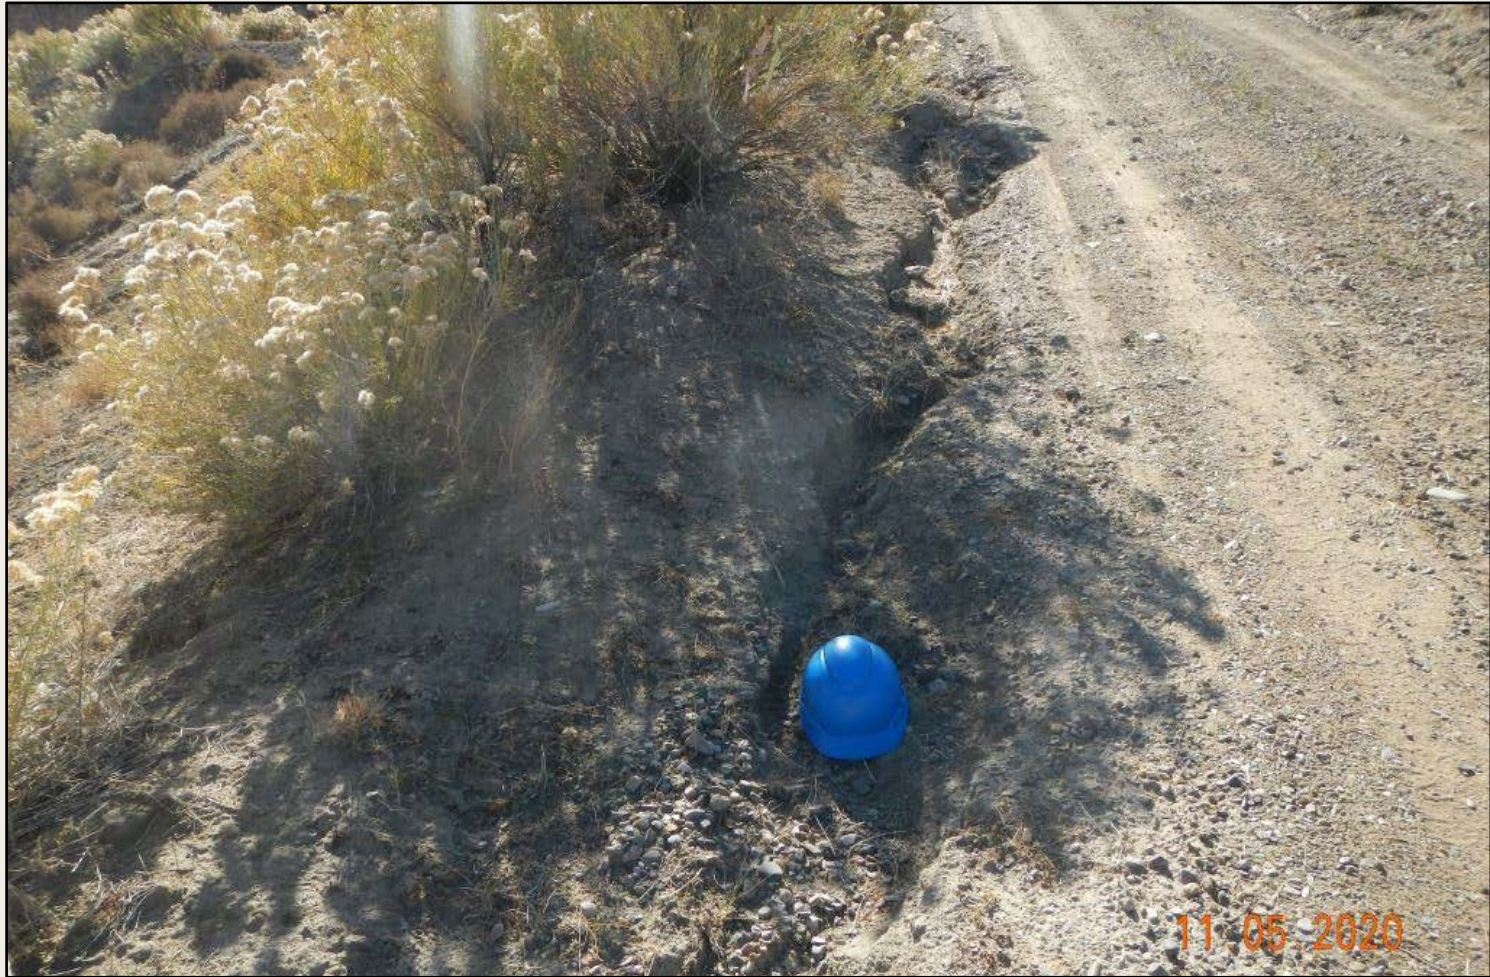
Photo 3. View of erosional channeling, approximately 10-12 inches deep, and 12 to 24 inches wide, occurring along the access- near the well pad entrance.

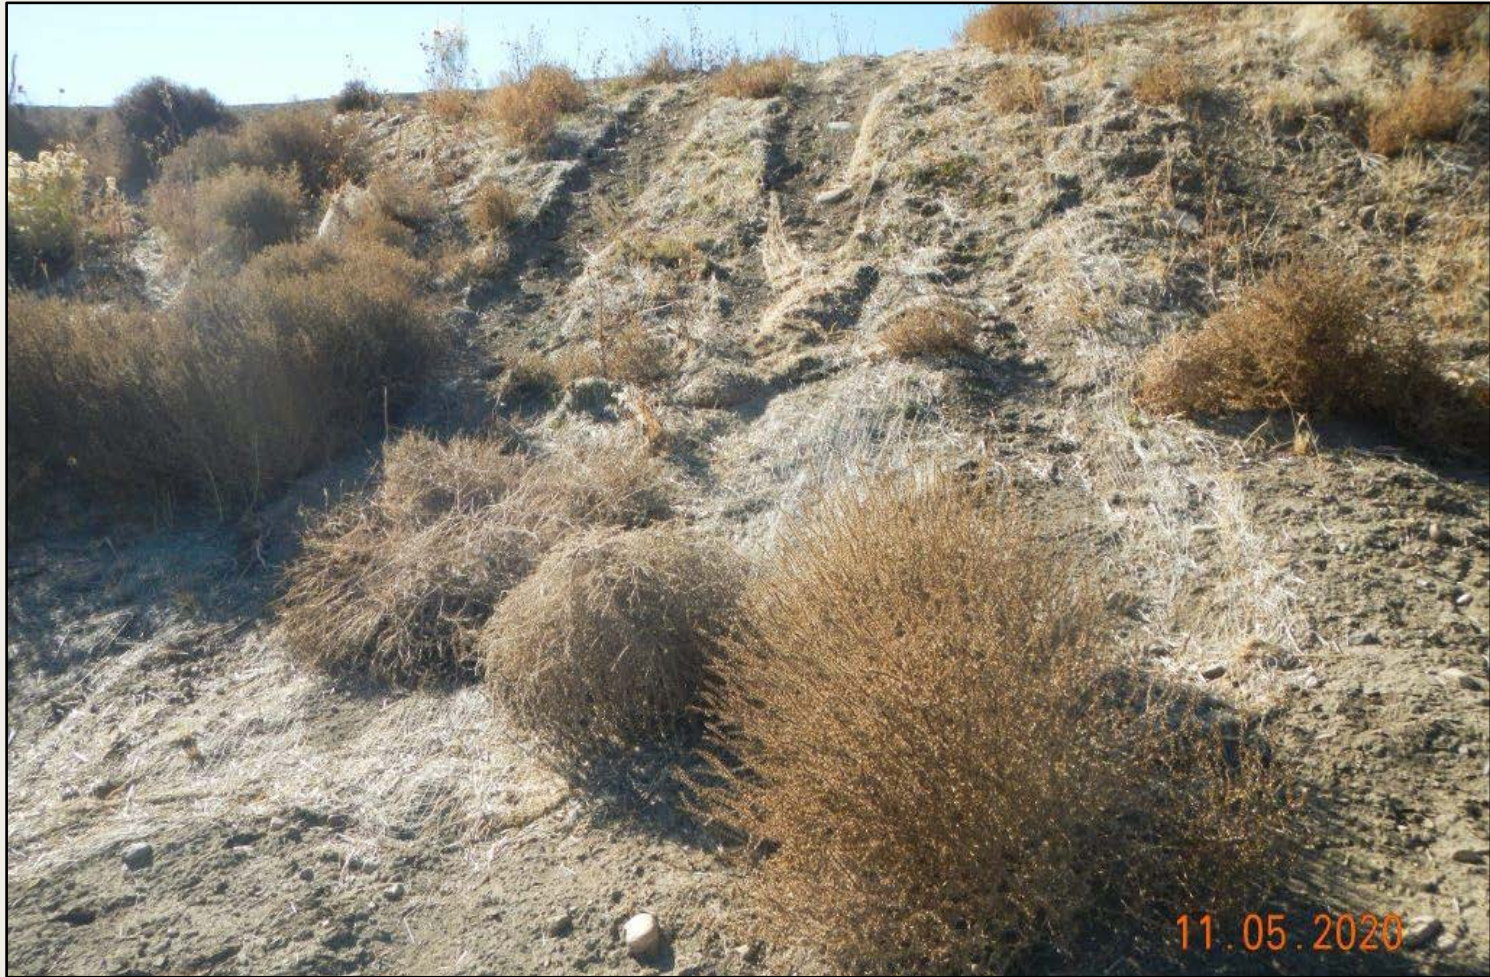
Photo 4. View of tracking damage on straw blanket in the northeastern fill slope. Russian thistle debris is present.

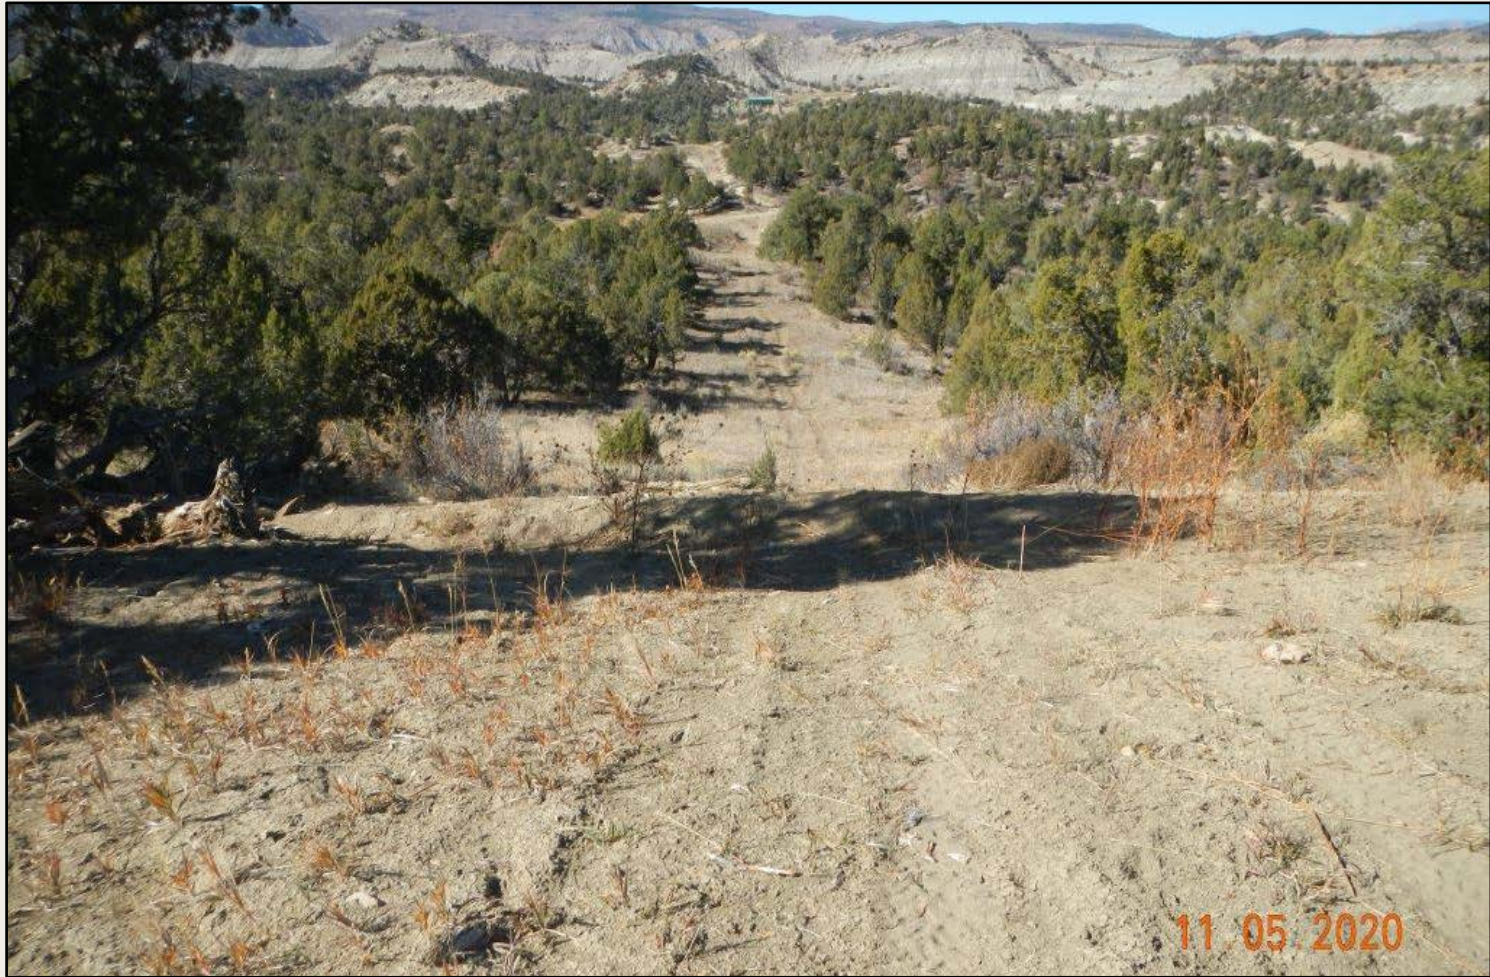
Photo 5. View of pipeline reclamation corridor. Vehicle tracking is damaging vegetation and threatening stabilization.

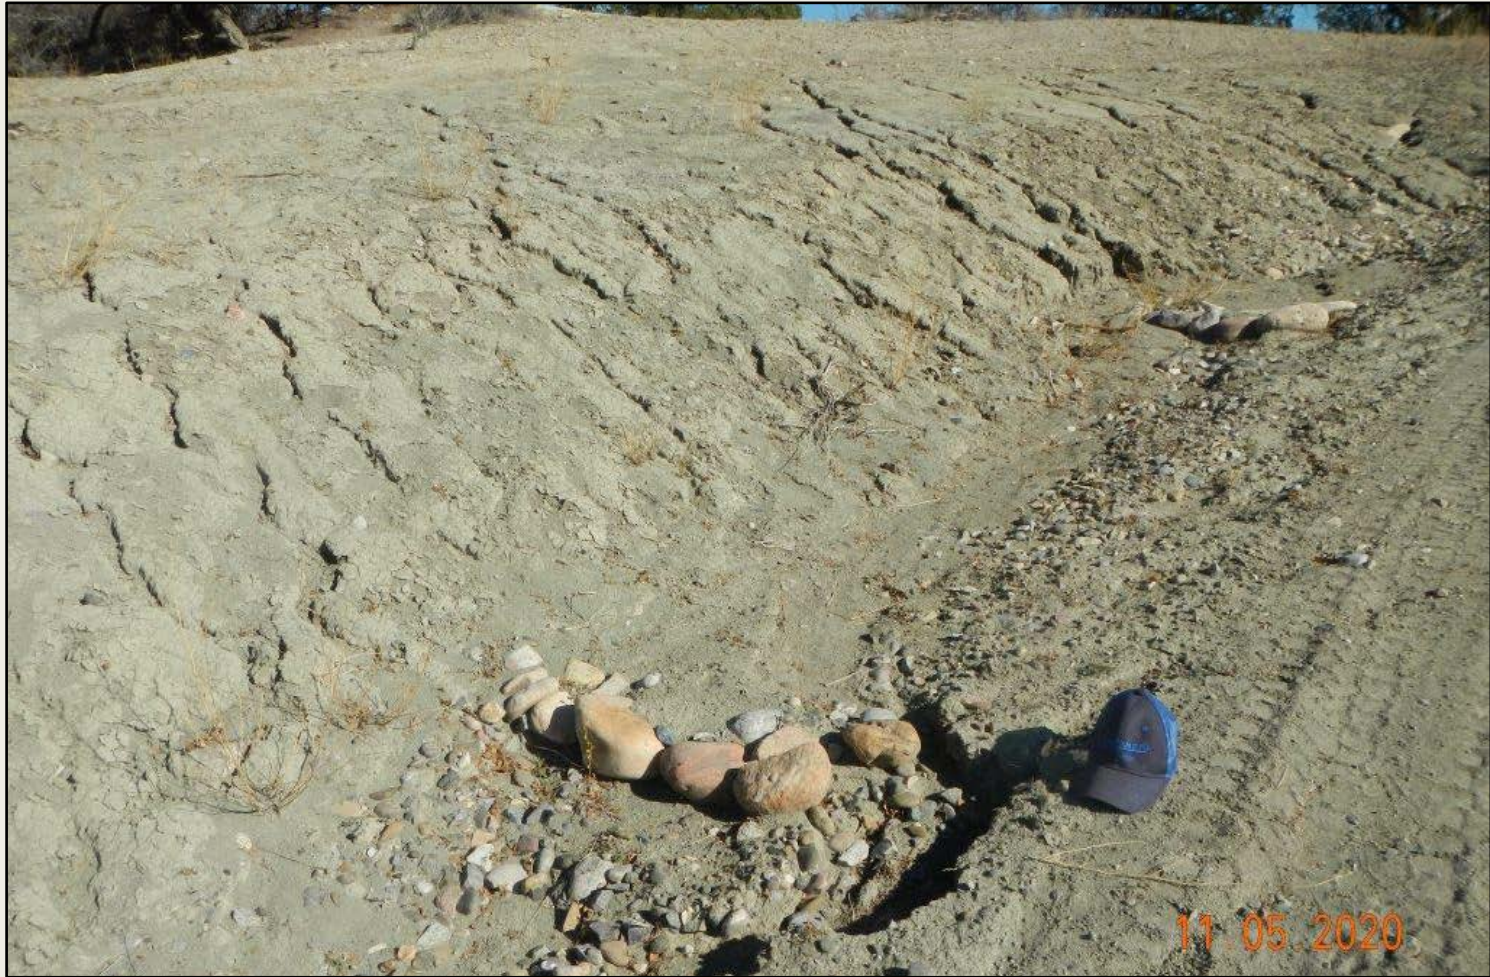
Photo 6. View of erosional rilling along the access road, and sediment filled cobble BMPs along the access. Slope is not stabilized, these BMPs are not adequate here.

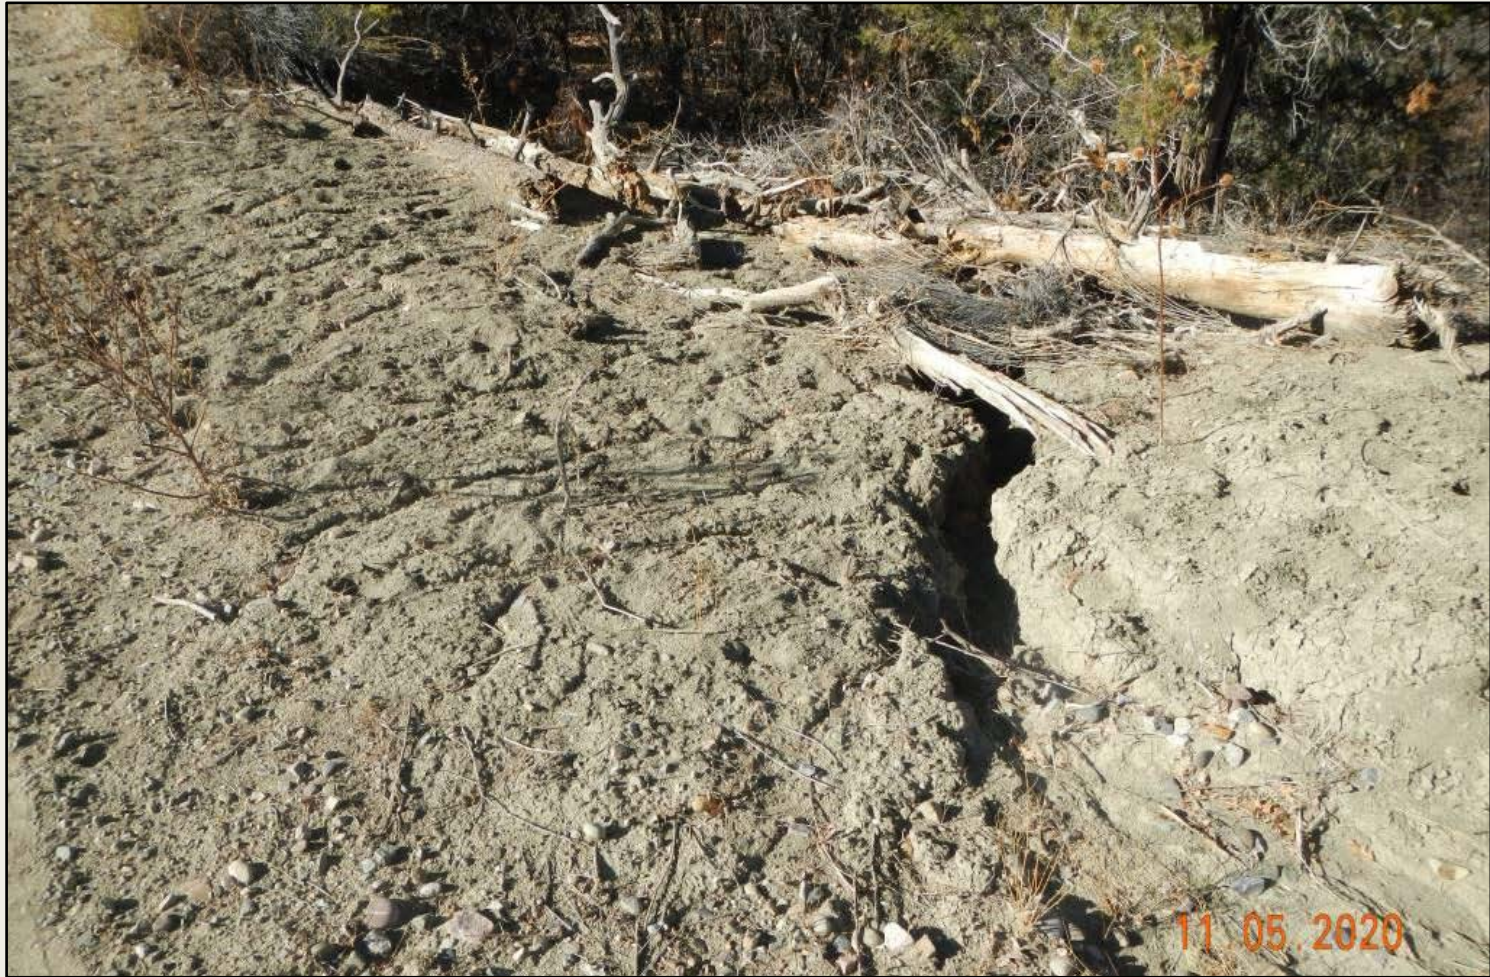
Photo 7. View of erosional rilling and channeling (approximately 1 foot wide and deep) occurring along the access road where erosional channel was repaired in response to a 2019 reclamation inspection.

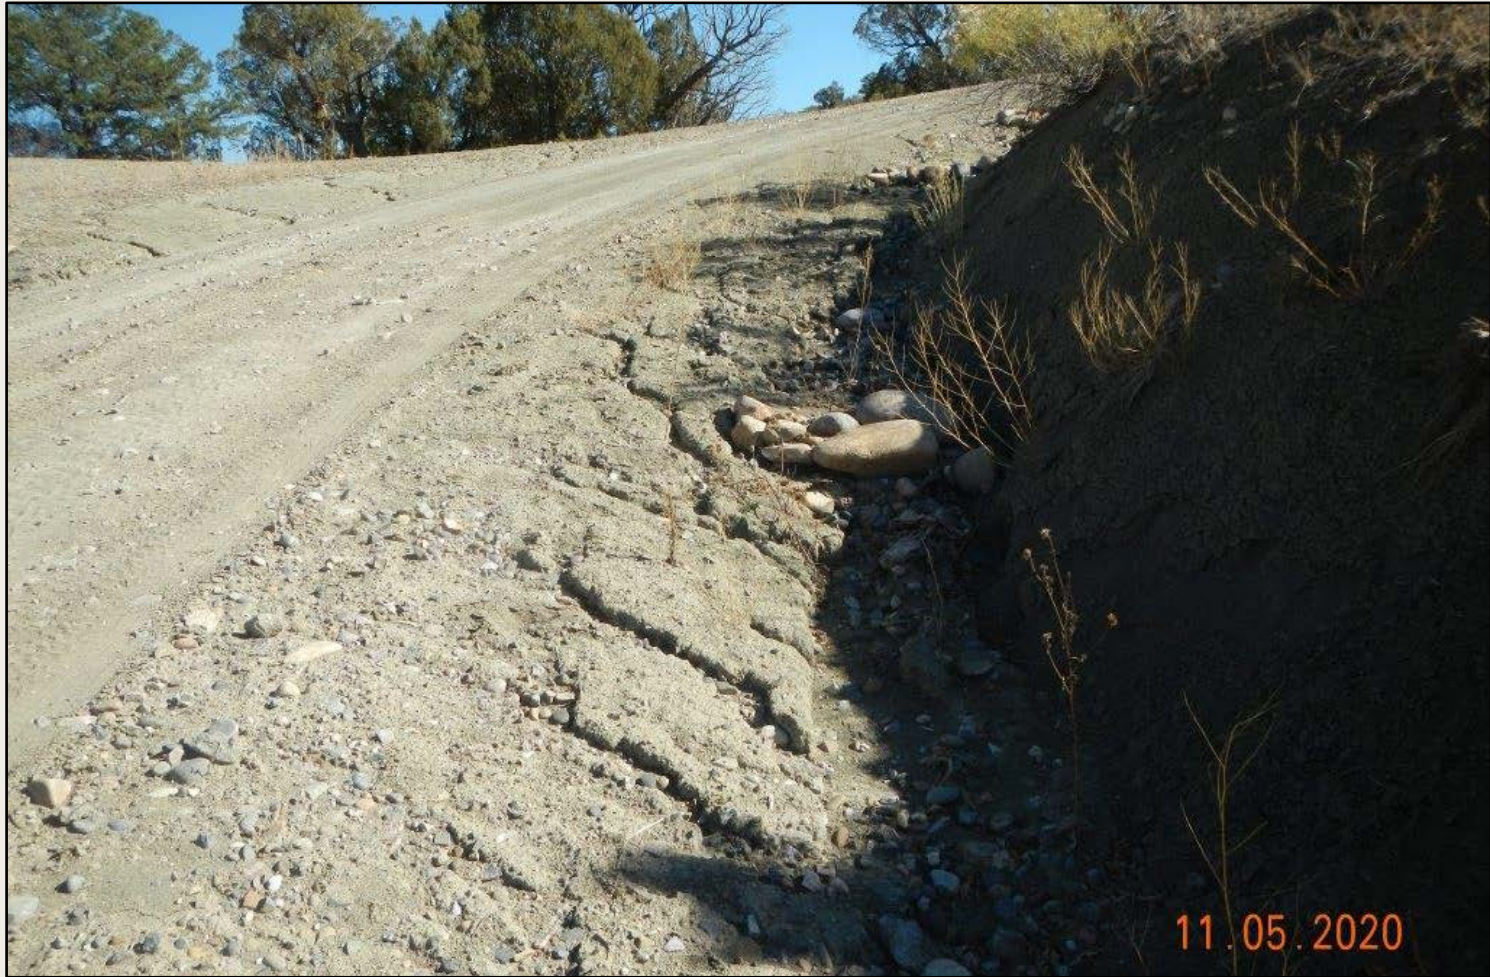
Photo 8. View of another area along the access road where shoulders are not stabilized with evident rilling and cobble BMPs that are inundated with sediment.

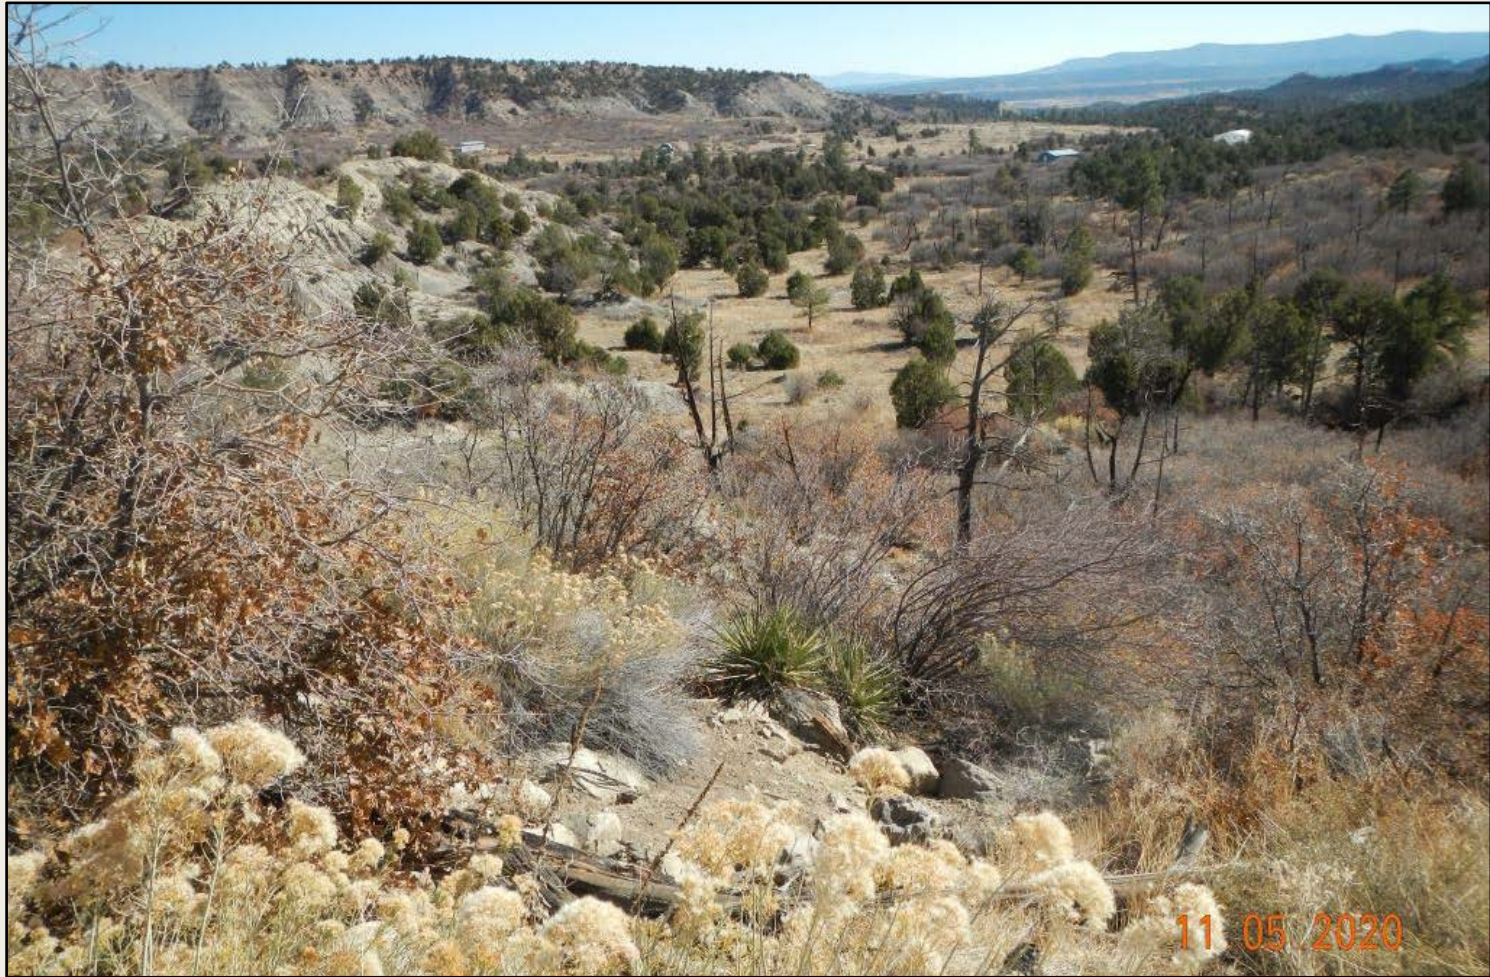
Photo 9. View of reference area facing southward. Vegetation is comprised of a mosaic of gambel oak shrubland, with ponderosa pine, pinyon and juniper trees, shrubs such as mountain mahogany, yucca, rubber rabbitbrush, and grasses/forbs such as rocky mountain penstemon, squirreltail, and western wheatgrass.

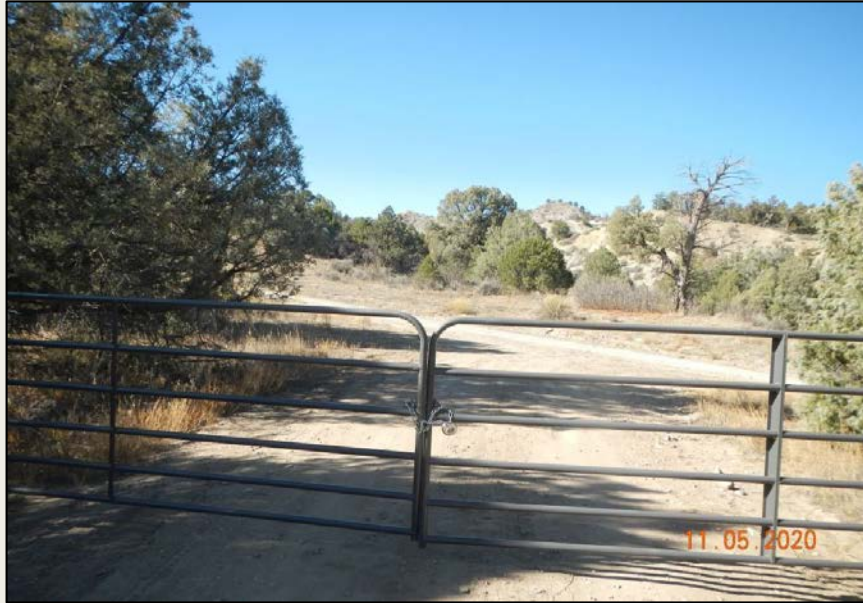
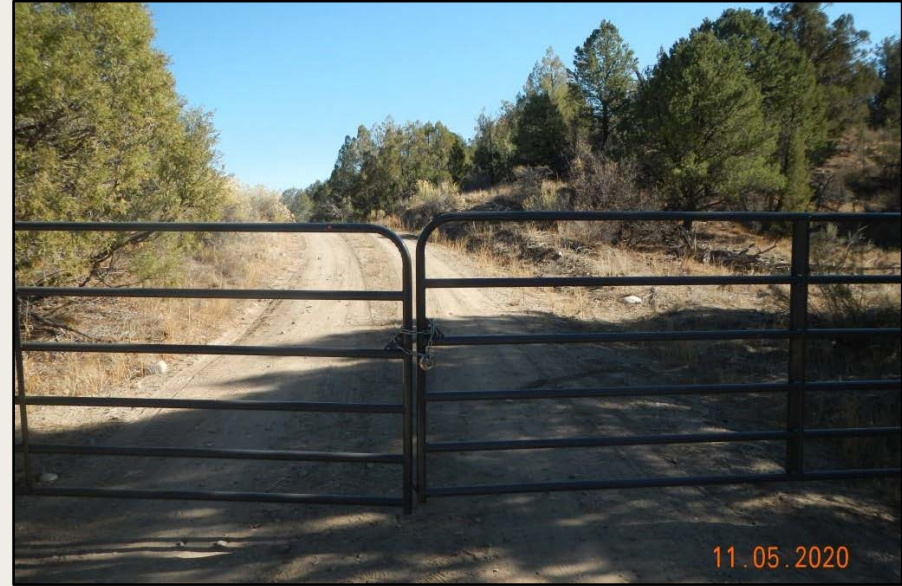
Photos 10/11. View of closed and locked gates after entering and exiting location.
