Inspection Photos
Operator: Benson Montin Greer
API: 067-06117
Date: 11/5/2020

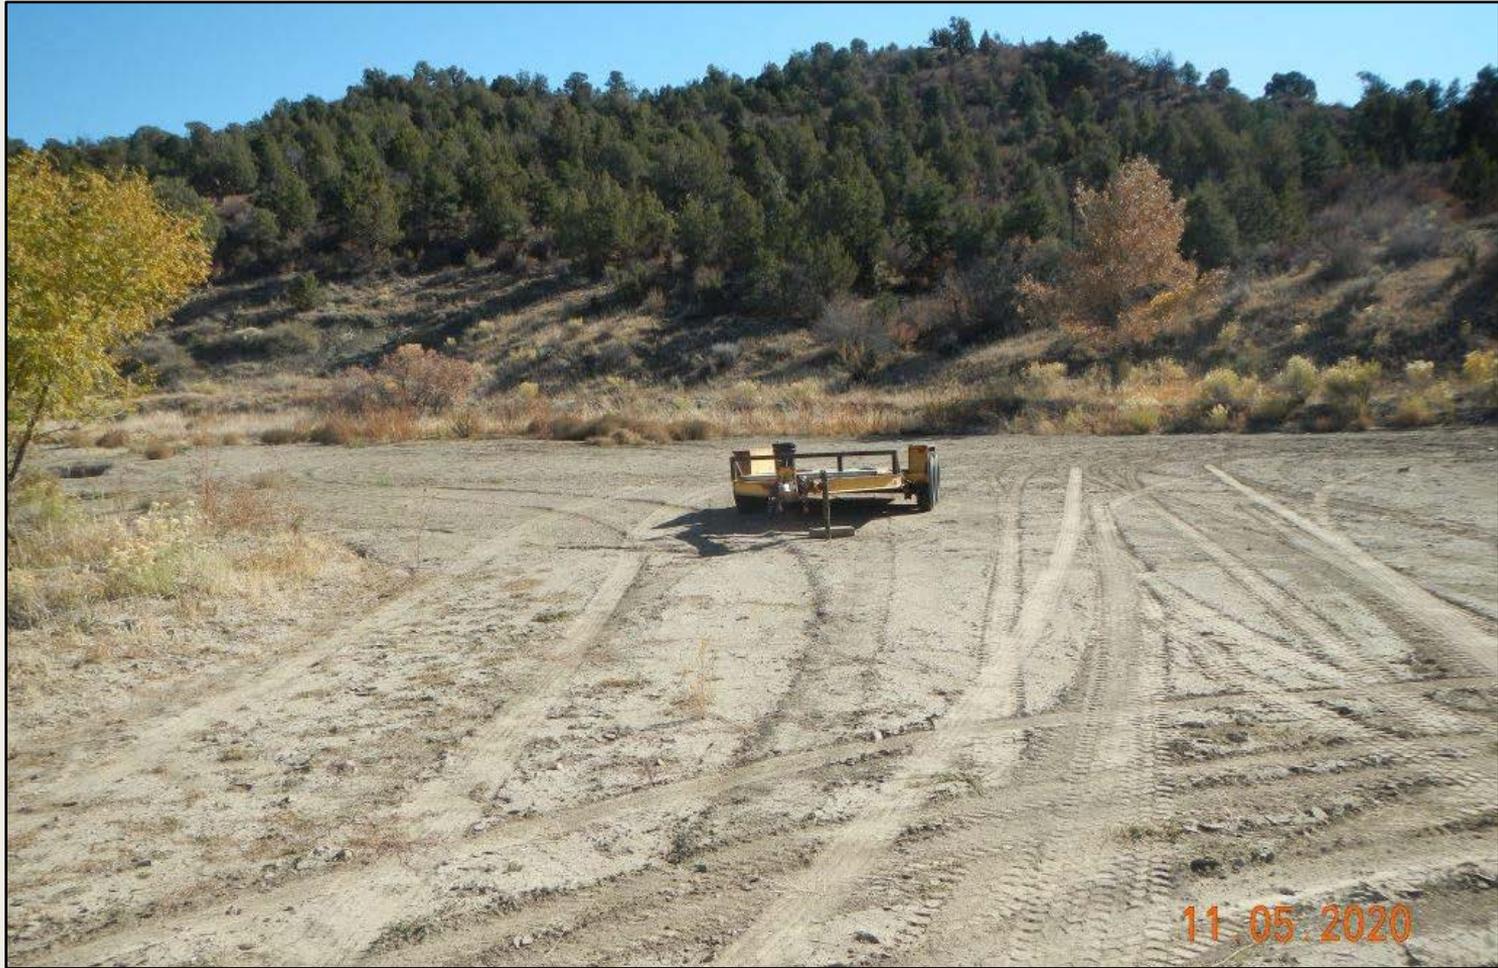
Photo 1. View of the project area from the well pad entrance facing center.

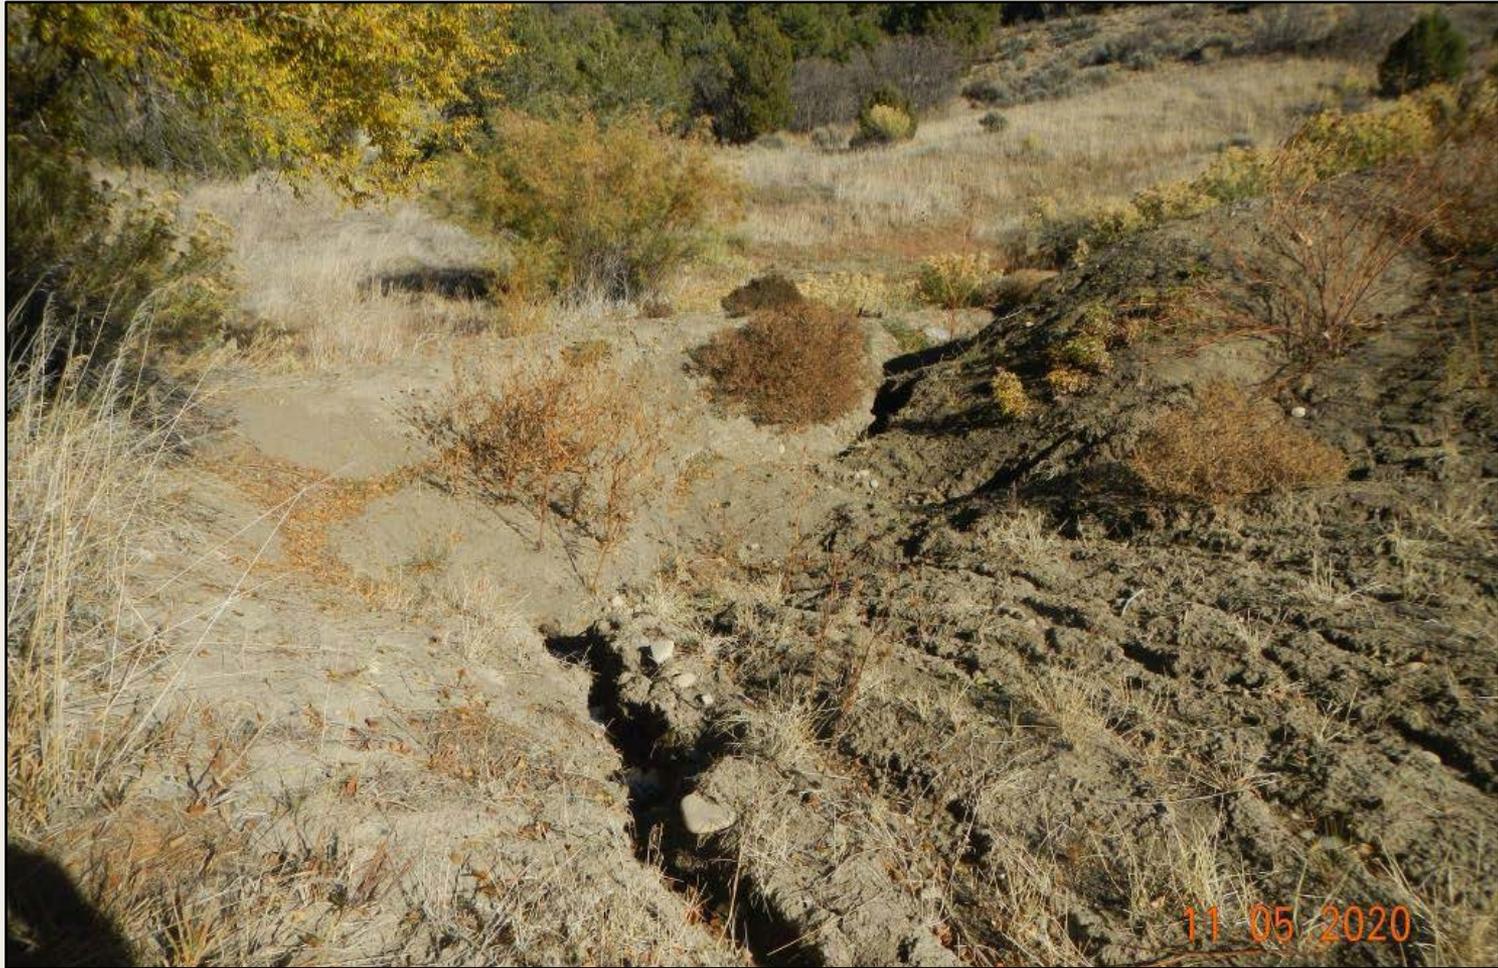
Photo 2. View of erosional rilling and channeling in the northwestern project area where sediment trap was installed and erosion channel filled in response to corrective action identified during a 2019 reclamation inspection.

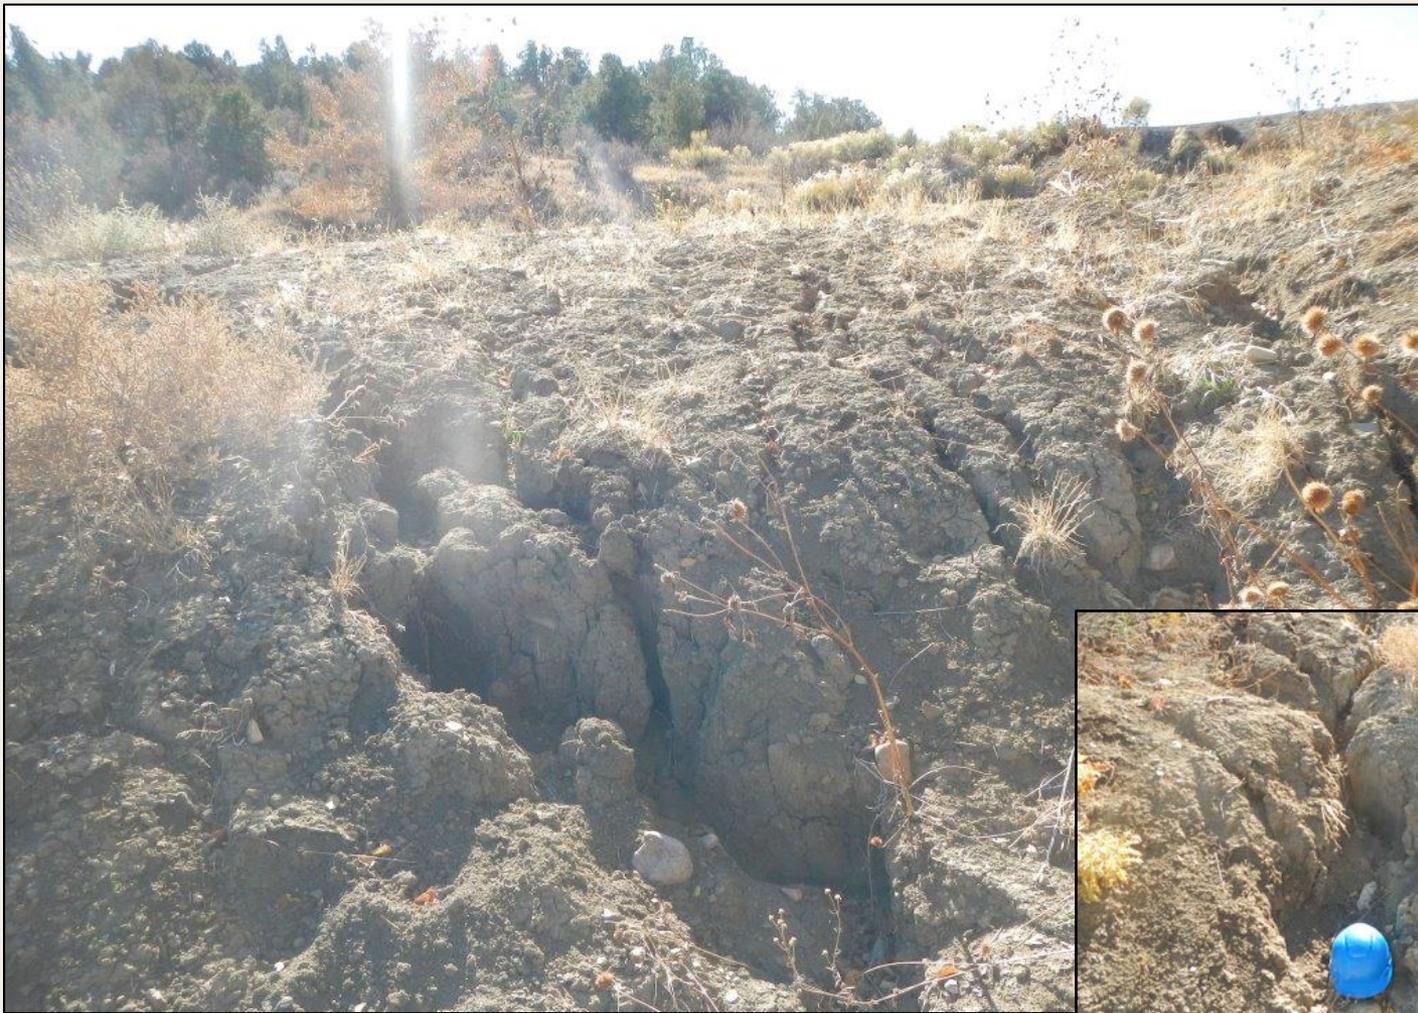
Photo 3. View of eroding area shown in Photo 2, facing up-slope. Erosional channels up to 1 foot wide and 2 feet deep in this area where stormwater flows off of the northwestern well pad. Blue hardhat placed in photo inset for scale.

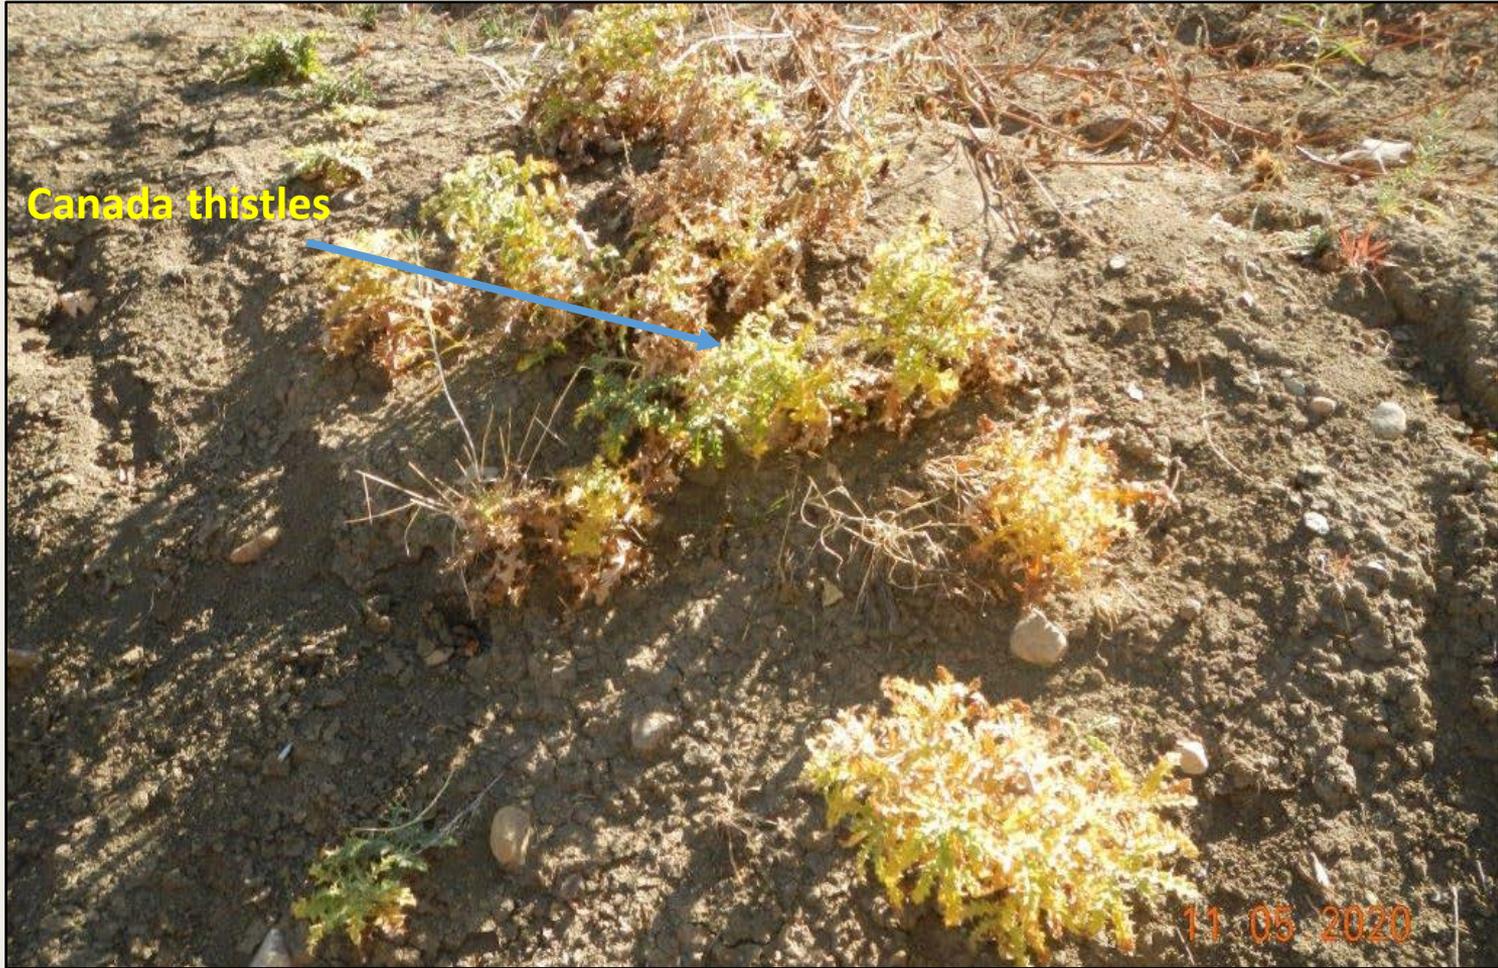
Photo 4. View of Canada thistles within the project area. Approximately 50 individuals observed.

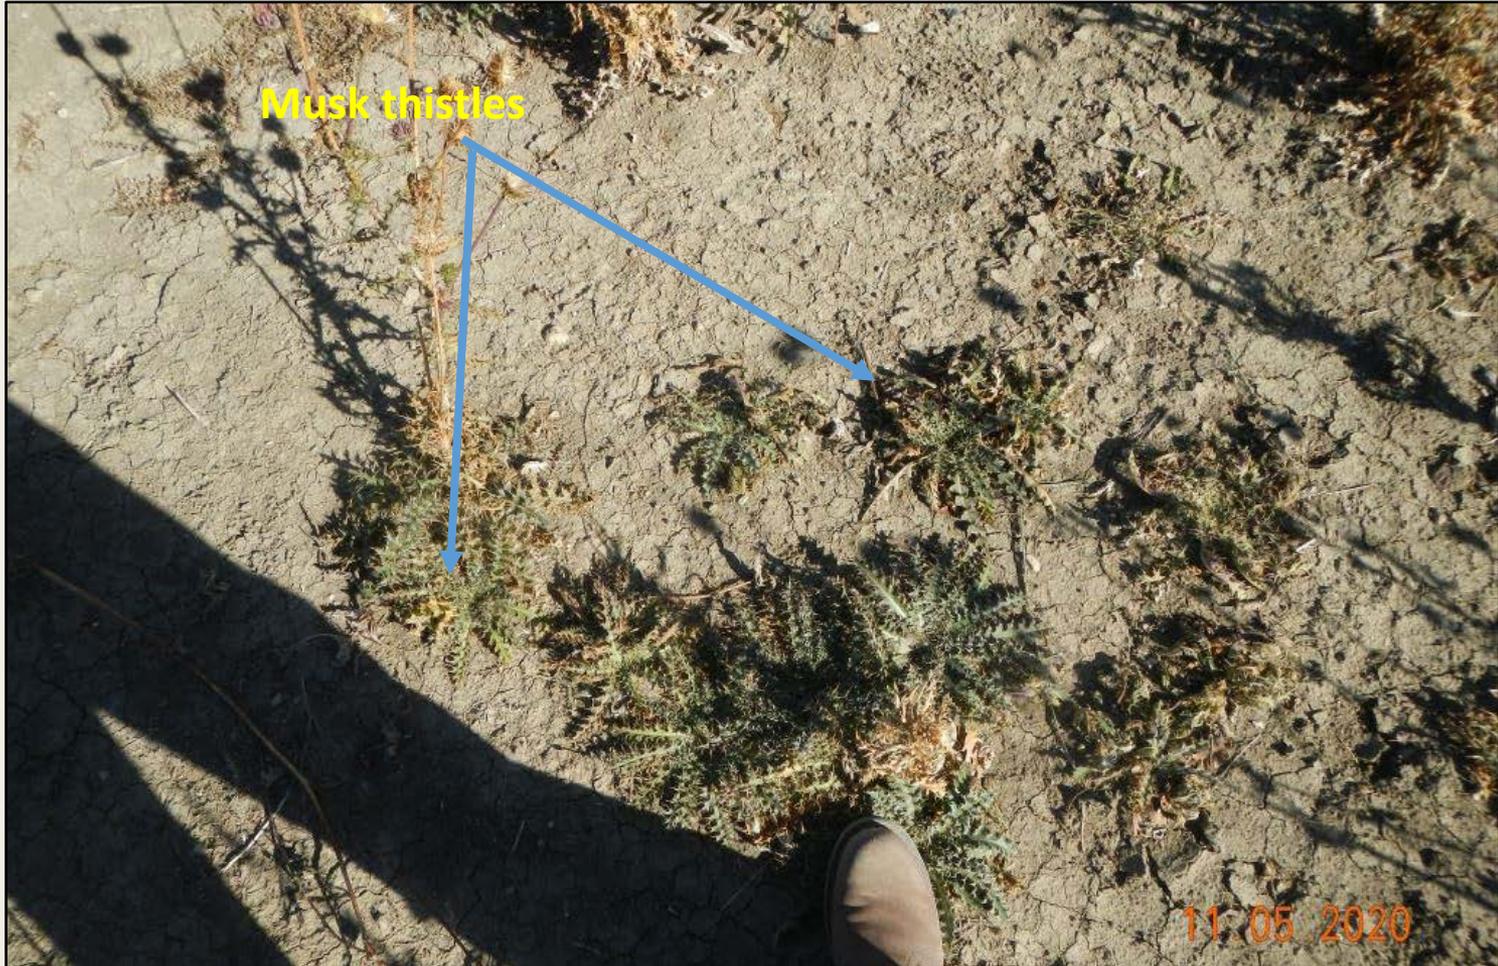
Photo 5. View of musk thistle rosettes within the project area. Approximately 250 individuals observed within the project area.

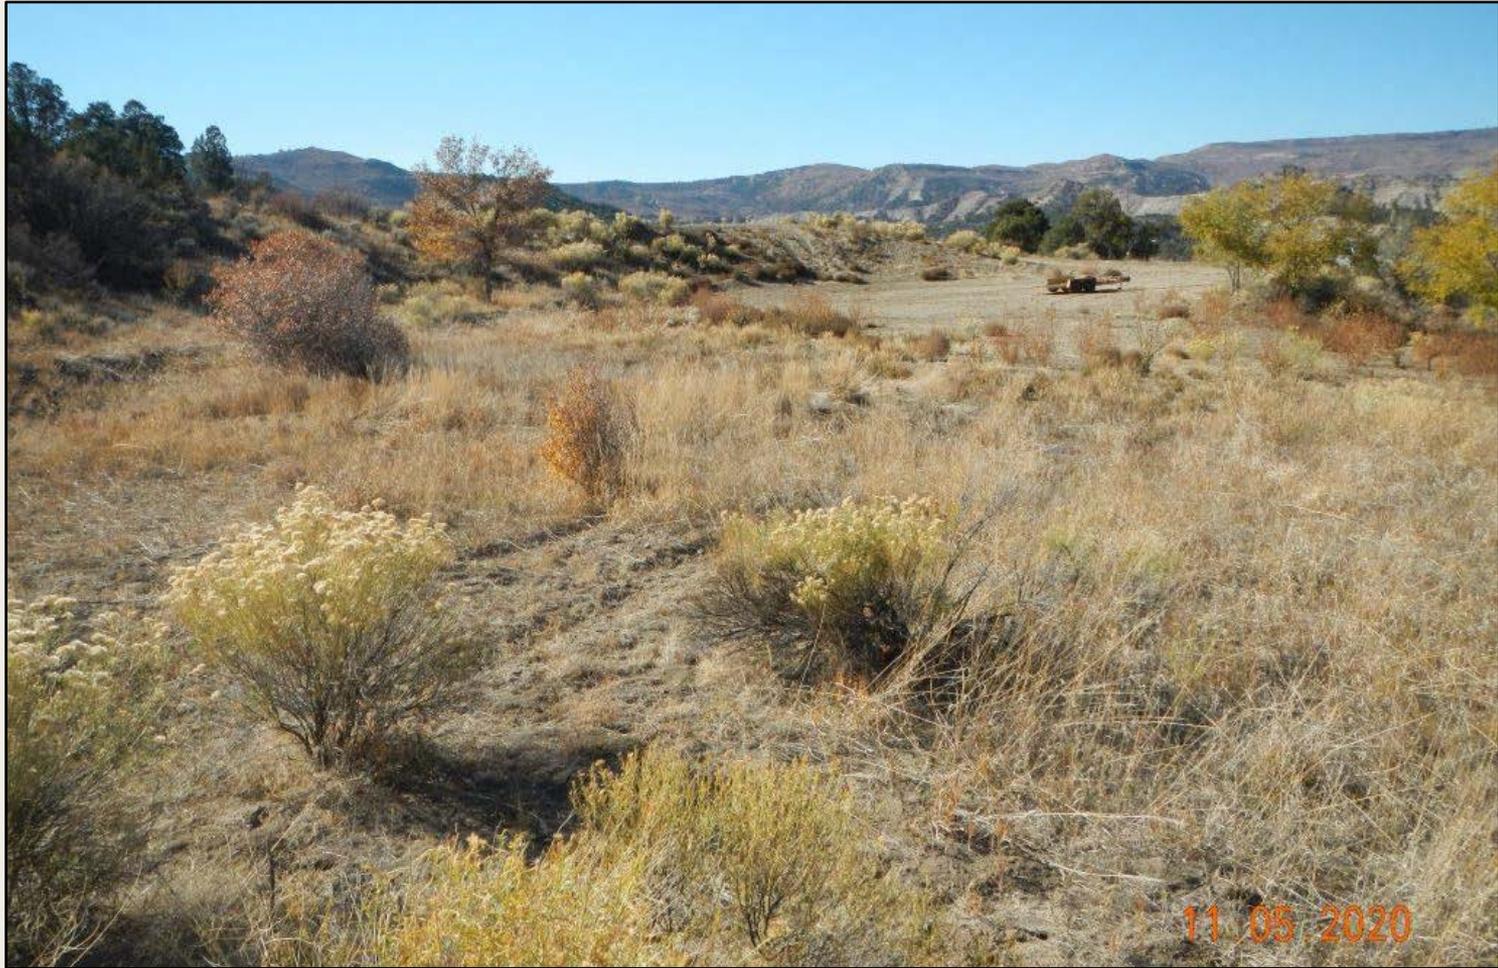
Photo 6. View of the project area from the northeastern corner facing center.

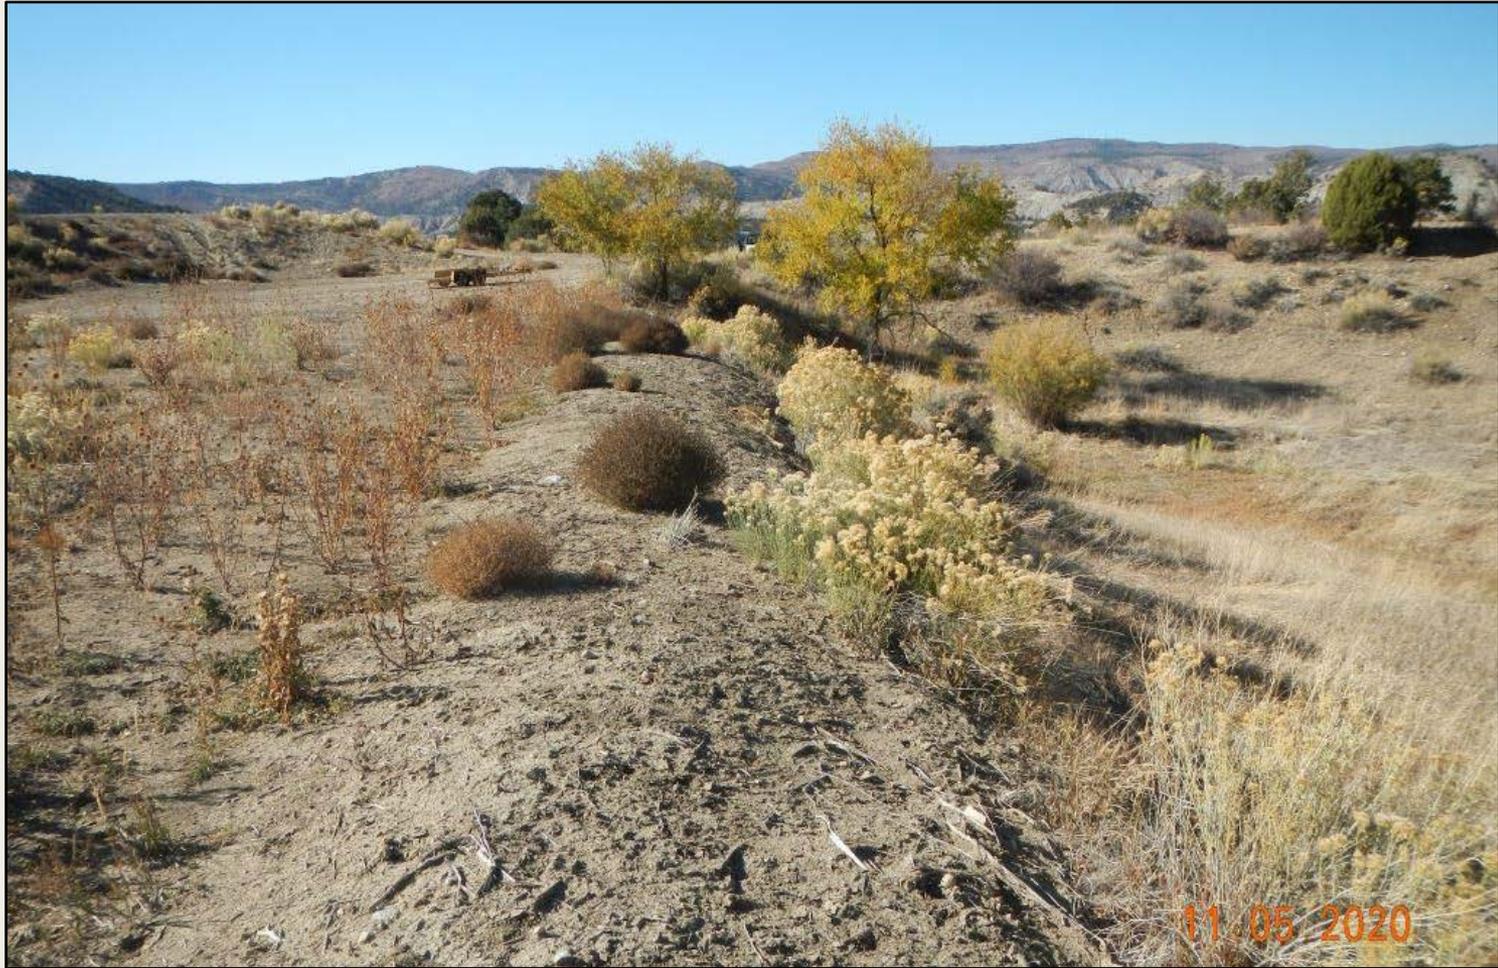
Photo 7. View of the northern project area from the northeastern corner facing westward.

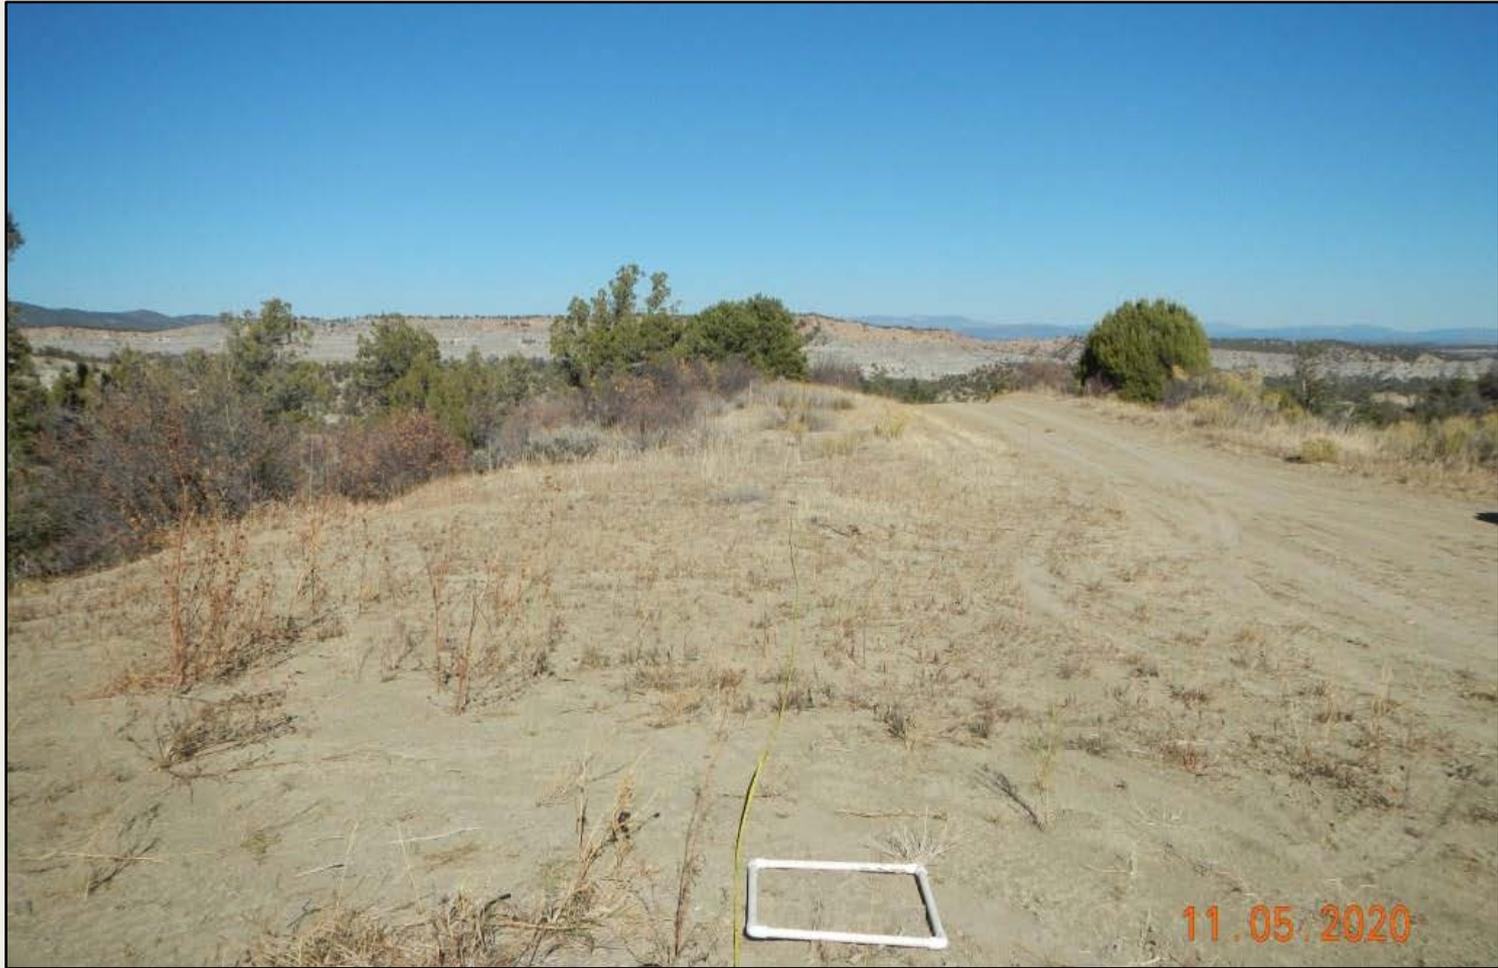
Photo 8. View of the beginning of germination transect, within pipeline revegetation area, facing northward.

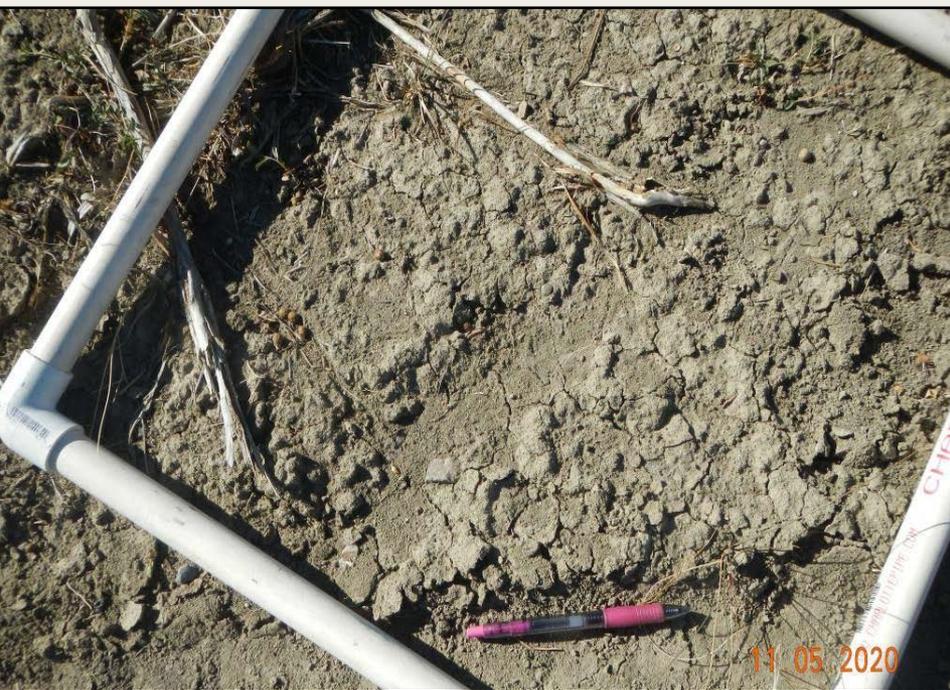
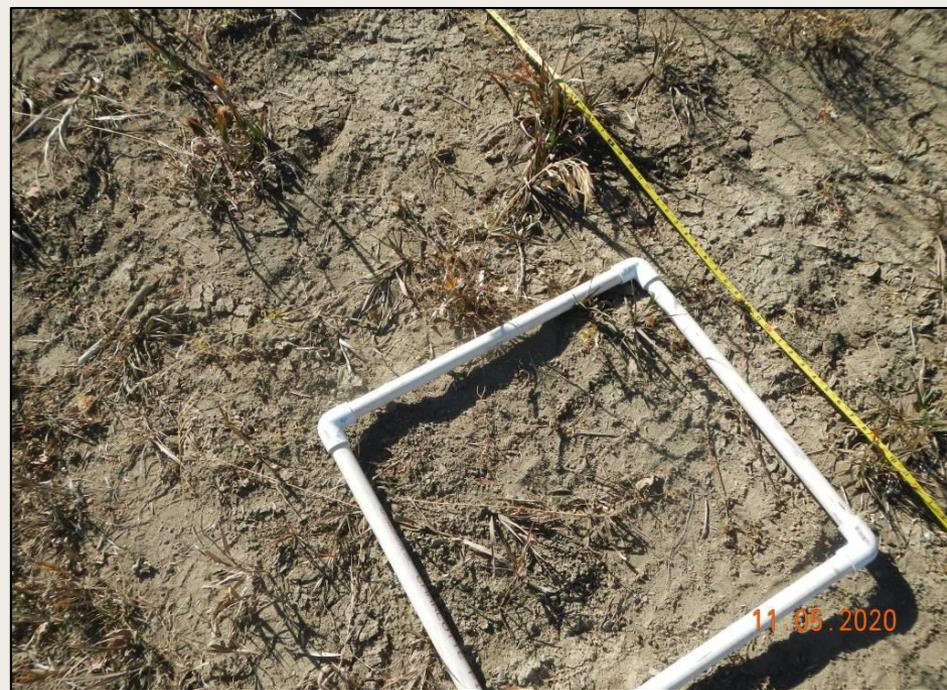
Photos 9/10. Birdseye view of quadrant samples taken along the vegetation transect. Pen in place for scale. Germination quadrats that revegetation is progressing within the revegetation area along the pipeline corridor. However, off-road vehicle tracking is threatening establishment and stabilization.

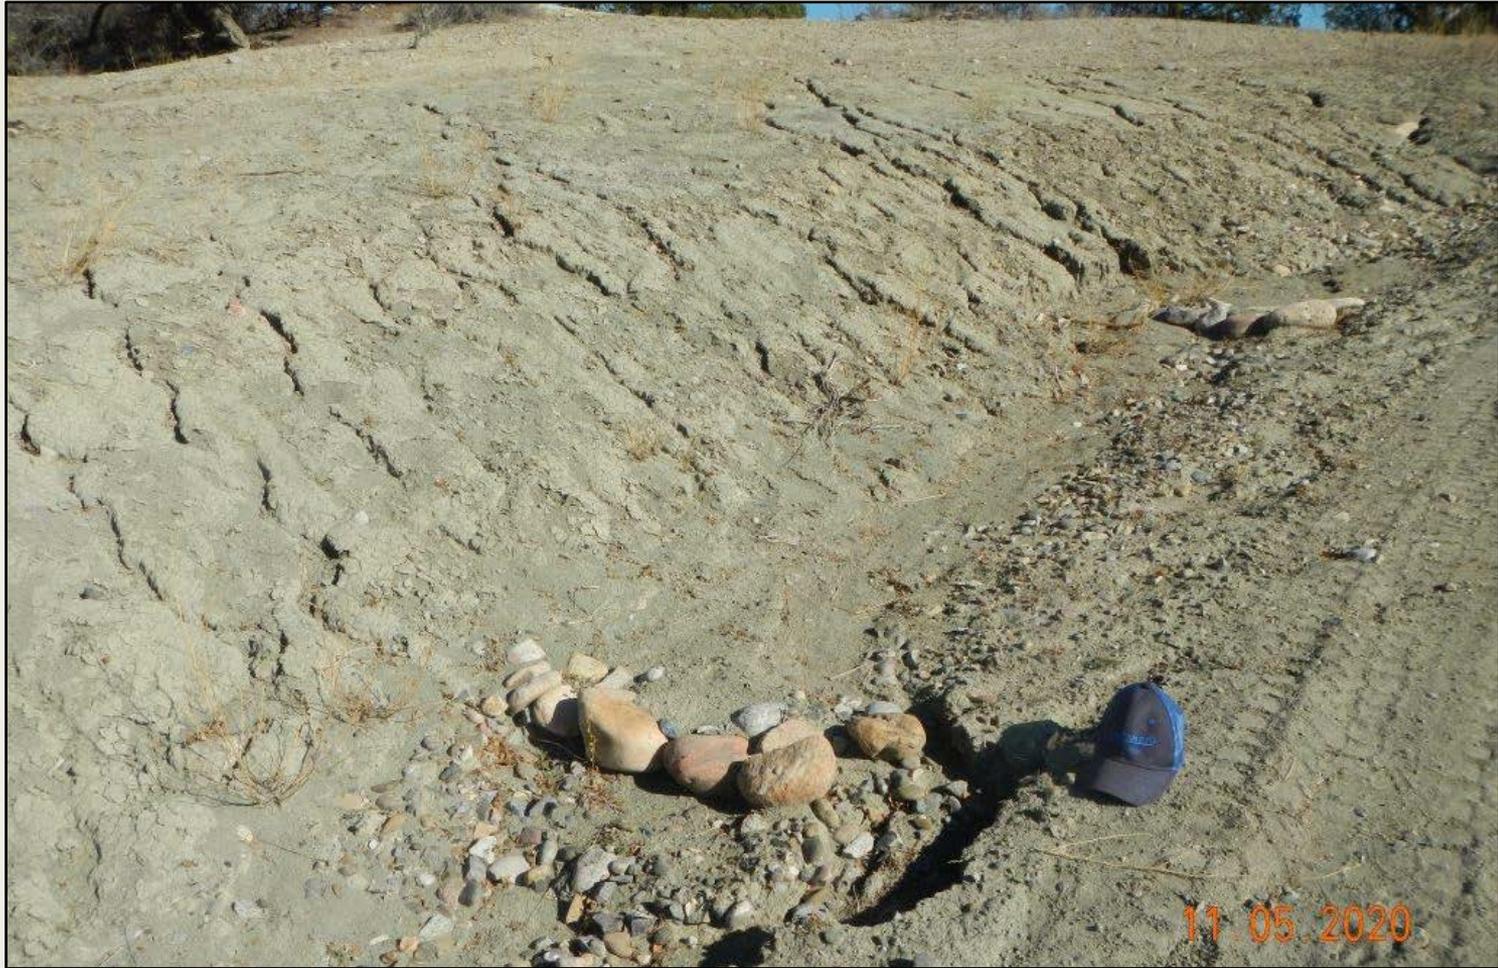
Photo 11. View of erosional rilling along the access road, and sediment filled cobble BMPs along the access. Slope is not stabilized, these BMPs are not adequate here.

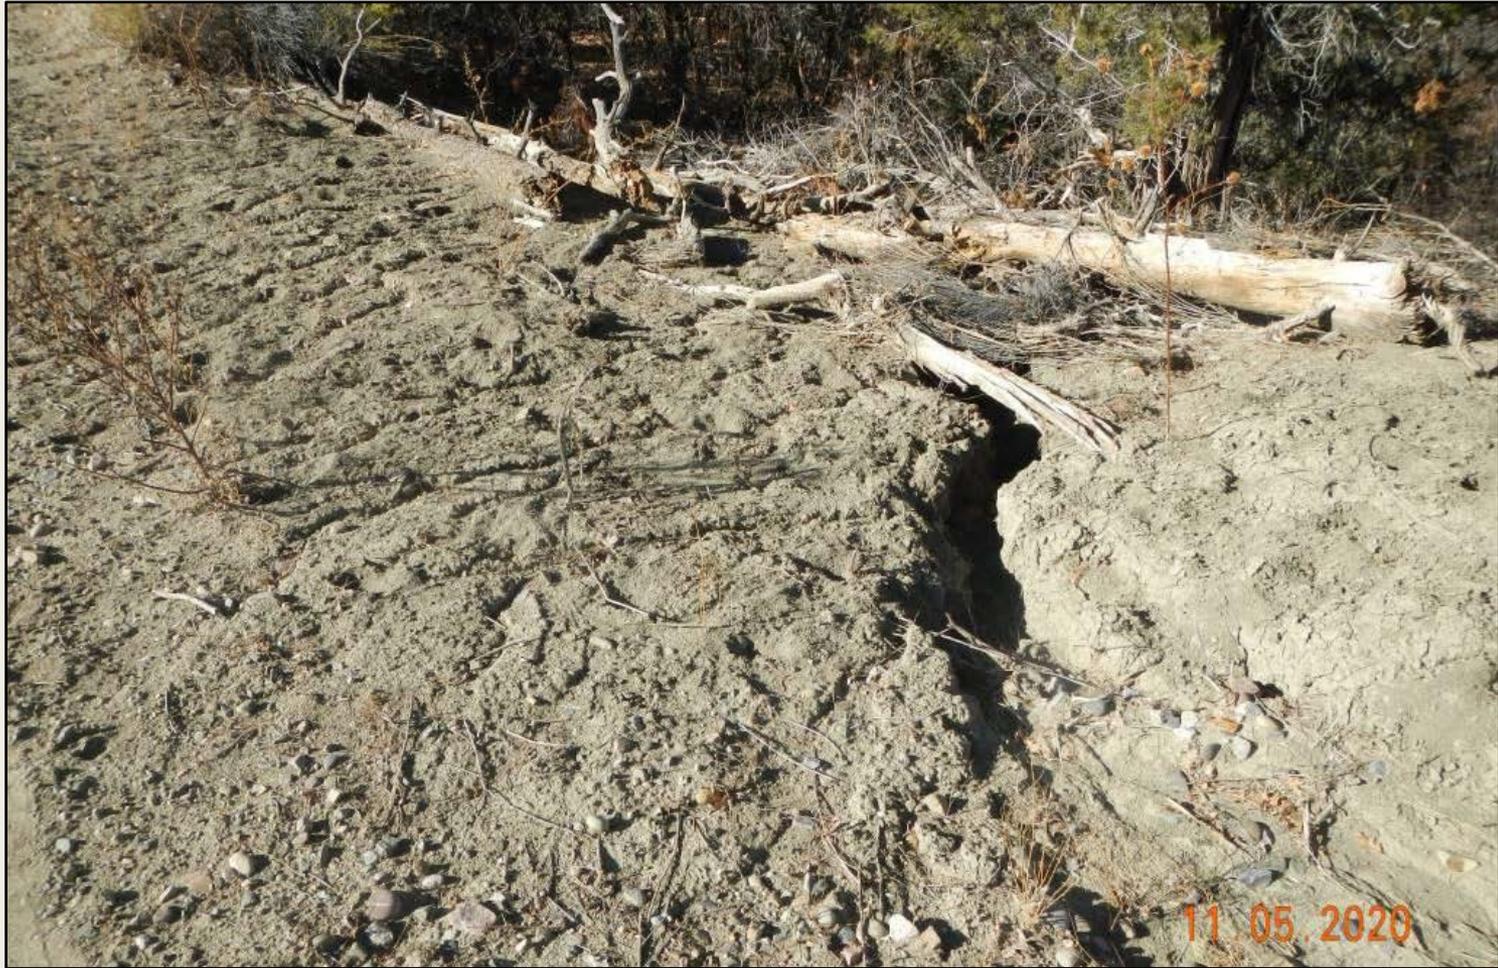
Photo 12. View of erosional rilling and channeling (approximately 1 foot wide and deep) occurring along the access road where erosional channel was repaired in response to a 2019 reclamation inspection.

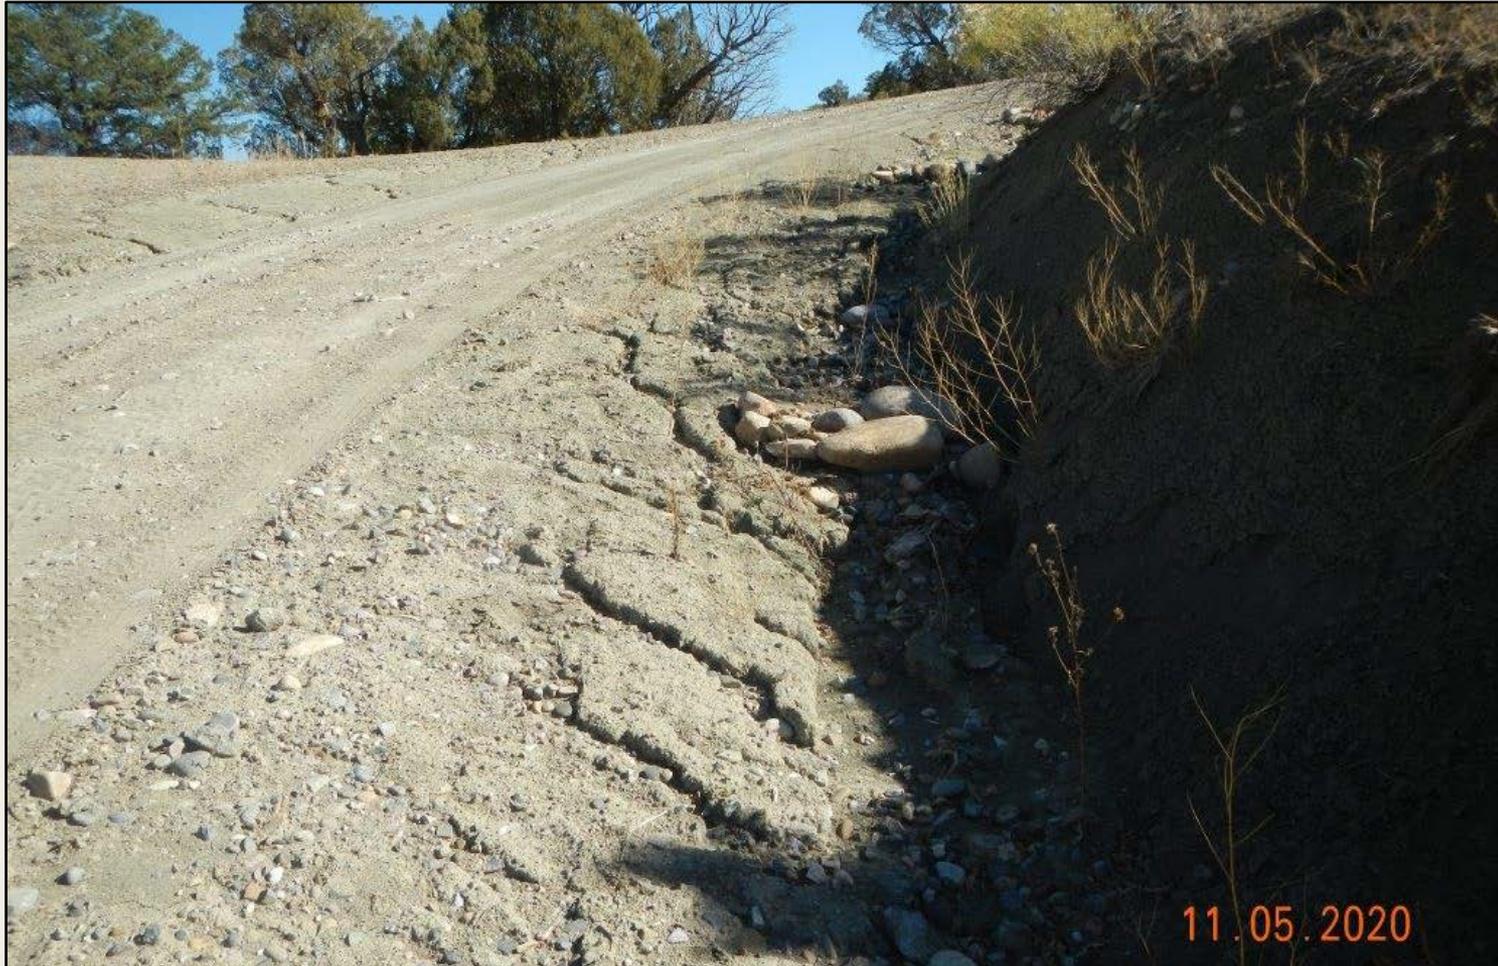
Photo 13. View of another area along the access road where shoulders are not stabilized with evident rilling and cobble BMPs that are inundated with sediment.

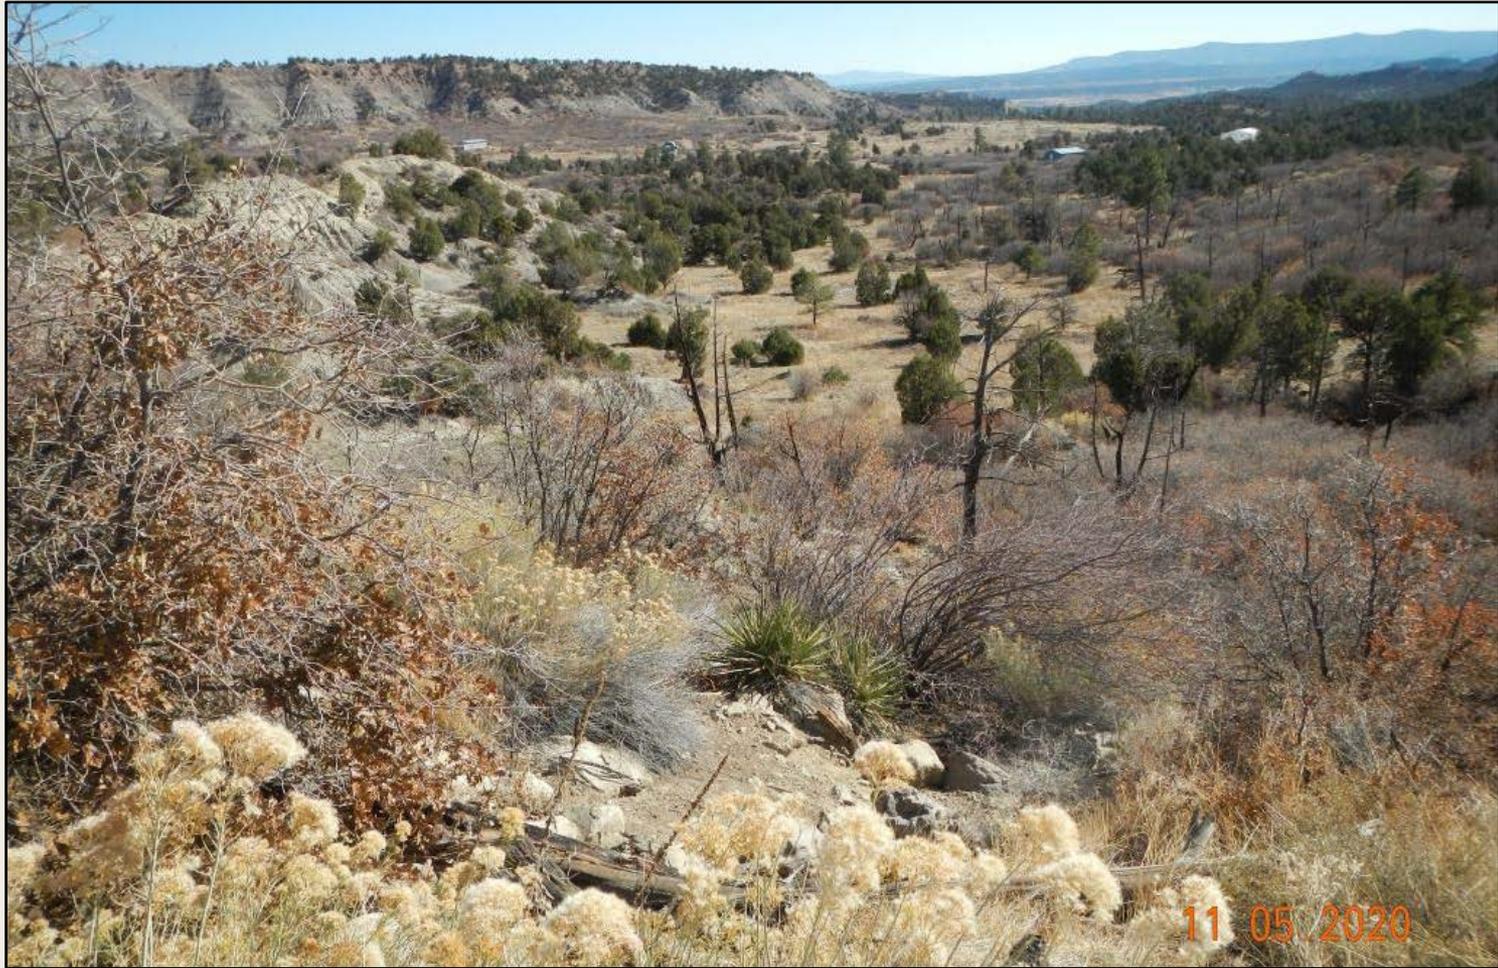
Photo 14. View of reference area facing southward. Vegetation is comprised of a mosaic of gambel oak shrubland, with ponderosa pine, pinyon and juniper trees, shrubs such as mountain mahogany, yucca, rubber rabbitbrush, and grasses/forbs such as rocky mountain penstemon, squirreltail, and western wheatgrass.

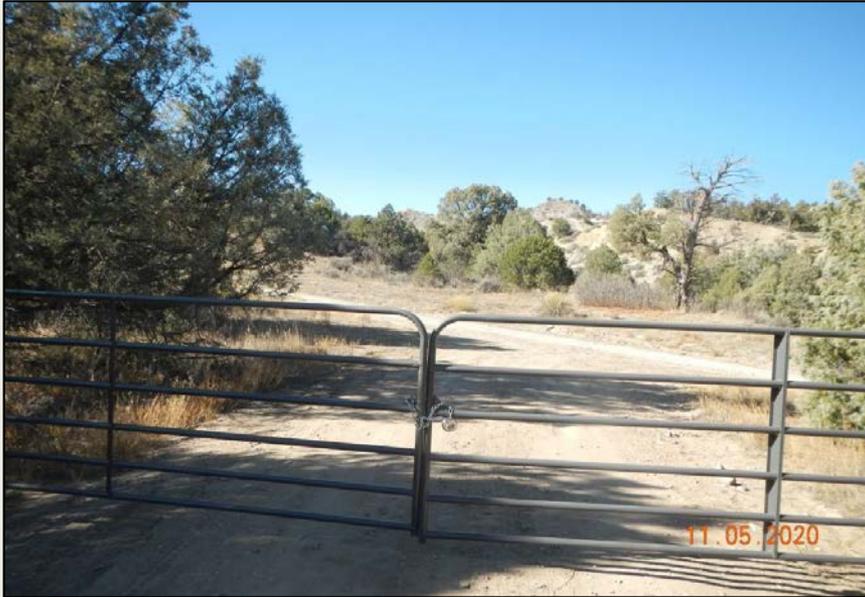
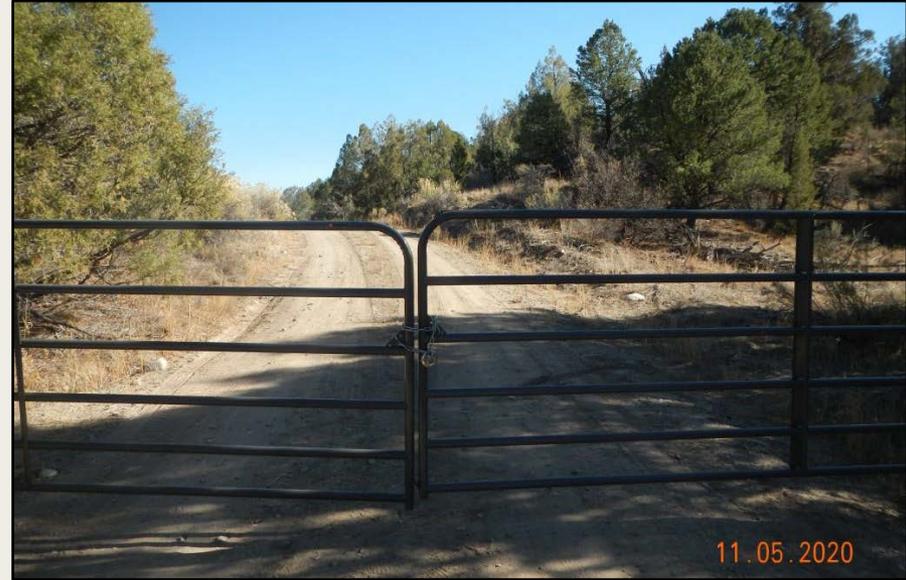
Photos 15/16. View of closed and locked gates after entering and exiting location.
