Inspection Photos
Operator: BP America
API: 067-05144
Date: 11/20/2020

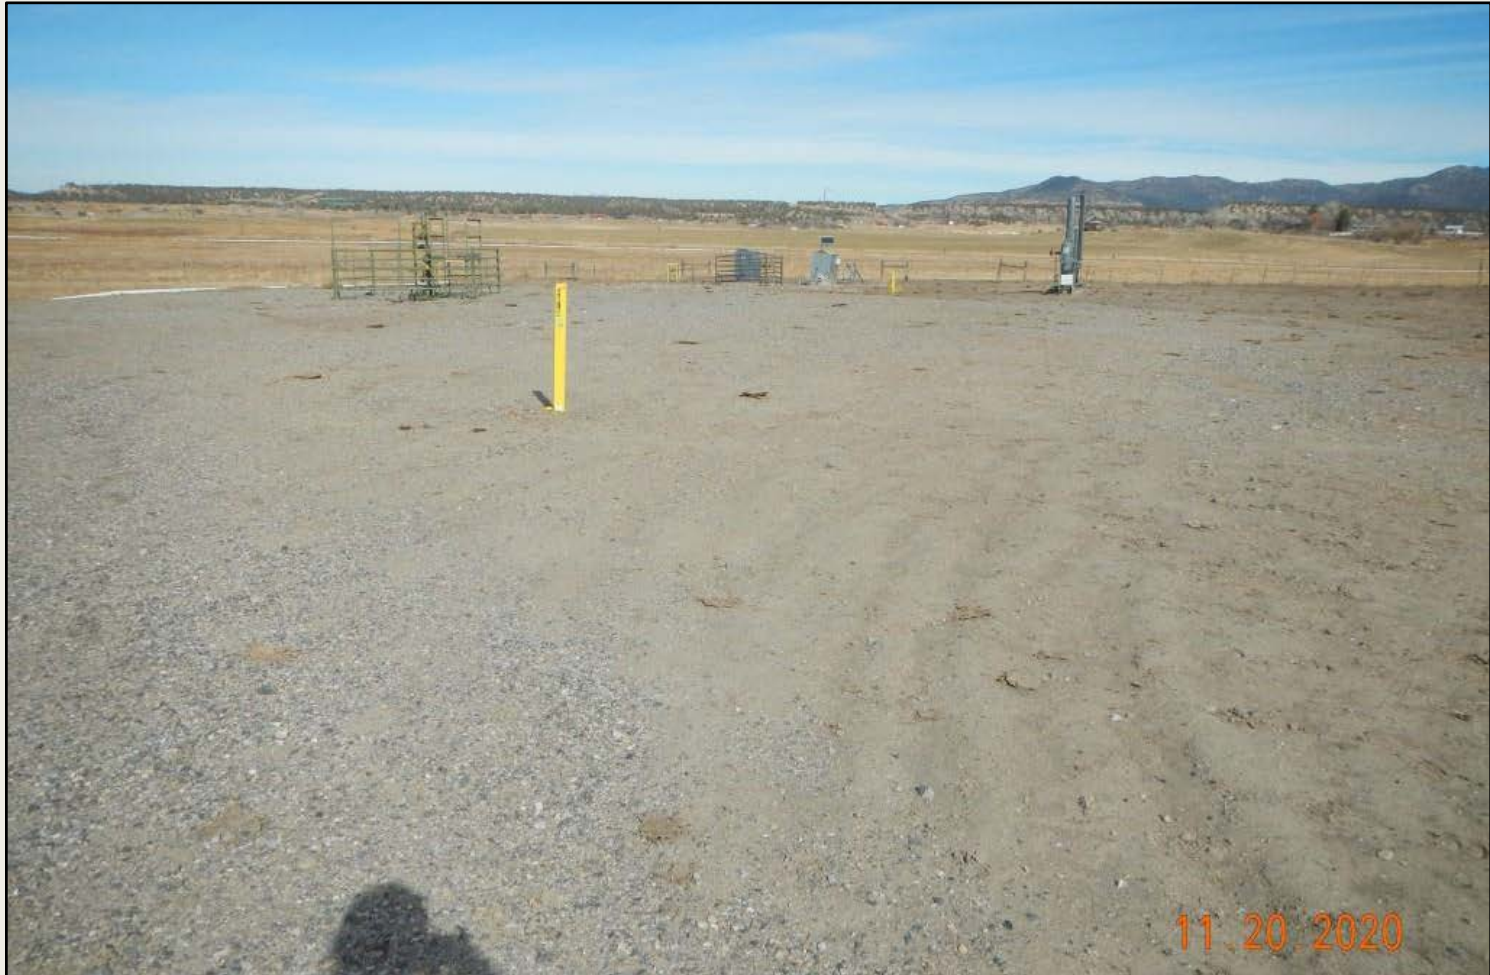
Photo 1. View of the project area from the well pad entrance facing center.

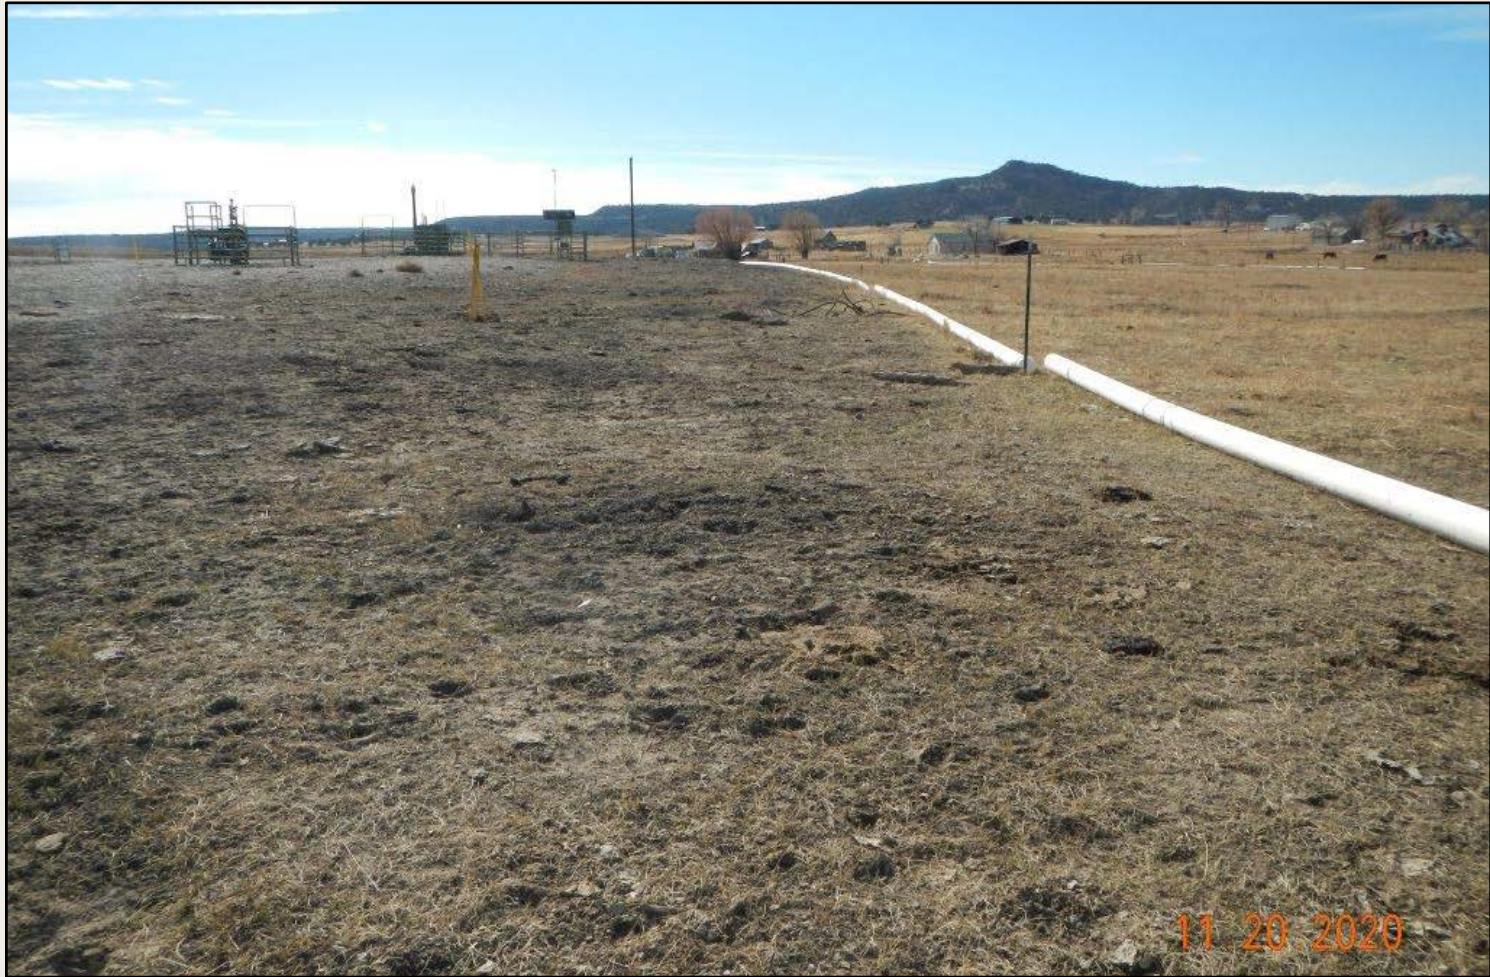
Photo 2. View of the western fill slope from the northwestern corner facing southward. Area is upslope from irrigation alignment, with grasses established in a more sparse and grazed condition than down slope, below irrigation.

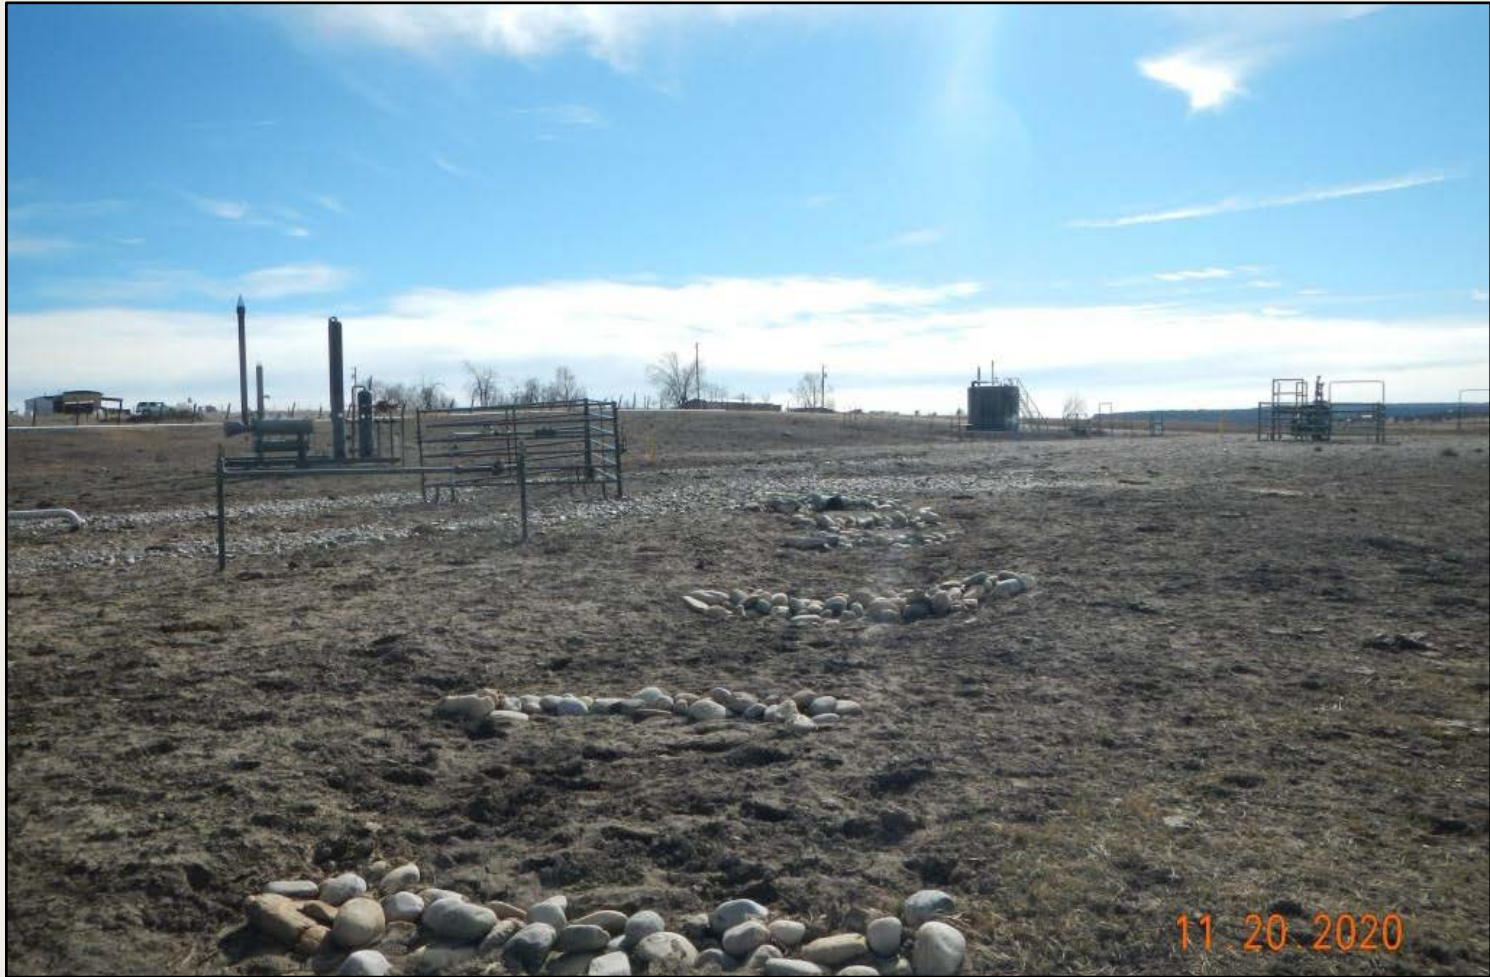
Photo 3. View of cobble checks placed within the project area. Checks are filling with sediment and will soon require maintenance.

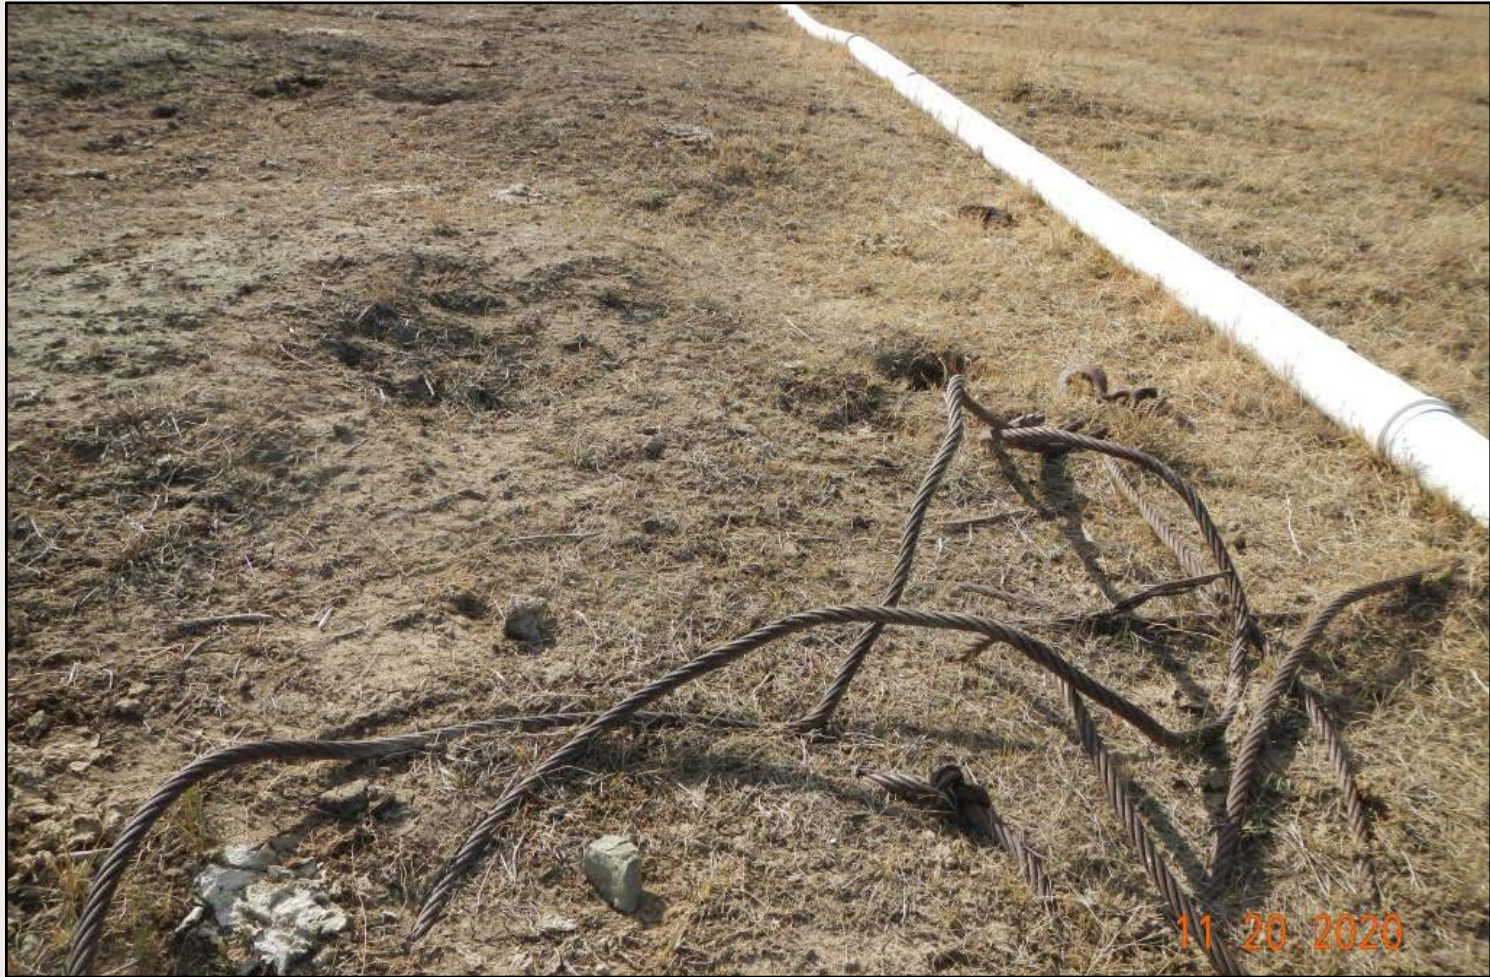
Photo 4. View of cable debris within the western project area.

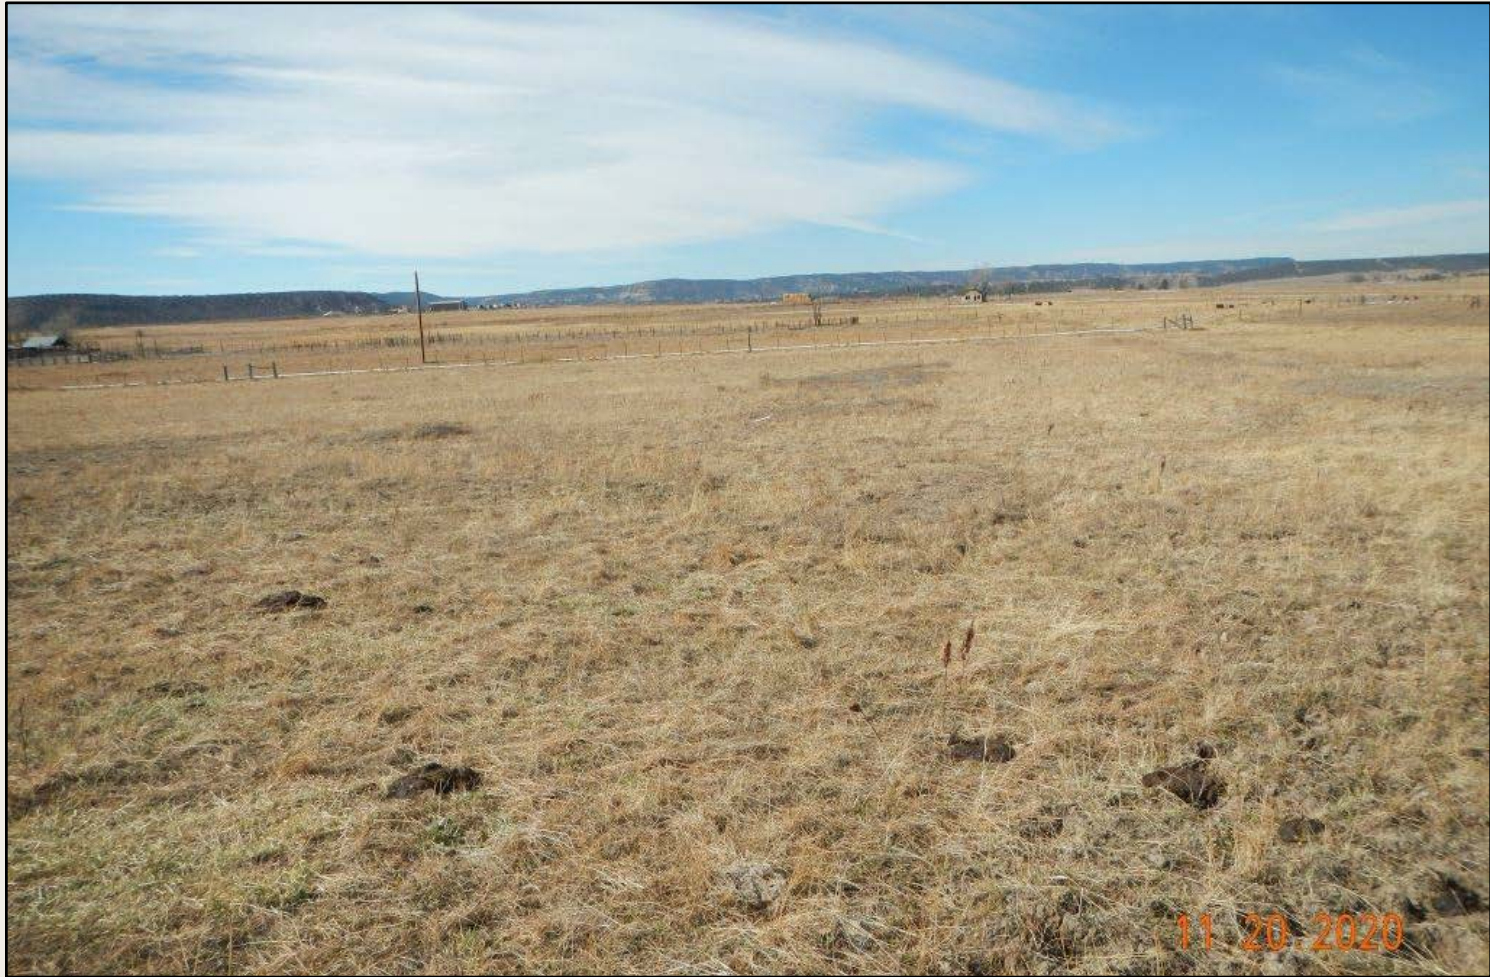
Photo 5. View of the reference area comprised of irrigated grass field with grasses such as timothy, tall fescue, orchard grass, and sedges.

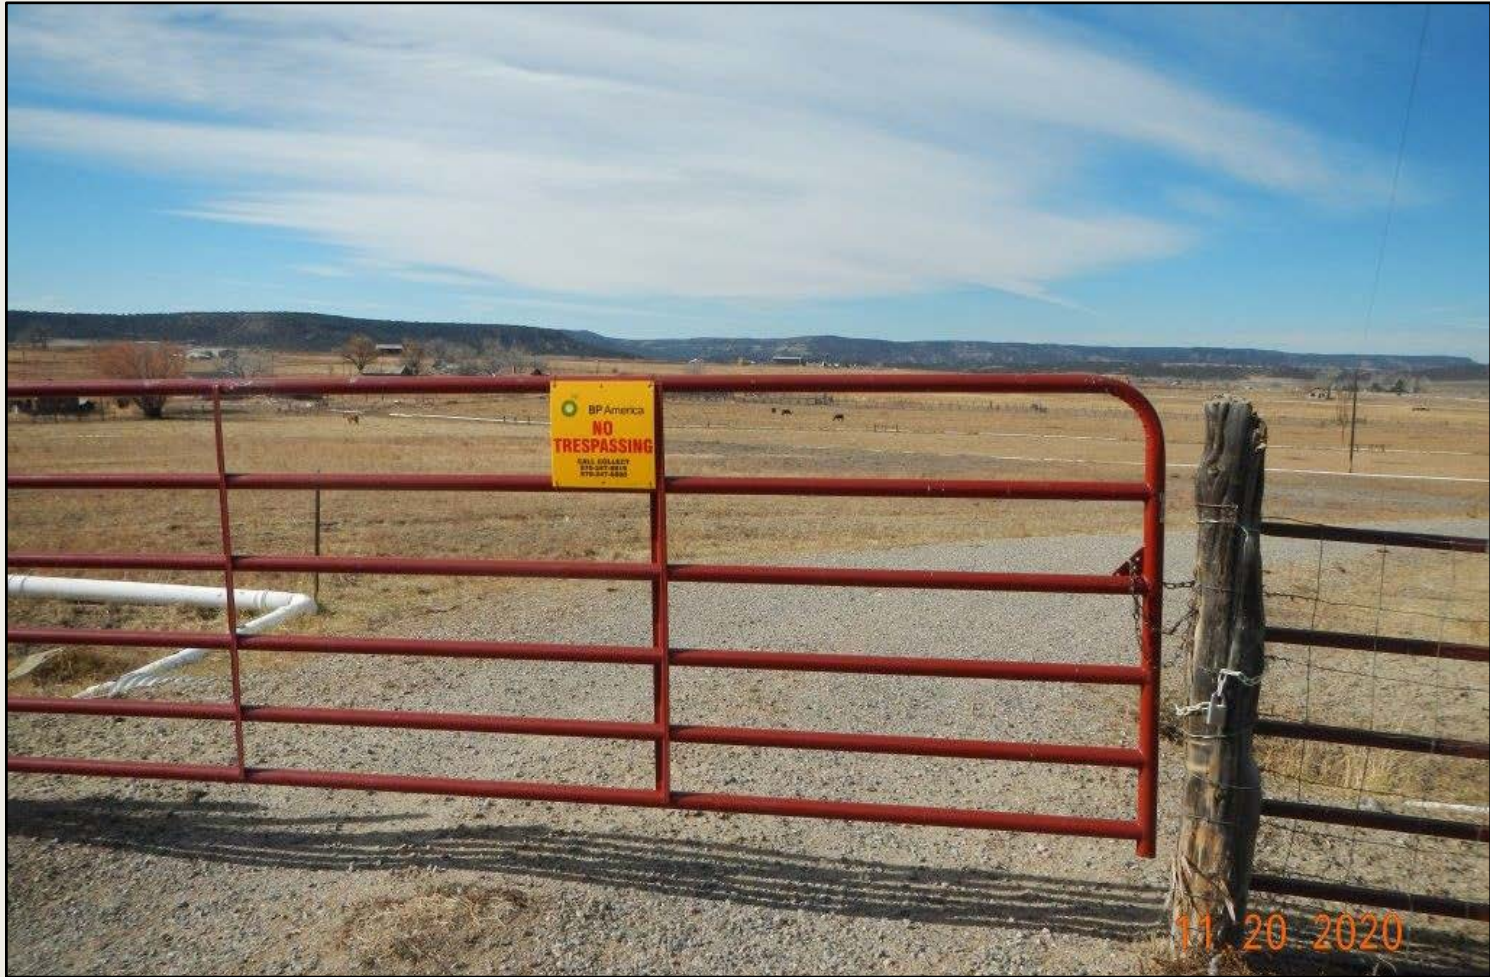
Photos 6/7. View of closed gates after entering and leaving location.
