# Inspection Photos

API: 071-06858

Operator: EVERGREEN NATURAL RESOURCES

Inspection Date: 11/30/2020

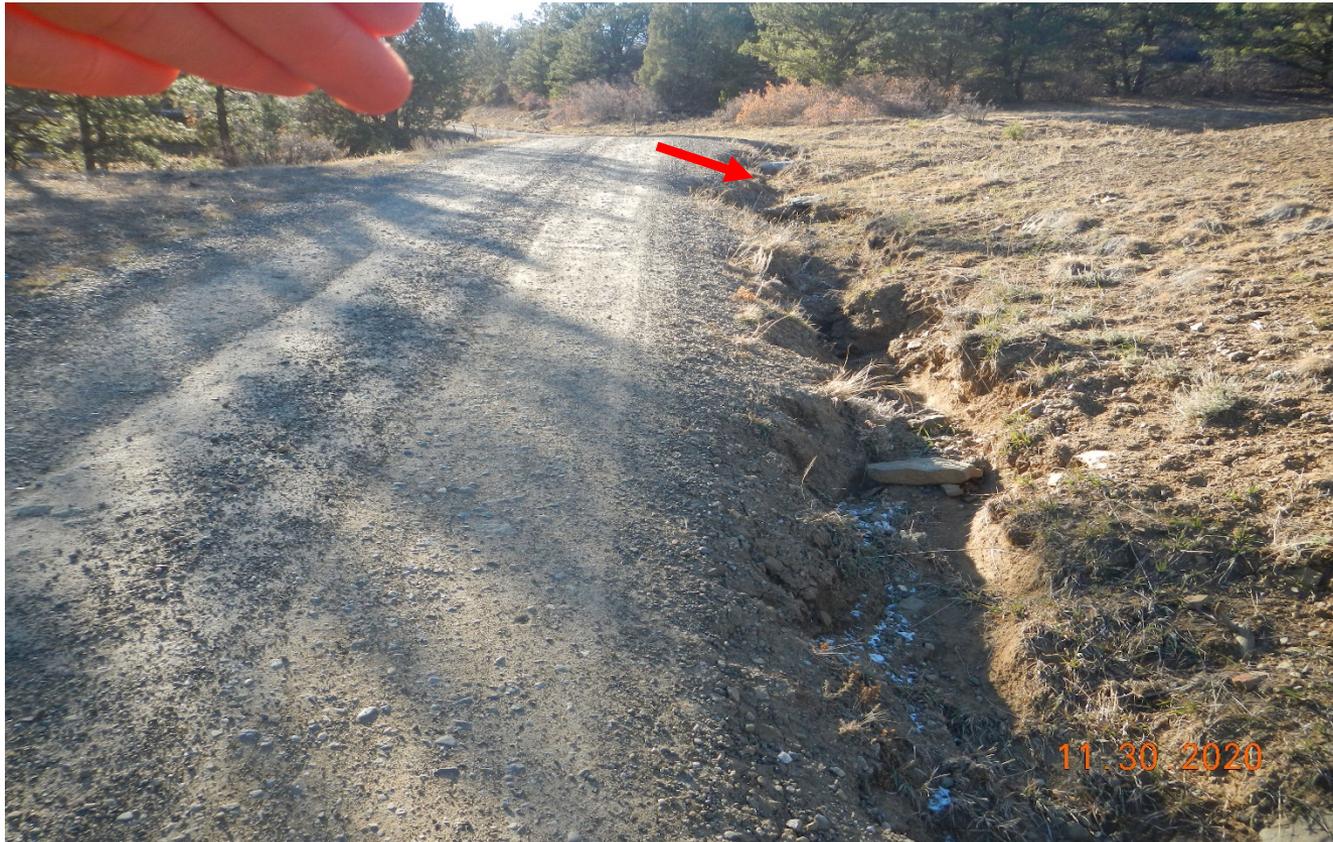
**Photo 1.** Facing southwest along the main road. The culvert shown at red arrow is not maintained causing erosion along the side of the road. Lat/Long:37.15900,-104.81291.

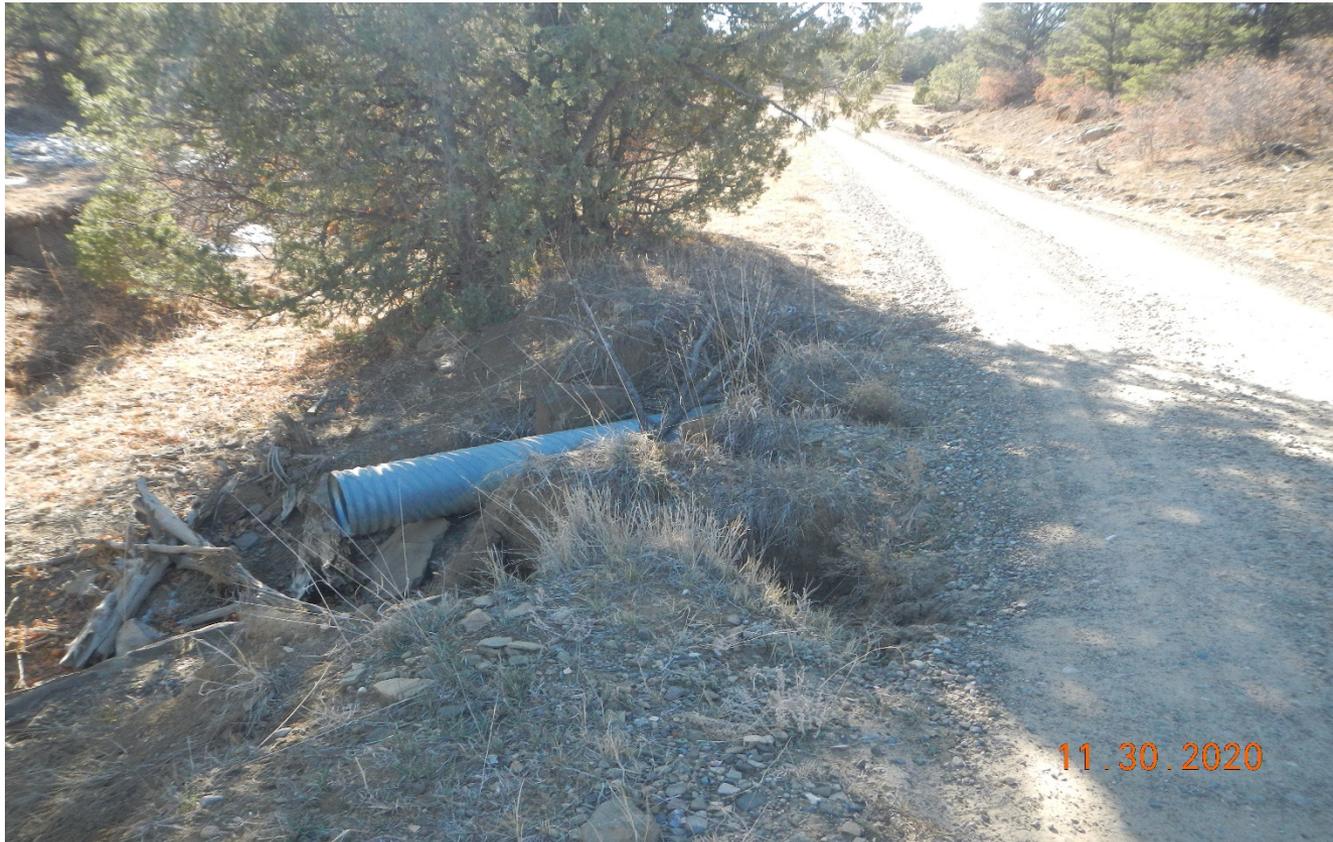
**Photo 2.** There is erosion at the culvert outlet at Lat/Long:37.15900,-104.81291.

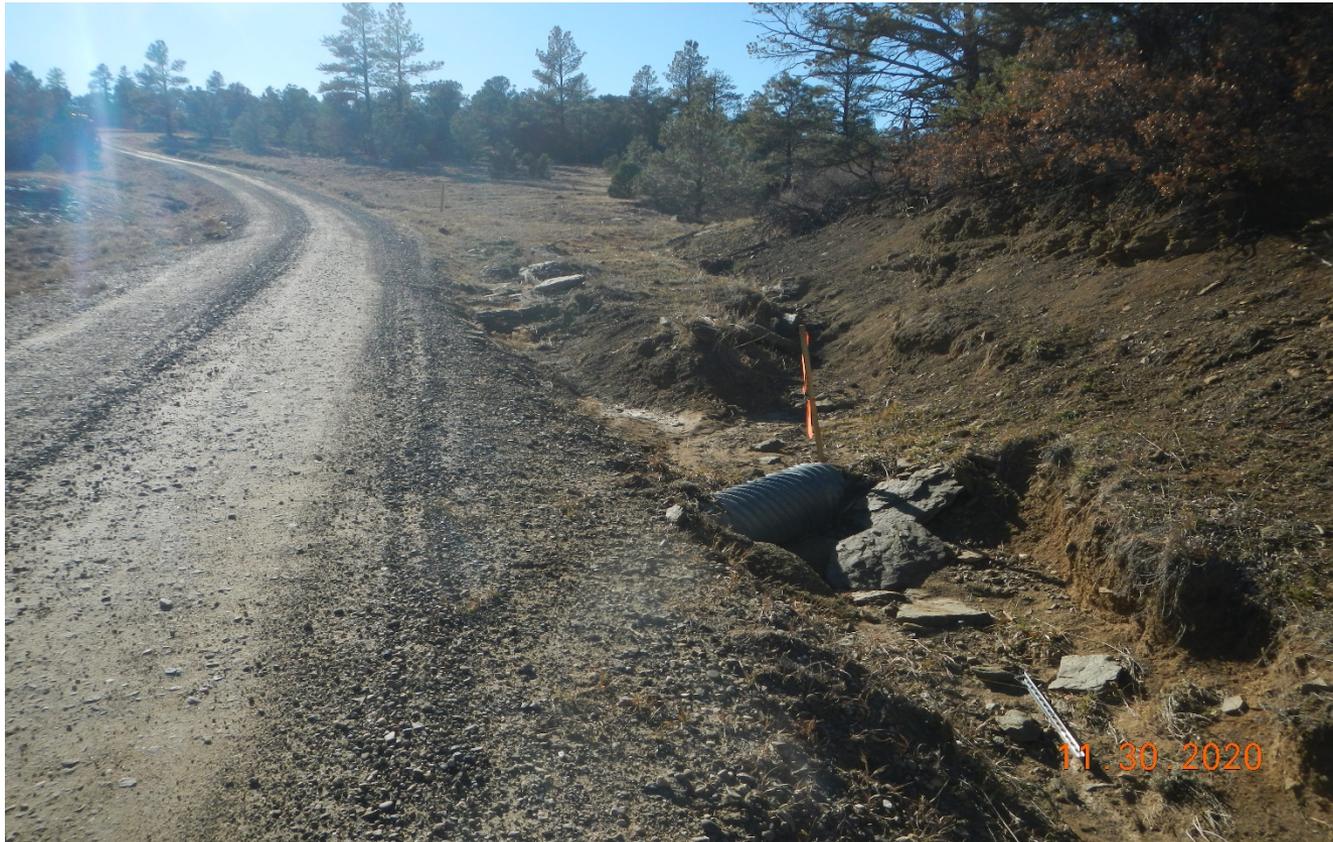
**Photo 3.** Facing southwest along the main road. This culvert is not maintained causing erosion along the side of the road.

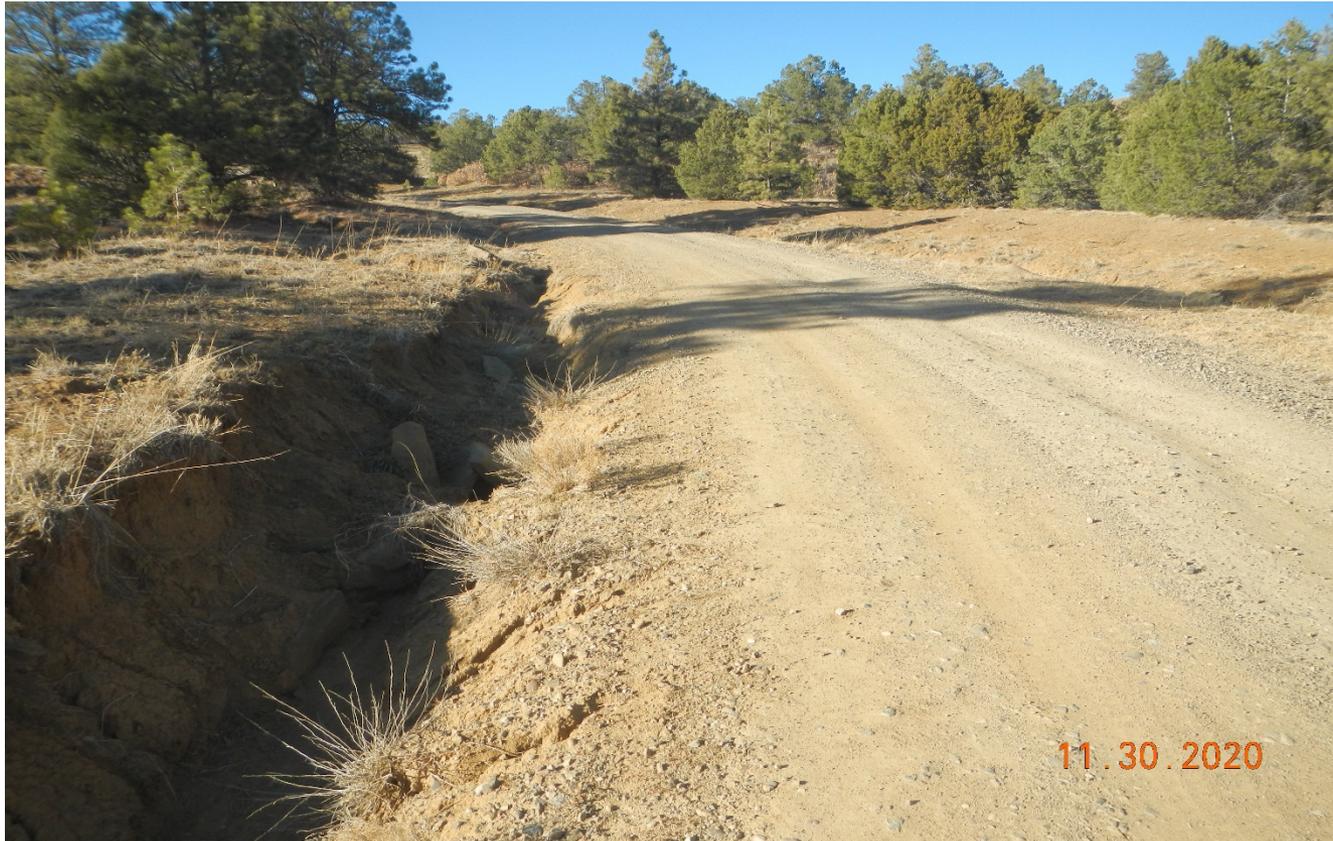
**Photo 4.** Facing north along the main road near the location. The side of the road has eroded.

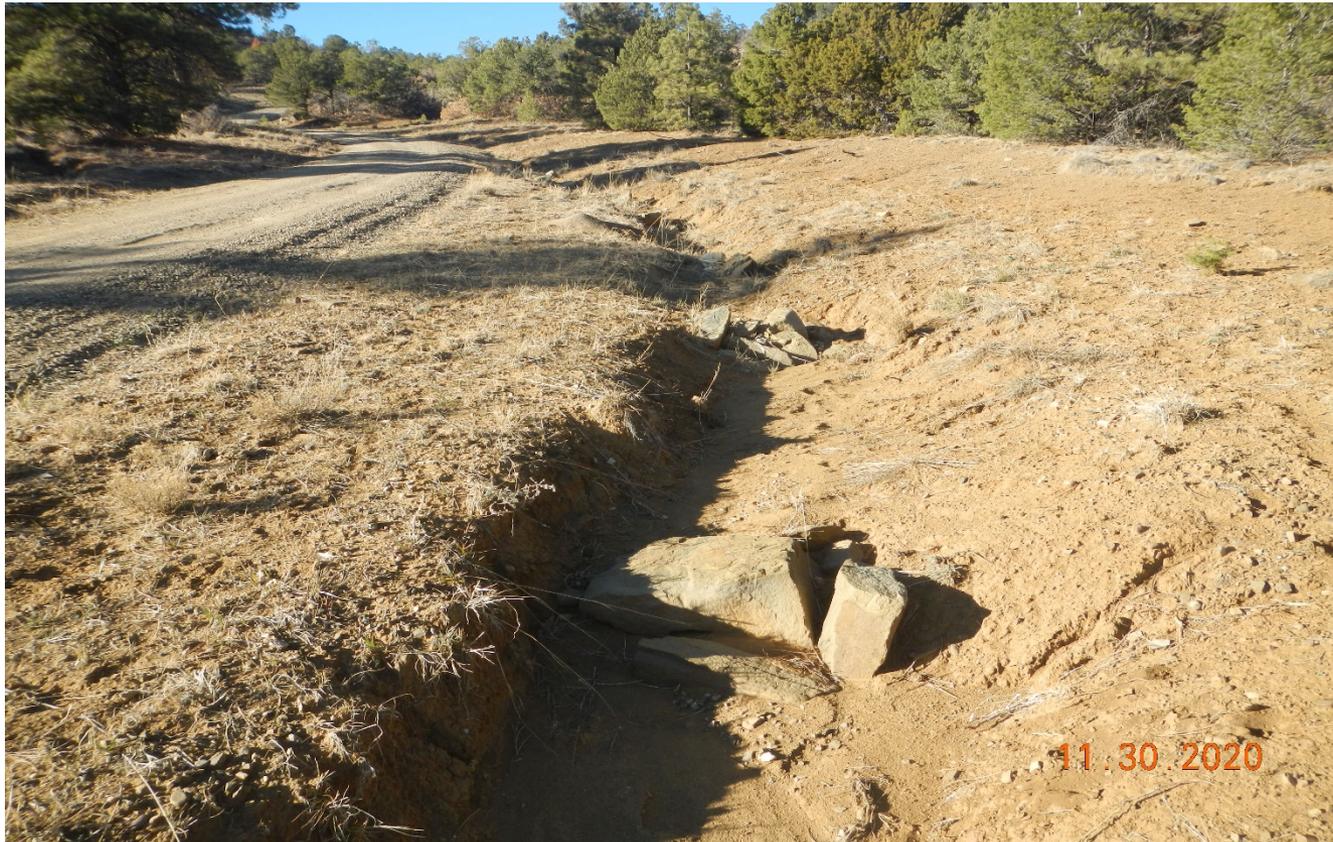
**Photo 5.** Facing north along the main road near the location. The side of the road has eroded. The rock check damns have failed.

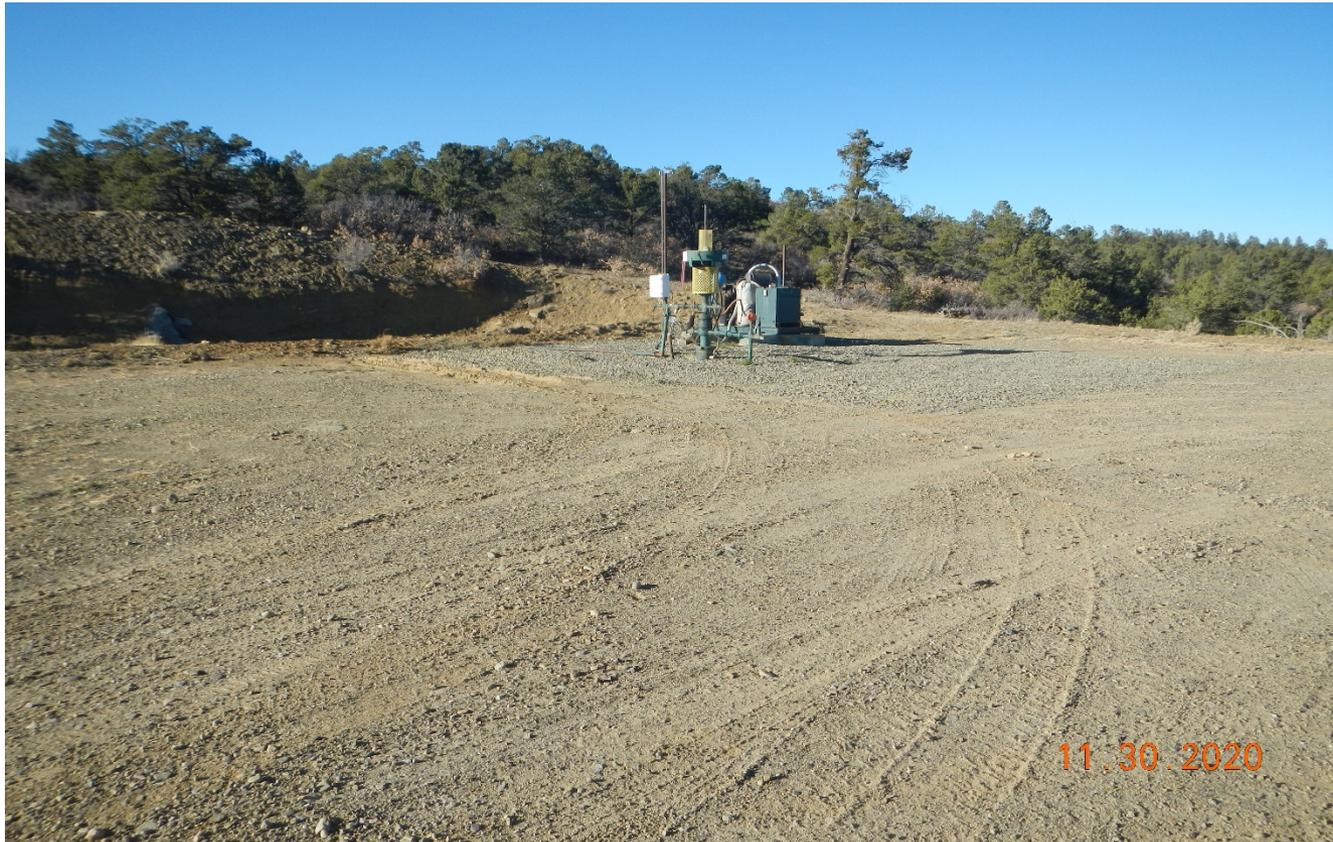
**Photo 6.** Facing north toward the location.

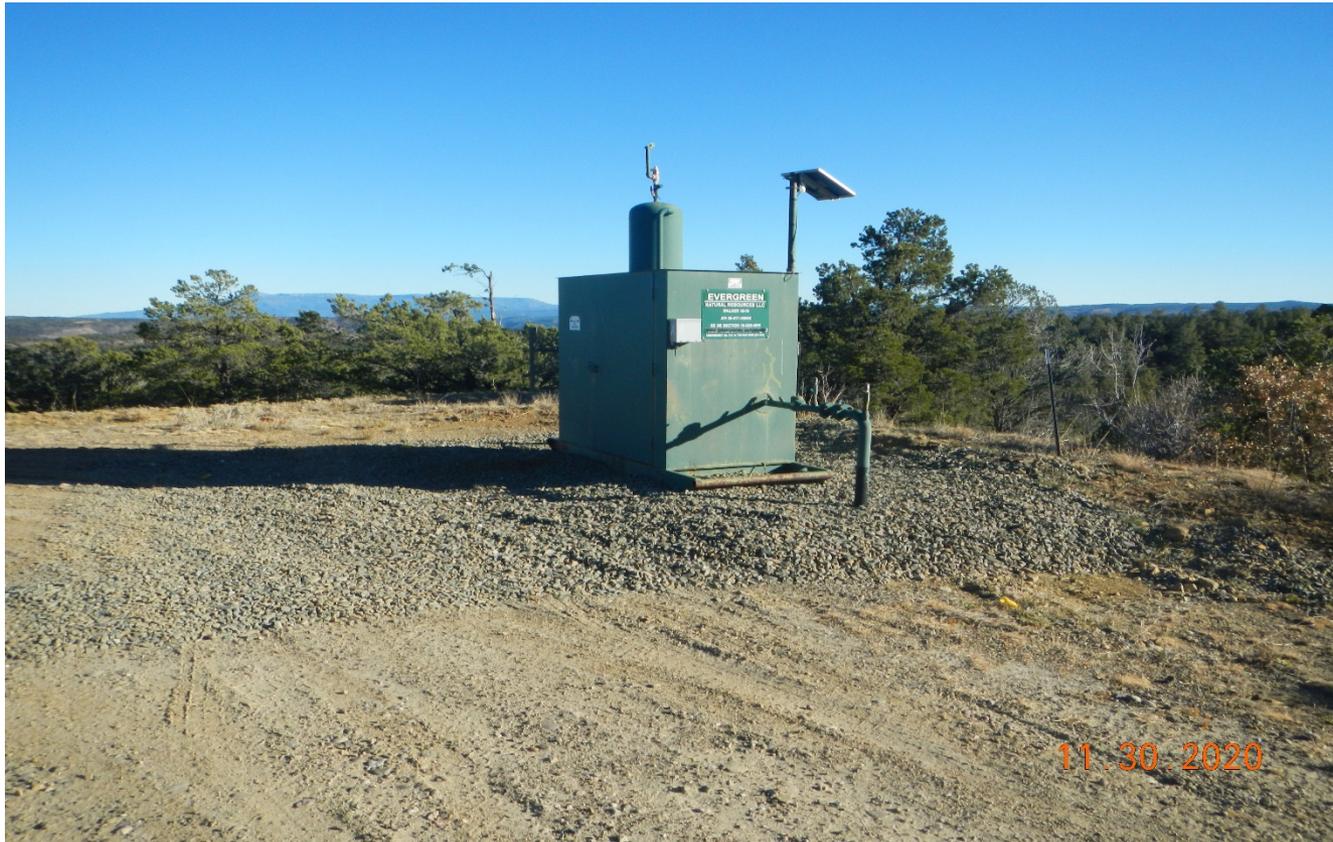
**Photo 7.** Well sign posted at meter shed.
