COLORADO
Oil & Gas Conservation
Commission
Department of Natural Resources

Douglas Train Unit 1325 API: 05-103-09448
Inspection: 700404394

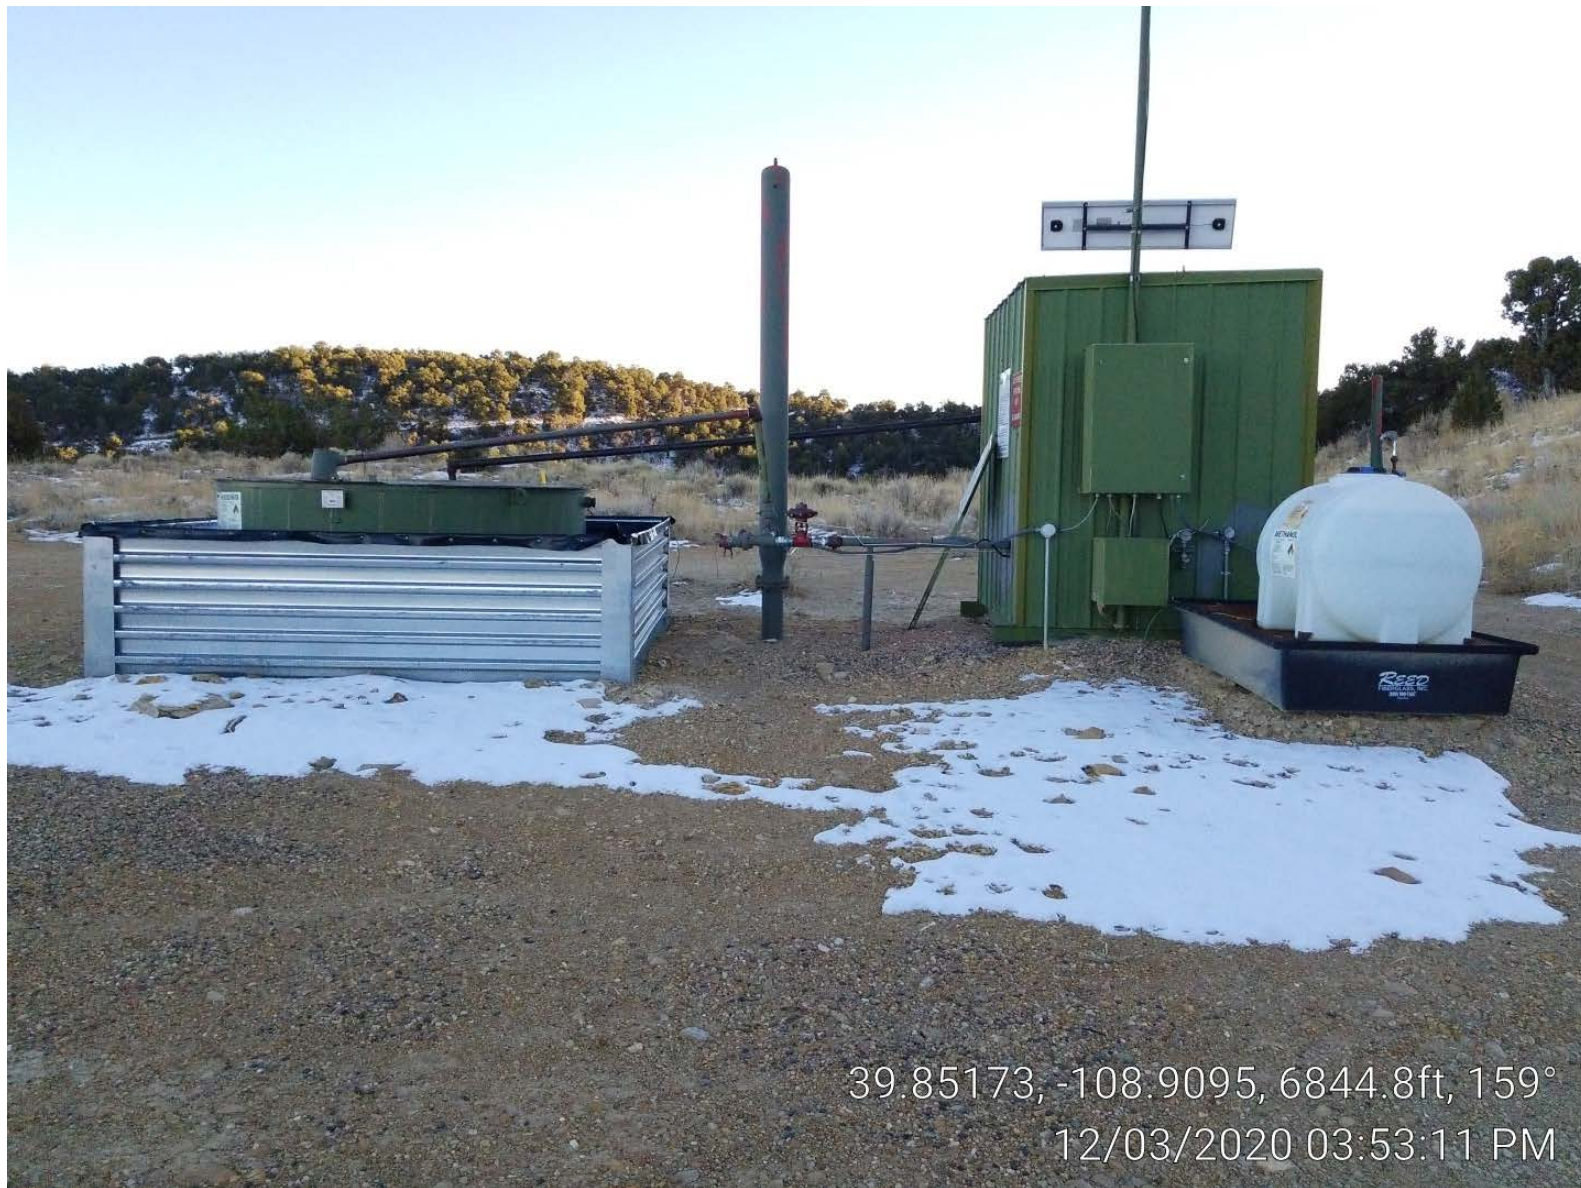
Photo 1. Tank & meter building.

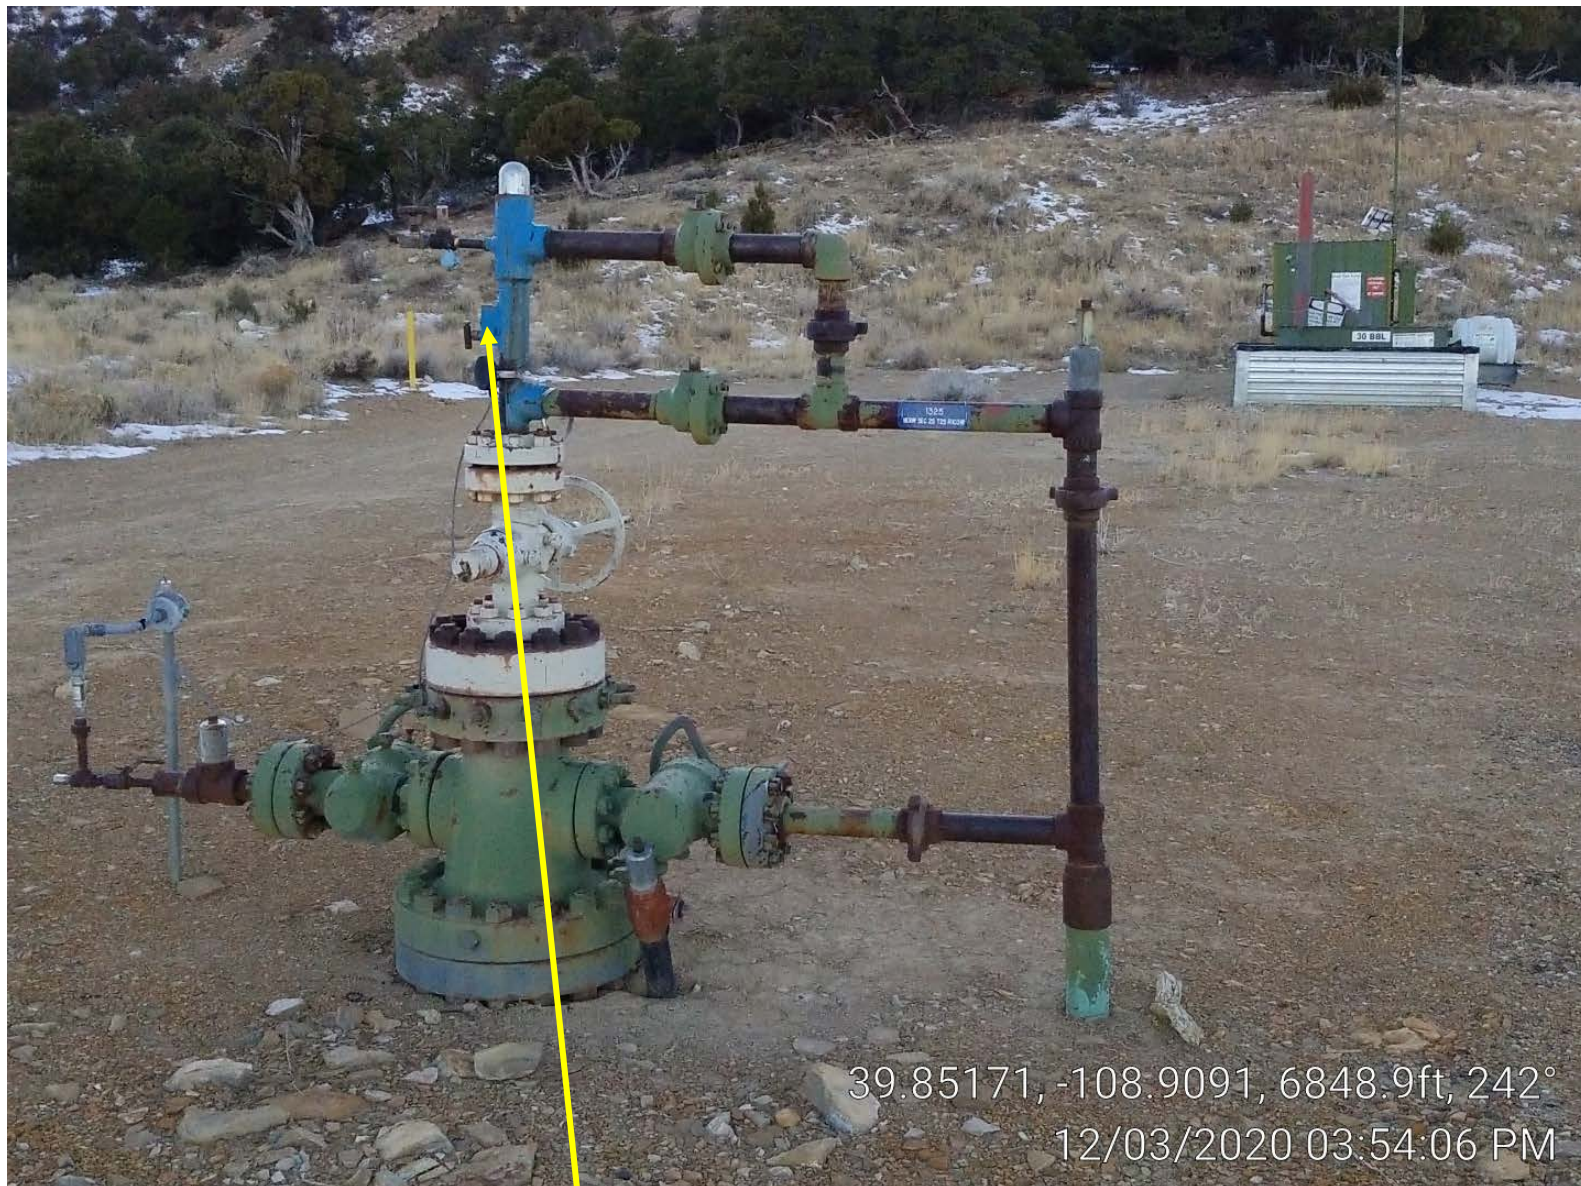
Photo 2. Location with gas leak.

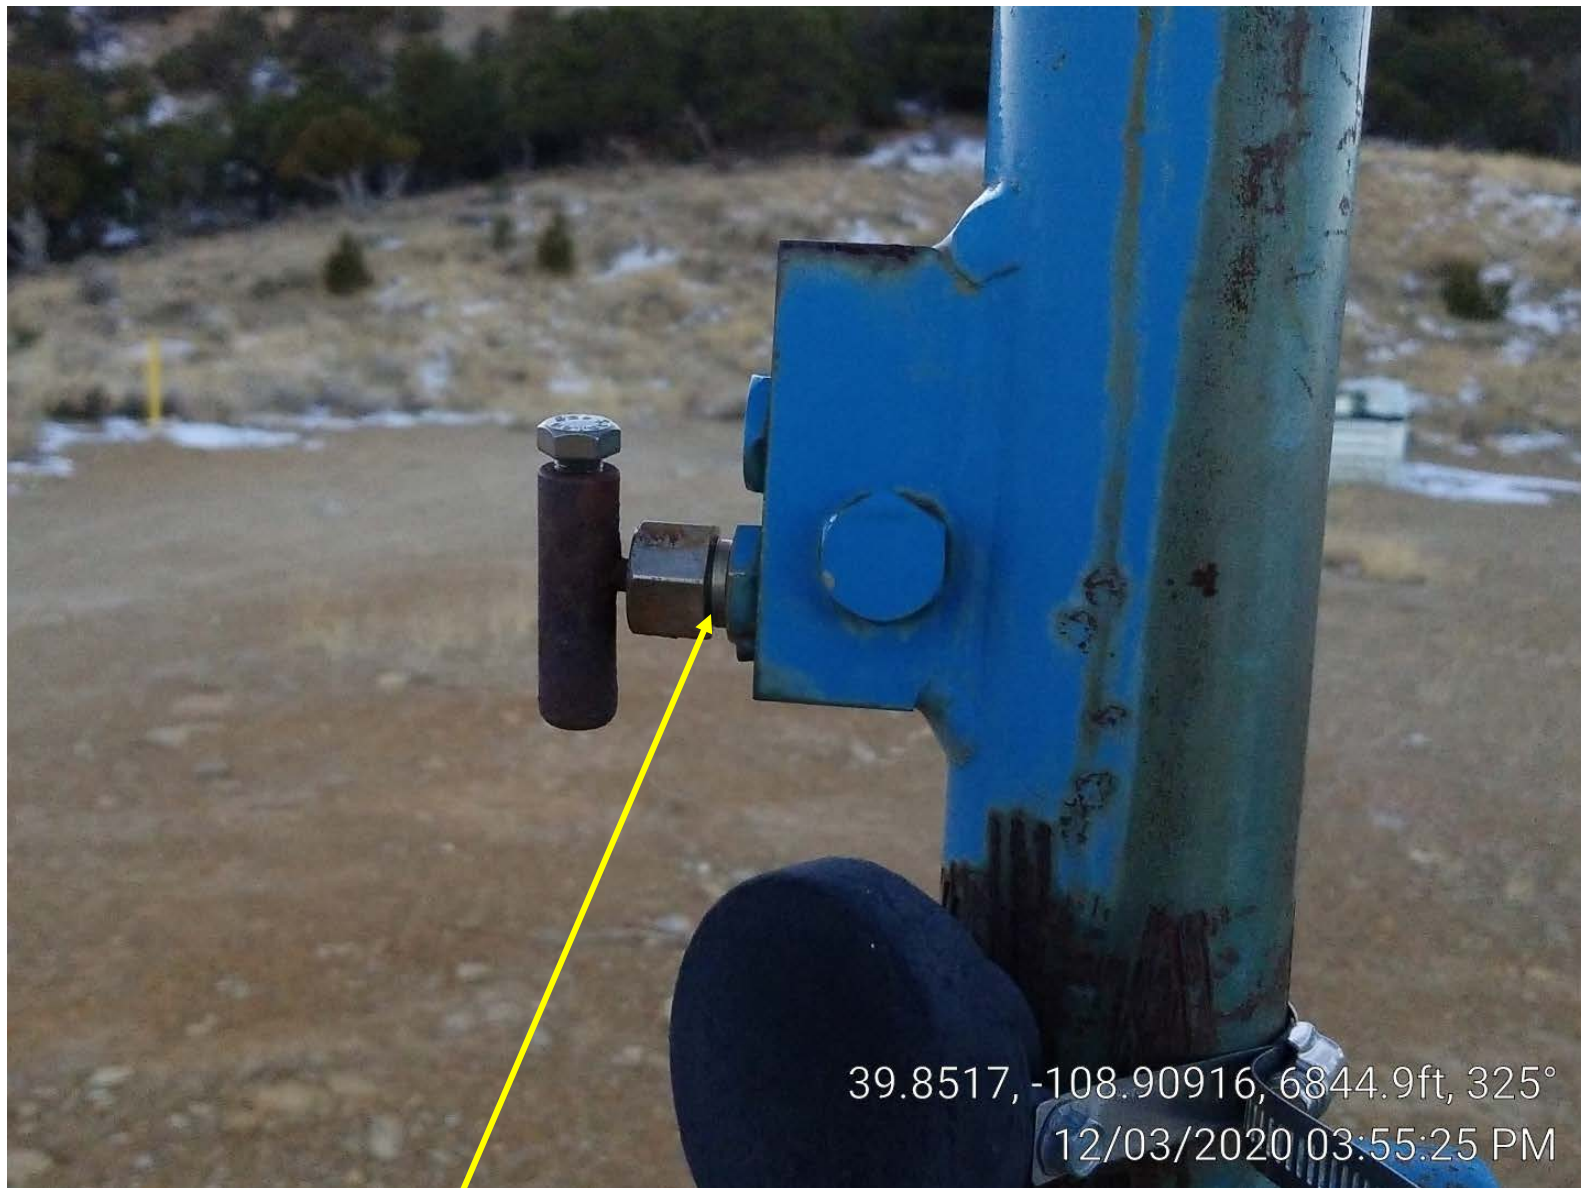
Photo 3. Gas leak.
