Inspection Photos

Location Name: SG INTERESTS I LTD FEDERAL-611S90W /24NWSW

Location ID: 324490

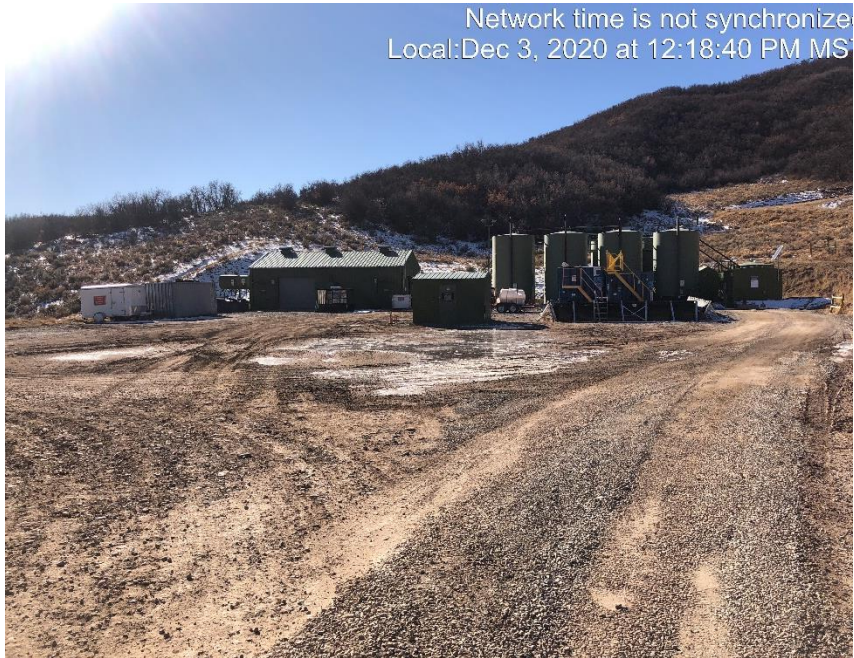
Photo #2385 from entrance to location.

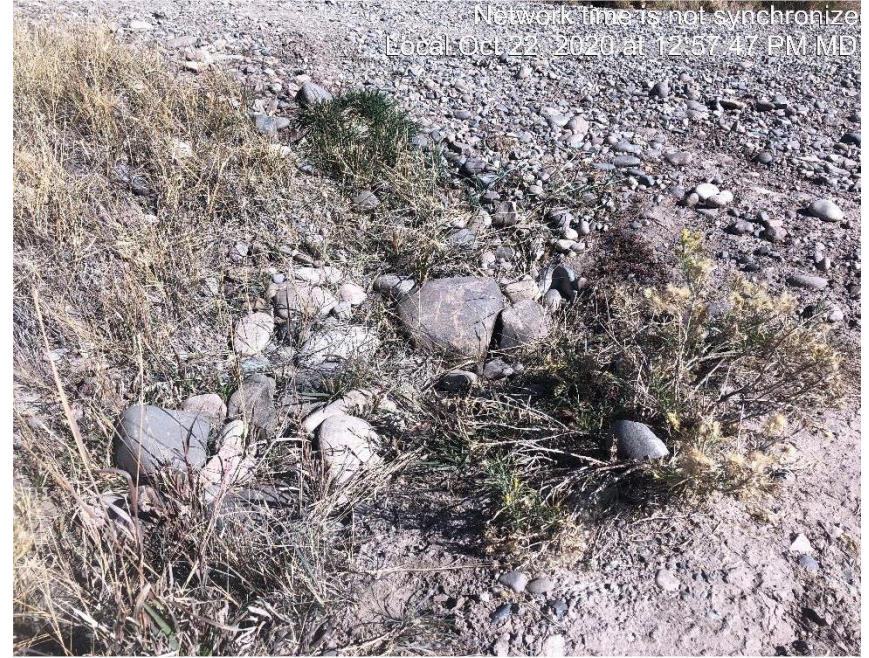
Photo #2082 Photo from inspection #699801978 conducted on 10/22/20 inlet culvert #1.

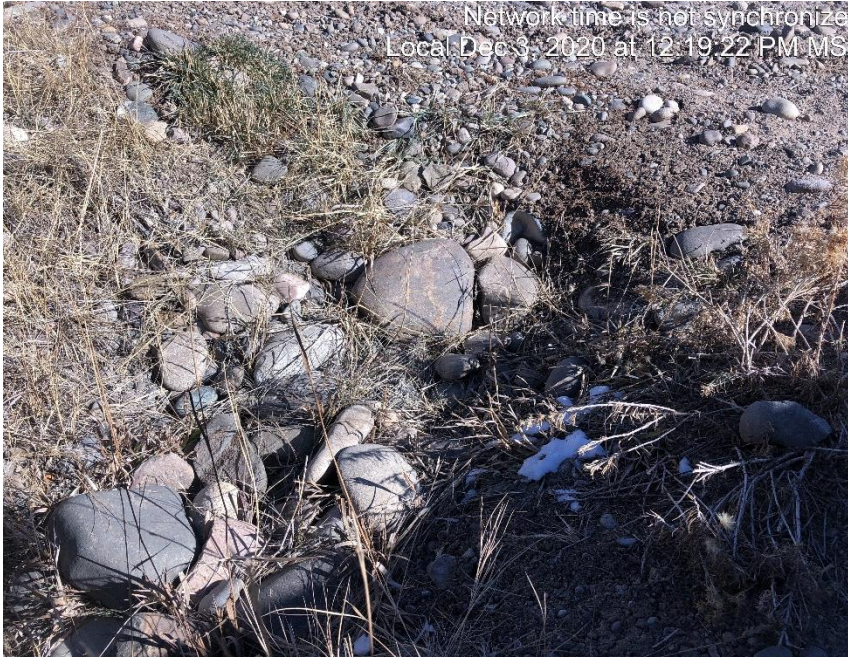
Photo #2386 inlet culvert #1.

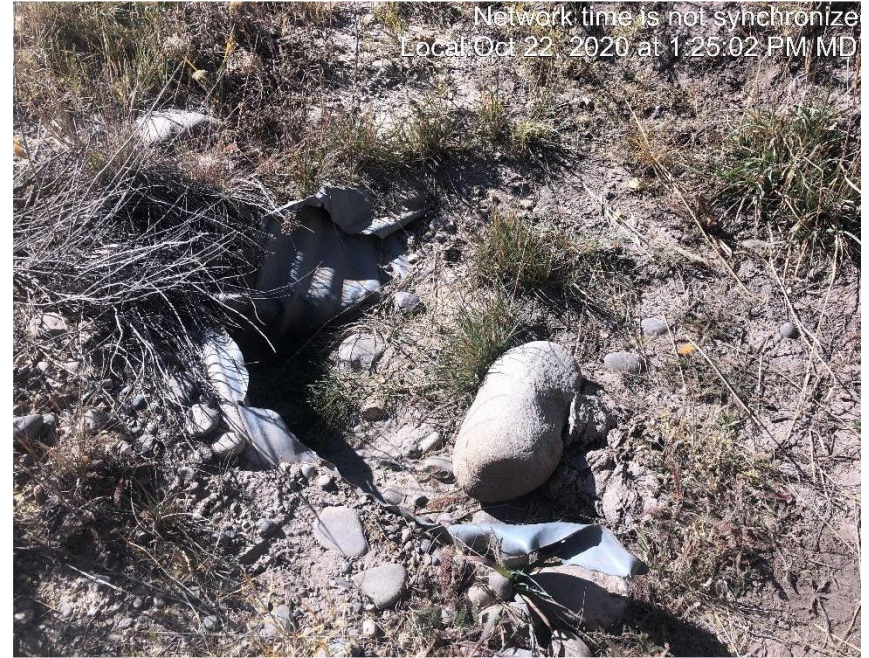
Photo #2085 Photo from inspection #699801978 conducted on 10/22/20 inlet culvert #2.

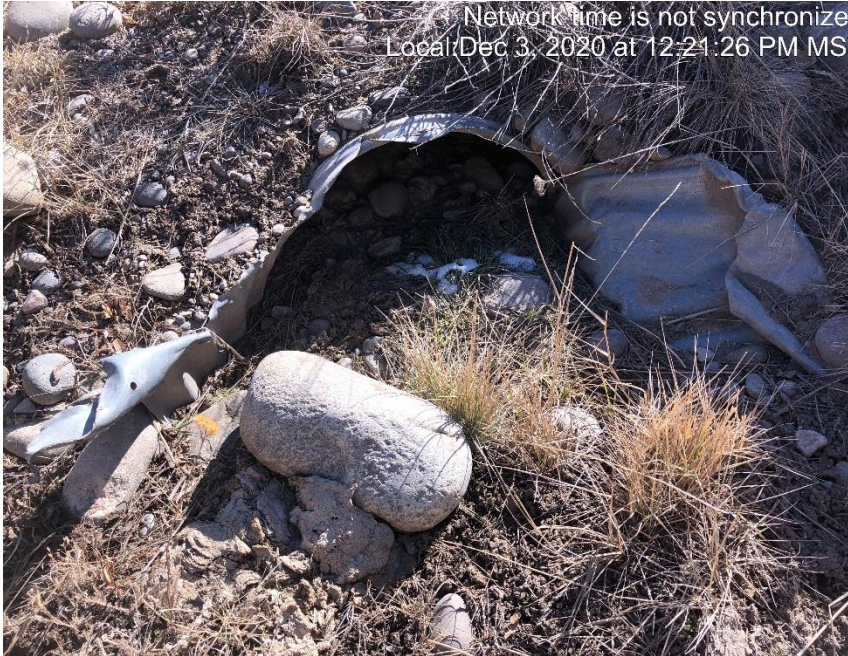
Photo #2388 inlet culvert #2.

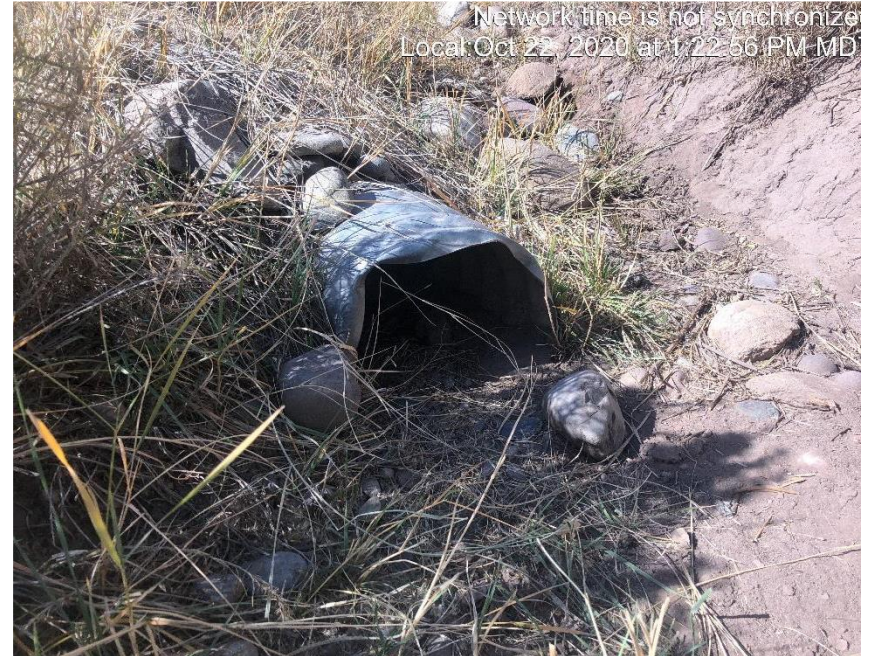
Photo #2084 Photo from inspection #699801978 conducted on 10/22/20 outlet culvert #1.

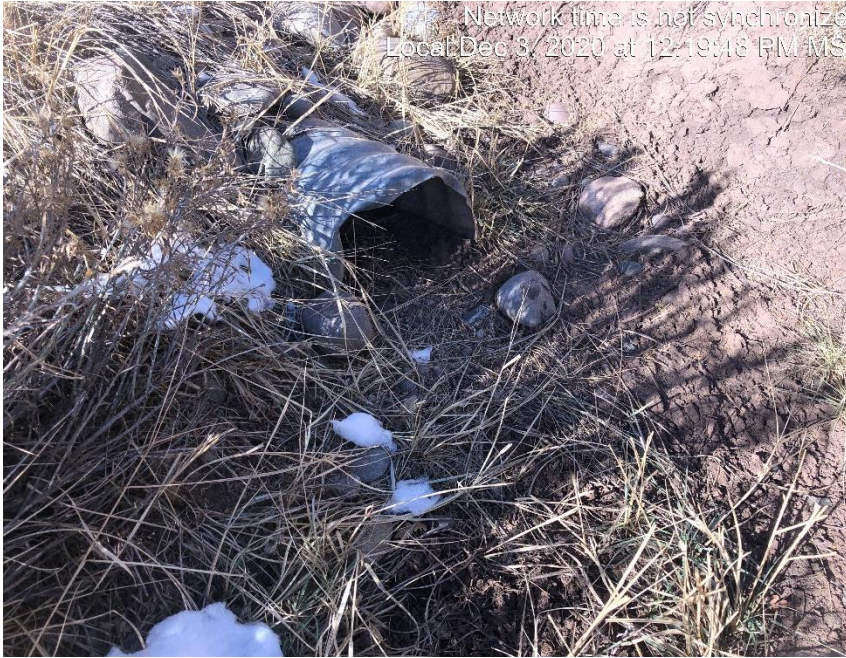
Photo #2387 outlet culvert #1.

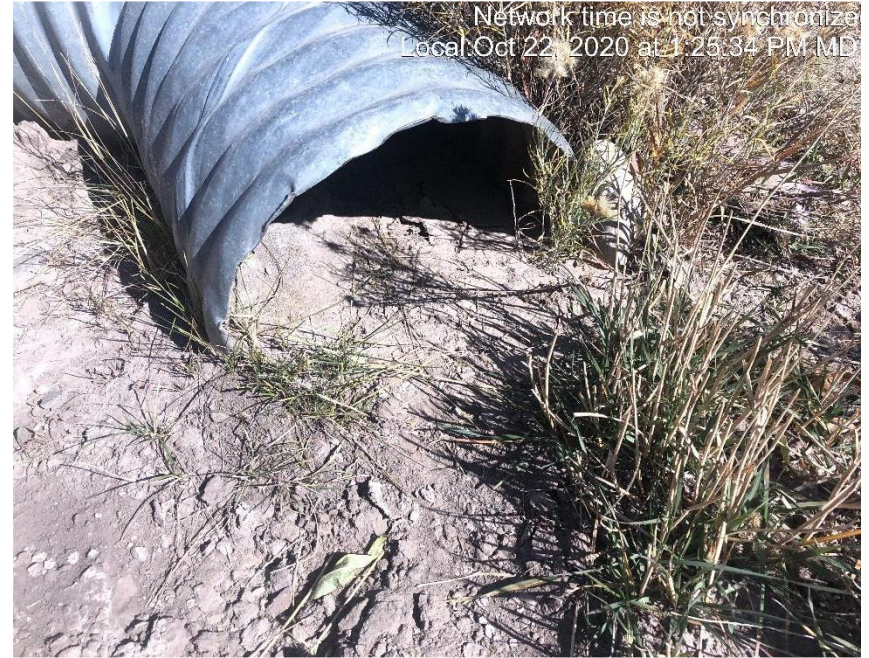
Photo #2087 Photo from inspection #699801978 conducted on 10/22/20 outlet culvert #2.

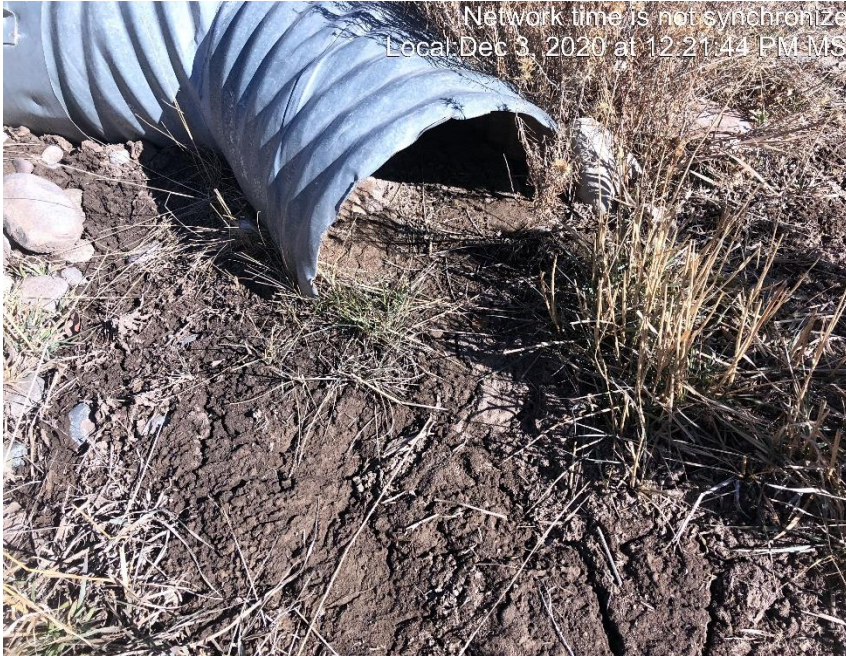
Photo #2389 outlet culvert #2.
