Inspection Photos

Operator: Hilcorp Energy
API: 067-08233
Date: 12/1/2020

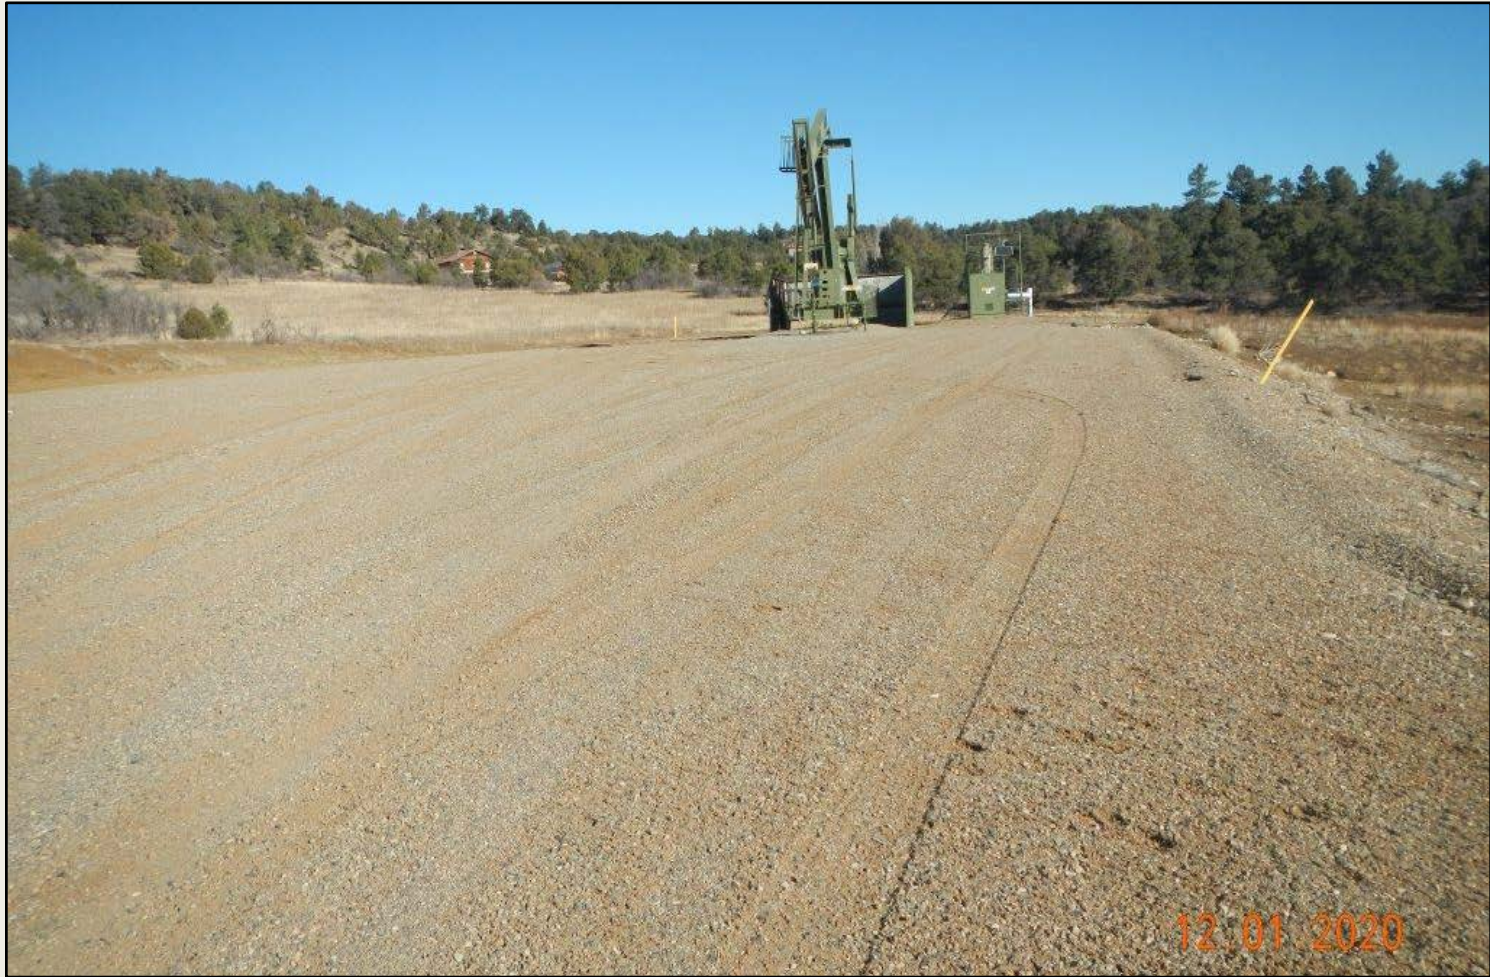
Photo 1. View of the project area from the well pad entrance facing center.

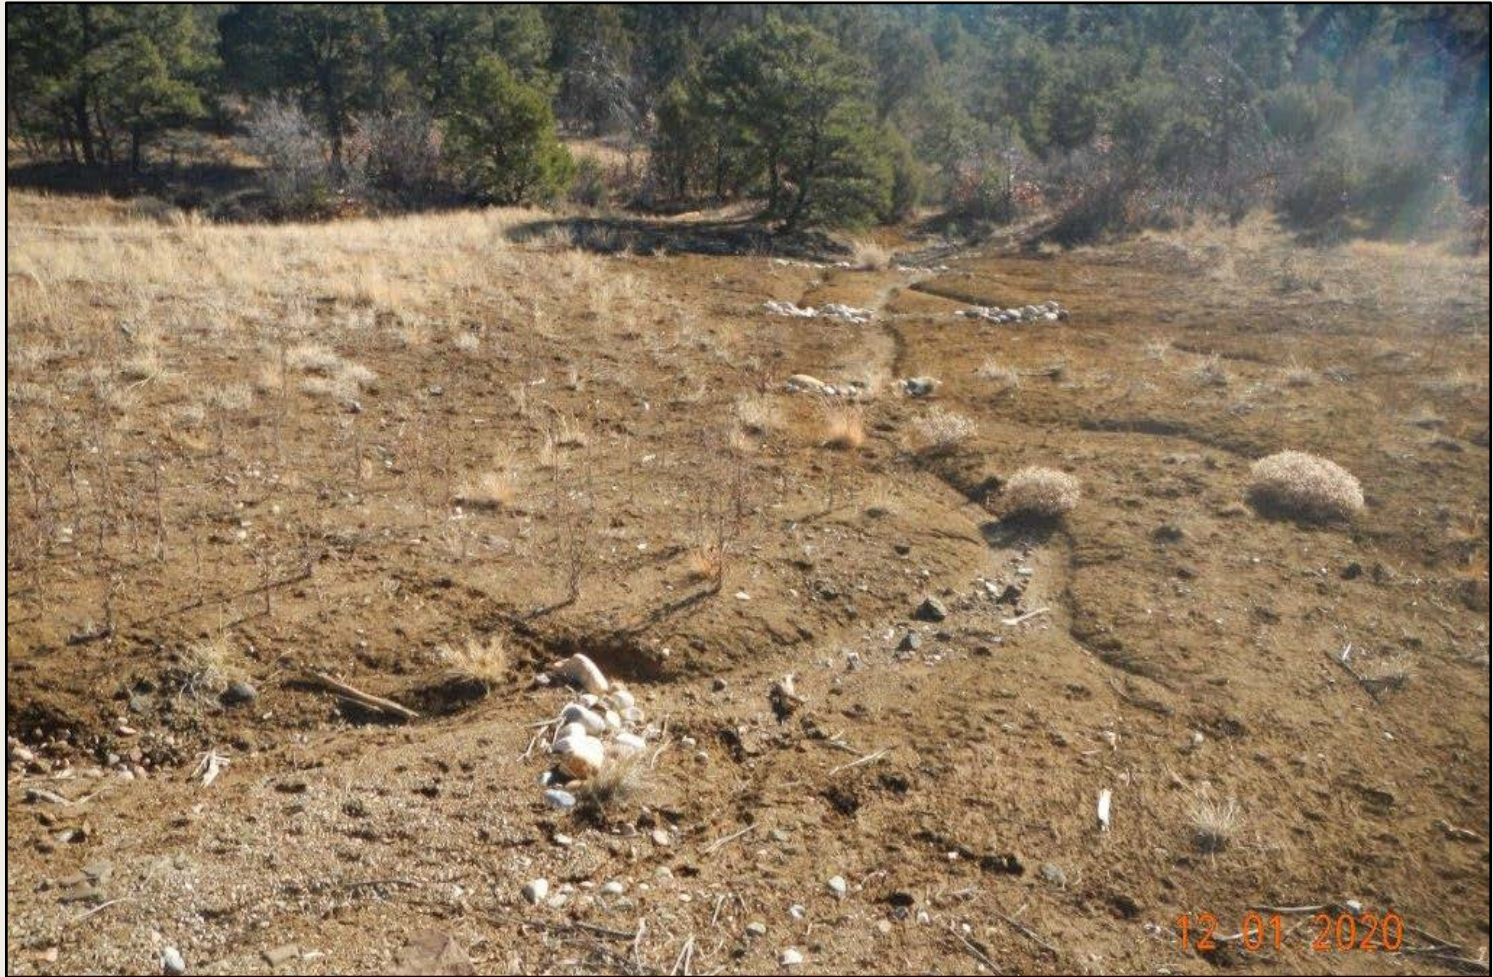
Photo 2. View of erosional channeling in the southern project area. Cobble in channels is not an adequate BMP. Bare soils in southern portions are not stabilized.

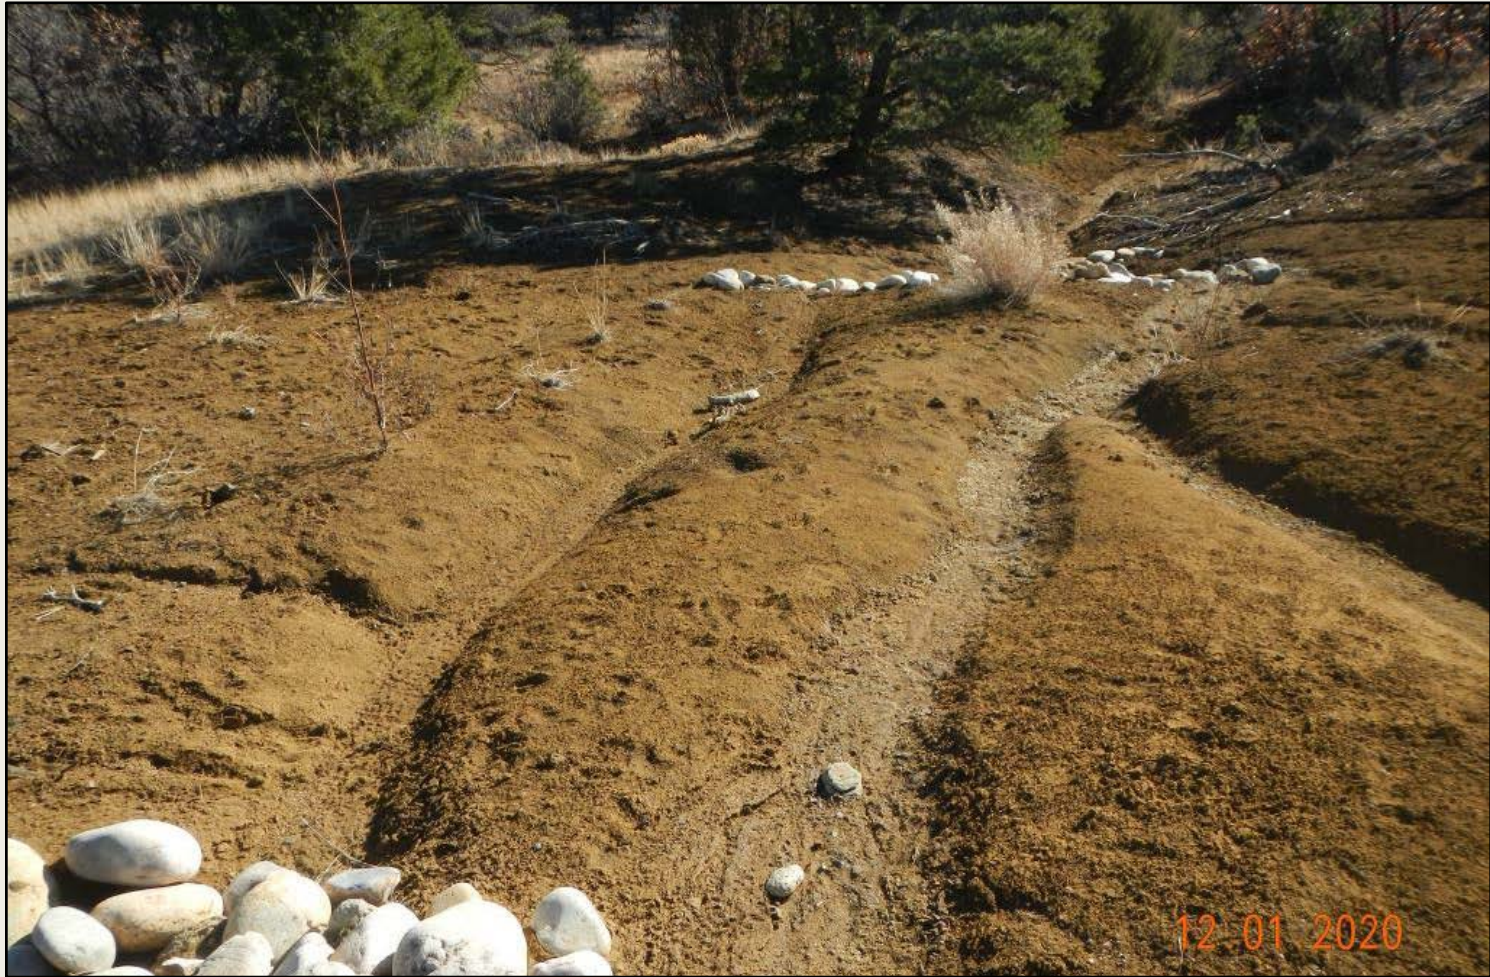
Photo 3. Another view of erosional channeling, bare soils in the southern/southeastern project area (facing downslope).

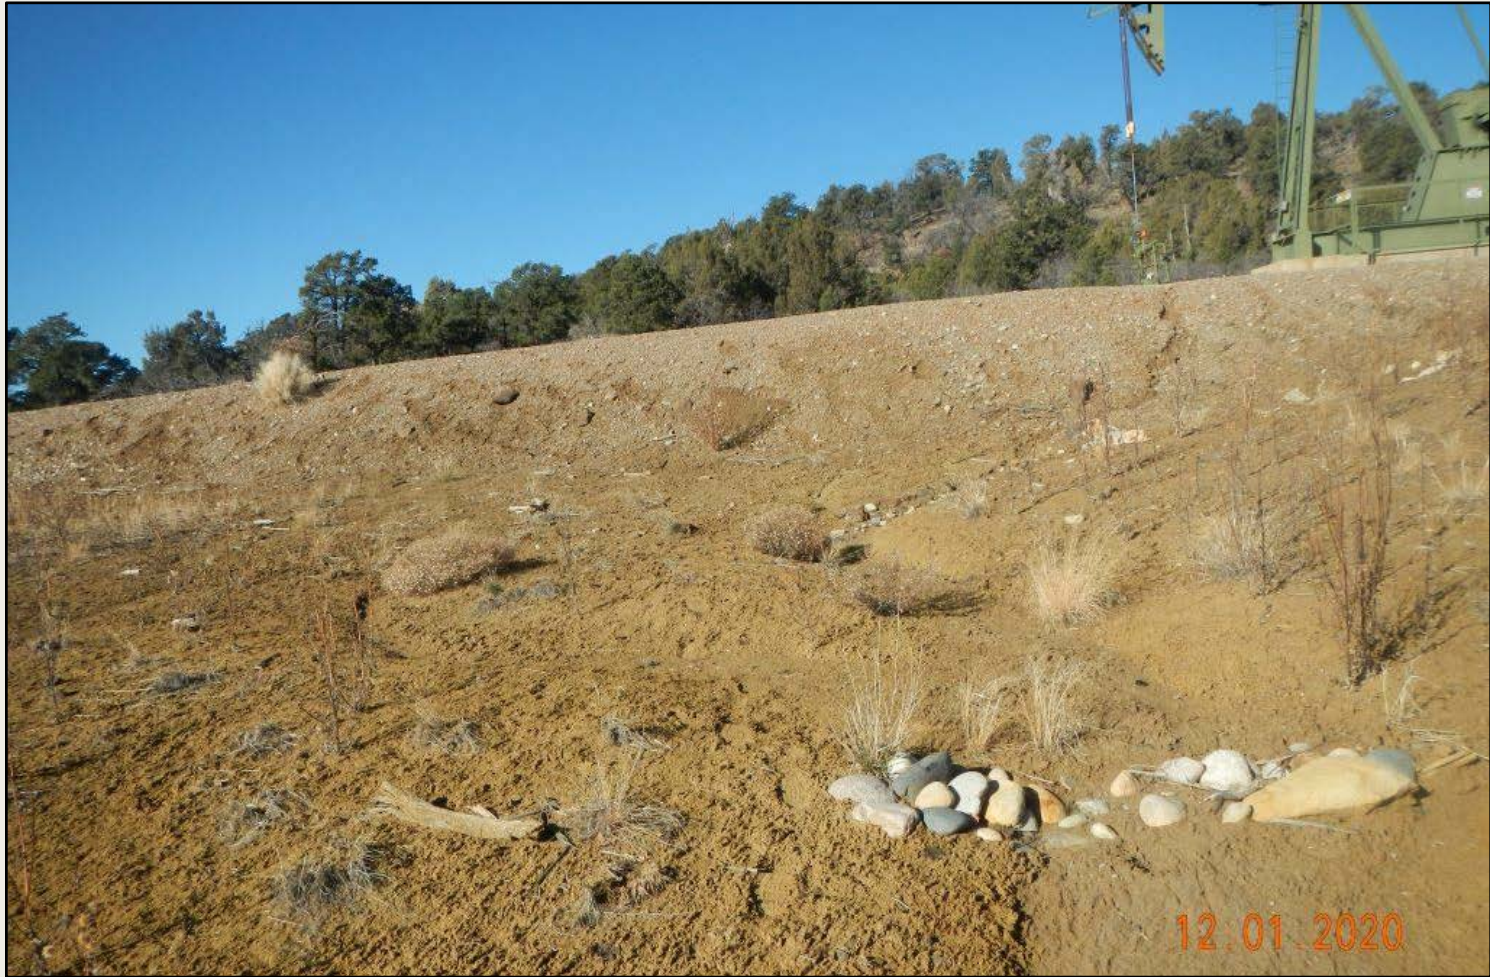
Photo 4. View of area along the southern edge of the well pad where stormwater flows off of the well pad creating erosional channels shown in Photos 3 and 4.

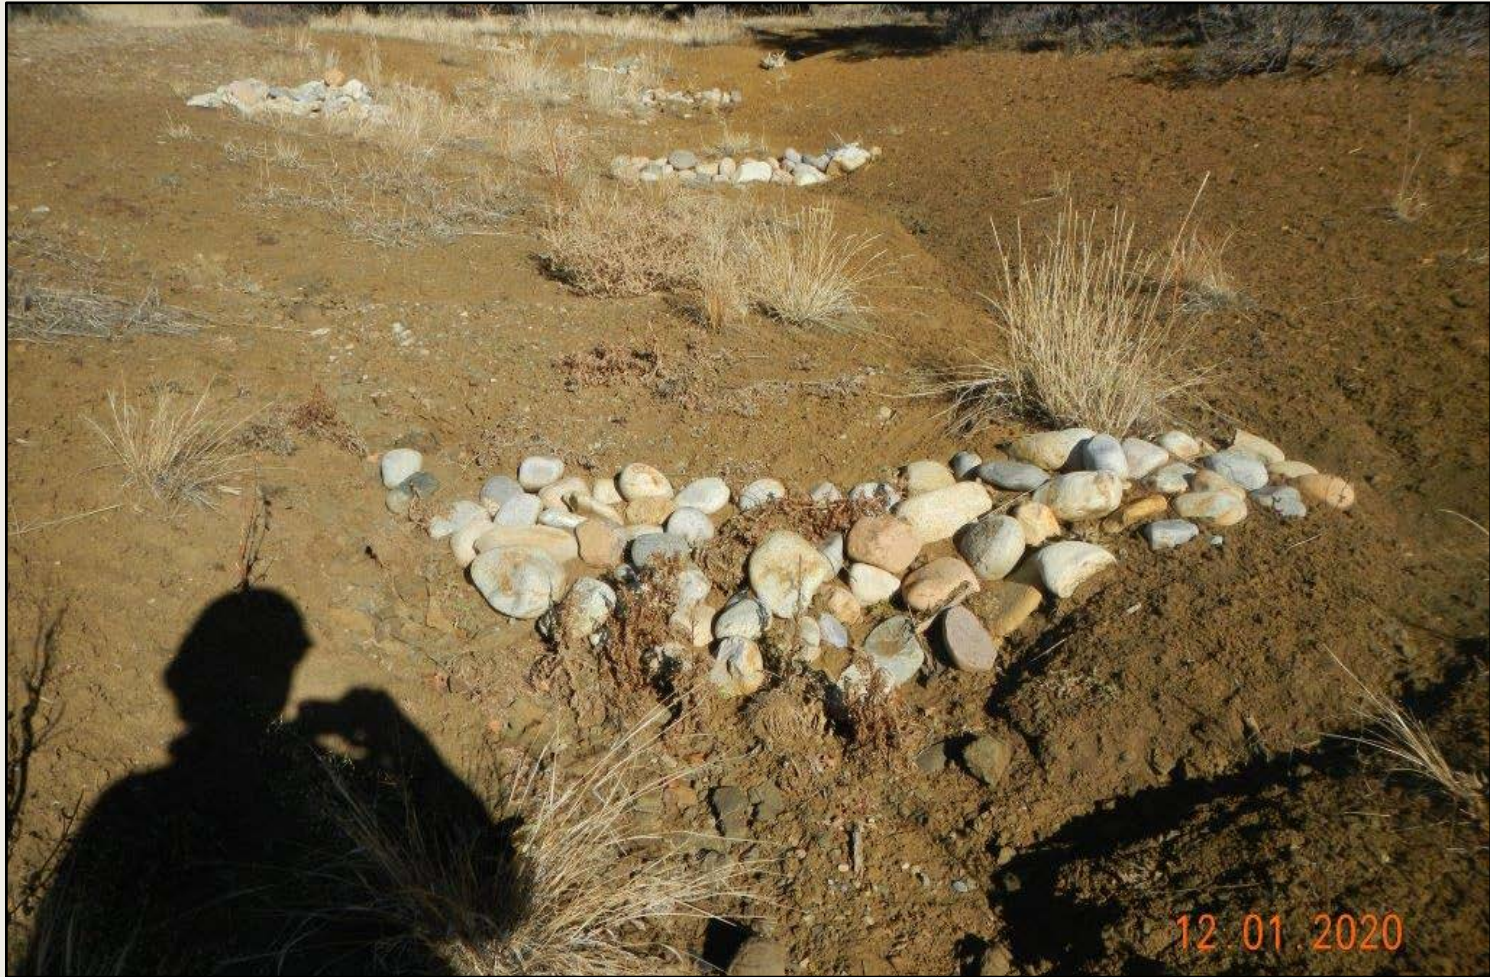
Photo 5. View of erosional channel/diversion in the southeastern project area where cobble BMPs are not adequate. Channeling around cobble, sediment deposition, and further channeling are evident. Canada thistles (approx. 50) observed during previous reclamation inspection are still present.

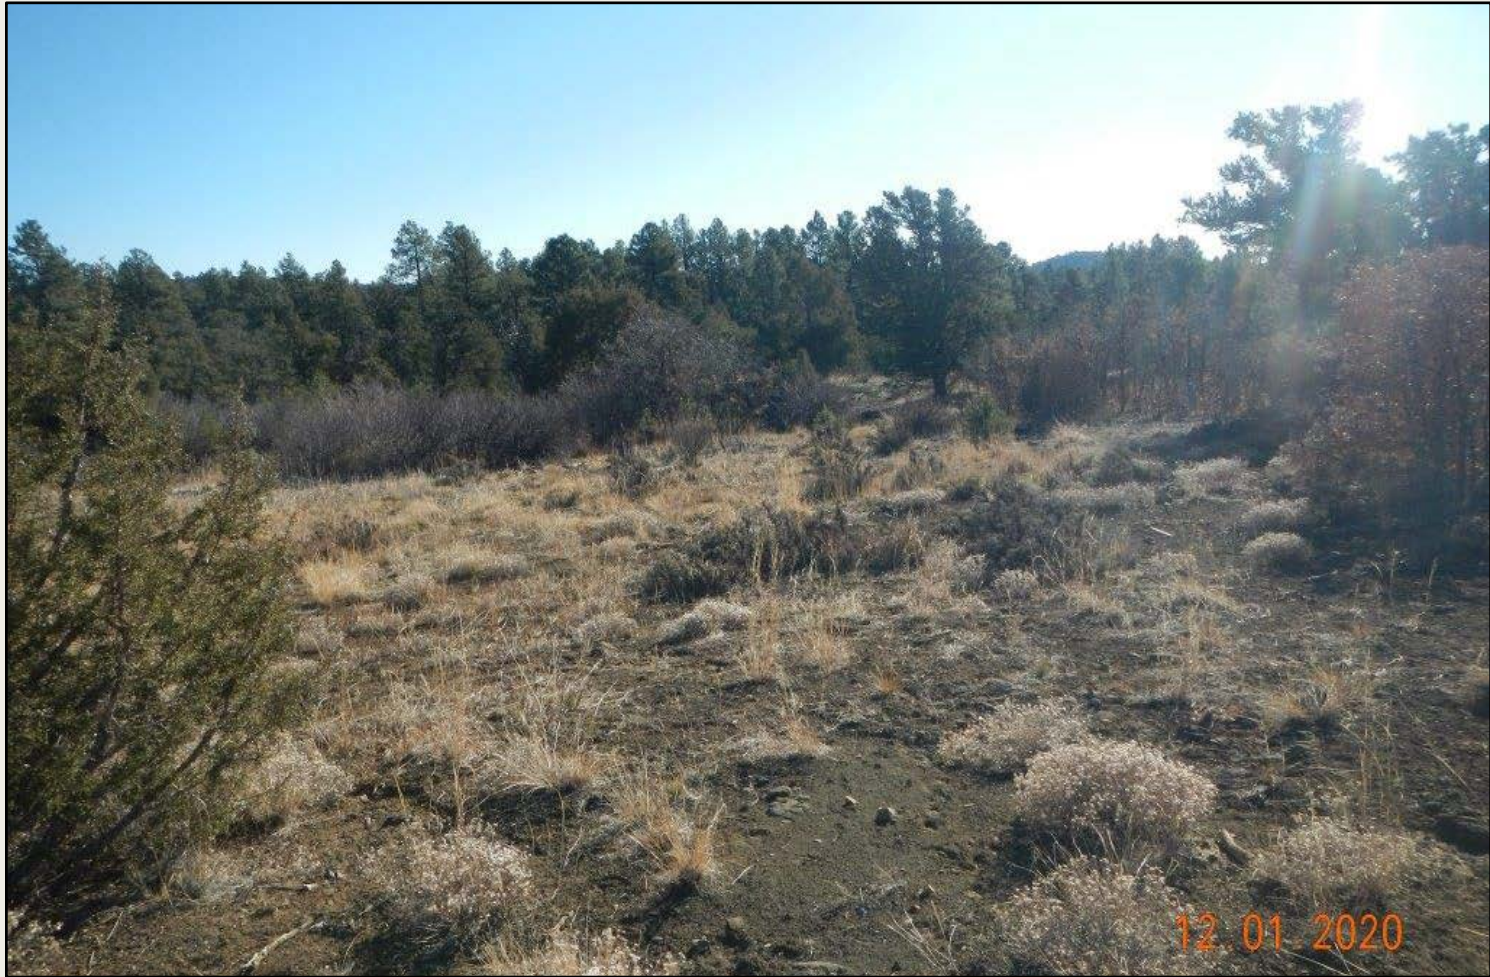
Photo 6. View of reference area vegetation comprised of pinyon and juniper woodland with gambel oak, sagebrush, and and antelope bitterbrush shrubs, along with *Heterotheca villosa*, western wheatgrass, sand dropseed, and Indian ricegrass in the understory.

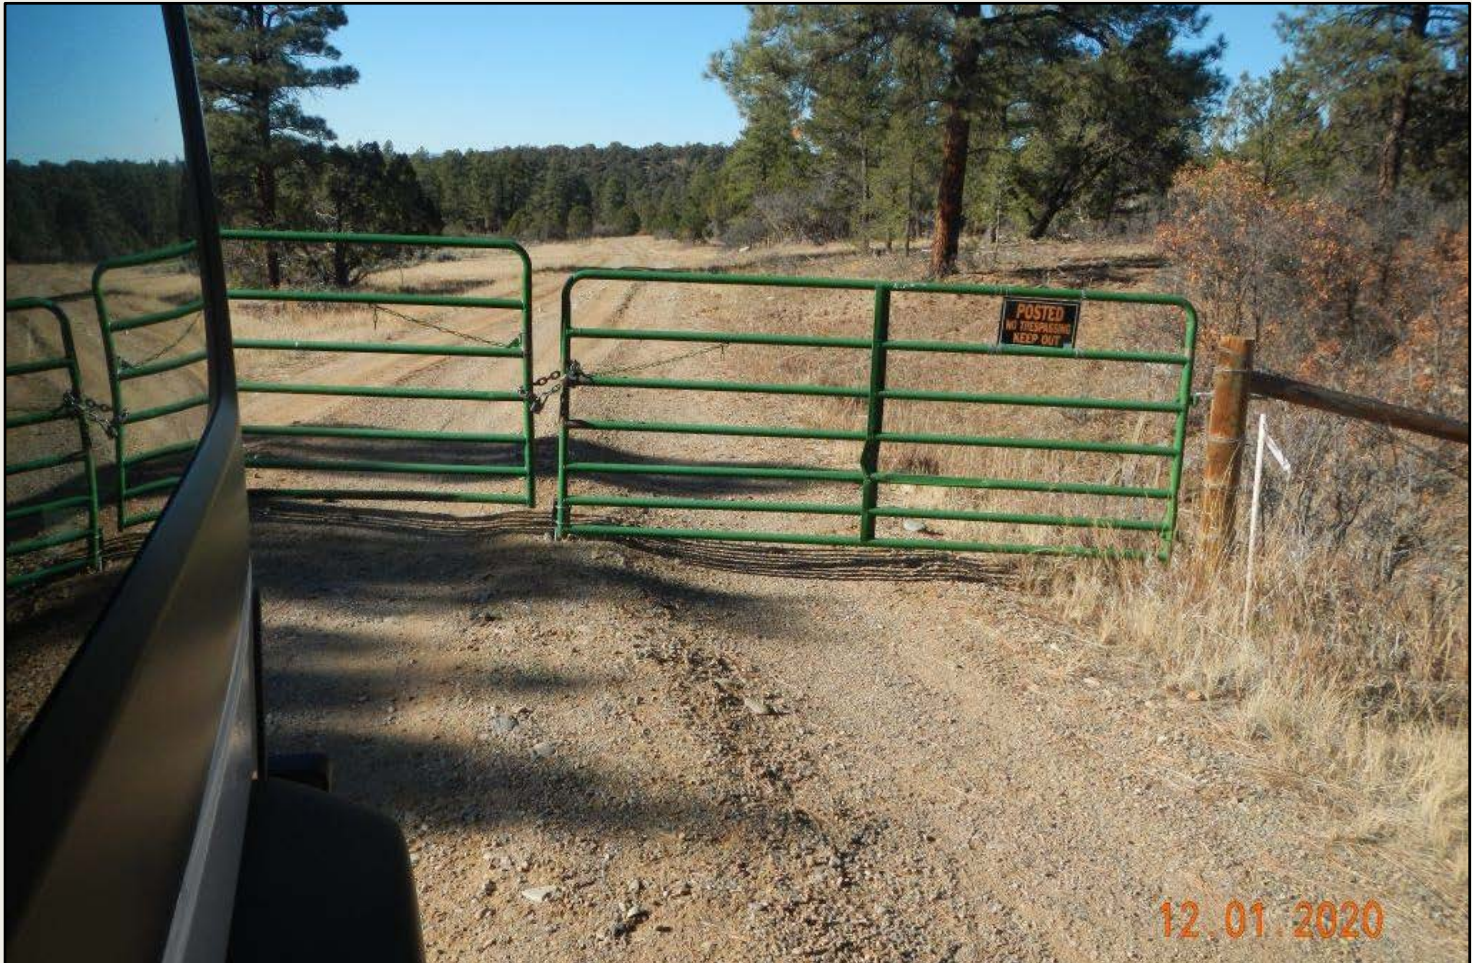
Photo 7. View of closed gate after leaving location
