Inspection Photos
Location Name: Conley 6 pad
API #: 007-06208

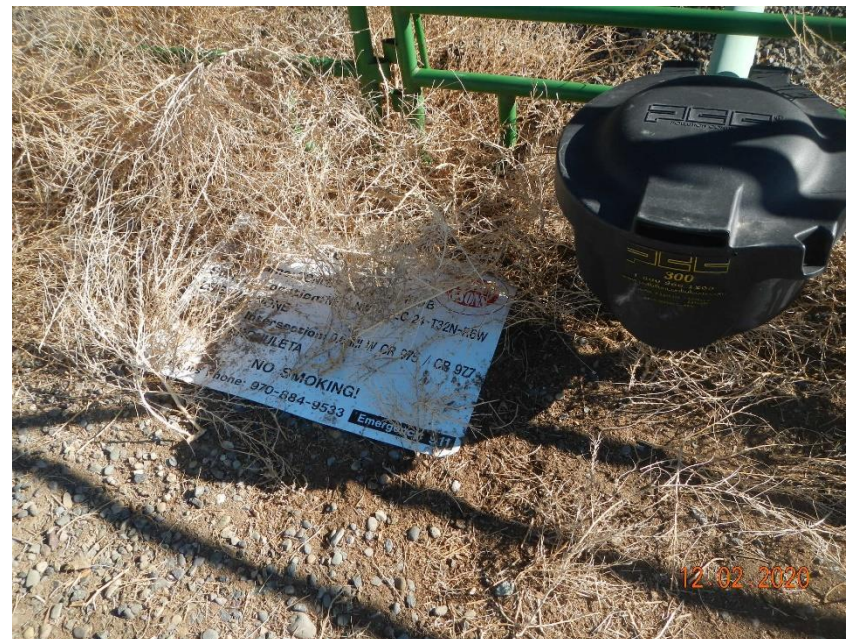
Old operator sign on ground in weeds, not visible by tanks

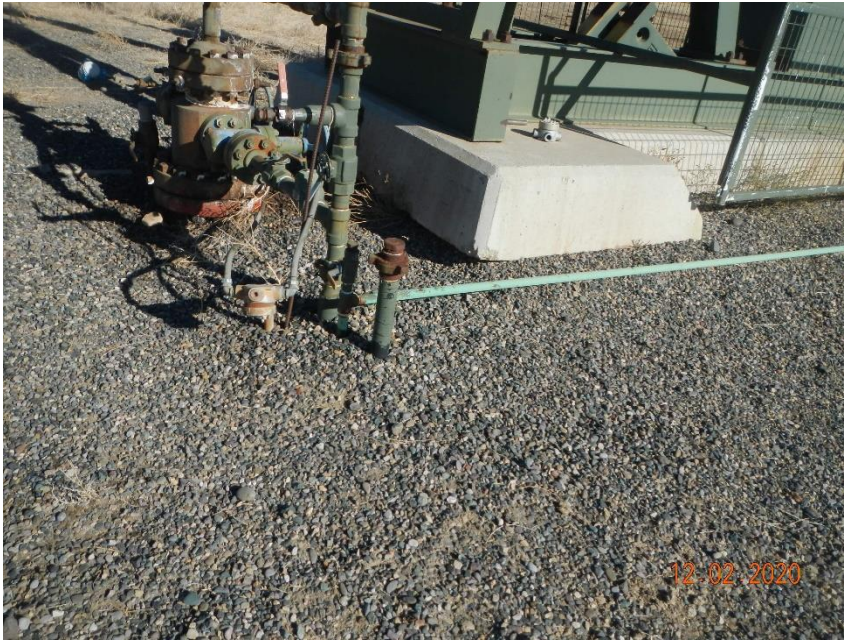
Unused and unmarked flowline riser

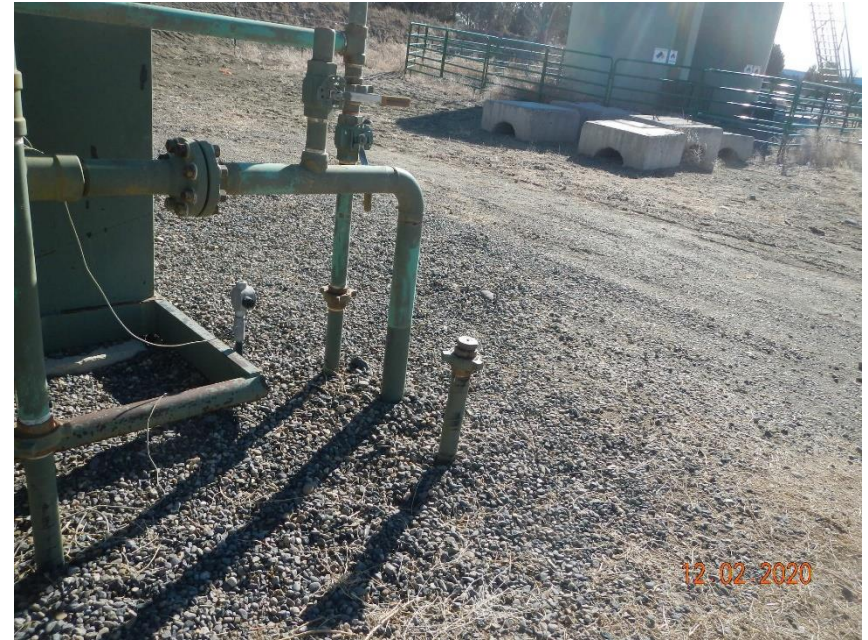
Unused and unmarked flowline riser

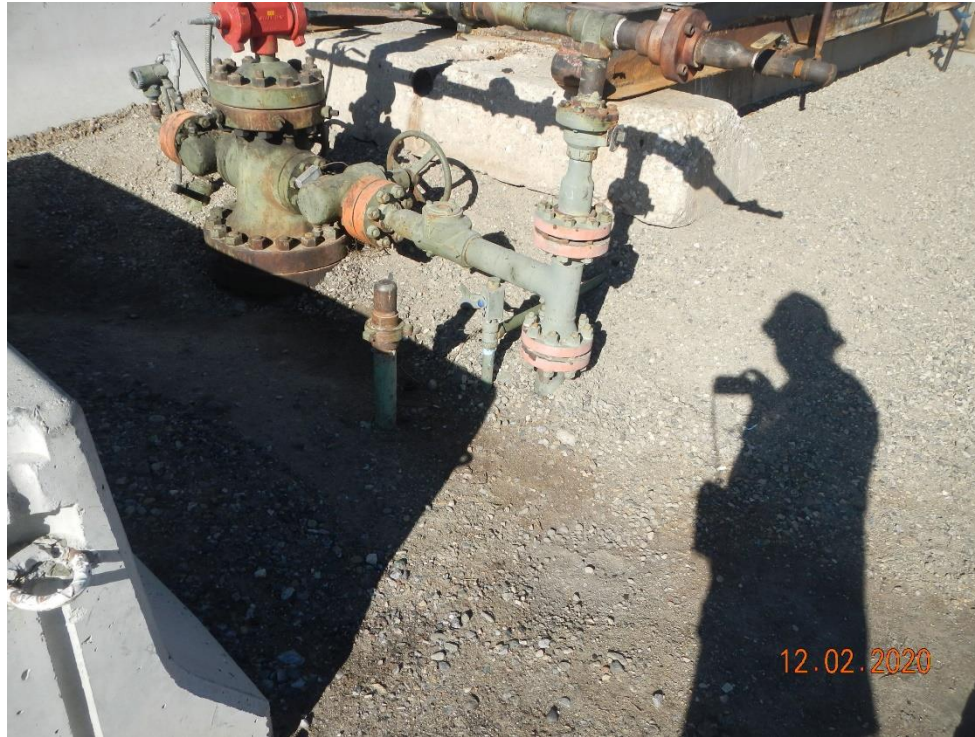
Unused and unmarked flowline riser

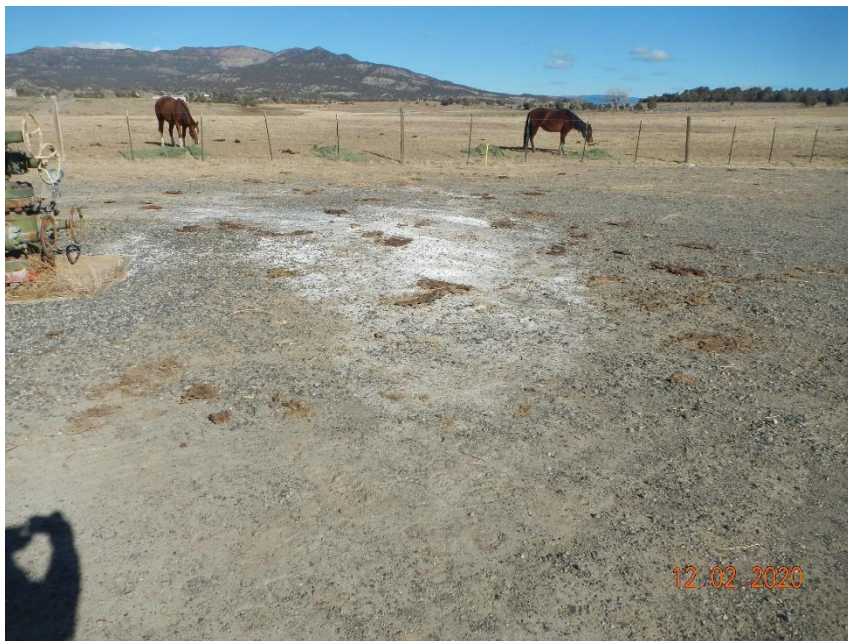
Mineral crust in flat area indicative of produced water release

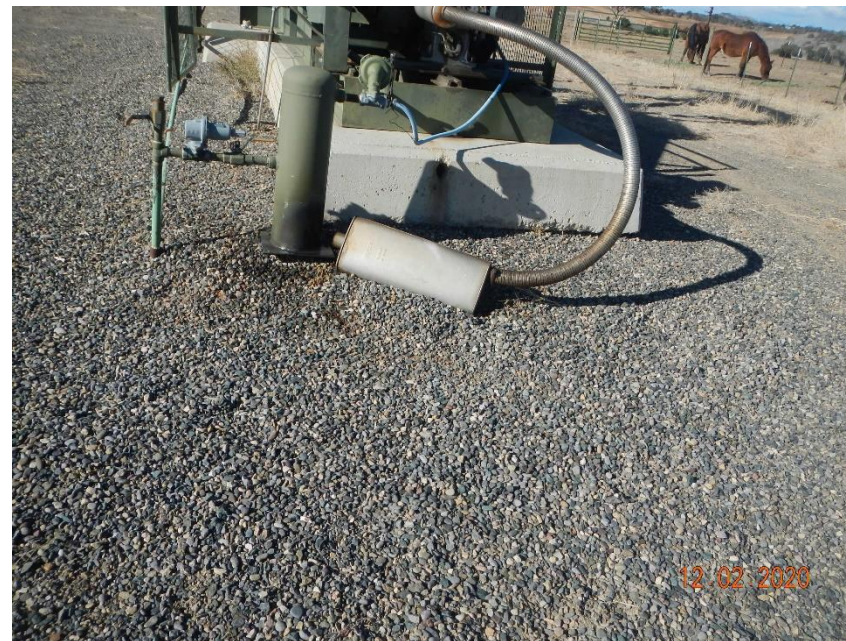
Exhaust leak

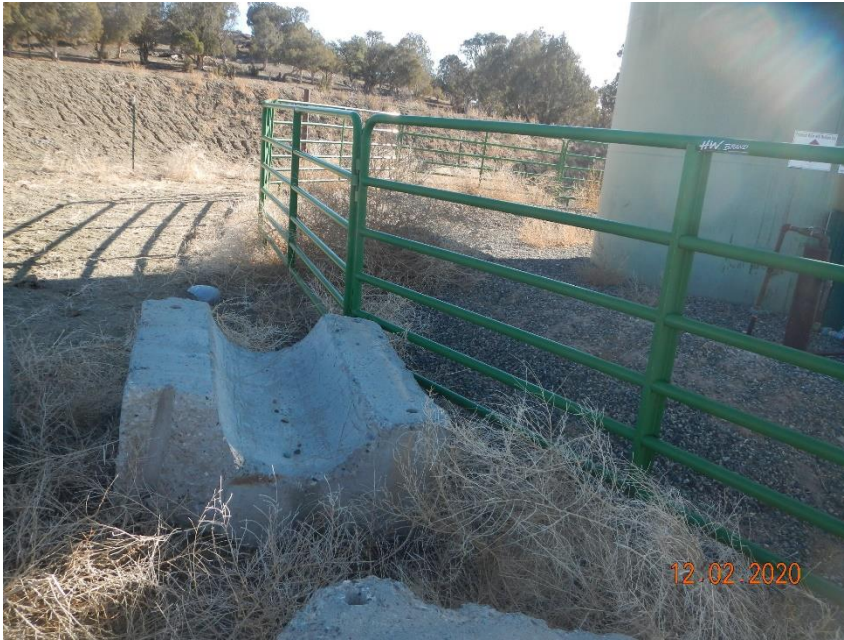
Unused concrete barriers and weeds

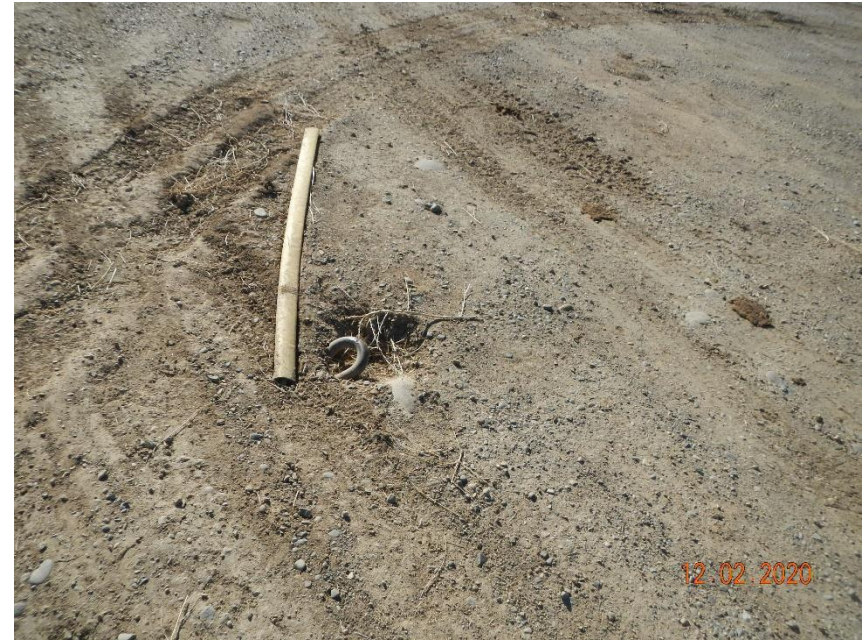
Most of rig anchor markers are down or inadequate

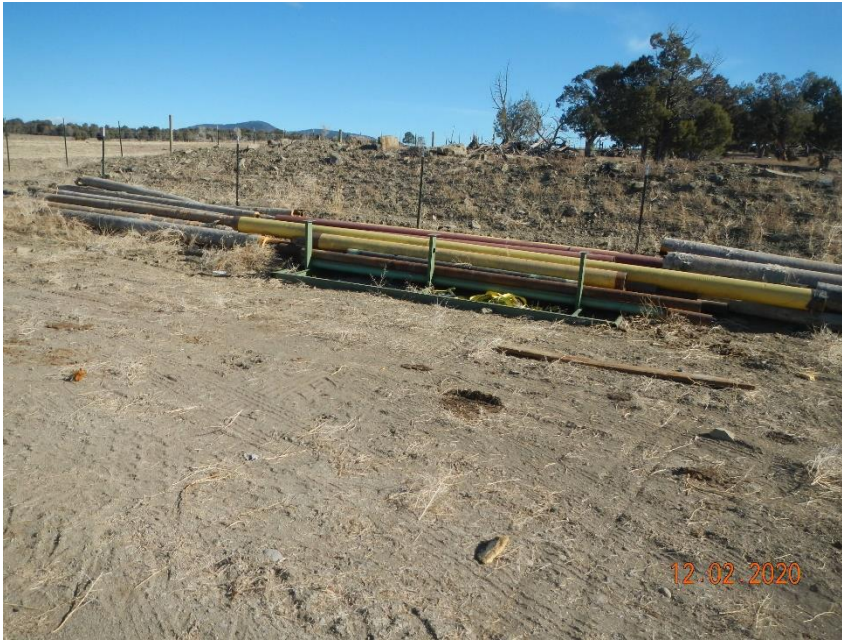
Unused equipment northeast side of location

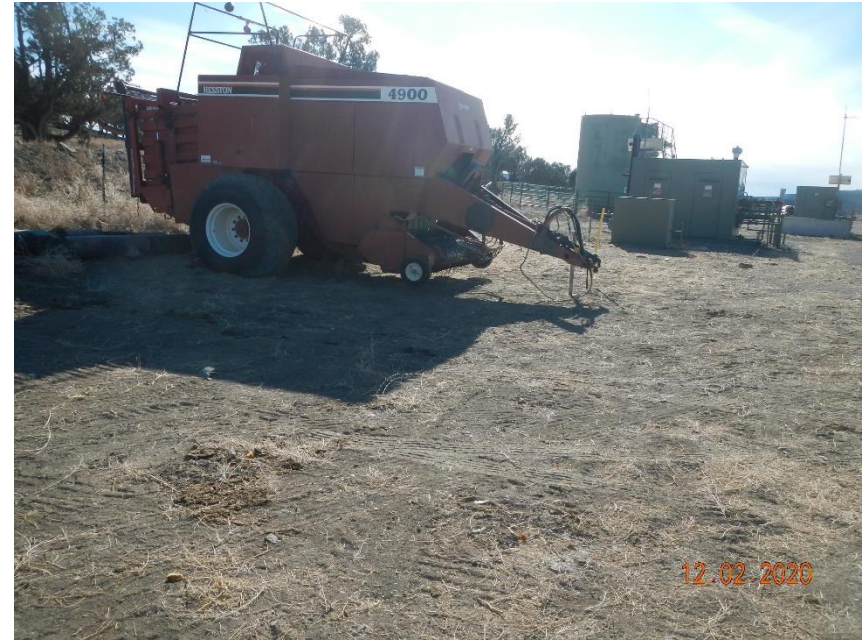
Landowner equipment

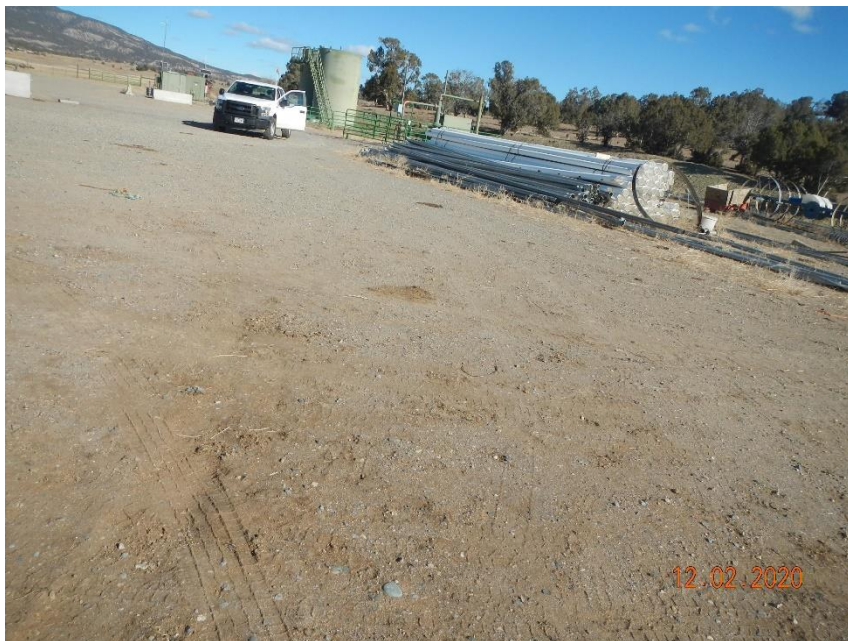
Landowner activities and storage on defined/delineated location

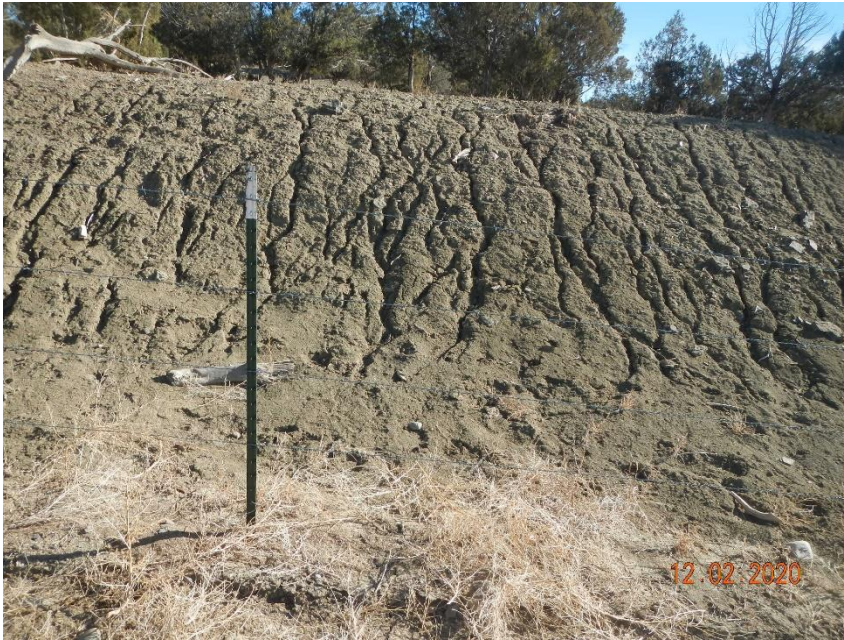
Looking east, rill erosion on bermed slope on east side of location

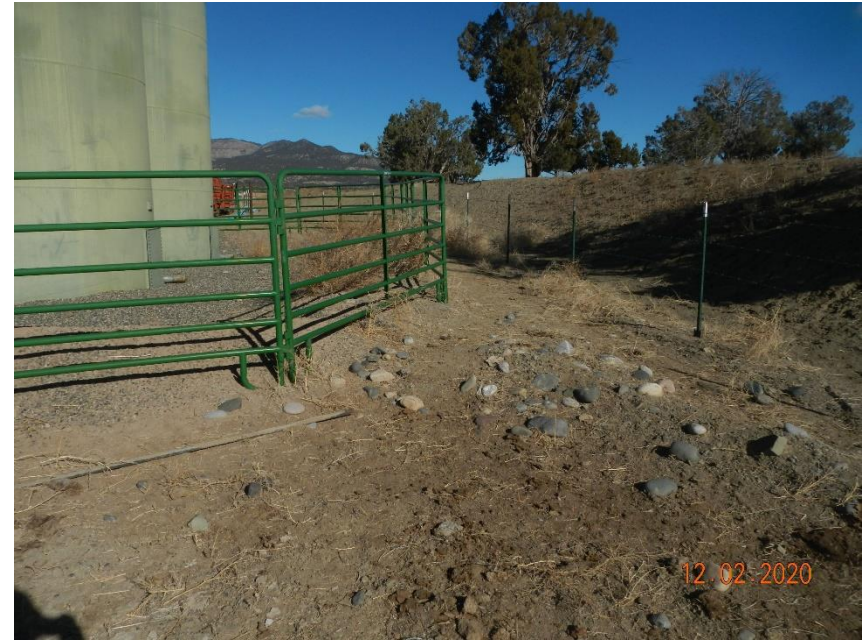
Dead dry weeds encroaching containment

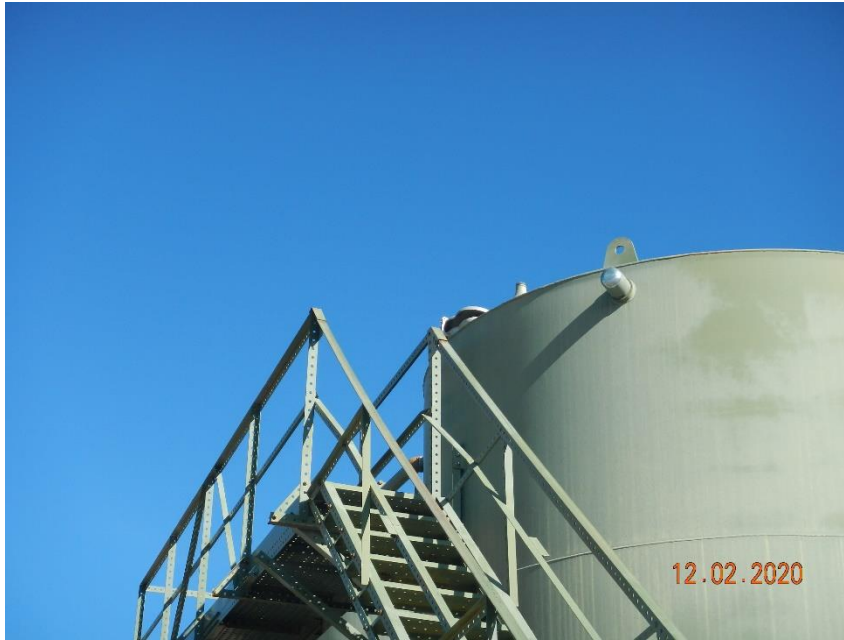
Thief hatches open 12/2/20

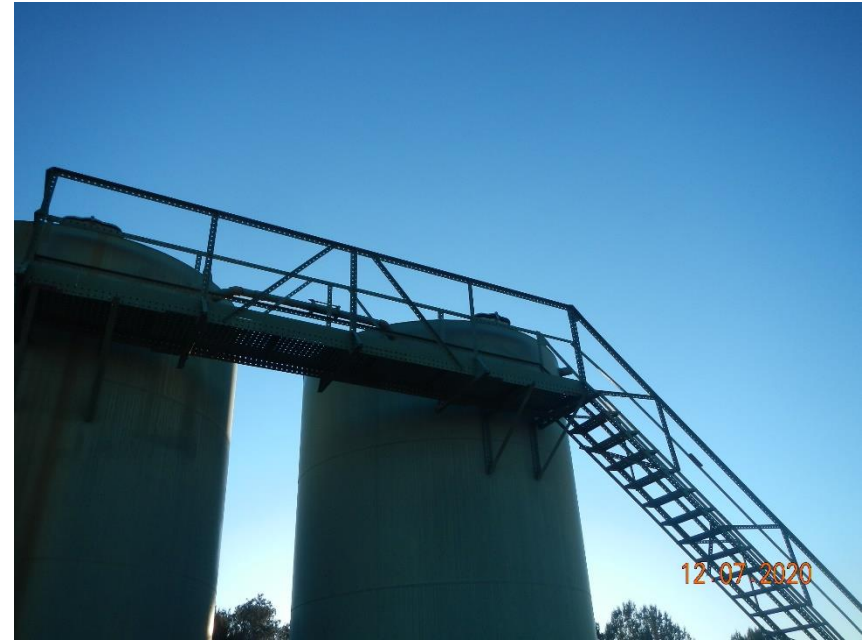
Thief hatches open 12/7/20
